## A New FLAGPOLE for Historic FORT SNELLING

## Stephen E. Osman

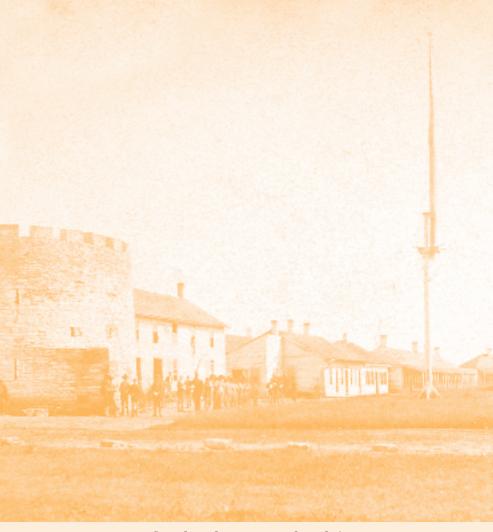
$New {\it flag pole, early 1870s, near the sutler's store}$

When regular army soldiers again took turns manning the fort after the Civil War, a new flagpole was erected near the sutler's store, about where the powder magazine had recently stood. This pole flew the flag through the 1880s while the Department of

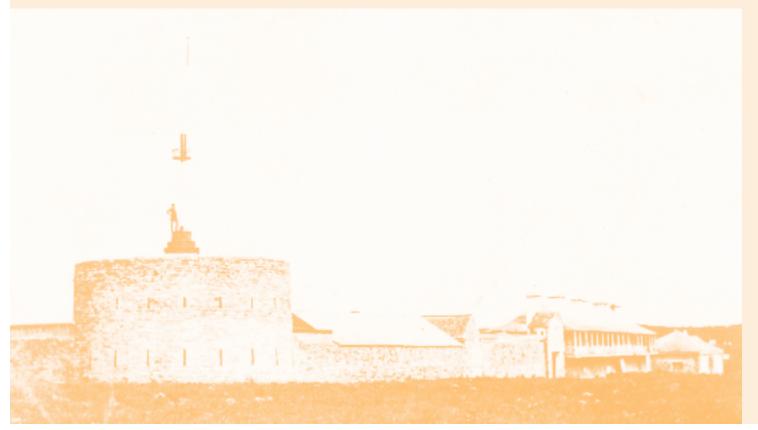
This September 1862 photograph by Whitney's Gallery provided the prototype for the 1966 flagpole.

hen the Minnesota Historical Society began reconstruction of the fort's buildings in 1966, the round tower was first on the list. Still standing after 146 years, it had been converted to a guardhouse, then a private residence and, later, to the Round Tower Museum, complete with a terrazzo floor, murals, and display cases. Removal of later additions so weakened the remaining stone walls that a foot-thick skin of new stone was added on the inside, along with conjectural replicas of historic beams, floors, and stairs. As the symbol of Minnesota's ambitious plan to recreate frontier Fort Snelling, the round tower was to fly an historic flag and sport a picturesque crow's nest on its flagpole. In 1966 the two-piece replica made from telephone poles was mounted in a solid stone "cake box," based in shape on an 1862 photograph of the pole's more likely wooden base.

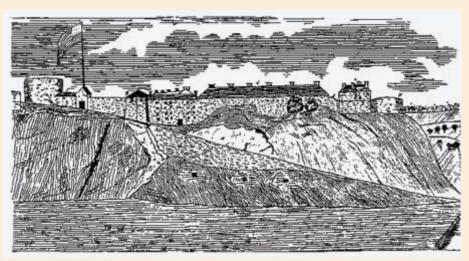
Sketch by Surgeon Nathan Jarvis, 1833, showing the flagpole rising high above the fort's walls and in front of—not on top of—the round tower

ocumenting the physical changes made to Fort Snelling in the decades before photography is a challenge. Quarterly inspection reports are incomplete, and letters requesting permission for construction are few and scattered. Only two maps show the original location of the flagpole. Fortunately, an 1833 sketch by fort surgeon Nathan Jarvis, several drawings by Lt. Seth Eastman, and a sketch by George Catlin corroborate the maps and clearly show a flagpole rising well above the walls in front of-rather than on top of-the round tower.

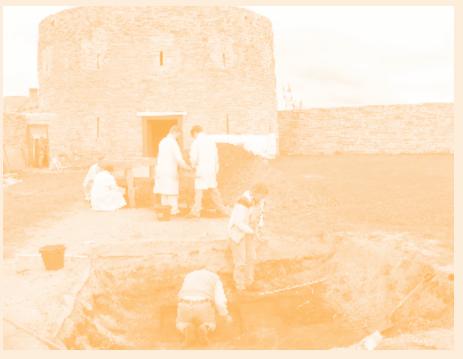
Archaeologist Patricia Emerson and Fort Snelling guides excavating for evidence of the original flagpole

archaeological methods practicum opened four adjacent one-meter test units under a visitor path in front of the tower. Their excavation site was based on measurements in Lt. James McClure's 1835 map of the fort grounds. In a thin layer of undisturbed soil just above bedrock, the students found remnants of a rectangular intrusion. This was all that remained of a roughly 55-inch-square sand-filled pit that had at some time been dug about 28 inches (from current grade) down to bedrock. While archaeologists did not find the expected footings cut into the bedrock, the location of the pit was precisely where McClure's map indicated the pre-1838 flagpole had stood. Unfortunately, major grading of the area in 1958 had destroyed evidence of the four footing braces typically used to support nineteenth-century flagpoles.

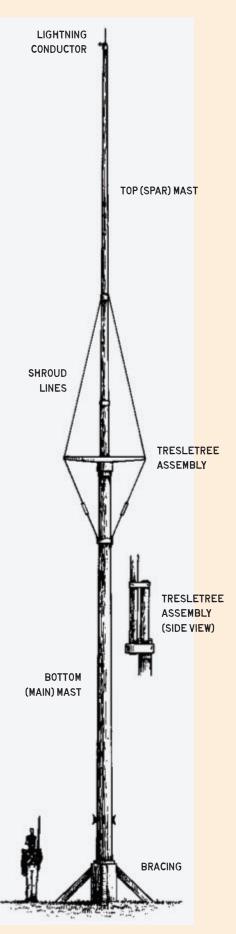
Flagpoles in the nineteenth century shared design elements with ship masts. They were stepped, with a bottom mast and smaller top mast overlapped and connected at the center through an iron trestletree and with iron ring bands. Shroud lines fastened to iron bands on the top and lower mast ran through the ends of wooden cross spars above the trestletree to stabilize the two sections. Mortised into the base of the topmast was a pulley, through which a rope was run to enable the topmast to be lowered or raised through brute strength of a crew of soldiers. The base of the flagpole was braced with four heavy timbers set into the ground at an angle. Below ground, a wooden crib filled with stones might have been used to further stabilize the heavy pole and take the wind load.

Bracing the flagpole against wind load from the huge flag proved a design challenge. Two hundred years ago, an underground crib with rocks and aboveground wooden braces might have provided stability for many poles. However, shallow bedrock at Fort Snelling prompted us to use a reinforced concrete foundation bolted to the bedrock; the other modern alternative would have been drilling a hole ten feet down through the limestone. While we retained the wooden braces as a visible feature, the underground concrete provides added stability. A few other comprises were made for longevity. Lightning protection was essential, but the rod on top is spring mounted so that a flag caught over its point can still be lowered. The lower mast is mounted in a steel sleeve solidly attached to the footing but concealed by a

wooden framework. Galvanized steel fittings are on both masts, and galvanized steel cable-shroud stays some 40 feet above the ground replace the hemp rope used in the nineteenth century. This new design ensures that repairs and adjustments will not be needed for many years. Fort Snelling no longer has skilled military craftsmen on hand to perform this oncefrequent maintenance.

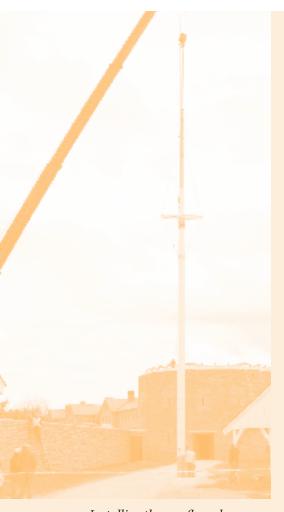
Cabinetmaker Charlie Nielsen working to square each round mast where it will overlap the other

nearly 100 years, stepped in with rough-turned Douglas fir logs originally slated for use as utility poles. A Minnesota shipwright had agreed to finish the masts but was forced to cancel when the log delivery was delayed. Marc Cutter of Fox Creek Builders then served as a liaison between architect Claybaugh and a team from Nordic Woodworks: cabinetmaker Charlie Nielsen and machinist Dan Gates.

In November 2006 the two huge logs were delivered to the 1904 cavalry stable next to the fort's parking lots. Meanwhile, archaeology at the site for the massive new concrete base revealed no additional clues about the original construction, and so the concrete footing was poured. Nielsen, Gates, and Historic Fort Snelling

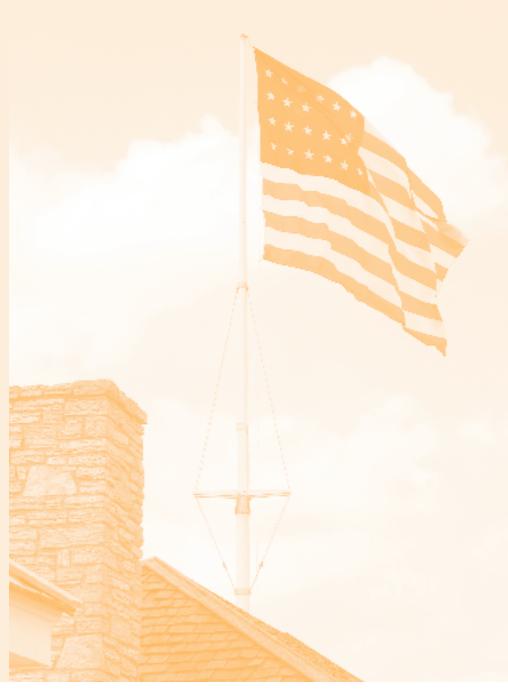
Installing the new flagpole, May 2007, and the replica garrison flag once again flying over the fort

woodworker Paul Cusick worked into May, building a giant lathe, shaping the two masts, assembling all of pieces, and, finally, installing the new pole. A replica 24-star garrison flag was raised for the first time in a commemorative ceremony on Memorial Day weekend 2007.
