## TEST & EVALUATION REPORT

### Shingle Rejuvenator Benchmark Life-Cycle Study

September 3, 2024

**Report For:** RoofRestor Rejuvenator  
Saskatchewan, Canada

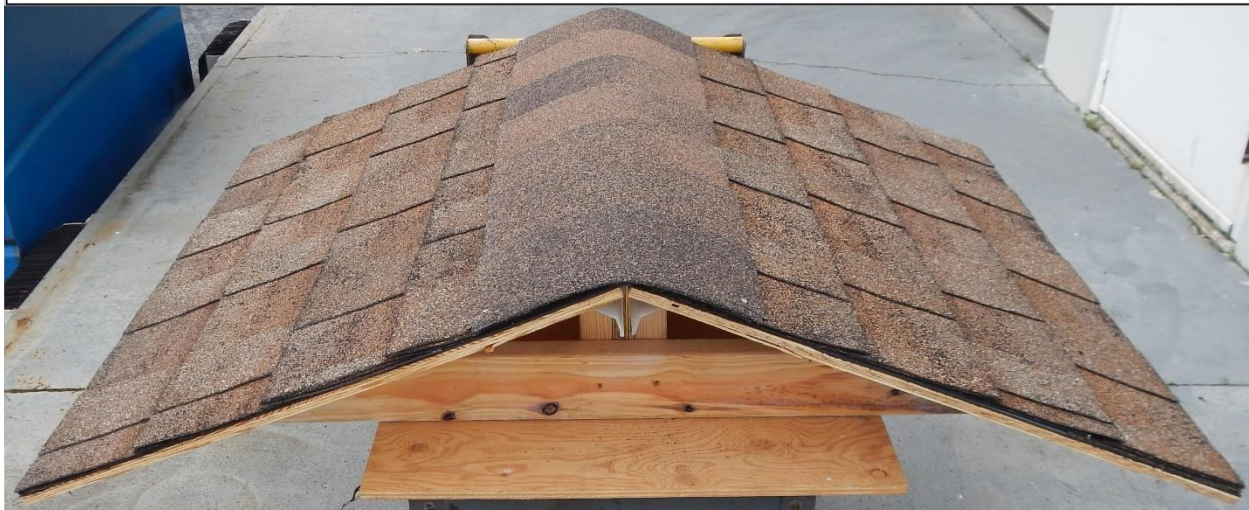
### APPENDIX A-1 (Roof Deck Construction):

#### Completed Roof Deck Before Rejuvenator Application

A type of common, commercially used ridge-cap shingles were then cut and applied to the cap of the roof deck. The cap was selected for the closest visual match to the shingles used.

The study used a miniature steep sloped roof, constructed at PRI made with commonly used stock material (2X4's, plywood, peel-n-stick underlayment, and stainless-steel roofing nails). Both slopes were roofed with the aged shingles, with one side being treated with RoofRestor rejuvenator and the other side being an un-treated roof deck. The rejuvenator was applied according the manufacturer's recommendations. See appendix for photos and details of construction

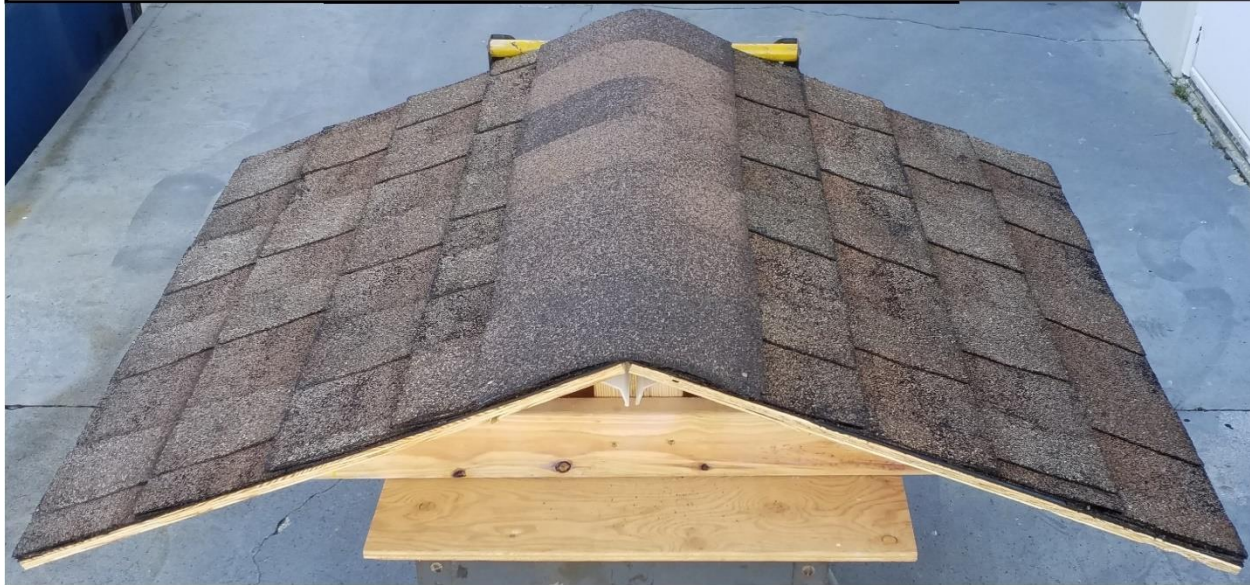
### APPENDIX A-2 (Roof Deck Construction):

### Roof Deck After Rejuvenator Application

The RoofRestor Rejuvenator was prepared and applied according to manufacturer guidelines using common garden spray bottles and allowed to cure for 24 hours:

- Manufacturer recommendations – A mixture of 70% water and 30% Rejuvenator concentrate stirred by hand to homogeneity.
- The product was applied were to one side of the roof deck at a target rate of 1 gallon per 100ft<sup>2</sup> using simple spray bottles.
- The other side was left un-treated.

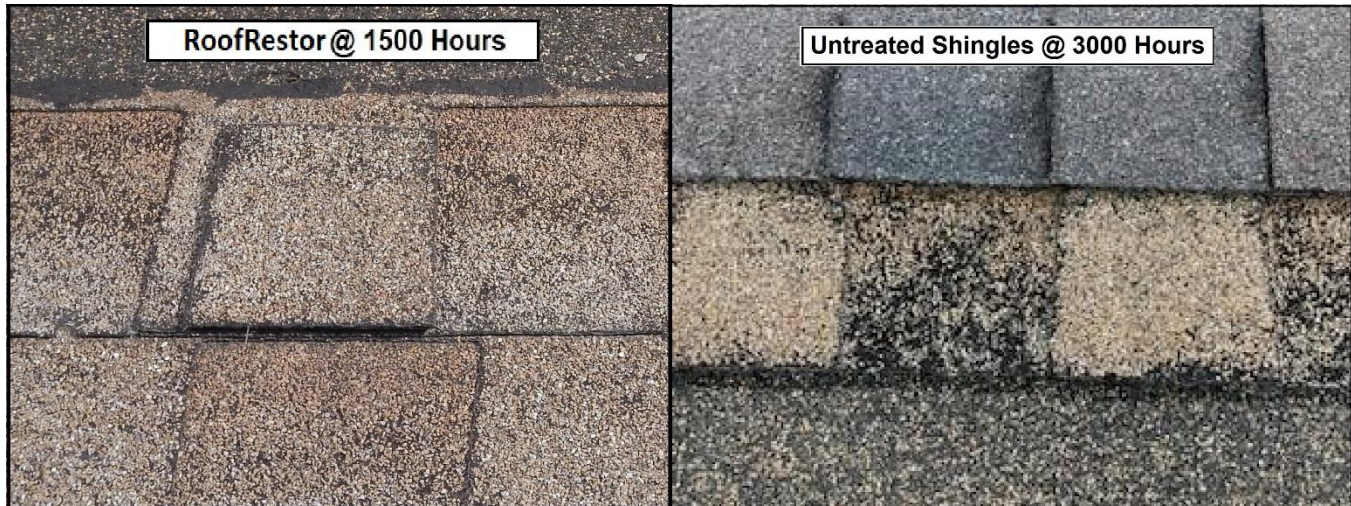
### APPENDIX A-5 (Shingle Appearance Comparison – ~3000 hours):

There is a notable difference in appearance between the untreated and treated shingles after 3000 Hours.

- **Shingle Flexibility:** After 1,500 and 3,000 hours of exposure, RoofRestor Rejuvenator improved low temperature flexibility from -22°F to -31°F.
- **Shingle Color and Appearance:** After 1,500 and 3,000 hours of exposure, the shingles treated with RoofRestor Rejuvenator exhibit a significantly different appearance than those left un-treated.

- Un-treated shingles show a clear increase in the roofing granules lost. (Appendix A-4/5)

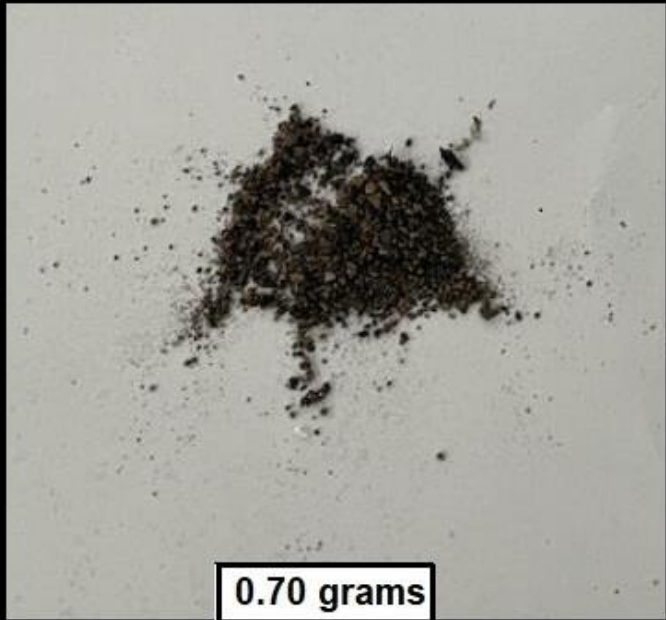
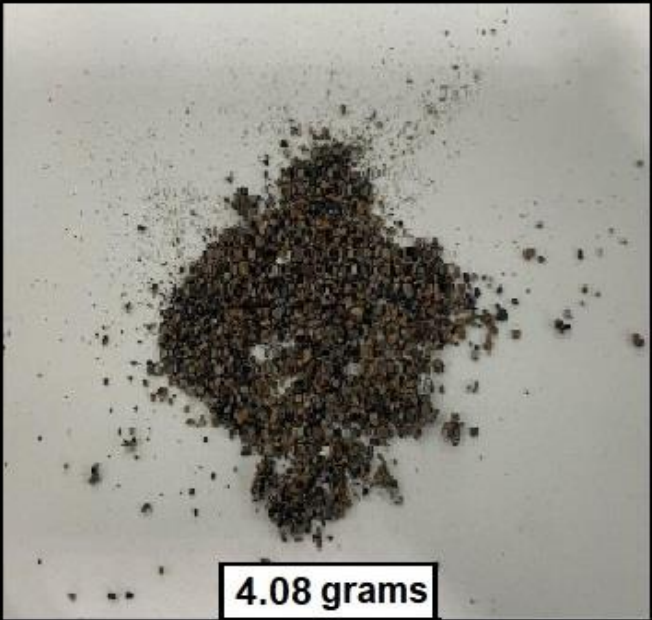
### APPENDIX A-6 (Granular Wash off Comparison – ~1500 hours):

RoofRestor	Un-Treated Shingles

0.70 grams	4.08 grams

Granules and particulate washed from the roof decks after 1500 hours of exposure. Particles have been filtered from the accompanying runoff water and dried for quantification.

- After 1,500 hours of exposure the mass of the collected particulate from the un-treated shingles was 4.08g compared to 0.70g for the RoofRestor' rejuvenator.
