# Confidential Inspection Report

LOCATED AT:  
Leaf Ln  
Felton, DE 19943

INSPECTED ON:  
Monday, February 17, 2020

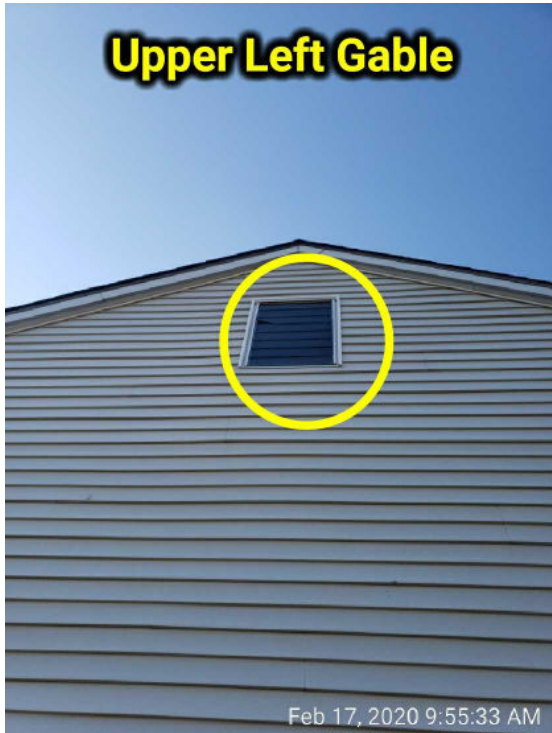
**REPA** 1: Cracked or broken glass was observed in the basement. We recommend immediate replacement for all cracked or broken windows. This is a safety concern and should be addressed.

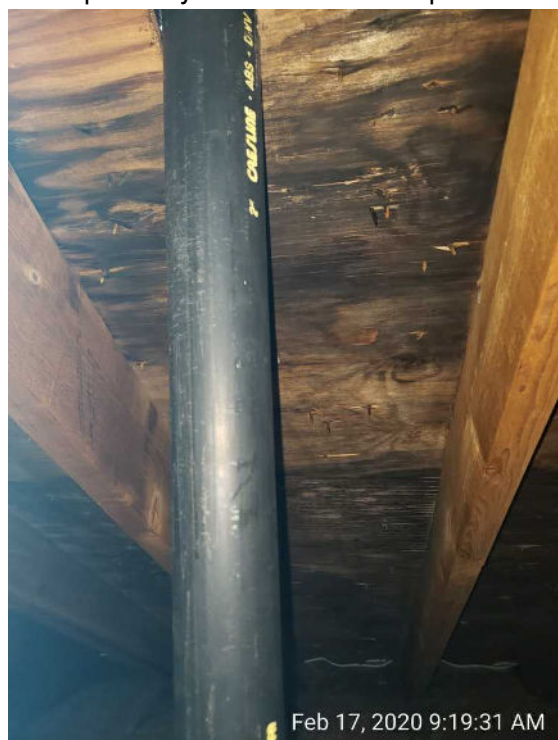
**REPA** 2: A mold like substance or growth was observed at the attic. We recommend repair or replacement as required by a licensed mold specialist.

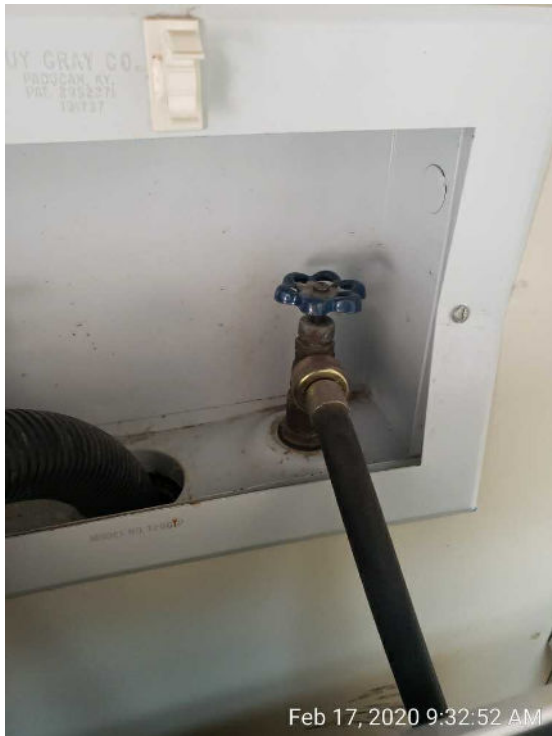
**REPA 3:** Frozen in place water valve(s) were observed in the laundry area at the washer supply bib. Attention to the water valves is required in order to shut water off to the appliance. We recommend that any leaking valve be repaired or replaced as required.

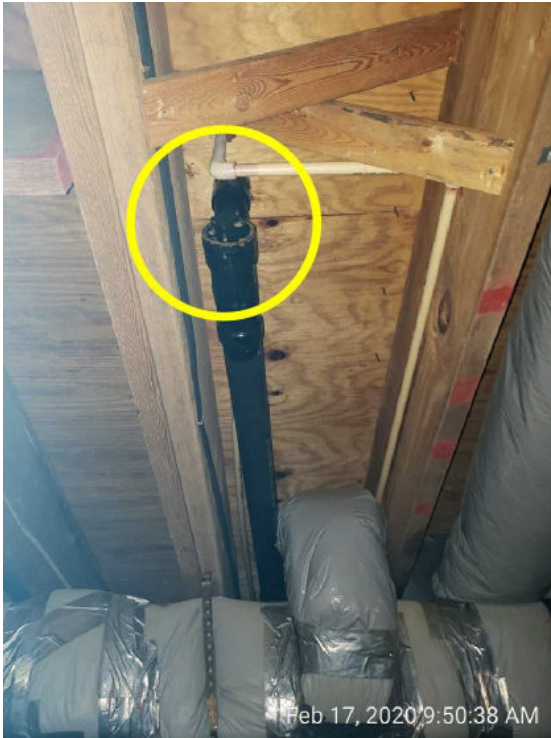
**REPA** 5: Leaking drain/waste pipes were observed. Attention to the leaking pipes is required for damage control as well as health issues. We recommend that the leaks be repaired as required.

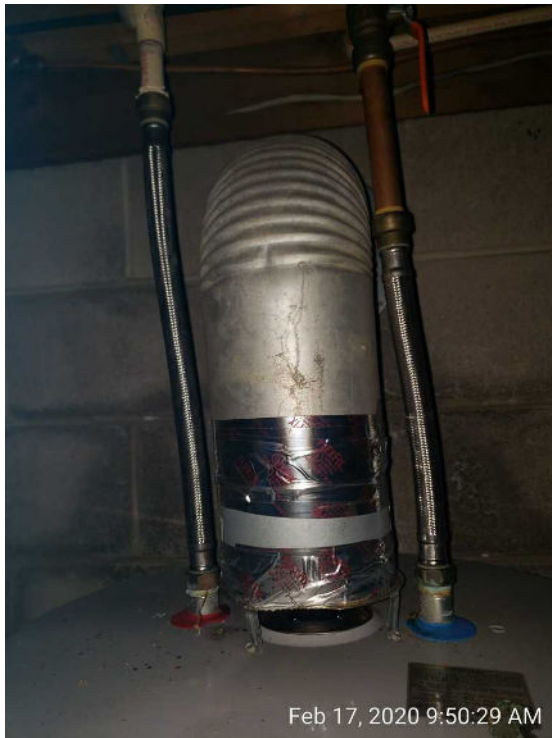
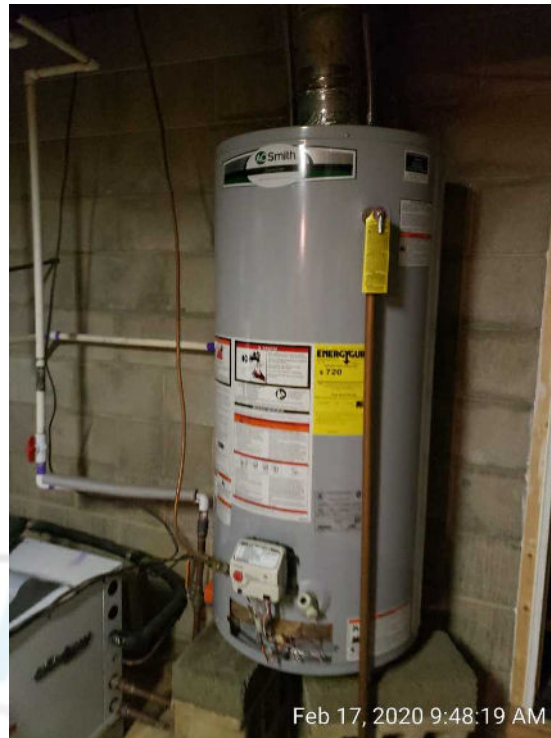
We recommend repair or replacement as required by a licensed contractor to ensure proper venting

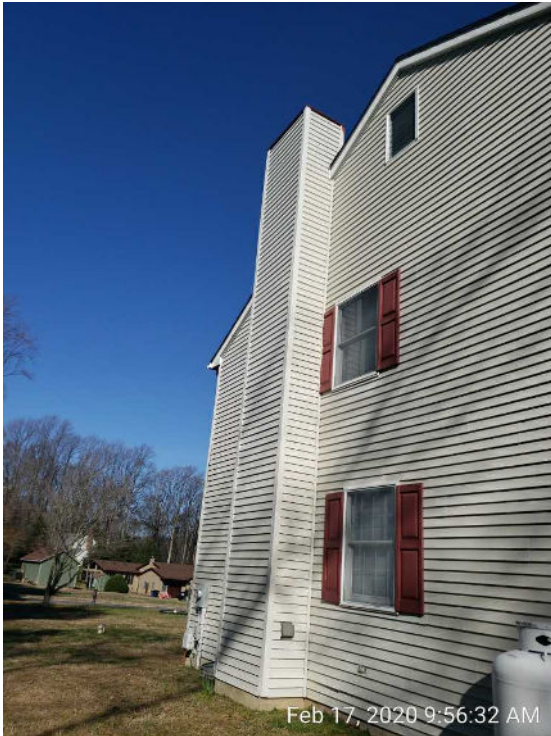
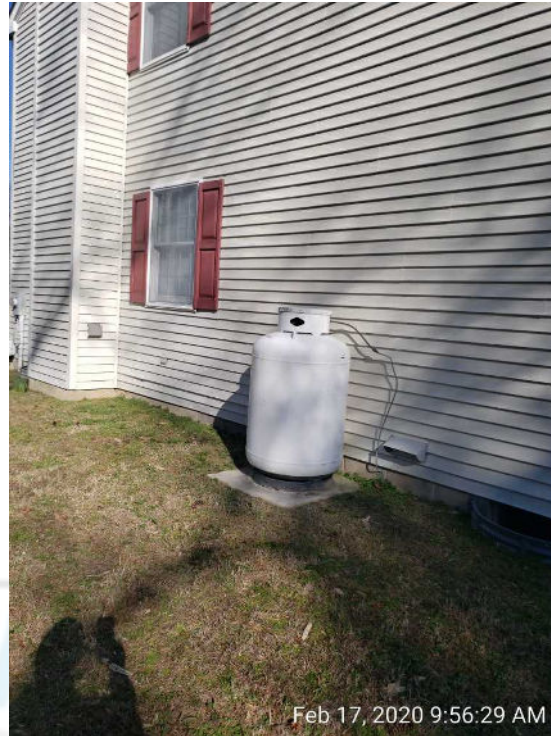
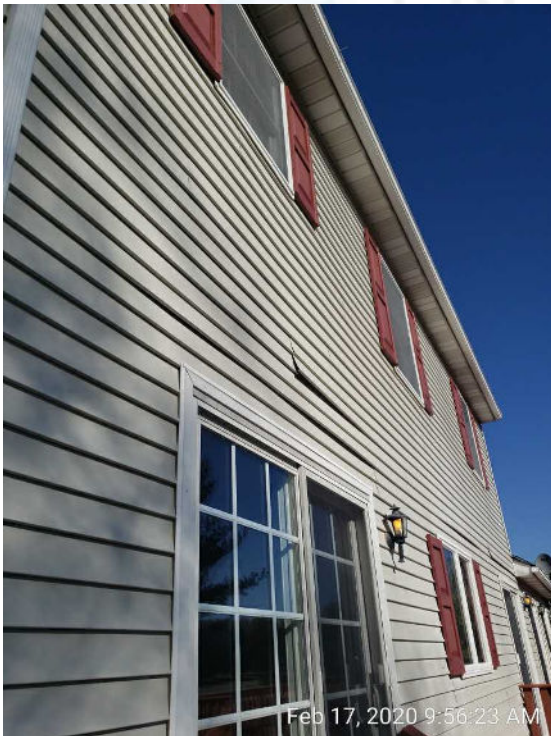
**REPA 7:** Loose siding was observed at the exterior wall surfaces. Attention to the loose siding and/or damage is required to keep out water intrusion and pests. We recommend repair to current industry trade standards as required.

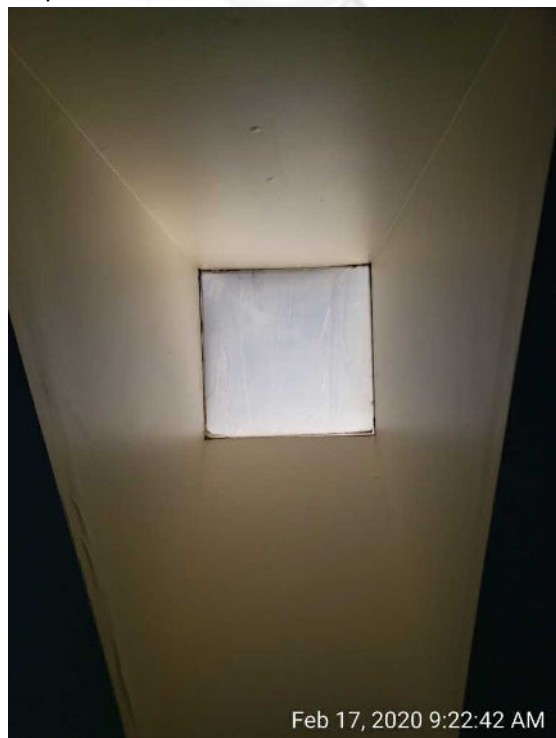
Condensation was noted between the skylight lens panels. We recommend repair or replacement as required

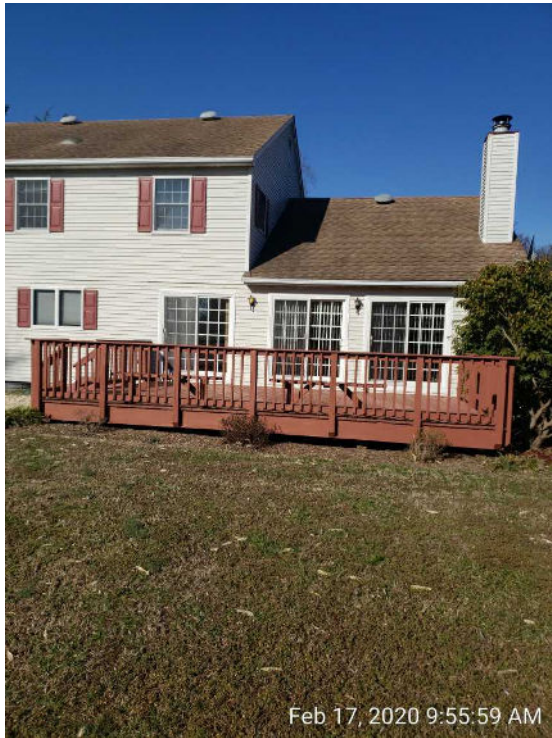
The chimney was observed to be constructed with Sheet metal flue(s) surrounded by a wood frame and covered with vinyl siding.

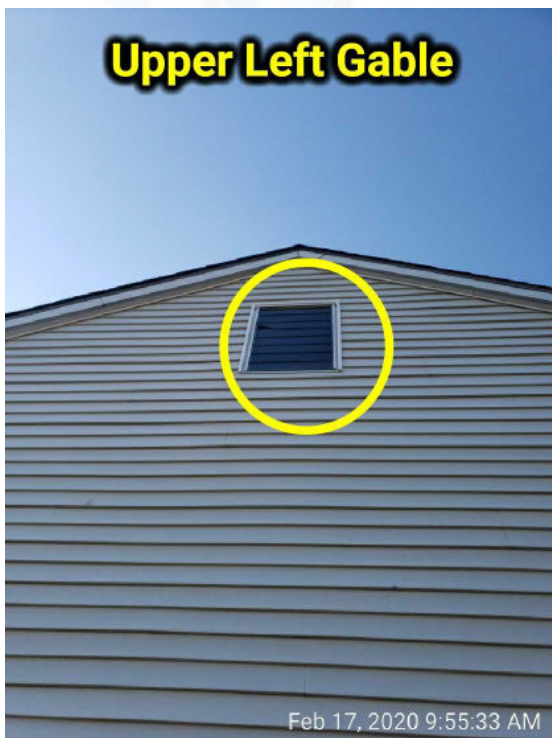
REPA

Cracked or broken glass was observed in the basement. We recommend immediate replacement for all cracked or broken windows. This is a safety concern and should be addressed.

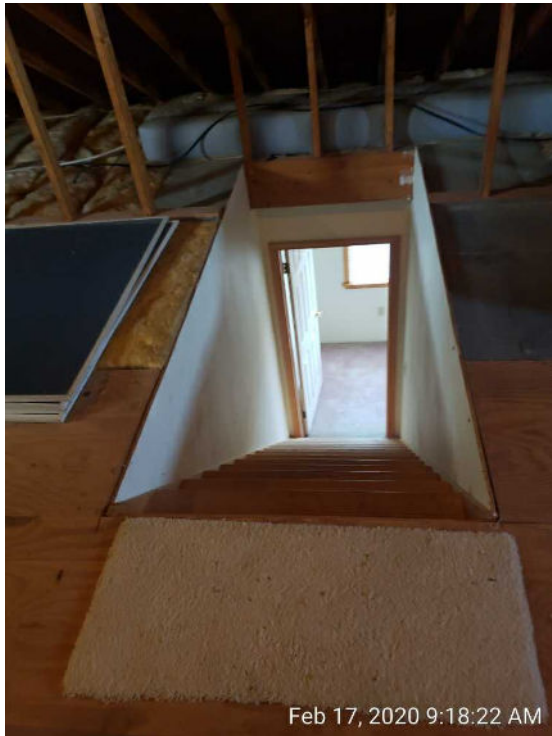
**SAFE** Present industry standards for railings indicate that railings should be present when there are 3 or more steps or where the drop off exceeds 30" in height. In addition, all railing balusters (poles) to be spaced close enough together so as to prevent the passage of a 4" sphere through any part of the railing.

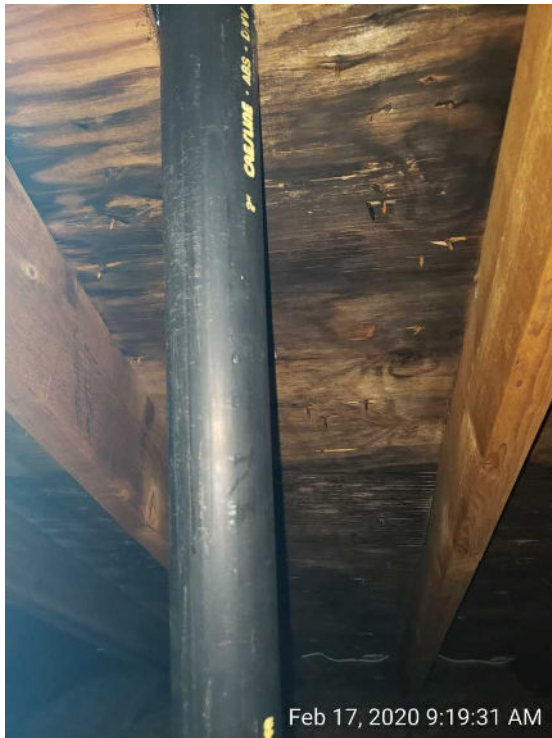
**REPA** A mold like substance or growth was observed at the attic. We recommend repair or replacement as required by a licensed mold specialist.

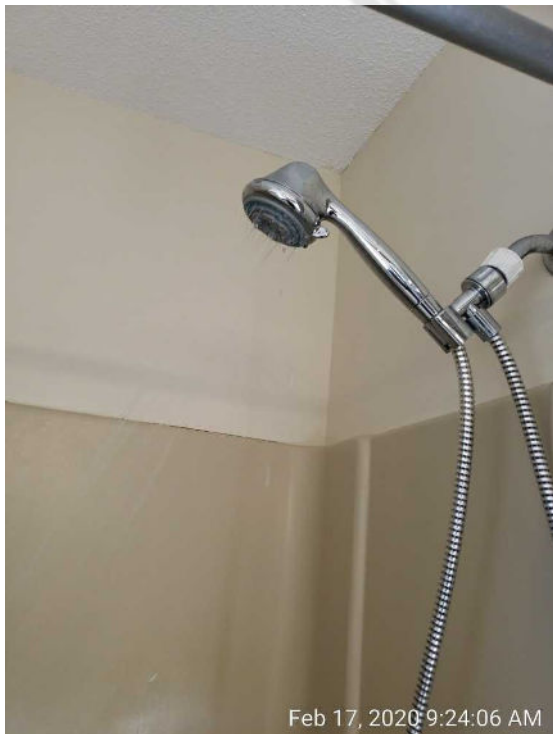
**REPA** Repair: The bath shower head was observed to be leaking at the connection to the shower arm. We recommend repair or replacement of the shower head to restore proper operation and use of the shower.

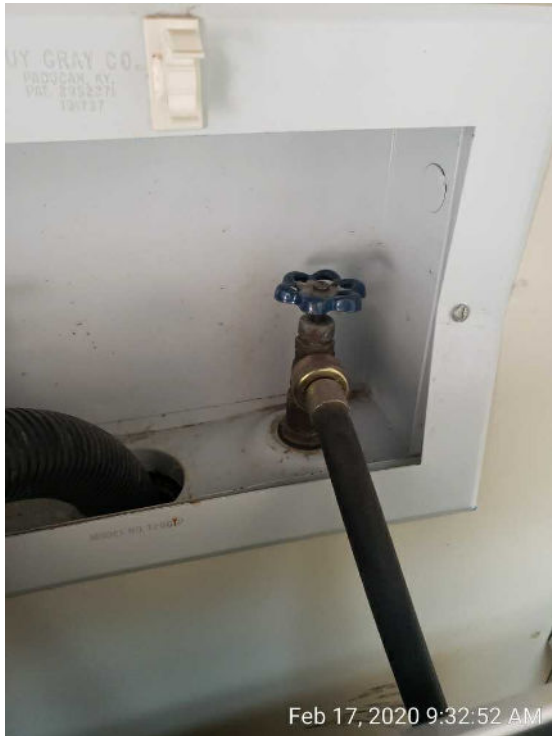
**REPA** Frozen in place water valve(s) were observed in the laundry area at the washer supply bib. Attention to the water valves is required in order to shut water off to the appliance. We recommend that any leaking valve be repaired or replaced as required.

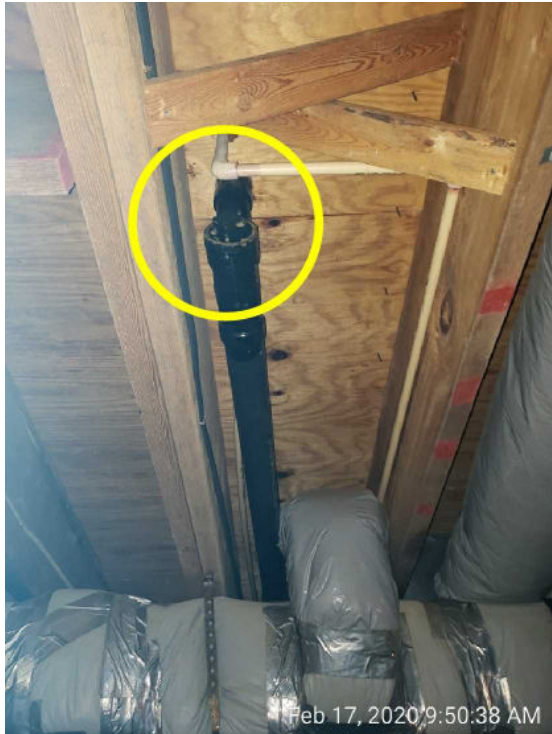
**REPA** Leaking drain/waste pipes were observed. Attention to the leaking pipes is required for damage control as well as health issues. We recommend that the leaks be repaired as required.

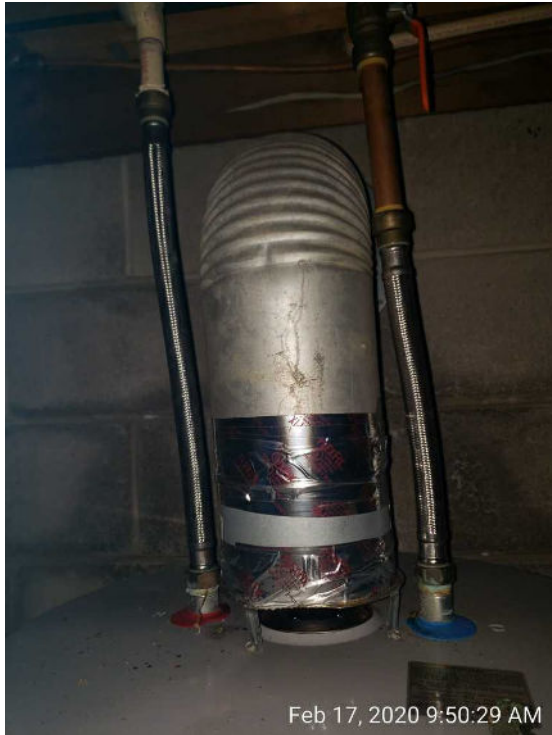
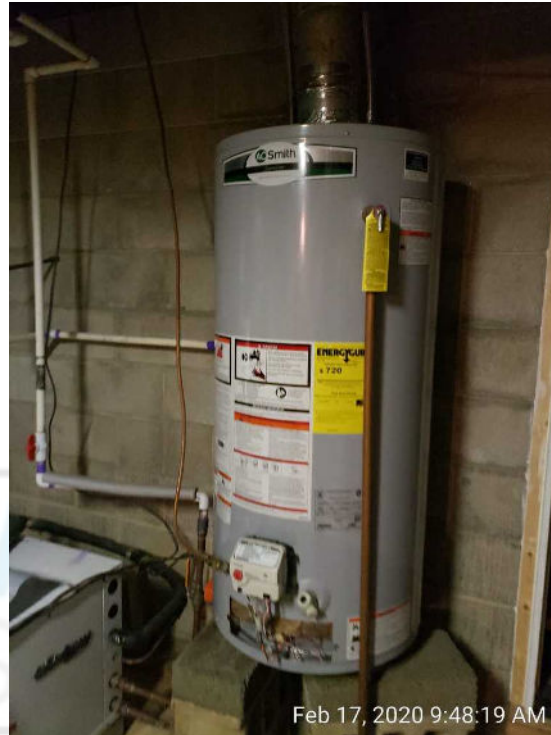
We recommend repair or replacement as required by a licensed contractor to ensure proper venting

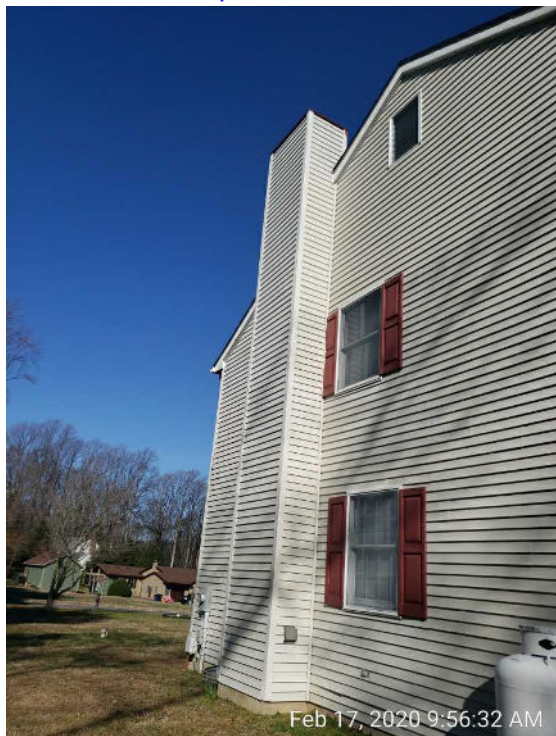
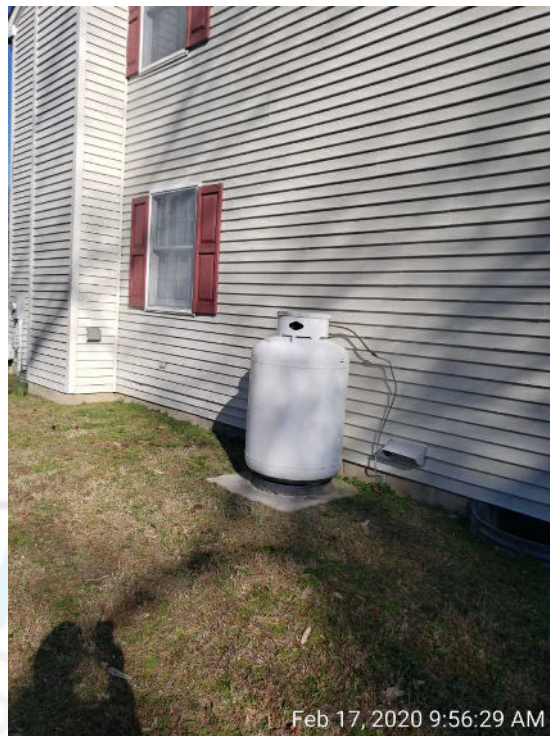
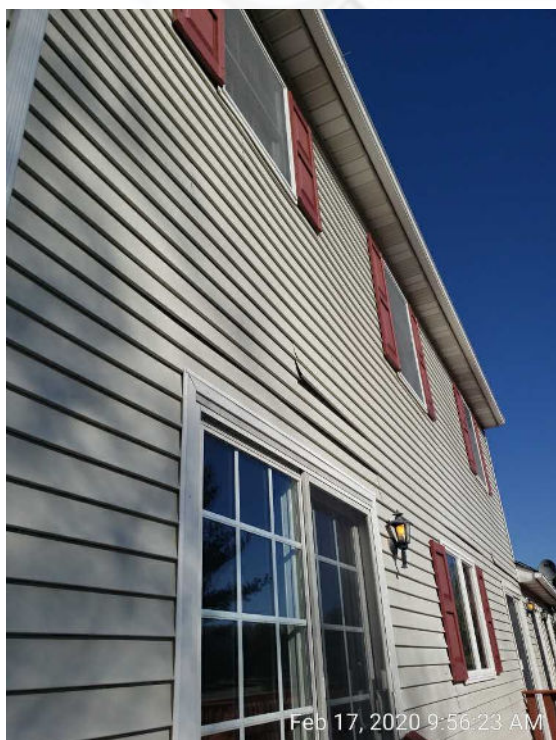
**REPA** Loose siding was observed at the exterior wall surfaces. Attention to the loose siding and/or damage is required to keep out water intrusion and pests. We recommend repair to current industry trade standards as required.
