FlashSeal[™]

*The Solution for Deteriorated
Flashings Around Chimneys,
Stack, and Vents*

ELASTOMERIC FLASHING SEALANT

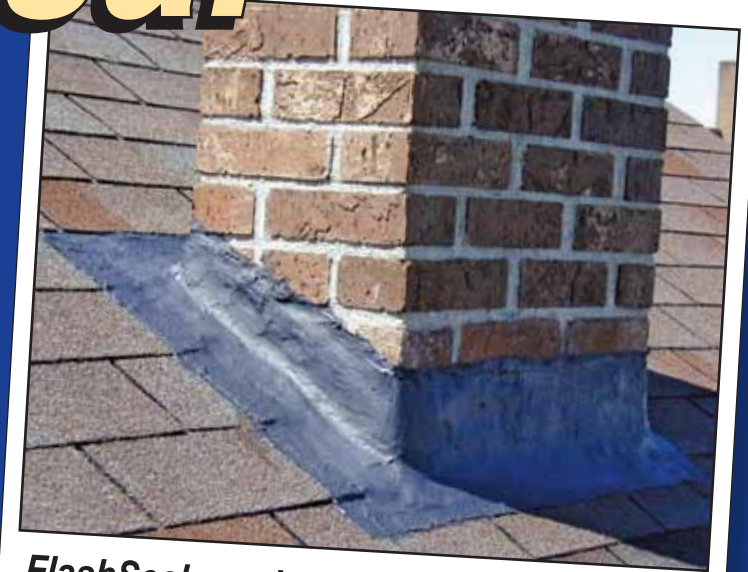
FlashSeal repairs faulty flashings around chimneys, stacks, and vents

A properly installed FlashSeal application is like installing a custom fit rubber boot around the base of your chimney. FlashSeal's strength and flexibility will provide years of trouble free service to help stop the damaging effects of water that can enter your home from a faulty or deteriorated flashing system.

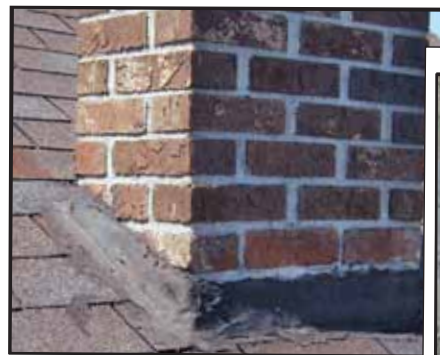
Chimney with cracked and deteriorated flashing

Flashing is the material at the base of chimneys, stacks and vents that is designed to waterproof the juncture where they penetrate the roof. Faulty or deteriorated flashings can cause leaks and water damage to the surrounding roof deck or eventually the interior finishes of your home.

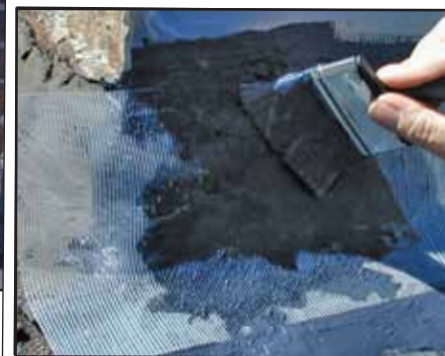
For added strength and flexibility, a fiberglass fabric is embedded between 2 coats of FlashSeal Elastomeric Sealant

FlashSeal Elastomeric Sealant is available in one gallon containers and is used in conjunction with FlashSeal Reinforcement Fabric sold separately in 150 ft. rolls. One roll of Reinforcement Fabric will last through 3 - 4 gallons of FlashSeal.

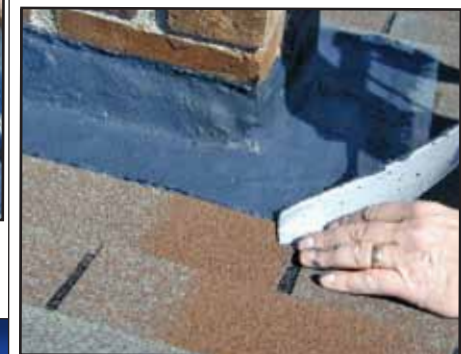
In most cases the roof deck and chimney are taped off to produce a neat appearance of the finished application

Simply measure and pre-cut the fabric, the repair is fast, easy, and provides you with a professional flashing repair option that is warranted for seven years! The new FlashSeal repair adds another level of protection to the waterproofing mix. Used with other ChimneySaver products, it will allow you to provide a total system of chimney protection.
