## SUMMARY

1234 Main Street  
Buyer Name  
02/06/2025 9:00AM

Brian Maute  
InterNACHI Certified Home Inspector  
Vivid Home Inspections  
(609) 922-7456  
[inspectionsbyvivid@gmail.com](mailto:inspectionsbyvivid@gmail.com)

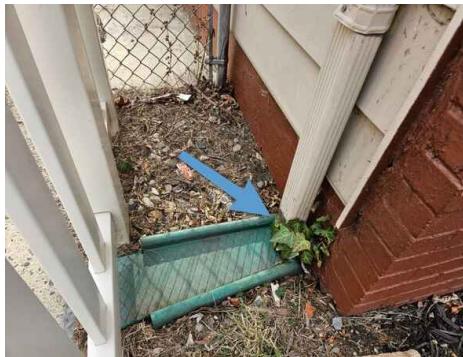
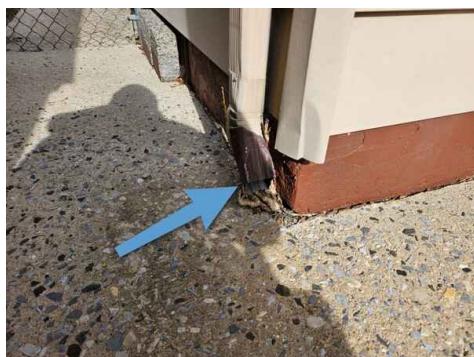
One or more downspouts drain too close to the home's foundation. This can result in excessive moisture in the soil at the foundation, which can lead to foundation/structural movement.

A gutter downspout discharging near the house poses a significant risk of water pooling around the foundation, potentially leading to structural damage and moisture infiltration into the basement or crawl space. This can result in mold growth, wood rot, and compromised structural integrity if not addressed promptly. Immediate redirection of the downspout away from the house's foundation is crucial to prevent water-related issues and maintain the structural integrity of the home. Neglecting this issue could lead to costly repairs and potentially hazardous living conditions for occupants.

**Recommend further evaluation and correction by a gutter contractor.**

Contact a qualified gutter contractor

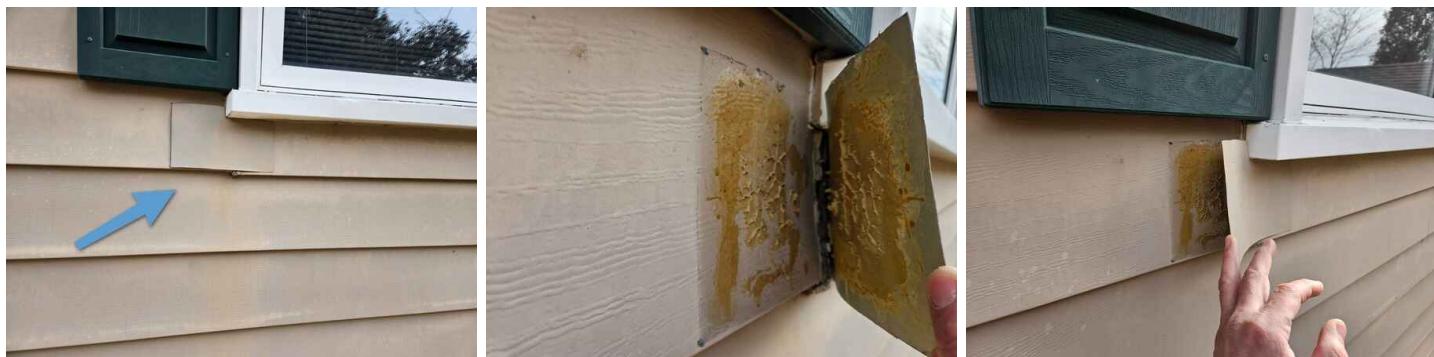
### 3.5.4 Siding, Flashing & Trim **PREVIOUS REPAIRS**

The previous repairs on the home's siding may indicate past damage or deterioration, which could suggest ongoing maintenance concerns. Poorly executed repairs can lead to moisture intrusion, potentially causing rot, mold, or interior damage over time. If incompatible materials or improper installation methods were used, the siding's durability and weather resistance may be compromised. Further evaluation is recommended to ensure the integrity of the repairs and prevent future structural or cosmetic issues.

Recommendation  
Contact a qualified professional.

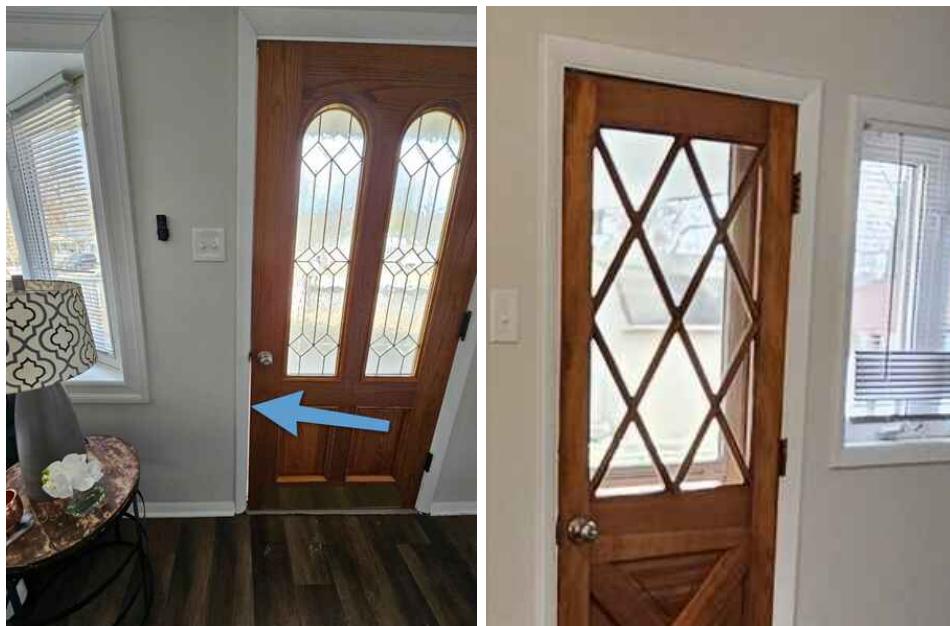
### 3.6.1 Exterior Doors **WEATHERSTRIPPING IMPROVEMENT**

The door weatherstripping was damaged or minimal. This can result in significant energy loss and moisture intrusion. Recommend installation of proper weatherstripping.

Recommendation  
Contact a handyman or DIY project

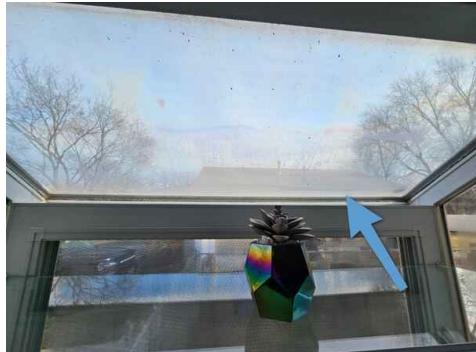
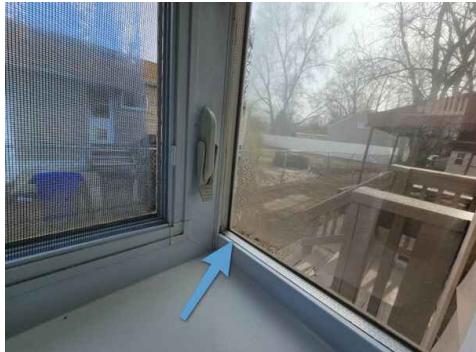
### 3.7.2 Windows **FOGGED WINDOWPANE**

I observed a fogged windowpane (a lost seal) at a window.

If multiple-pane windows appear misty or foggy, it means that the seal protecting the window assembly has failed, and condensation has formed in between the two panes of glass. Condensation in double-paned windows indicates that the glazing assembly has failed and needs repair or replacement. Visible condensation can damage glazing and is the main indication of sealant failure. Condensation is not always visible. If the failure is recent, a failed window may not be obvious, since condensation doesn't usually form until the window is heated by direct sunlight. Windows in the shade may show no evidence of failure, so it is nearly impossible to observe and report all failed double-paned windows.

Contact a qualified window repair/installation contractor.

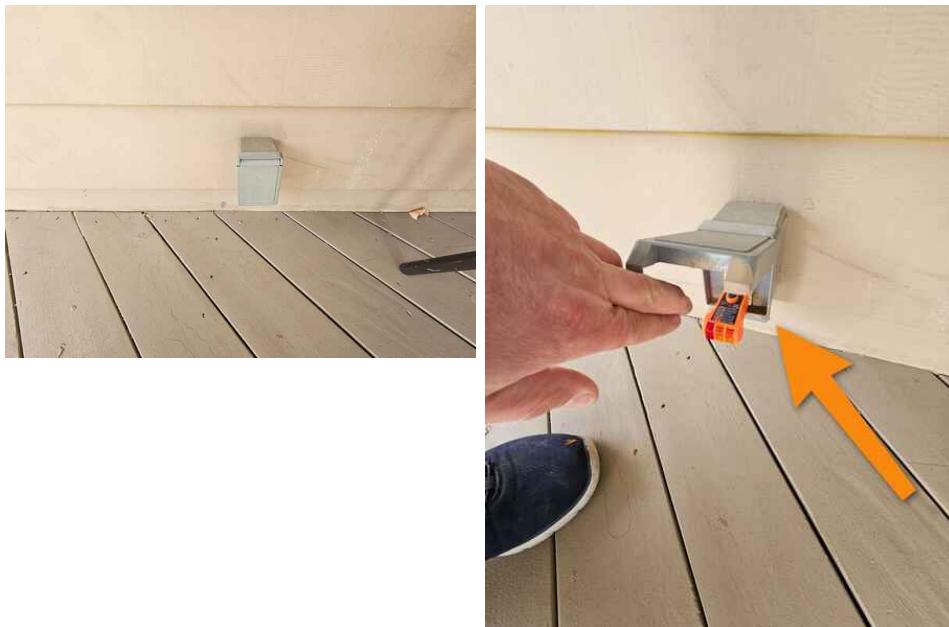
A non-functioning outlet can pose safety risks, as it may indicate underlying electrical issues that could lead to shock hazards or fire. Additionally, it limits the usability of electrical devices in the affected area, which may hinder daily activities. If left unaddressed, the problem could escalate, necessitating costly repairs or even requiring an electrician for more extensive electrical work. It is important to investigate the cause of the malfunction and repair or replace the outlet to ensure safe and reliable electrical service.

**Recommend further evaluation and correction by a licensed electrical contractor.**

Recommendation  
Contact a qualified professional.

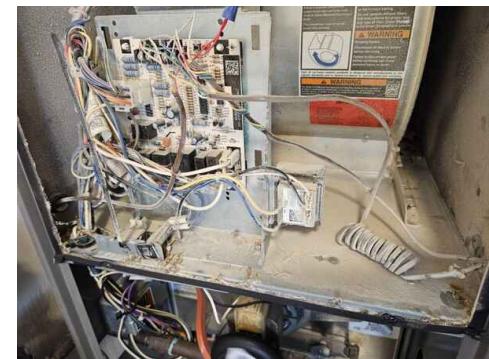
#### 5.1.1 Heating Equipment **SYSTEM IS DIRTY**

A dirty heating system can significantly reduce efficiency, leading to higher energy bills and inconsistent heating throughout the home. Additionally, accumulated dirt and debris can pose a fire hazard and may contribute to health issues by circulating dust and allergens in the air. Regular maintenance and cleaning are essential to ensure the system operates safely and effectively. Addressing this issue promptly can extend the lifespan of the heating system and improve indoor air quality.

**Recommend further evaluation and correction by a licensed HVAC contractor.**

Recommendation  
Contact a qualified professional.

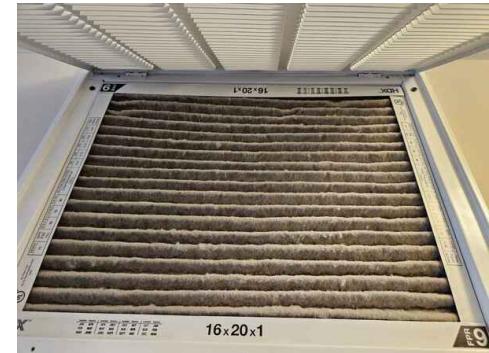
### 5.3.1 HVAC Filter **DIRTY FILTER**

The HVAC filter plays a critical role in maintaining indoor air quality by trapping dust, allergens, and other particles. A dirty or clogged filter can restrict airflow, reducing the efficiency of the HVAC system and potentially leading to higher energy bills. Neglecting to replace or clean the filter regularly can also cause the system to overheat or malfunction, increasing the risk of costly repairs or premature system failure. Regular inspection and replacement of HVAC filters are essential to ensure optimal system performance, improve air quality, and prolong the lifespan of heating and cooling equipment in the home.

**Recommend changing the filter out at least once a month. Filter life expectancy depends on many factors such as filter type, filter size, and environment.**

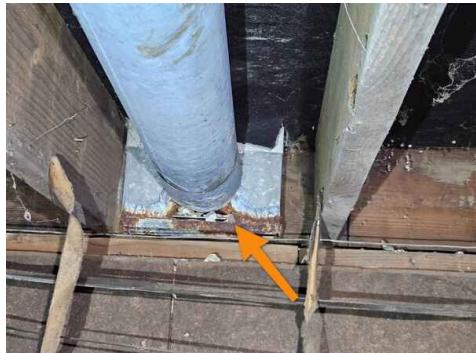
Deteriorated ductwork can lead to air leaks, reducing the efficiency of the HVAC system and increasing energy costs. Gaps, tears, or disconnected sections may allow contaminants such as dust, mold, or pests to enter the airflow, negatively impacting indoor air quality. In crawlspaces or attics, damaged ducts can also contribute to moisture issues by allowing humid air to enter, potentially leading to mold growth. Repair or replacement of the affected ductwork is recommended to maintain proper airflow, energy efficiency, and indoor air quality.

Rusted out and has a hole

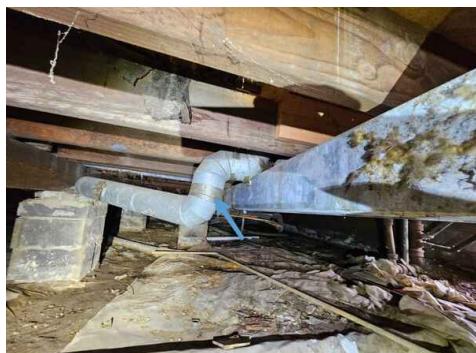
Improperly sealed ductwork can lead to significant air leakage, reducing the efficiency of the HVAC system and increasing energy costs. Leaks in the ducts may allow unfiltered air, dust, and moisture to enter the system, negatively impacting indoor air quality. In crawlspaces or attics, unsealed ducts can also contribute to temperature imbalances by allowing conditioned air to escape into unconditioned spaces. Proper sealing is recommended to improve energy efficiency, maintain consistent airflow, and prevent potential moisture-related issues.

Duct not to be sealed by duct tape

Contact a handyman or DIY project

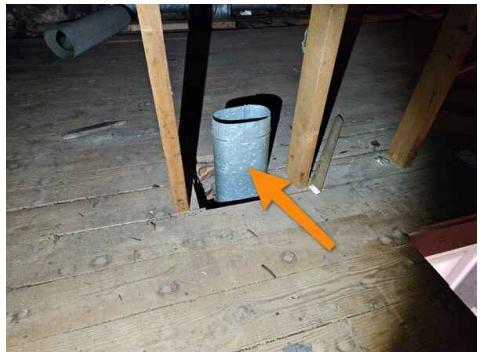
## 5.5.5 Distribution Systems **DUCT LEADS TO ATTIC OR CRAWLSPACE**

HVAC ductwork that does not lead to a proper vent or register can result in significant energy loss, reducing the efficiency of the heating and cooling system. Conditioned air may be wasted in unconditioned spaces like attics or crawlspaces, leading to higher energy costs and uneven temperature distribution throughout the home. Additionally, disconnected or open ducts can introduce dust, debris, or moisture into the system, potentially affecting indoor air quality. Proper repair or sealing of the ductwork is recommended to ensure efficient airflow and maintain system performance.

Needs to be capped

Contact a qualified professional.

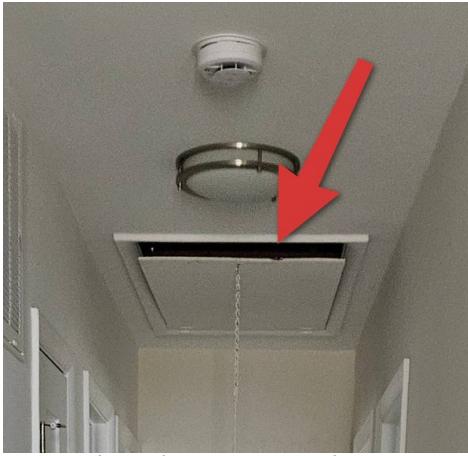
The folding attic access ladder requires repair or replacement.

Access door does not stay shut nor latch shut

Recommend a qualified contractor evaluate and repair soon prior to use.

Contact a qualified carpenter.

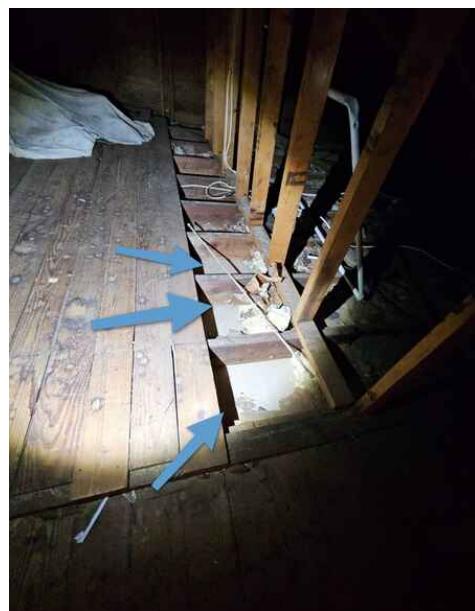
I observed a few areas where insulation was missing.

Missing insulation throughout

**Recommend further evaluation and correction by a licensed qualified professional.**

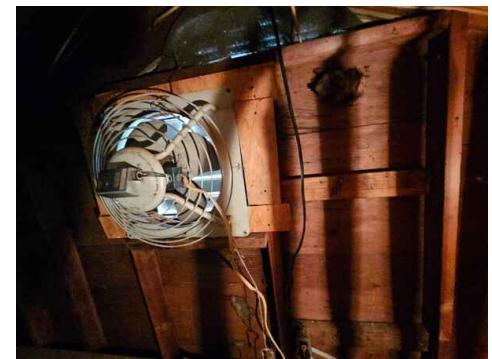
#### 6.3.1 Ventilation **ATTIC FAN NOT TESTED**

Attic fan was not tested at time of inspection due to the out door temperature being too low. Recommend an attic fan specialist evaluate and verify serviceability.

Contact a qualified electrical contractor.

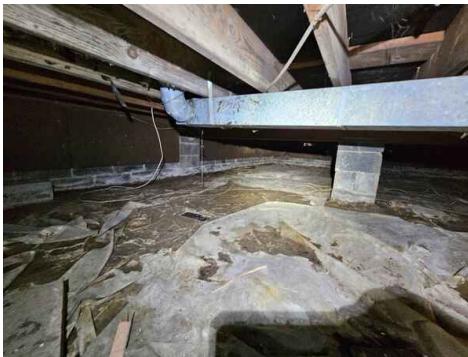
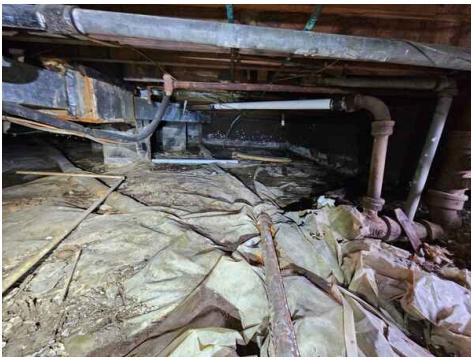
#### 7.2.1 Vapor Retarders **IMPROPER VAPOR BARRIER**

An improperly installed vapor barrier in the crawlspace can allow excess moisture to accumulate, leading to mold growth, wood rot, and deterioration of structural components. Gaps, missing sections, or incorrect placement may reduce its effectiveness, allowing ground moisture to rise and impact indoor air quality. Prolonged exposure to high humidity levels can also attract pests and contribute to insulation damage, reducing the home's energy efficiency. Proper installation and sealing of the vapor barrier are recommended to prevent moisture-related issues and maintain the integrity of the crawlspace.

Recommendation  
Contact a qualified professional.

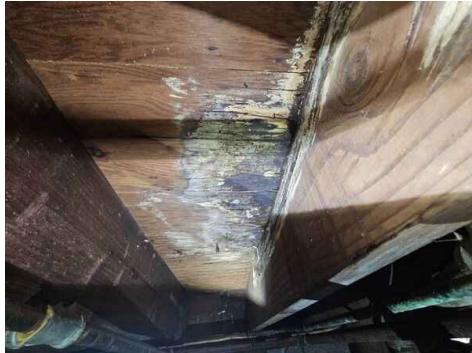
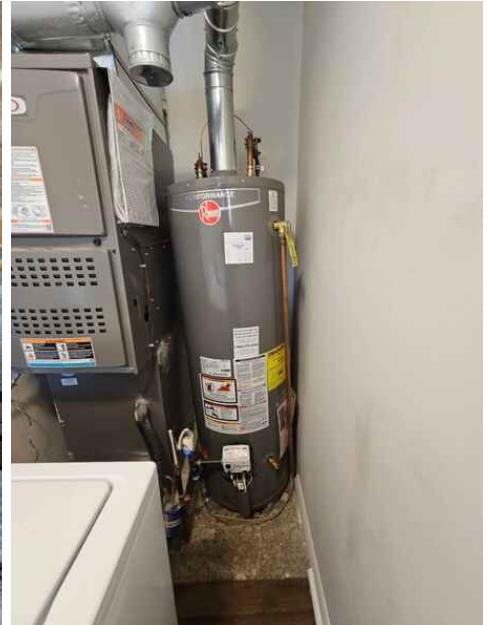
Damaged subflooring can compromise the structural integrity of the flooring system, leading to soft spots, sagging, or potential failure under load. Moisture intrusion, rot, or pest damage may be contributing factors, which can spread and affect surrounding materials if left unaddressed. Weak or deteriorated subflooring can also impact the safety and stability of the home, increasing the risk of trip hazards or flooring collapse. Further evaluation and repairs are recommended to prevent worsening conditions and maintain the home's structural soundness.

Water heater is leaning due to damaged subflooring

Recommendation  
Contact a qualified professional.

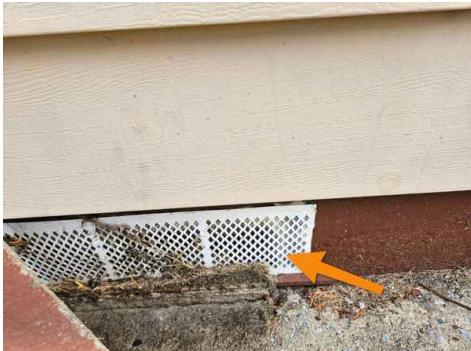
Damaged crawlspace vents can compromise proper ventilation, leading to excess moisture buildup, which may promote mold growth, wood rot, and structural deterioration. Restricted airflow can also create an environment conducive to pest infestations, potentially causing further damage to insulation and wooden components. In colder months, inadequate ventilation may contribute to condensation issues, increasing the risk of freezing pipes. Repair or replacement of the damaged vents is recommended to maintain proper airflow and prevent moisture-related issues.

Improper vent cover

Contact a qualified insulation contractor.

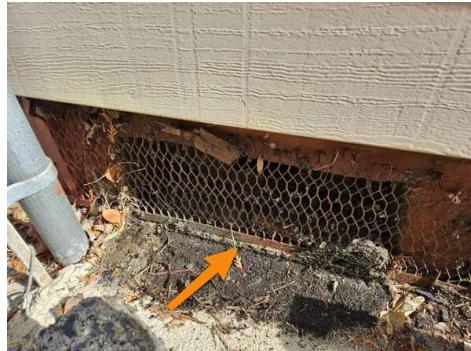
Improper vent cover

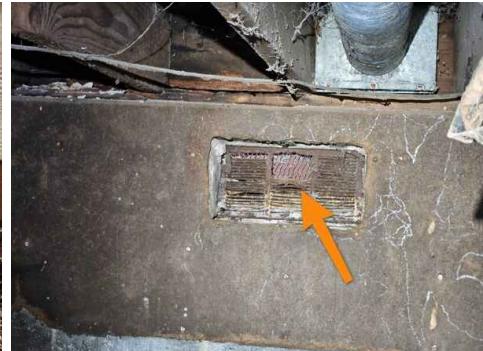
Damaged vent cover

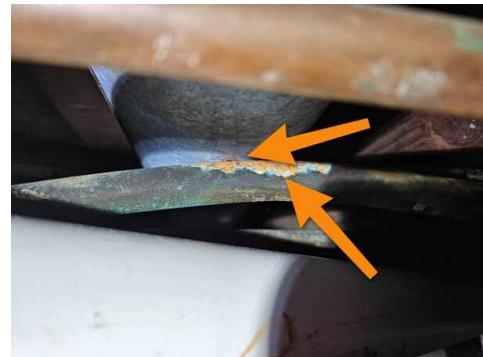
Two different metals should not be touching because they can create a condition known as galvanic corrosion. This occurs when metals with different electrochemical properties come into contact in the presence of an electrolyte, such as moisture. Galvanic corrosion can accelerate the deterioration of the metals involved, leading to rust, weakening of structural components, and potential failure over time. To prevent this, insulation or a non-conductive barrier should be used between dissimilar metals to minimize the risk of galvanic corrosion and ensure the longevity of building materials.

Contact a qualified professional.

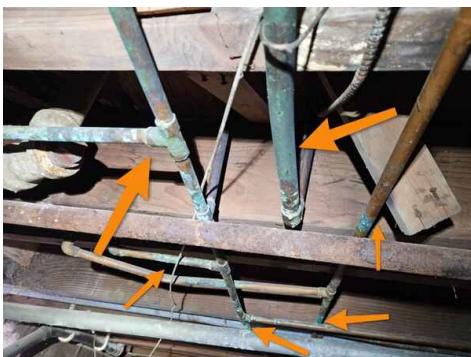
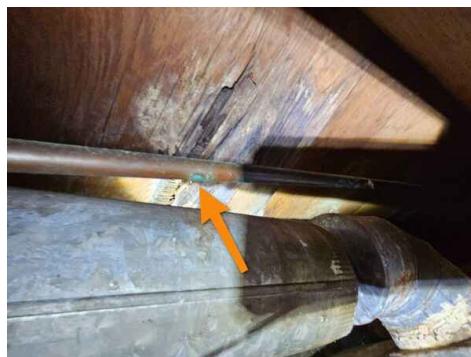
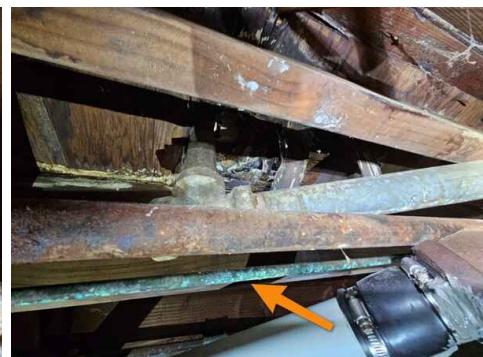
##### **COPPER LINES SHOW SIGNS OF CORROSION**

Corroded water lines may indicate aging pipes that are at risk of leaks, restricted water flow, or potential failure. The corrosion can lead to weakened pipe walls, increasing the likelihood of pinhole leaks or bursts that could cause significant water damage. Additionally, rust and mineral buildup inside the pipes can affect water quality, potentially introducing discoloration or contaminants. Further evaluation and potential replacement of the affected pipes are recommended to prevent future plumbing issues and maintain water system integrity.

Contact a qualified professional.

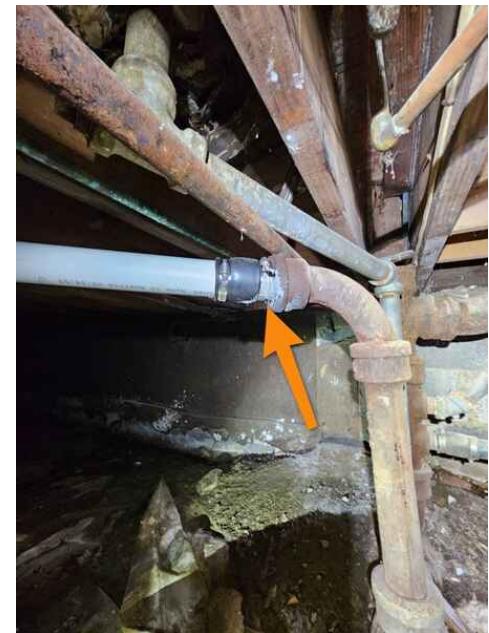
### 8.3.1 Drain, Waste, & Vent Systems **IMPROPER CONNECTION**

An improper connection was observed at a drain, waste or vent pipe. Recommend a qualified plumber evaluate and repair.

Recommendation  
Contact a qualified plumbing contractor.

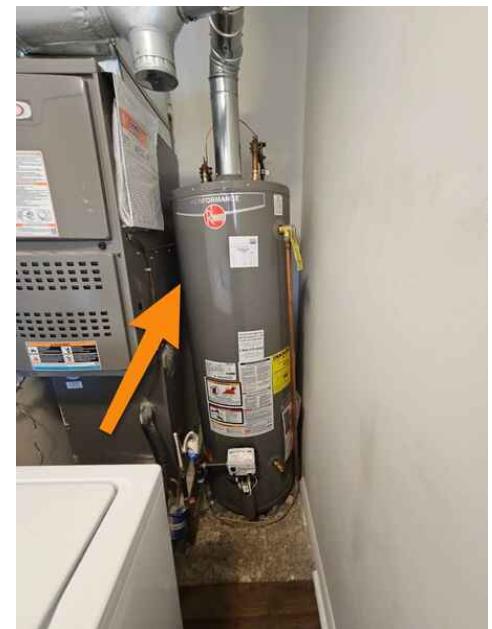
A leaning water heater may indicate an unstable or weakened base, which can lead to further tilting, potential tipping, or strain on the plumbing connections. This misalignment can cause stress on the gas or water lines, increasing the risk of leaks, water damage, or even a hazardous gas leak. Additionally, a tilted unit may impact the proper function of the heating elements or burner, reducing efficiency and potentially shortening the lifespan of the water heater. Immediate evaluation and correction are recommended to ensure safe operation and prevent potential safety hazards.

Recommendation  
Contact a qualified professional.

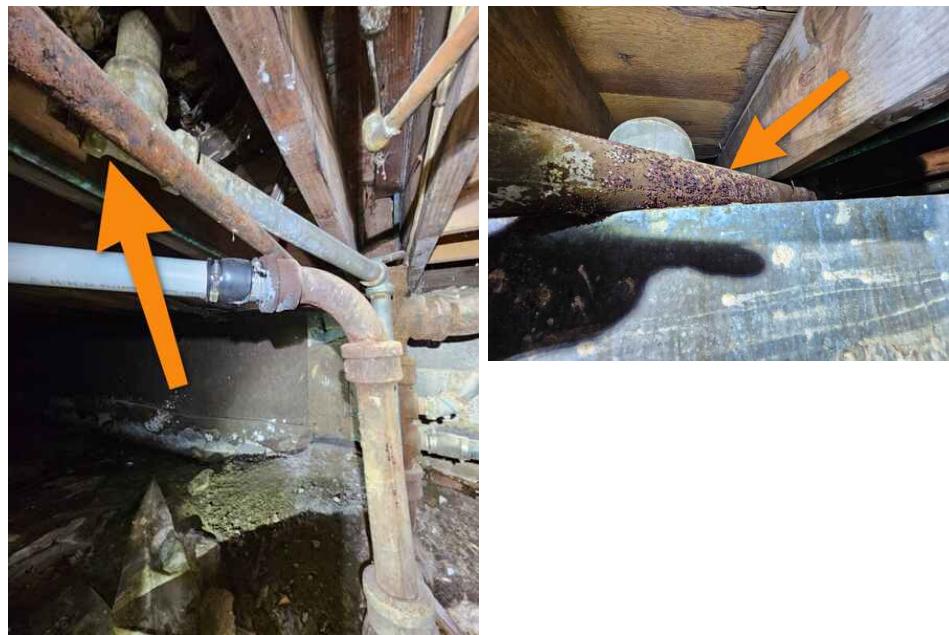
##### RUSTED GAS LINES

Rusted gas lines may indicate corrosion, which can weaken the pipe material and increase the risk of gas leaks. A compromised gas line poses a serious safety hazard, including fire, explosion, or carbon monoxide exposure. Corrosion can also worsen over time, potentially leading to costly repairs or emergency replacements if left unaddressed. Further evaluation by a qualified professional is recommended to determine the severity of the rust and whether repair or replacement is necessary for safe operation.

Recommendation  
Contact a qualified plumbing contractor.

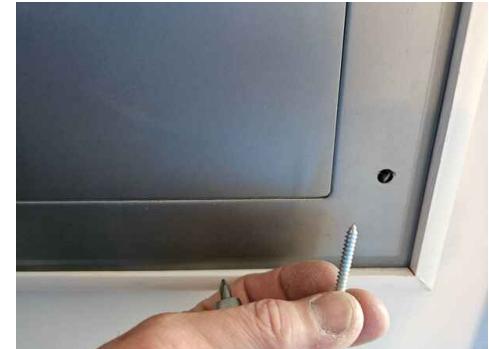
Proper panel screws are recommended for the panel. Any pointed screws should be replaced or missing screws should be installed.

Recommendation  
Contact a qualified electrical contractor.

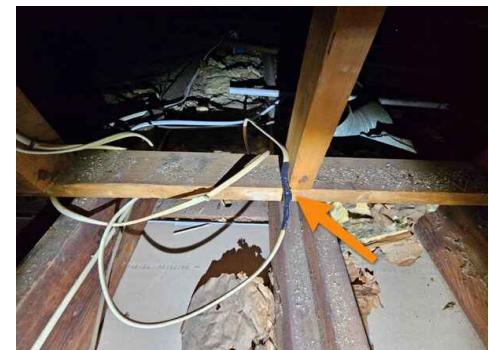
### 9.5.1 Fixtures, Outlets, Switches **WIRE SPLICE NOT IN A JUNCTION BOX**

A wire splice not being contained within a junction box can create a fire hazard, as exposed or improperly secured wires may overheat or short-circuit. Without a junction box, the splice is also vulnerable to physical damage, which could lead to faulty connections or electrical failure. Additionally, such a condition may violate local electrical codes, potentially complicating future inspections or property sales. It is important to have the splice properly enclosed in a junction box to ensure both safety and compliance with code requirements.

Recommendation  
Contact a qualified professional.

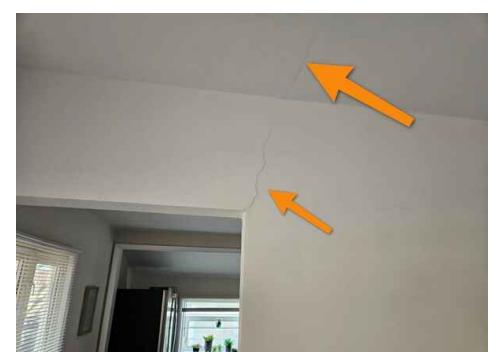
### 10.2.1 Walls & Ceiling **MINOR CORNER CRACKS**

Minor cracks at the corners of doors and windows in walls. Appeared to be the result of long-term settling. Some settling is not unusual in a home of this age and these cracks are not a structural concern.

Recommendation  
Contact a qualified drywall contractor.

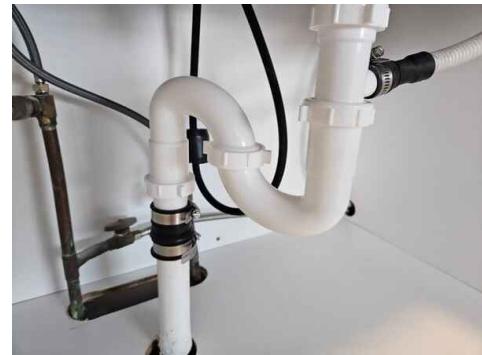
**12.1.1 Kitchen Sink  
DEFECT AT S-TRAP**

An S-trap in a plumbing system can create a siphoning effect, which may lead to the loss of the water seal in the trap and allow sewer gases to enter the home. Exposure to these gases can cause unpleasant odors and potential health hazards for occupants. Additionally, improper venting associated with S-traps can result in slow drainage and increased risk of clogs. Replacing the S-trap with a properly vented P-trap is recommended to ensure proper drainage function and prevent sewer gas intrusion.

Recommendation  
Recommended DIY Project

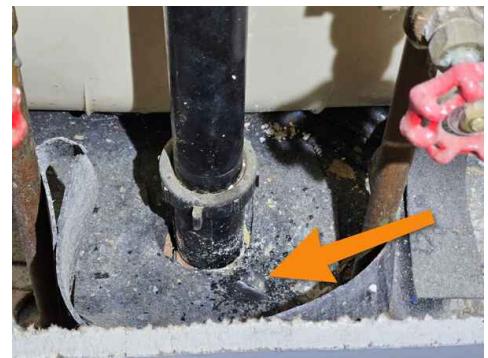
#### 16.8.1 Tubs & Showers **ACTIVE WATER LEAK**

I observed a active water leak when the tub/shower water was ran.

An active water leak in a home can lead to extensive water damage, mold growth, and structural deterioration if left unchecked. It poses immediate risks such as property damage, increased utility bills, and potential health hazards from mold and mildew. Recommending immediate repair by a qualified plumber and thorough inspection for any resulting damage is crucial to mitigate these risks and preserve the integrity and safety of the property.

**Recommend further evaluation and correction by a licensed plumbing contractor.**

Recommendation  
Contact a qualified plumbing contractor.
