VIVID HOME INSPECTIONS

IRRIGATION SYSTEM

1234 Main Street
Cherry Hill, NJ 08002

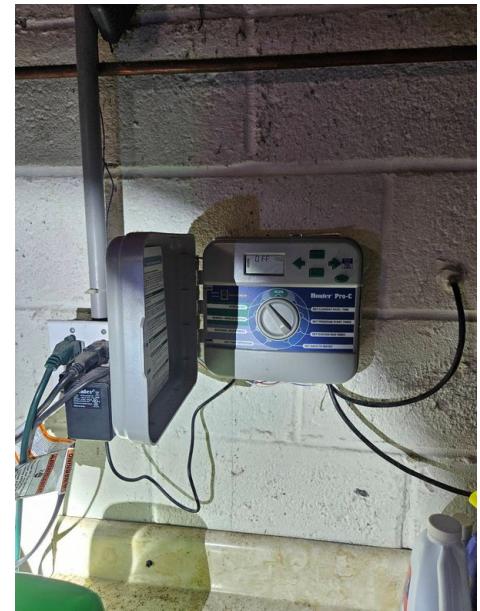
Irrigation Controls: Brand

Hunter

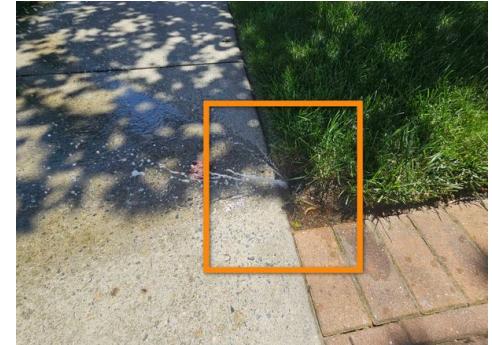
1.4.1 Heads

BROKEN OR MALFUNCTIONING HEAD

The sprinkler head was broken or in need of repair and was not functioning as intended at the time of inspection. This condition may affect the coverage and efficiency of the irrigation system. Repair or replacement is recommended to ensure proper operation and adequate watering in the affected area.

Zone 3 head needs adjustment

Recommendation

Contact a qualified landscaping contractor

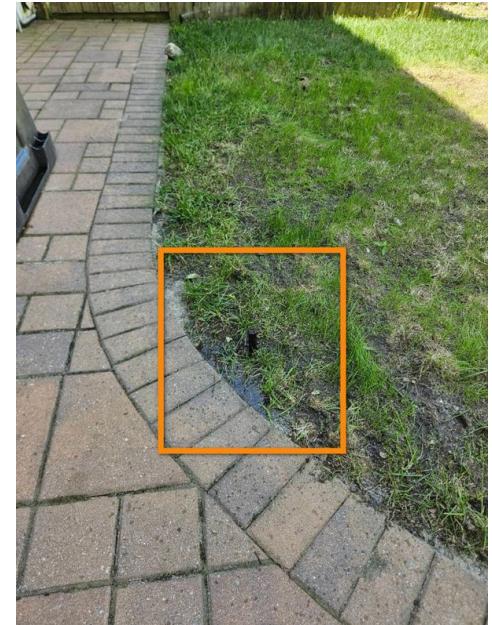
1.4.2 Heads

INOPERABLE HEAD/ZONE

Several sprinkler heads did not activate during testing of the irrigation zones, which may indicate malfunctioning components or control issues. This condition can lead to uneven watering and potential stress to surrounding vegetation. The irrigation system should be evaluated by a qualified irrigation specialist to identify the cause and perform necessary repairs to restore full functionality.

Zone 4 head - inoperable

Recommendation

Contact a qualified landscaping contractor

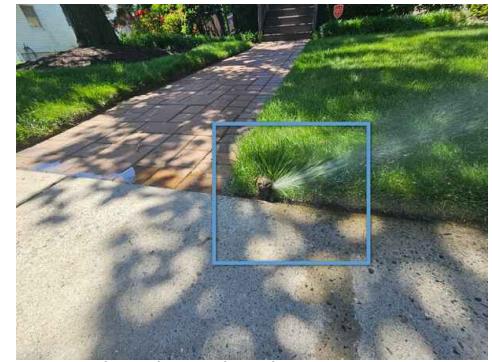
1.4.3 Heads

VEGETATION TOO HIGH

Vegetation around the sprinkler head was too high, obstructing the spray pattern and reducing the system's coverage efficiency. This can lead to uneven watering and dry spots in the landscape.

Zone 3 head needs adjustment

Trimming or removing the obstructing vegetation is recommended to allow proper operation of the sprinkler head. Regular maintenance will help ensure consistent and effective irrigation.

Contact a qualified landscaping contractor
