HOME INSPECTION REPORT

550 Skylake Dr
West Palm Beach, Florida 33415

Felipe Pena Diaz
12/01/2025

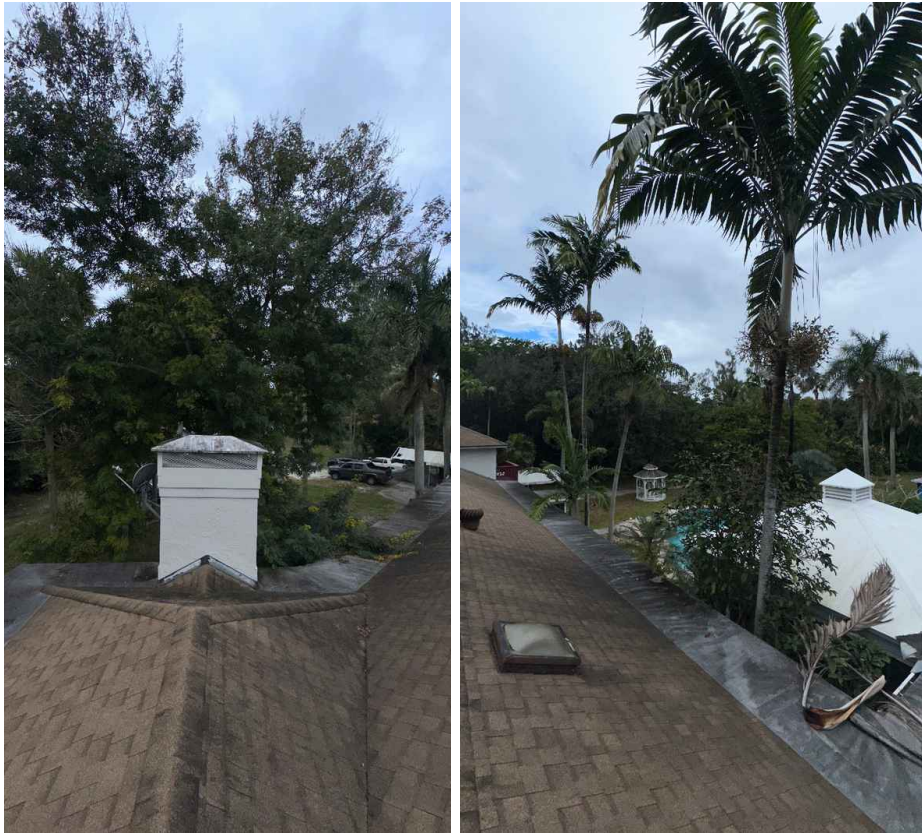
ROOF COVERINGS ***: Vegetation Overhanging Roof

Vegetation overhanging the roof may increase the chance of damage from excessive debris and/or pieces of the tree falling on the surface. See photo(s).

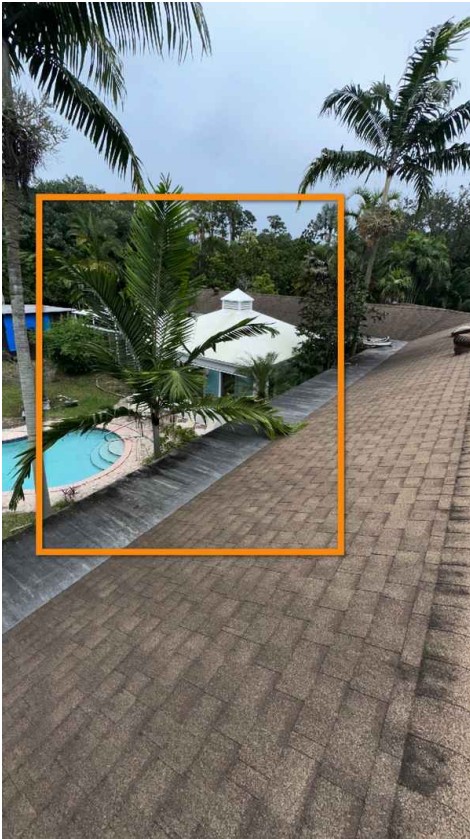
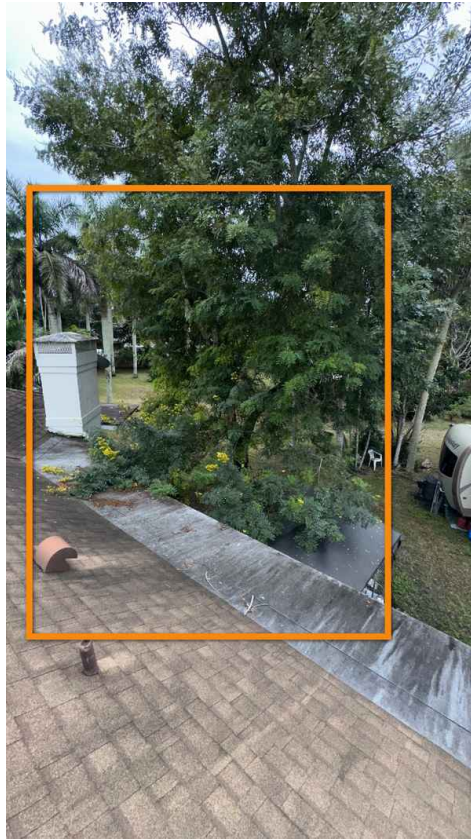
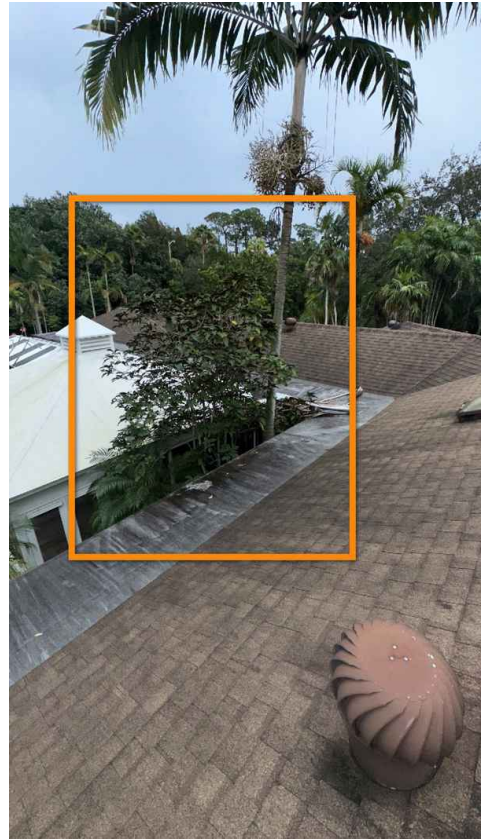
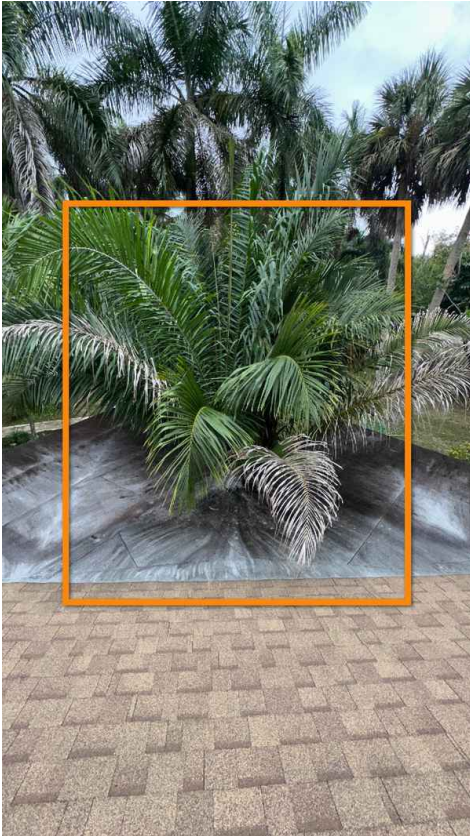
Tree branches touching roof can cause damage and/or excessive wear. Recommend trimming branches away from the roof surface. See photo(s).

Contact a qualified professional.

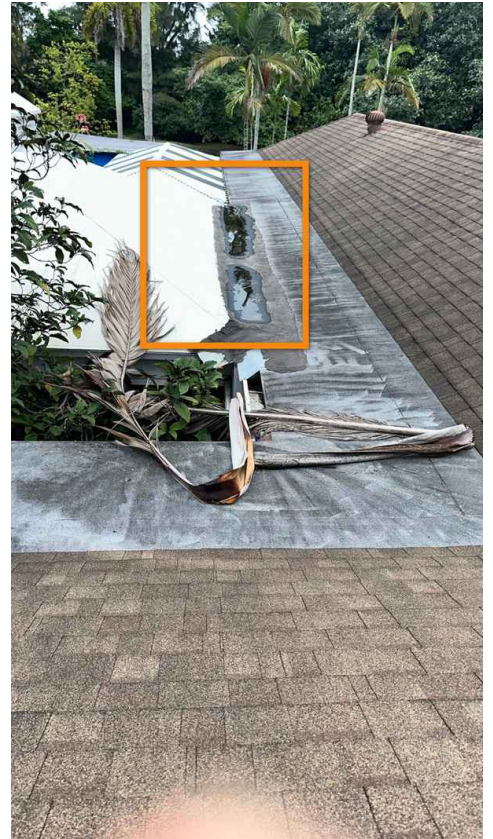
2.2.2 ROOF COVERINGS ***

DRAINAGE ISSUES (ROOF SURFACE)

Evidence of poor roof surface drainage found. Further evaluation and improvements recommended to ensure that water will adequately drain to the edges of the roof. Slow moving or standing water on a roof surface increases the probability of a leak. See photo(s).

Contact a qualified professional.

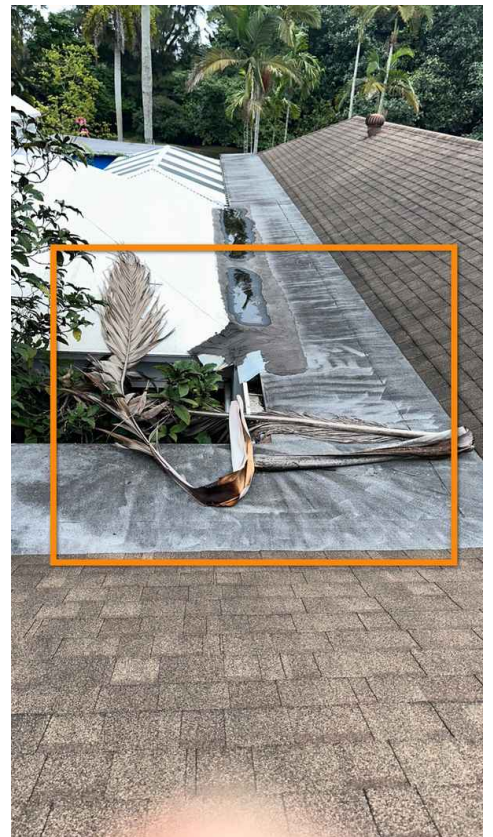
2.2.3 ROOF COVERINGS ***

DEBRIS ON ROOF

Excess debris noted on the roof. This debris can act as a sponge and hold water which may encourage leaks and prevent adequate drainage. Recommend to have debris cleared. Debris also somewhat limits visual inspection of the roof surface. See photo(s).

Contact a qualified professional.

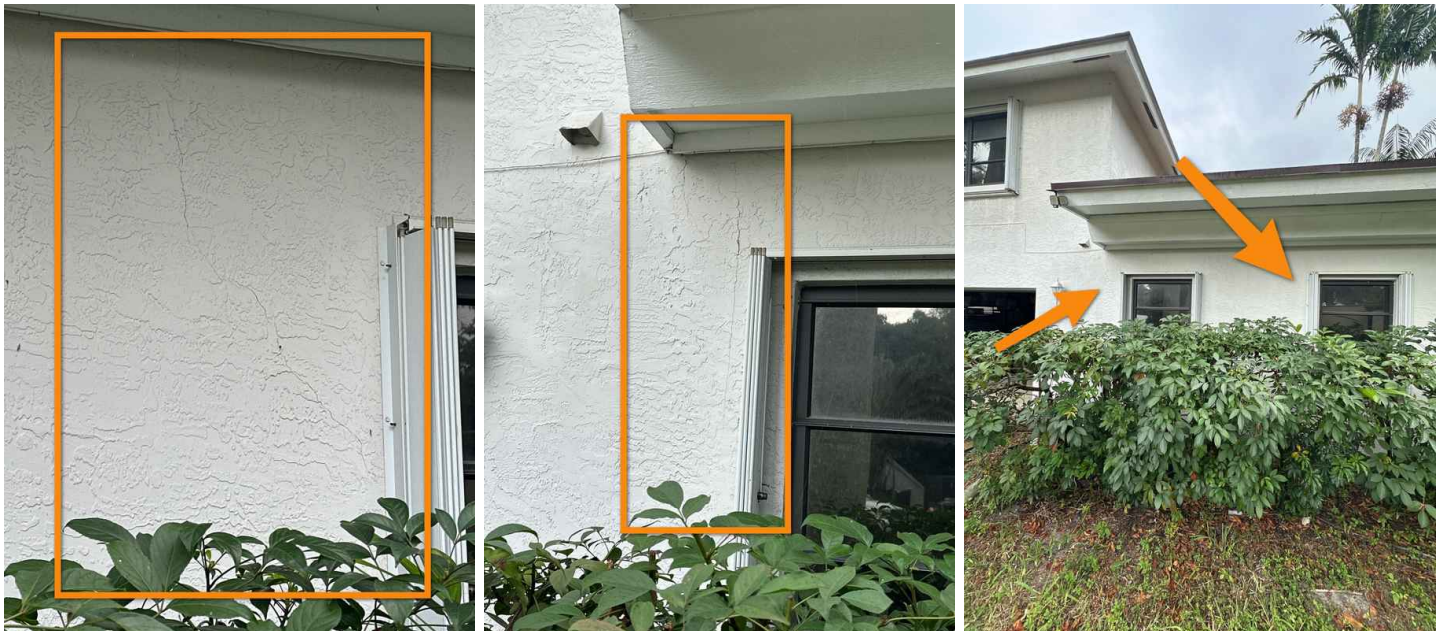
STUCCO - HAIRLINE CRACKS

Cracks noted on the stucco in several areas. The typical threshold for cracks in hard coat stucco is 1/16" and any crack that size or larger should be repaired to help prevent potential water entry. Smaller, hairline cracks are common and more will likely occur as the seasons change (expansion and contraction). It may be beneficial to have a separate stucco inspection to determine severity of cracks and potential water entry locations. See photo(s) for example(s).

Contact a stucco repair contractor

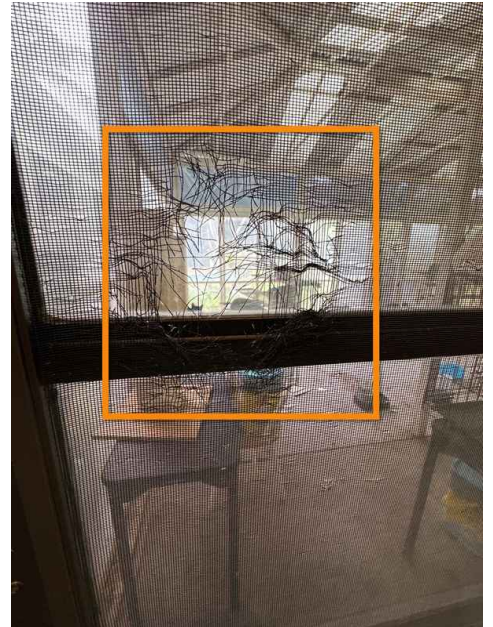
3.4.1 WINDOWS(Exterior)

WINDOW SCREEN DAMAGE

Screens are torn and damaged. Replace as needed. See photo(s) for example(s).

Contact a qualified professional.

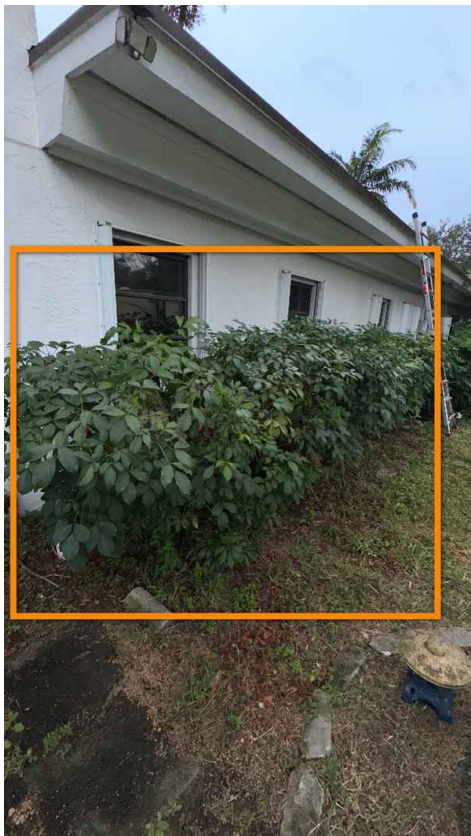
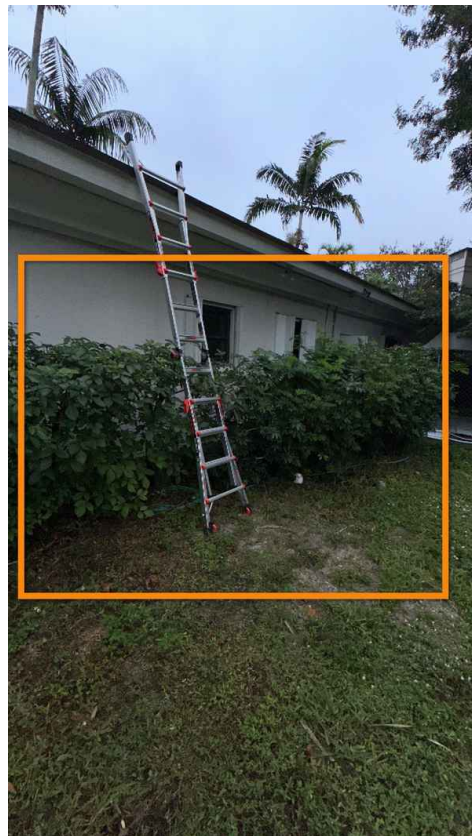
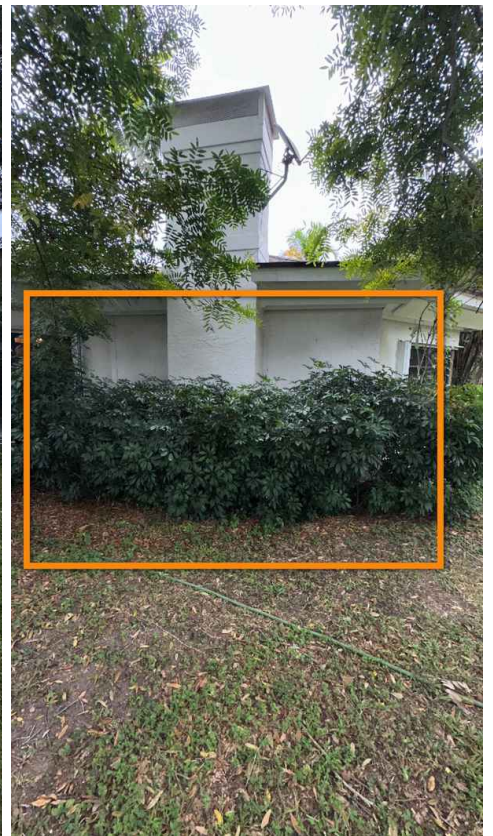
3.7.1 VEGETATION, GRADING, DRAINAGE, RETAINING WALLS

CAPTURED GARDEN

Garden area(s) between the walls of the home and the driveway/sidewalk may prohibit quick drainage of rain water. These garden areas often are slow to drain and can cause water entry into the home. Recommend to monitor during rain and repair as needed. Some form of drainage may be needed to help correct this issue. See photo(s).

Contact a qualified professional.

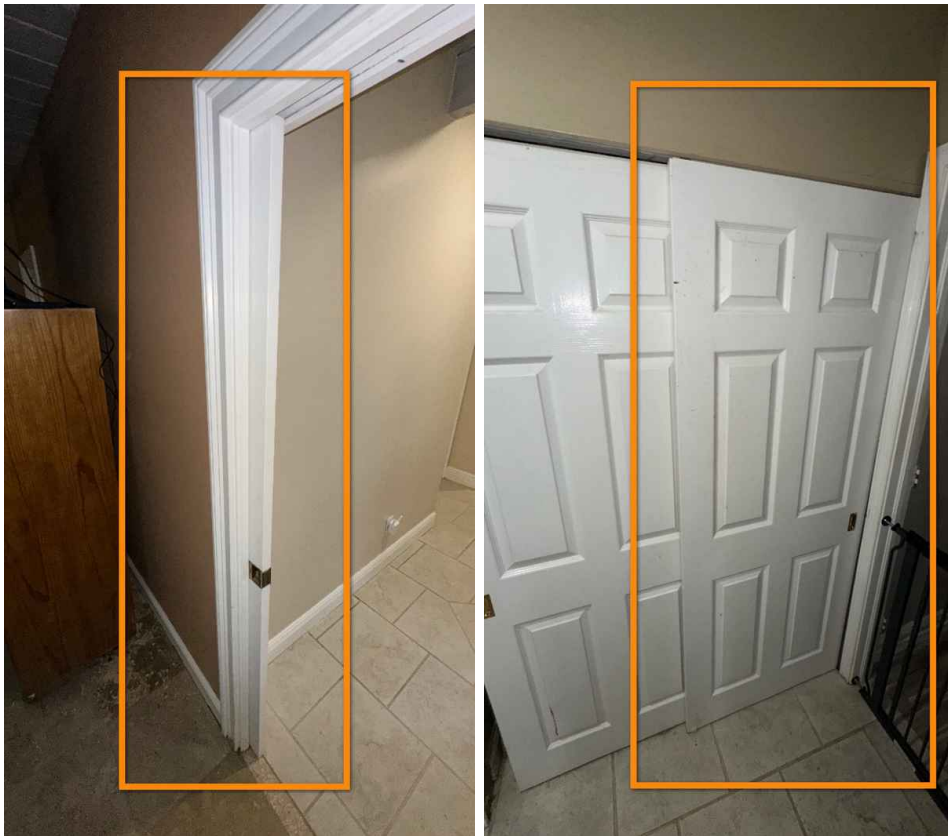
HARDWARE DEFECTS

Defects with the hardware found on interior doors. This can include latches, knobs, locks, stoppers, handles, strikers, etc.... See photos for locations. Repair as needed.

Contact a qualified professional.

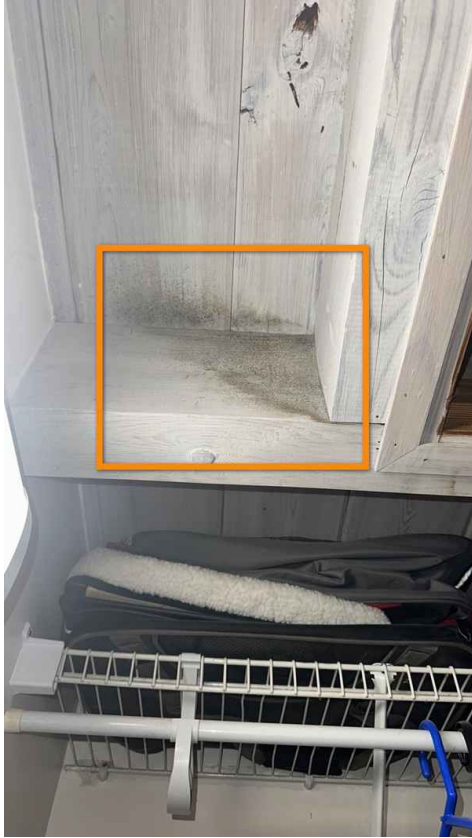
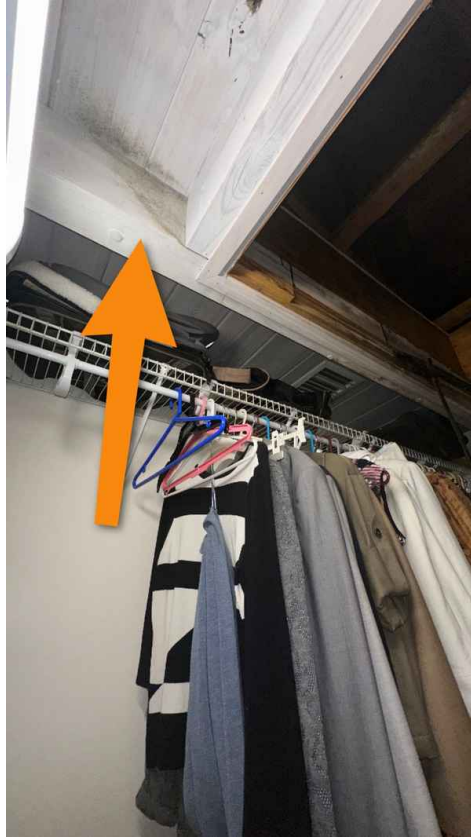
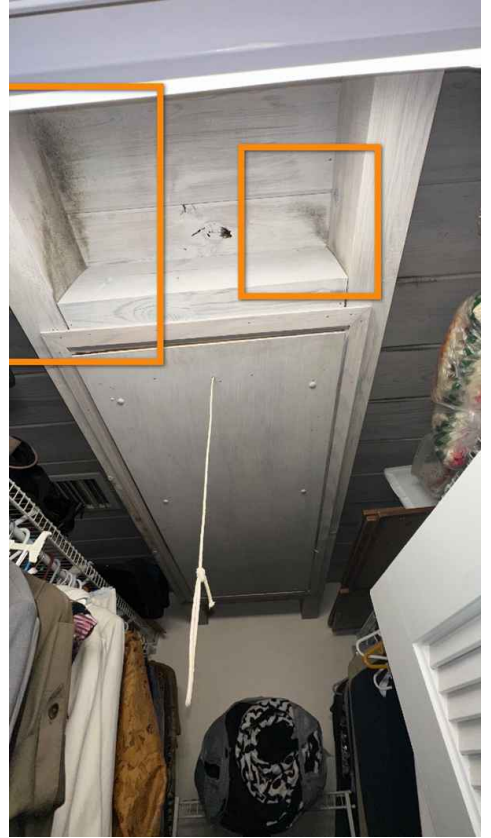
6.4.1 CEILINGS

MICROBIAL GROWTH POSSIBLE

Signs suspected microbial growth is present. The underlying cause of microbial growth problems is normally moisture or high humidity. A visual inspection cannot determine the extent of the problem or if any health hazards exist. Testing is recommended and can be completed if desired. Condition of framing behind finished surface is not visible and is not known. Buyer should resolve all concerns prior to closing. See photo(s) for example(s).

Contact a qualified professional.

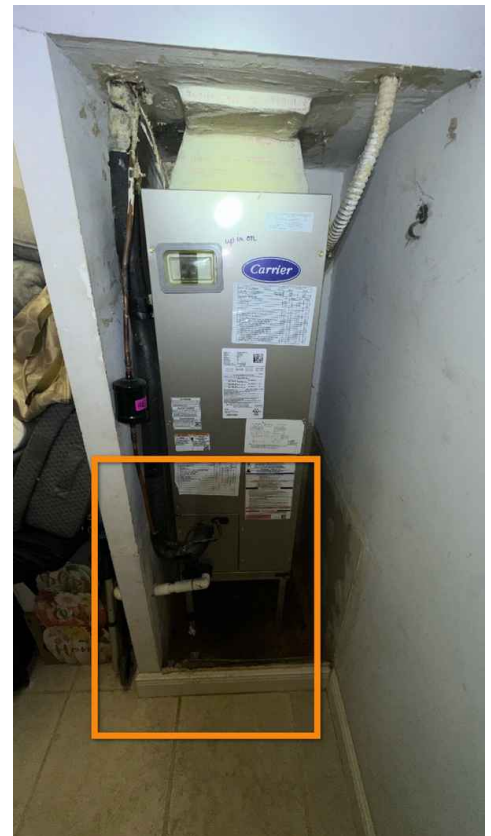
OVERFLOW PAN - MISSING

Recommend to have an over-flow pan installed under the air handler and/or water heater. An over-flow pan is intended to receive excess condensation and prevent damage to the surrounding area. See photo(s).

Contact a qualified heating and cooling contractor

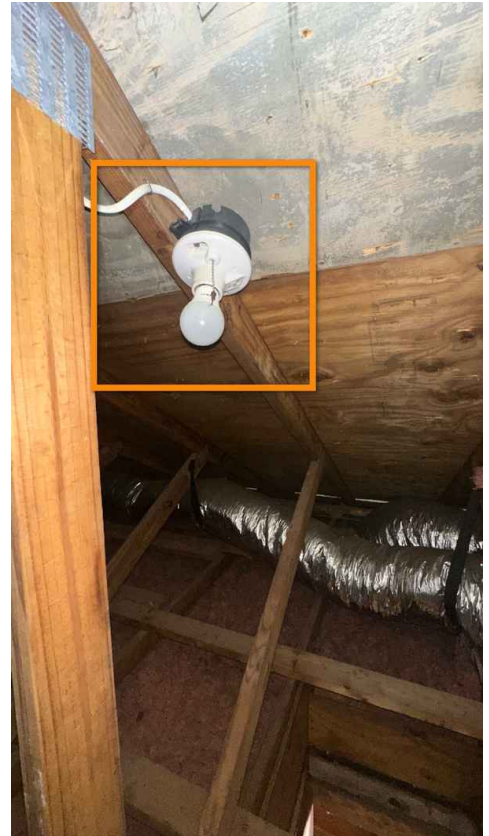
Light(s) not operating at time of inspection. Recommend ensuring that all light fixtures are operational and wired correctly. This is usually an issue with a burned out bulb but the inspectors do change out light bulbs in the owners house. See photos for example(s) of location(s).

Contact a qualified professional.

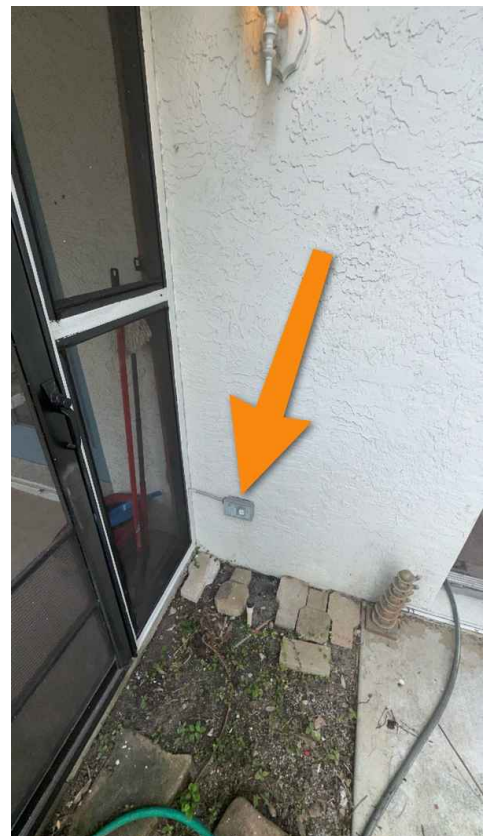
8.4.2 OUTLETS & FIXTURES

WEATHERPROOF COVER-BROKEN

Weatherproof cover is broken on an exterior outlet. Exterior outlets need this type of cover so they will remain dry where the outlet is being used. See photo(s).

Contact a qualified professional.

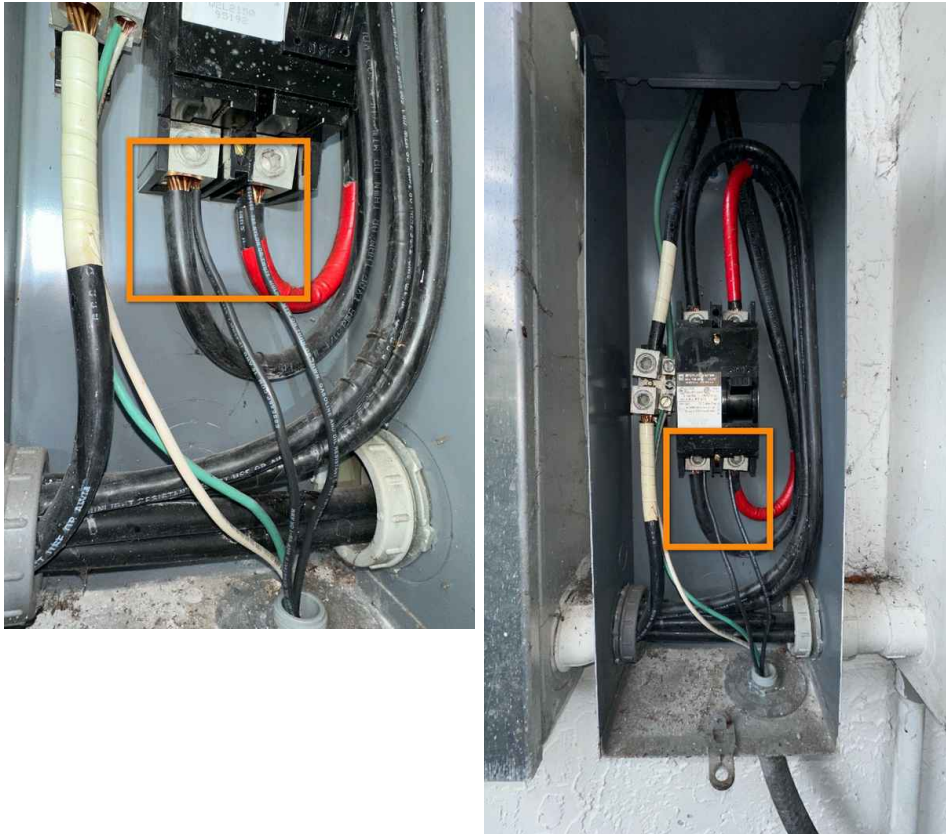
8.5.1 CIRCUIT BREAKERS & WIRING

DOUBLE TAP

Double-wired breaker(s) noted in the electrical panel. Usual wiring methods suggest one wire for each breaker to avoid over-heating. See photo(s).

Contact a qualified electrical contractor.

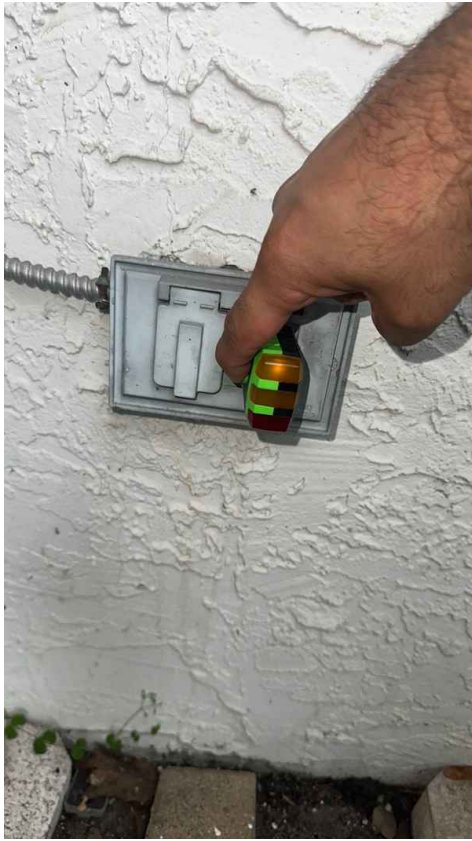
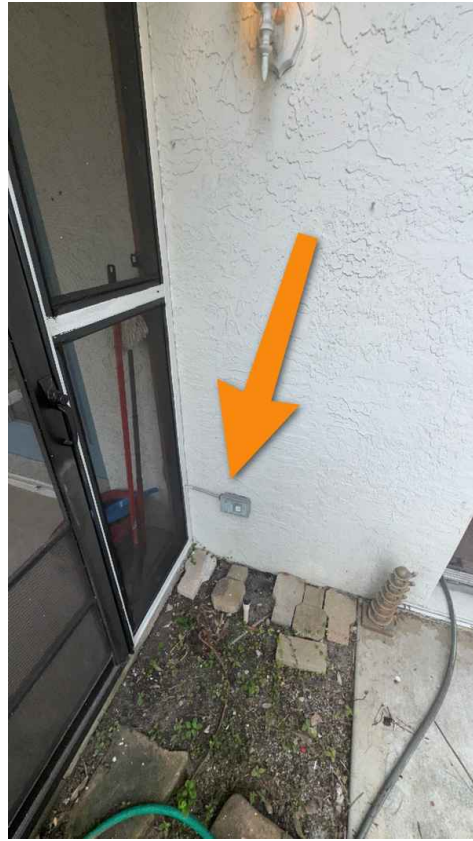
8.6.1 GFCI/AFCI

GFCI - UPGRADE SPECIFIC

GFCI protection recommended in all potentially wet locations to help prevent against shock. See photo(s) for example(s).

Contact a qualified electrical contractor.

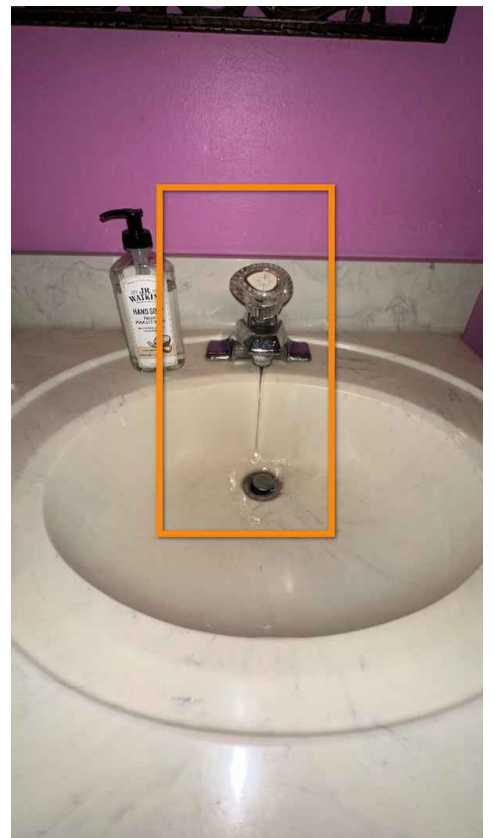
Low water flow was noted at the sink at the time of the inspection. There may be debris in the aerator or the shut-off may be defective. See photo(s).

Contact a qualified plumbing contractor.

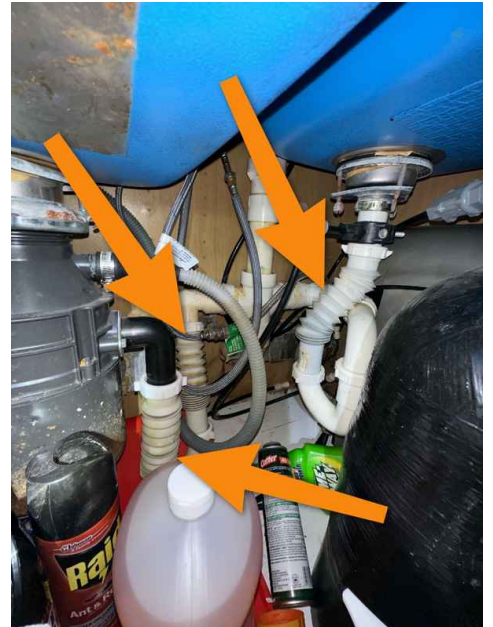
9.4.2 SINKS

FLEX/ACCORDION PIPE

Flexible drain pipe noted. This type of pipe is functional, but tends to trap debris. It may be beneficial to have a smooth wall pipe installed as a replacement to allow proper flow. See photo(s).

Contact a qualified plumbing contractor.

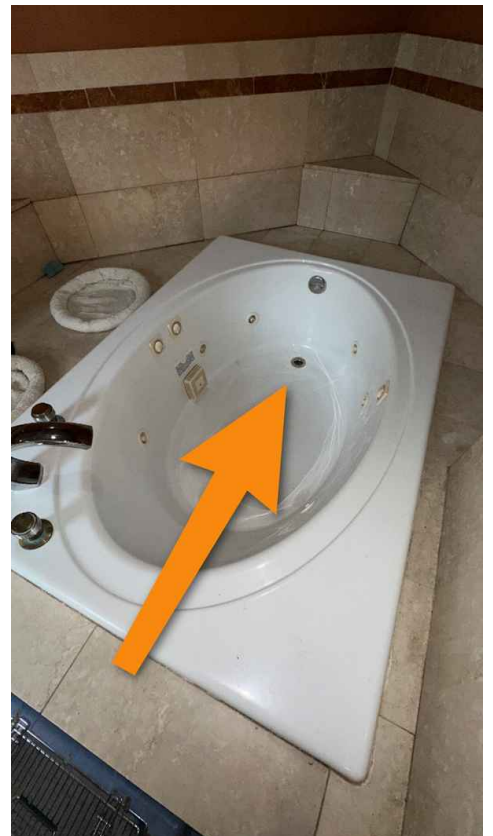
9.6.1 SHOWERS and TUBS (Plumbing)

TUB - MISSING STOPPER

Stopper missing in the tub drain. Replace as needed. See photo(s).

Contact a qualified professional.

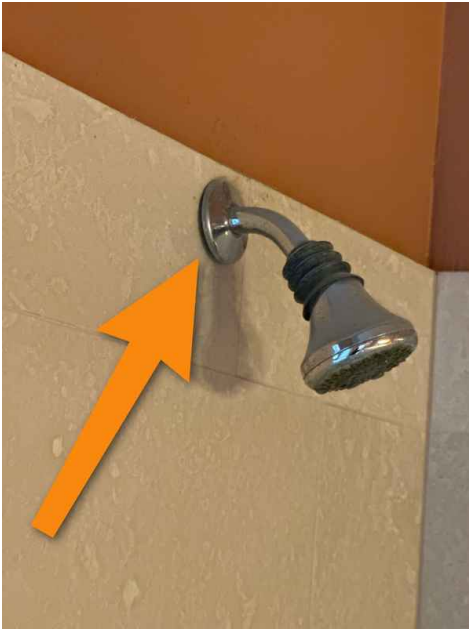
9.7.1 SHOWERS and TUBS (Non-Plumbing)

SEAL HANDLES/FAUCETS TO WALL

Recommend sealing the gaps where the faucets/handles meet the wall to help prevent water entry and damage into the wall cavity behind. See photo(s).

Contact a qualified professional.

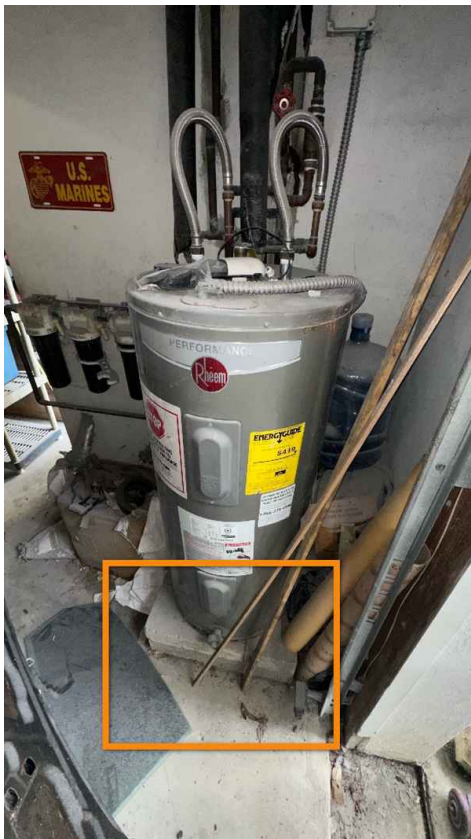
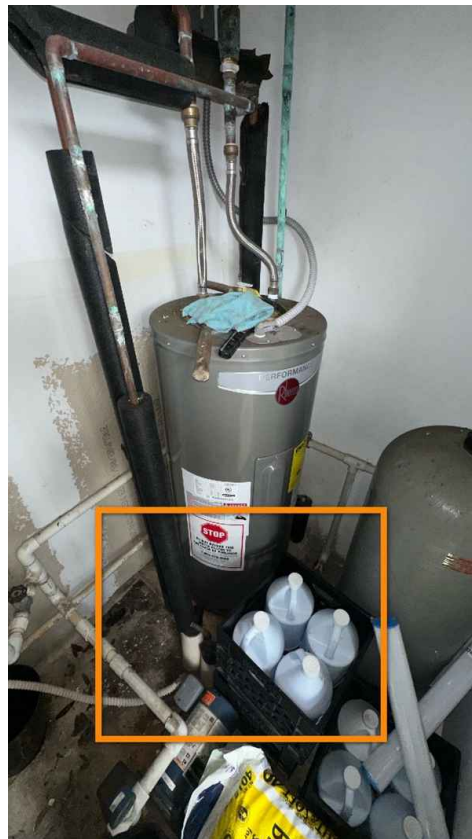
9.8.1 WATER HEATER***

OVERFLOW PAN MISSING (GARAGE)

Over-flow pan not installed under the water heater. Pans are intended to receive any leaks from the water heaters and should be piped to the exterior or a safe location where it cannot cause damage to the surrounding areas. Most manufacturers specs call for a pan to be installed under the tank. Water heater is installed in an unfinished garage and it is likely that a leak from the tank would not cause significant damage to any finished surfaces. Install as needed. See photo(s).

Contact a qualified plumbing contractor.

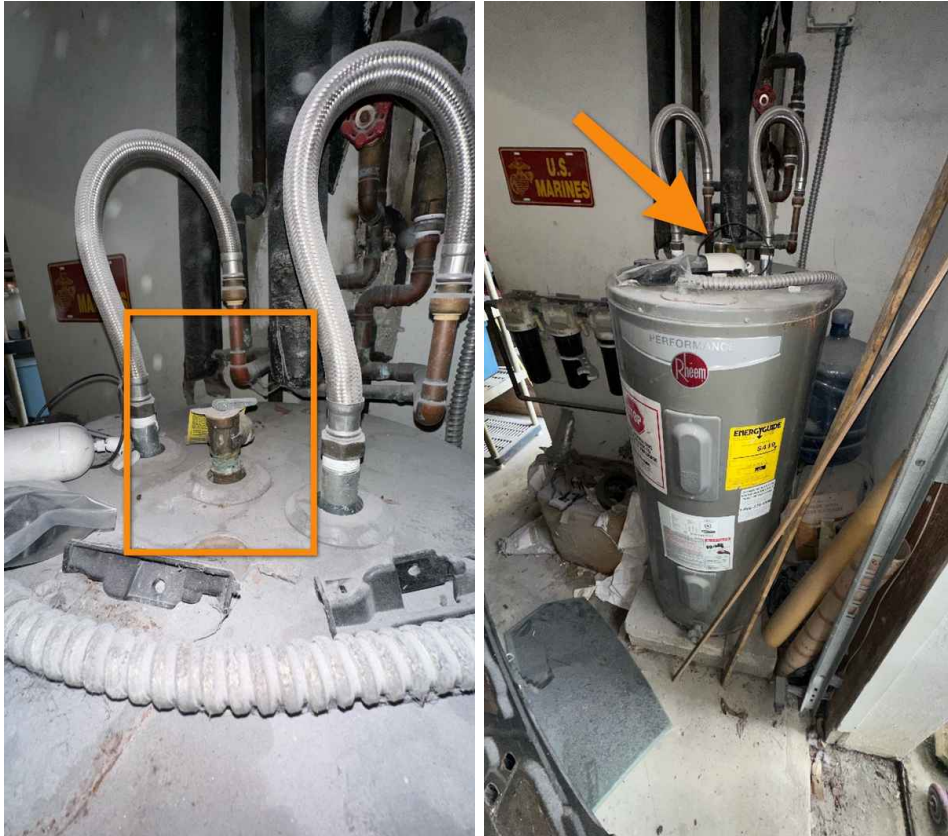
9.8.2 WATER HEATER***

MISSING DISCHARGE PIPE

Drain pipe for the Temperature & Pressure Relief Valve is missing for the water heater. This pipe should extend to the exterior or safe location as it may purge extremely hot or high pressure water. This is a potential safety issue. See photo(s).

Contact a qualified plumbing contractor.

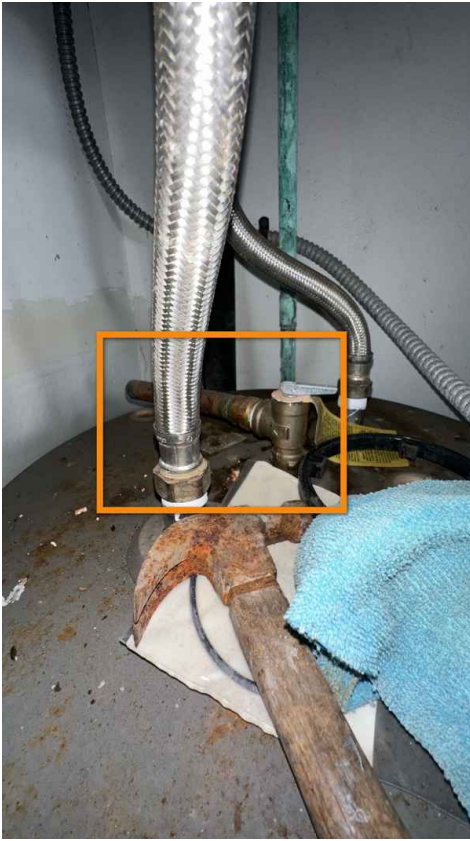
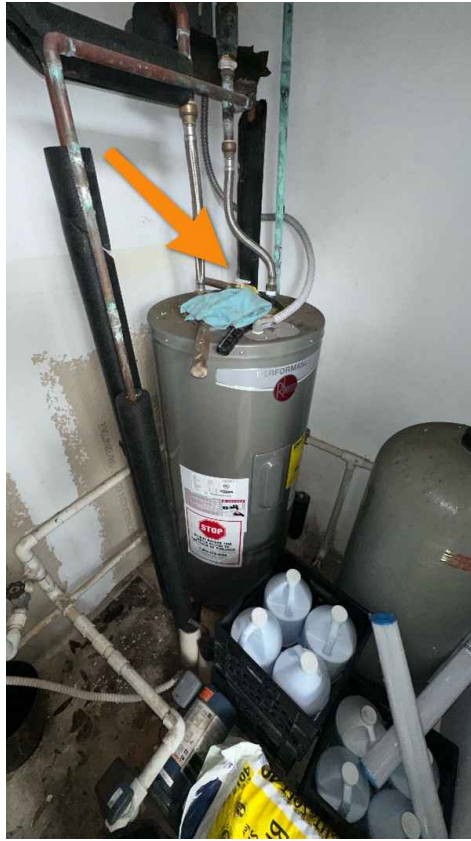
9.8.3 WATER HEATER***

DRAIN PIPE CLEARANCE

Contact a qualified plumbing contractor.

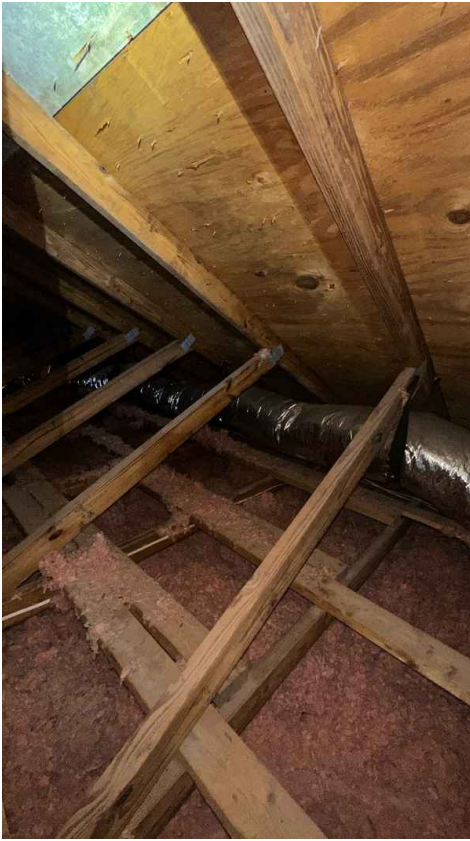
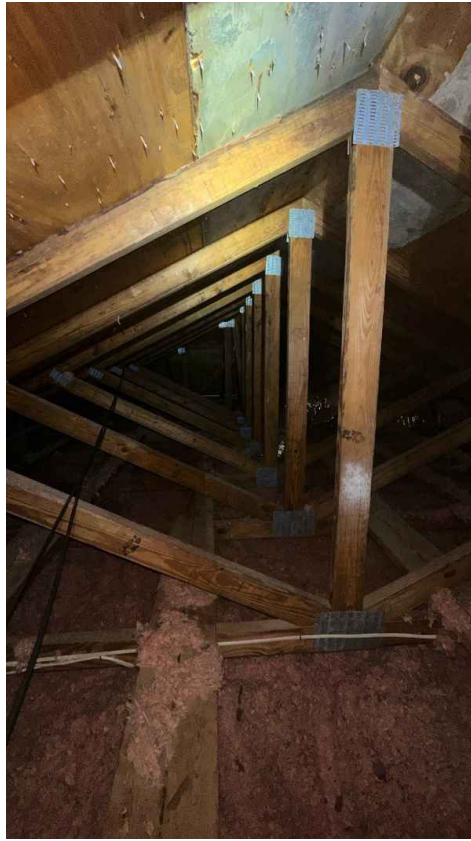
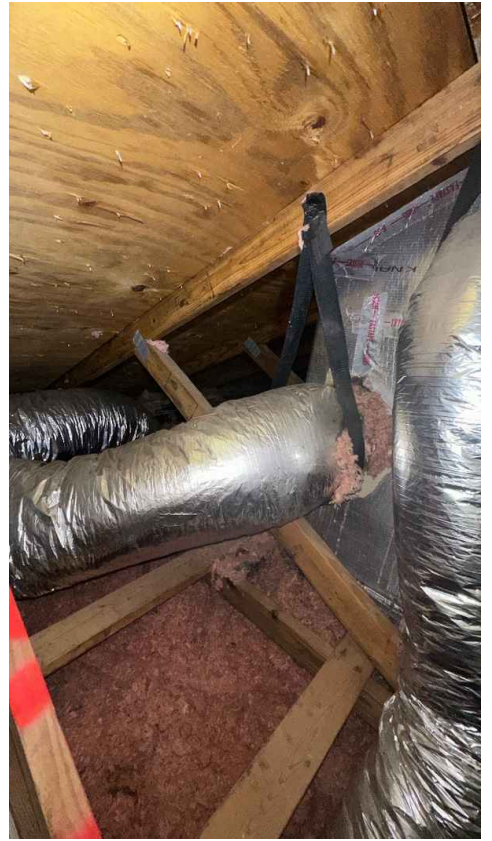
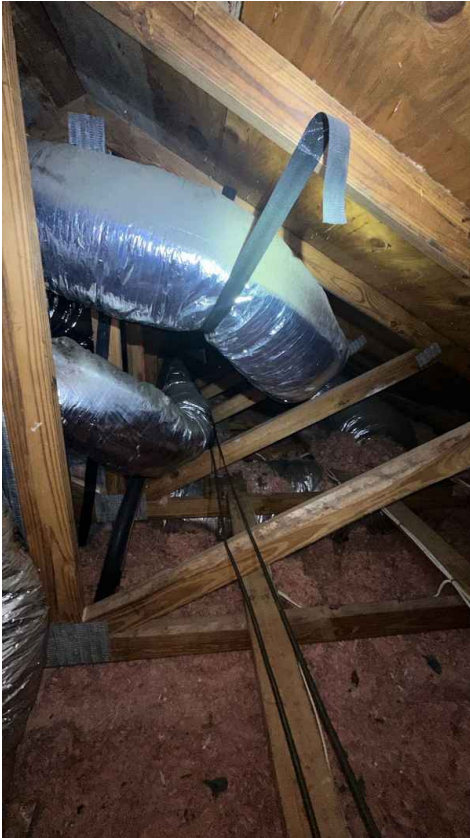
ATTIC - PARTIALLY INACCESSIBLE (CLEARANCE)

Parts of the attic space were observed from the closest point possible due to low clearance which limited physical entry. Inspector makes the best effort to inspect all parts of the attic area. See photo(s).

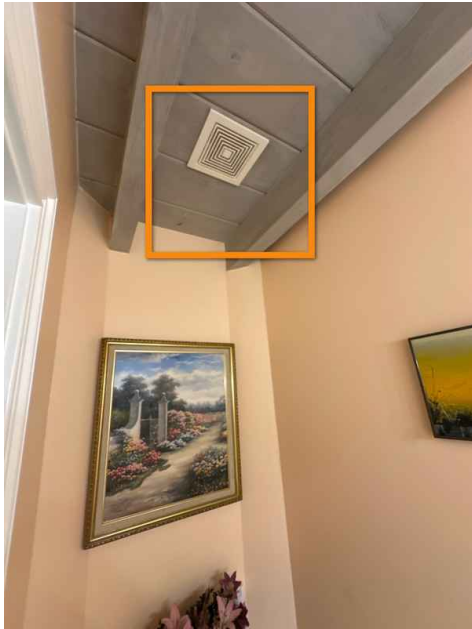
Bath vent(s) did not work when tested. These are needed to remove moisture and odors from the bath area. See photo(s).

Contact a qualified professional.

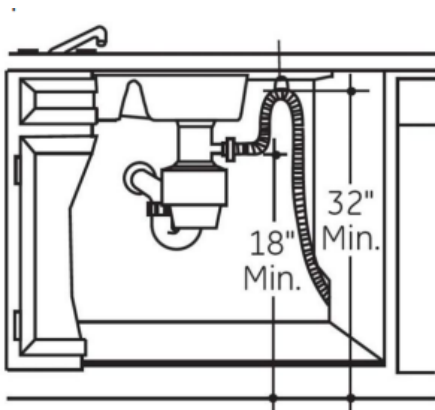
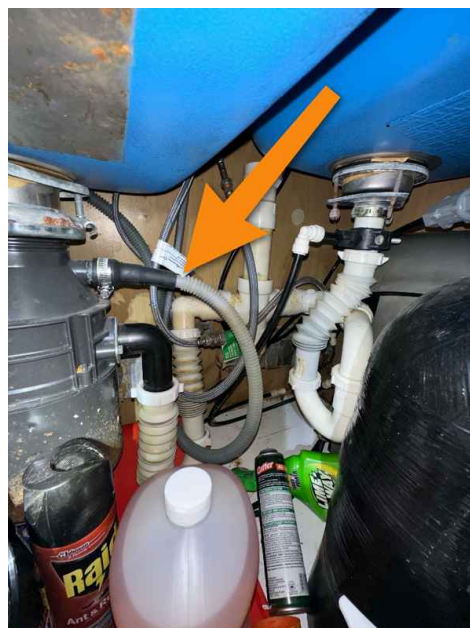
Drain line for the dishwasher is not installed properly. This line should loop above the sink drain line to prevent potential garbage and debris from entering into the dishwasher. Recommend to have this condition corrected. See photo(s).

Contact a qualified appliance repair professional.

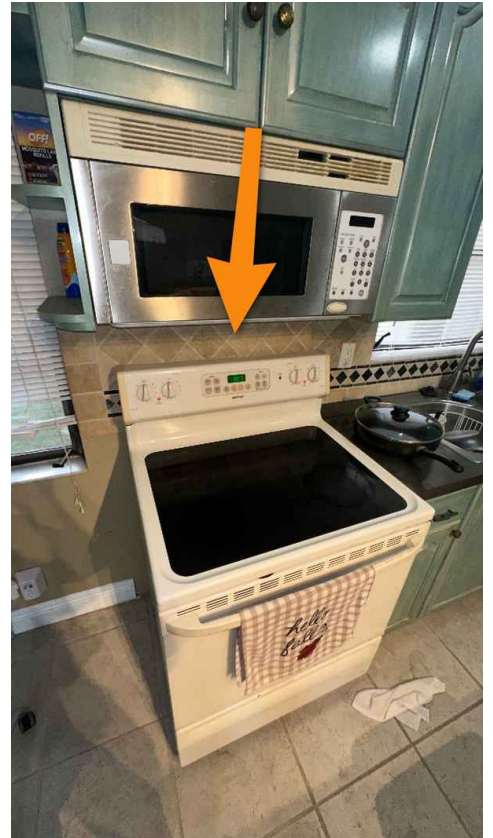
12.3.1 RANGES/OVENS/COOKTOPS

ANTI-TIP BRACKET

Contact a qualified professional.
