EU Life Recreation ReMEDIES Solent Recreational Activities Surveys 2023 - Report

Project Summary Report

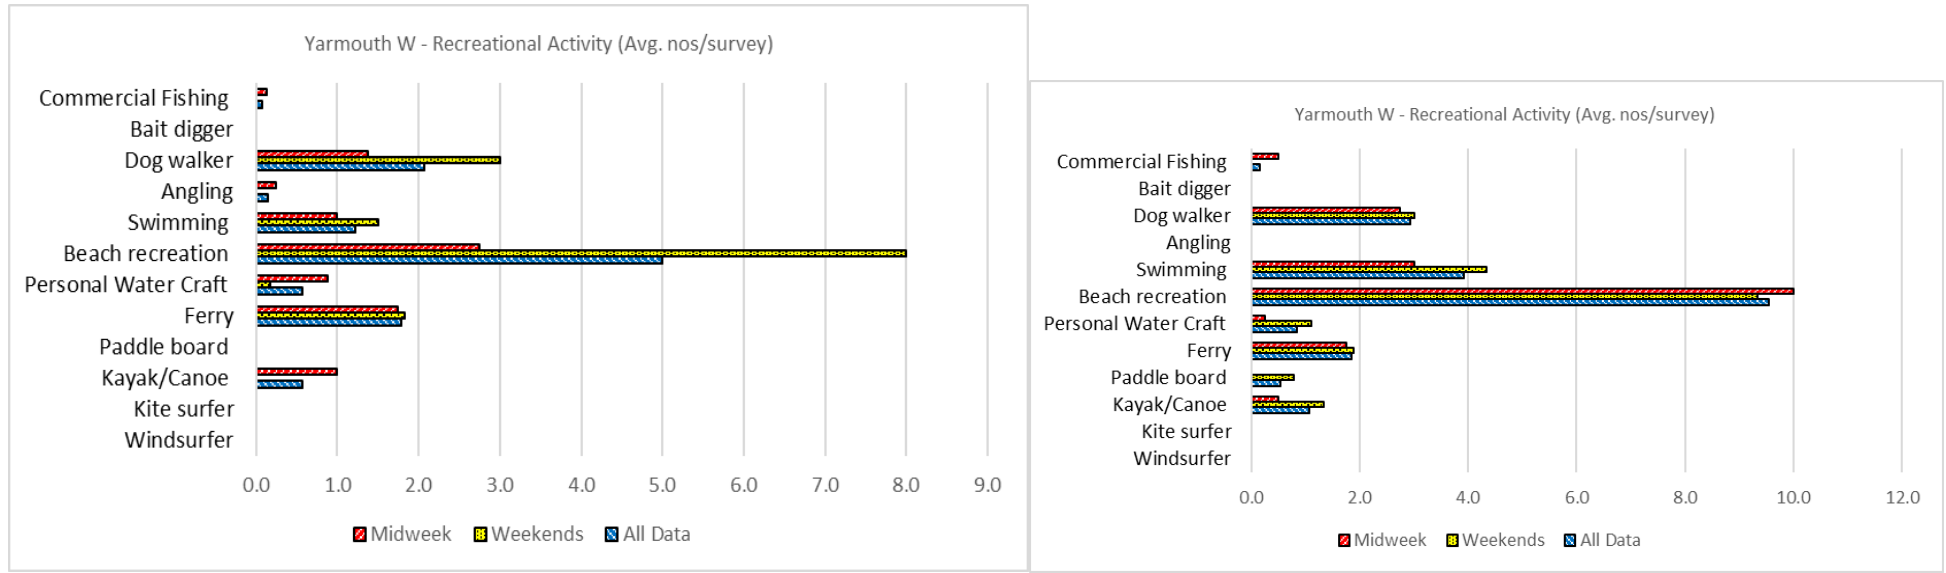
Figure 3. Yarmouth West: Average (mean per survey) 2023 data for (A) Boating Activity, (B) Vessel type and (C) Recreational Activity recorded across the survey period, shown for midweek, weekend and combined data. 2022 Graphs inset on the right hand side

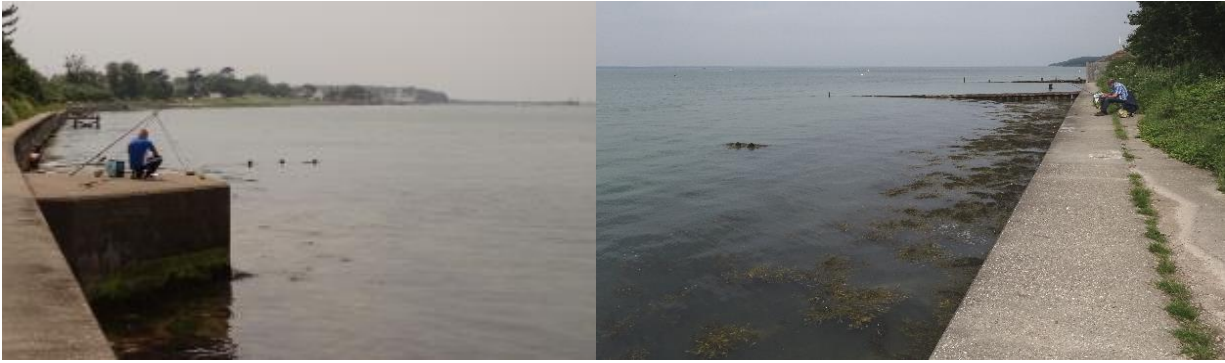
Figure 4. Bouldnor.: General views of area taken from the survey point. Looking East (right hand photo) and West (left hand photo)

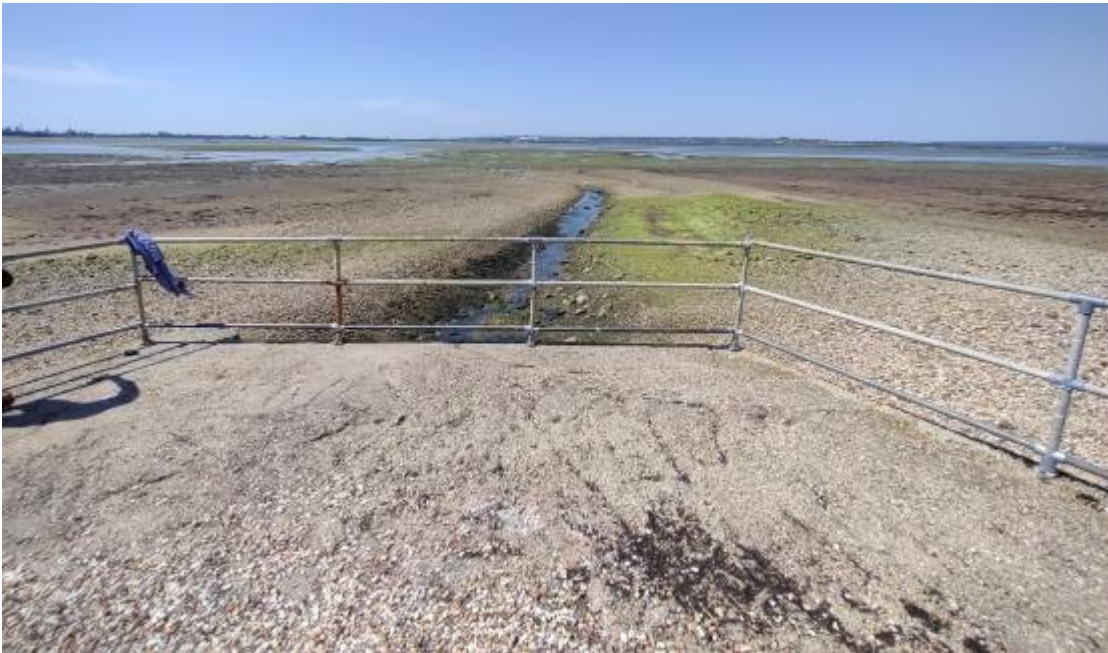
Figure 13. Langstone Harbour.: General view of area (tide out) taken from the survey point

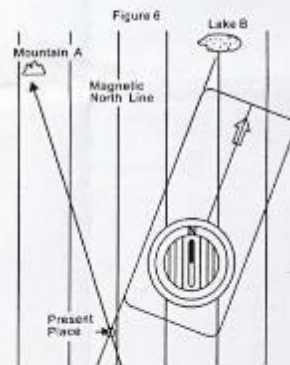
Many books on compass reading and orienteering are in print. We recommend reading them and/or taking a course to refine your compass and map reading skills.

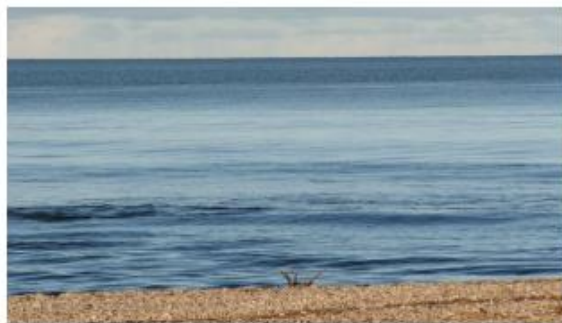
Conditions: Sea like a mirror.
Wind Speed: Under 1 knot (smoke rises vertically)
Wave Height: 0 feet

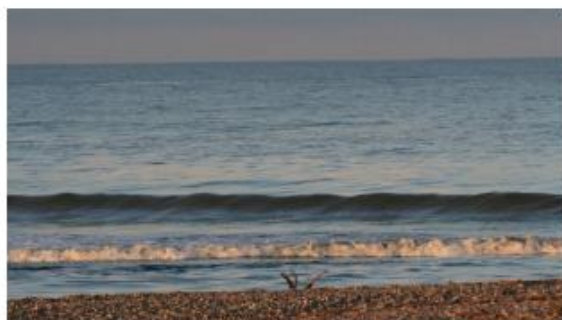
Conditions: Ripples.
Wind Speed: 1 - 3 knots (wind motion visible in smoke)
Wave Height: 0.33 feet/10cm

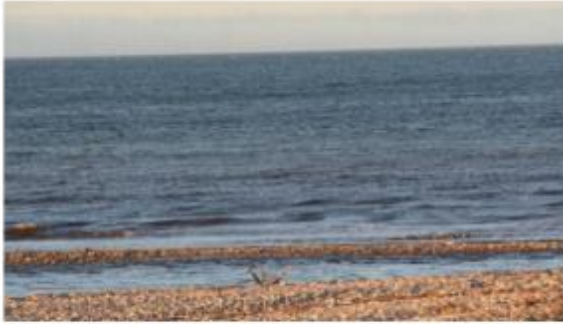
Conditions: Small wavelets all over. No whitecaps.
Wind Speed: 4 - 6 knots (wind felt on exposed skin and leaves rustle)
Wave Height: 0.66 feet/20cm

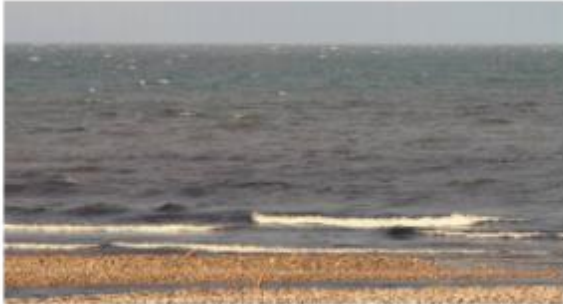
Wave Height: 2 feet/60cm

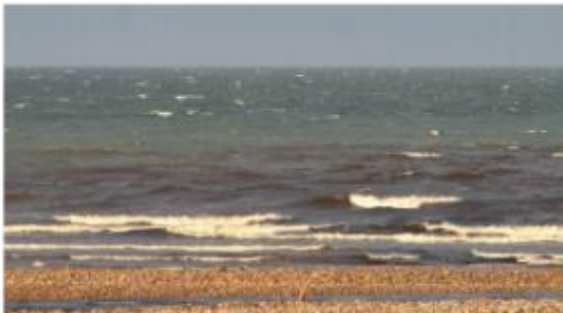
Wave Height: 3.3 feet/1m

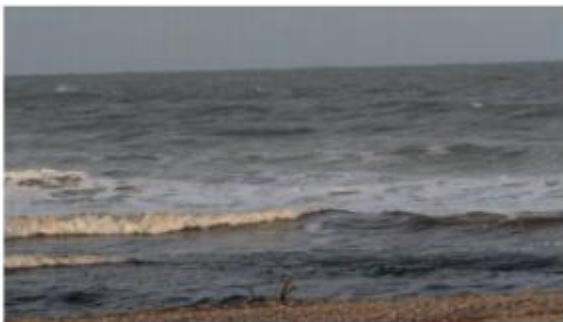
Wave Height: 6.6 feet/2m

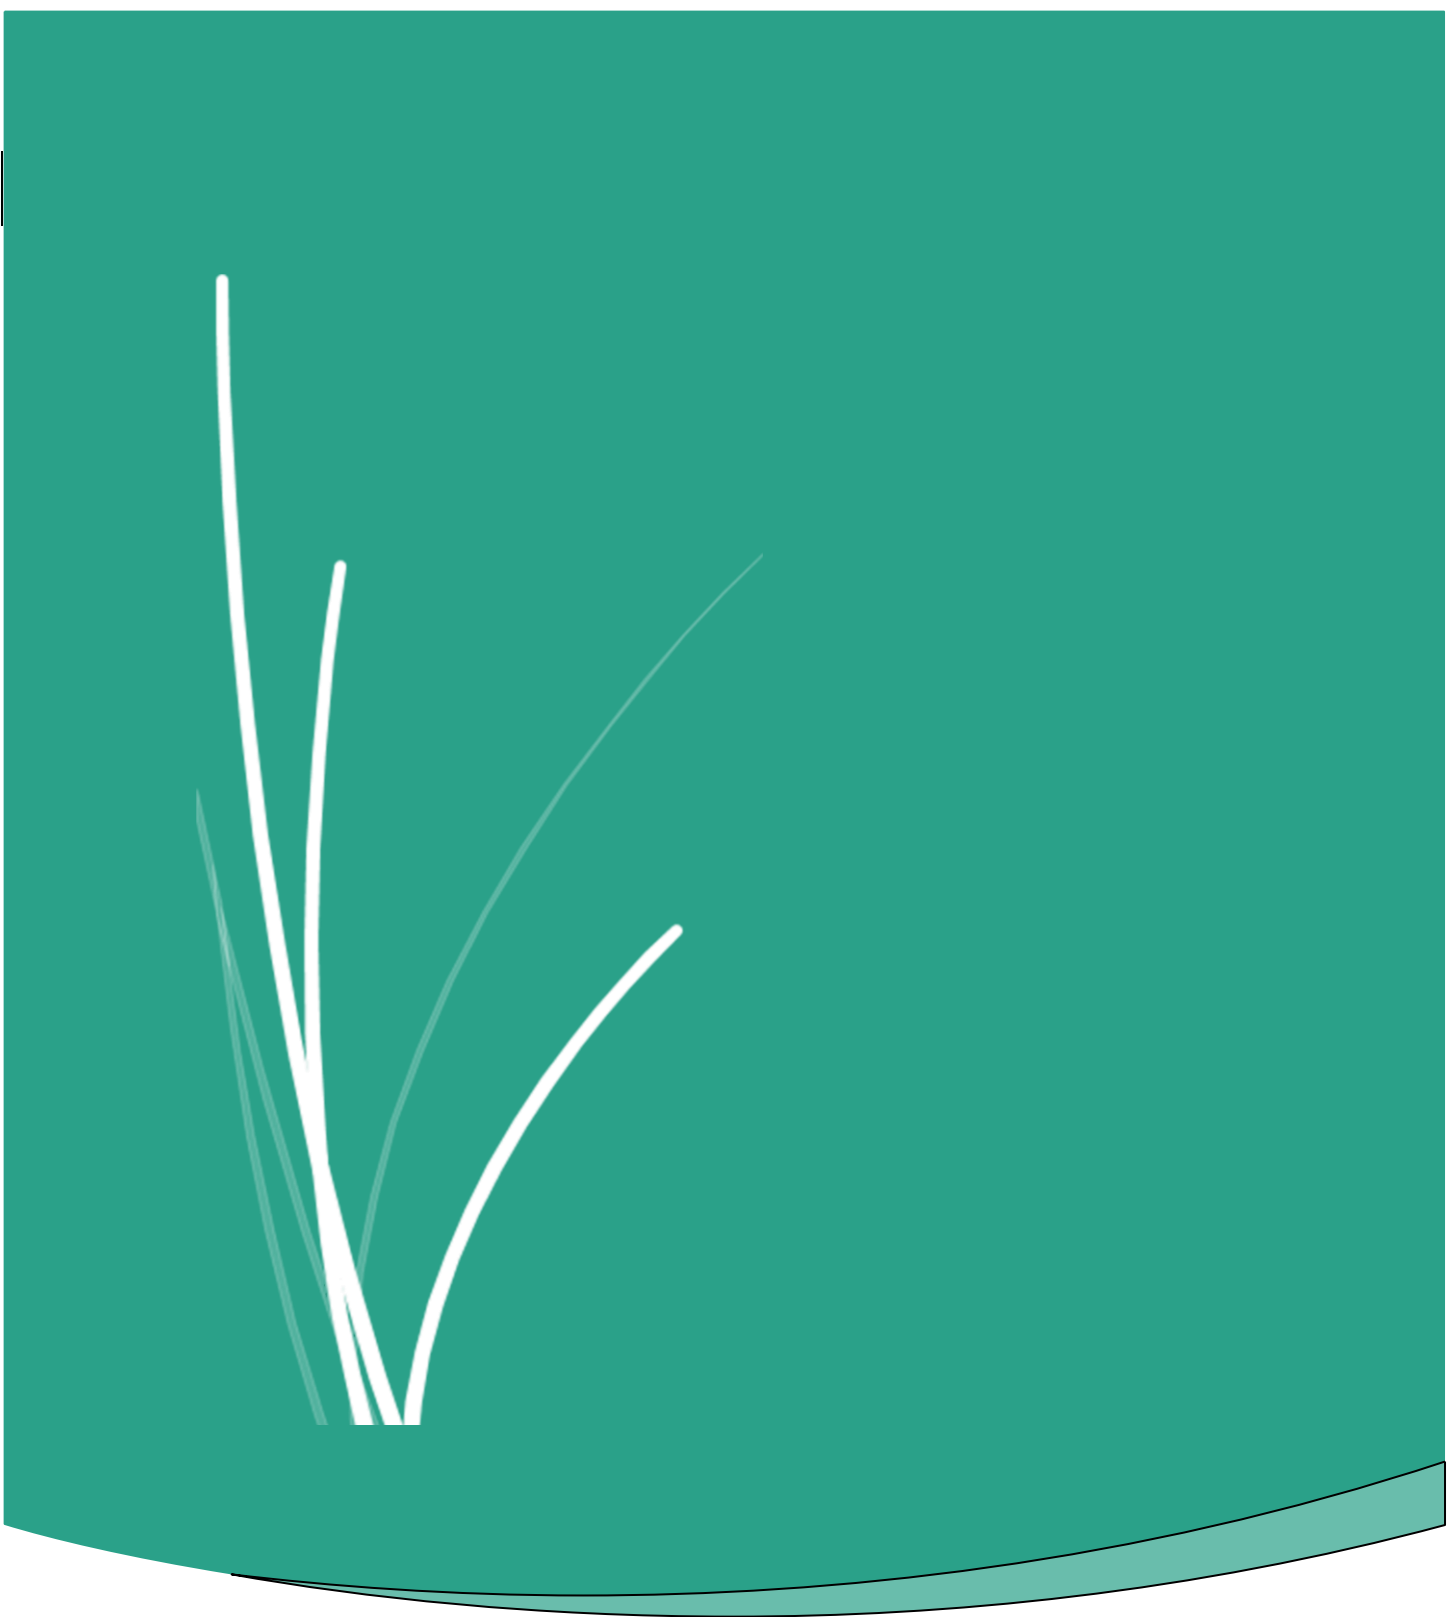
The **LIFE Recreation ReMEDIES: Reducing and Mitigating Erosion and Disturbance Impacts affecting the Seabed** project (LIFE18 NAT/UK000039) runs from July 2019 – October 2023 and will improve the condition of five SACs between Essex and Isles of Scilly. This will be
