#### Payload 3 Daily Flight Report

**Date**: 2020-08-16

Flight Campaign ID: P3C1

Airport, FBO ID, City: Rhinelander-Oneida County Airport (KRHI) - Rhinelander, WI

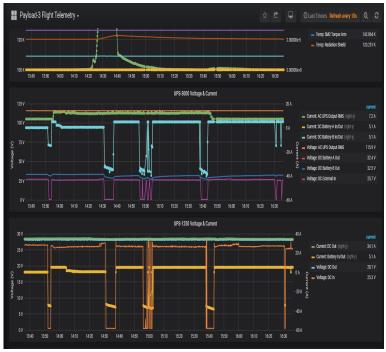
System experienced several drops in power which started prior to takeoff during taxi and was intermittent throughout the flight. The issue appears to be isolated to survey power. At this point we are unsure of the cause but have deduced many theories. We will keep monitoring the situation and conduct more test/troubleshooting if the problem reoccurs.

Right shows that the AXE was reviving voltage but no amps
