Second World War Road Block

Site Record Form

NZAA SITE NUMBER: R26/284

PUKERUA BAY RSA SUBMISSION IN SUPPORT OF THE TE HARA PUKERUA HERITAGE GROUP

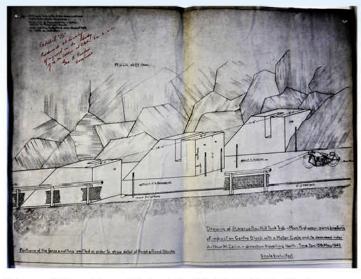
Drawing of Pukerua Bay road block made by Albert Collin the day after the accident. Archives Reference: ACGS 16231 COR1942/989. Archives New Zealand, Department of Internal Affairs, Te Tari Taiwhenua.

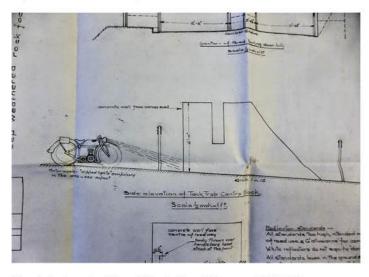
Part of plan drawn by Albert Collin. Archives Reference: ACGS 16231 COR1942/989. Archives New Zealand, Department of Internal Affairs, Te Tari Taiwhenua.

Japan's victories in Asia and the Pacific had created a fear of invasion in New Zealand. Officially known as a type-E Road Block, and popularly known as a tank trap, it consisted of three substantial concrete pillars each 1.8 metres high, 1.5 metres wide and 3.7 metres long with grooves in the side. When invasion was imminent sections of railway iron were to be dropped into the grooves to slow down a Japanese advance on Wellington. Two of the concrete pillars were on each side of the road and the third was in the centre of the highway.

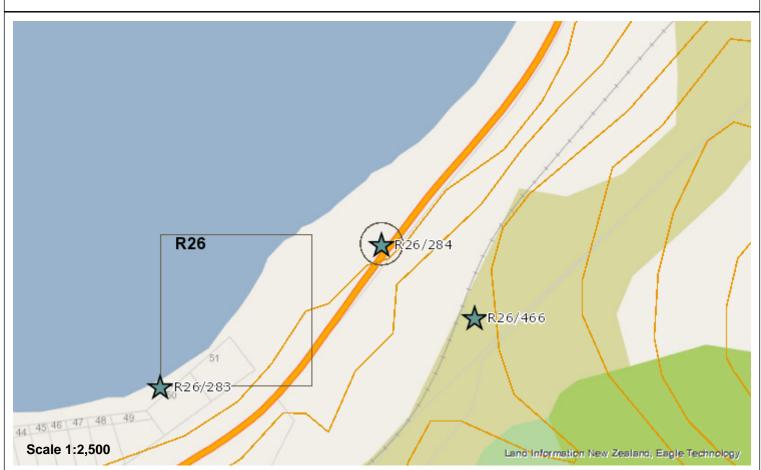
East side of SH1, immediately north of prominent gut in hillside.

Concrete World War II Road Block.

| SITE RECORD HISTORY | NZAA SITE NUMBER: R26/284 |
|--|---|
| Highly visible in roadside bank/cliff. Remaining eastern portion is intact and structurally sound. | |

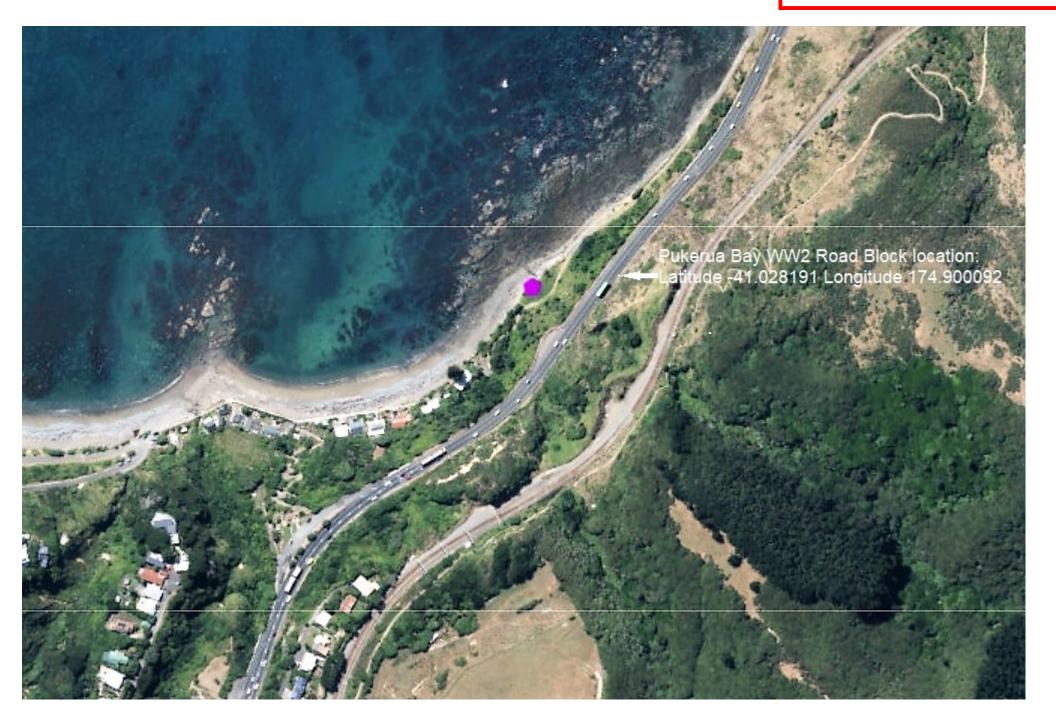
East side of SH1 at roadside. Cliffs immediately behind. north of prominent gut in hillside. Very visible.

Part that survives is good as concrete construction makes for a fairly durable feature. Presumably always at risk from road works.

Road blocks were created at points on the road where natural obstacles either side of the road made by-passing the road block difficult. They consisted of two solid block of concrete, one on each side of a road, and each with a slot to hold a barrier. Only the block on the eastern side survives at this site. Generally date to c.1942.
