STATEMENT OF REBUTTAL

SNA 102 - 3A SOLWAY PLACE, PORIRUA

GRAEME D WALKER on behalf of SAMANTHA MONTGOMERY LIMITED

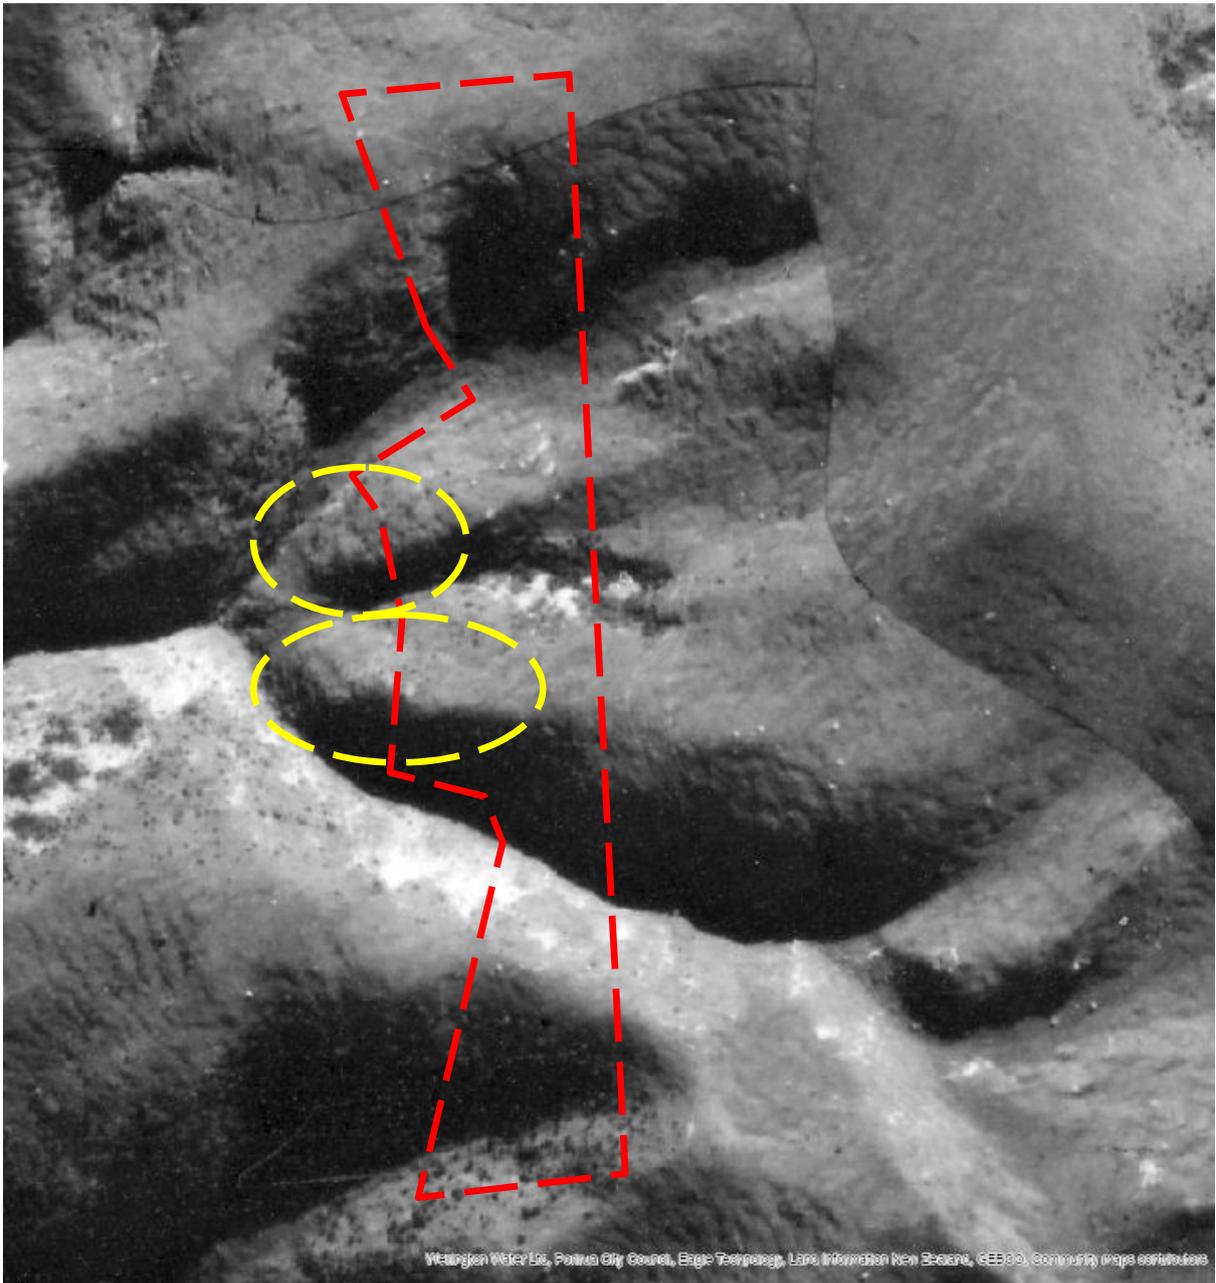
Title Boundaries

Earthworked Batters

SITE AERIAL 1962

In attached Figure 1 an aerial photograph taken in 1962 of the area (PCC GIS Mapping) is provided with the site boundaries overlain. It will be seen the land is bare farmland with no sign of an escarpment in our property, or in the adjacent Public Reserve.

The landform along the Solway Place frontage had been previously subject to significant earthworks with two large steep cut batters along the frontage - these can be seen in the 1962 aerial photograph (Figure 1 attached Page 4) where their substantial nature is evident.

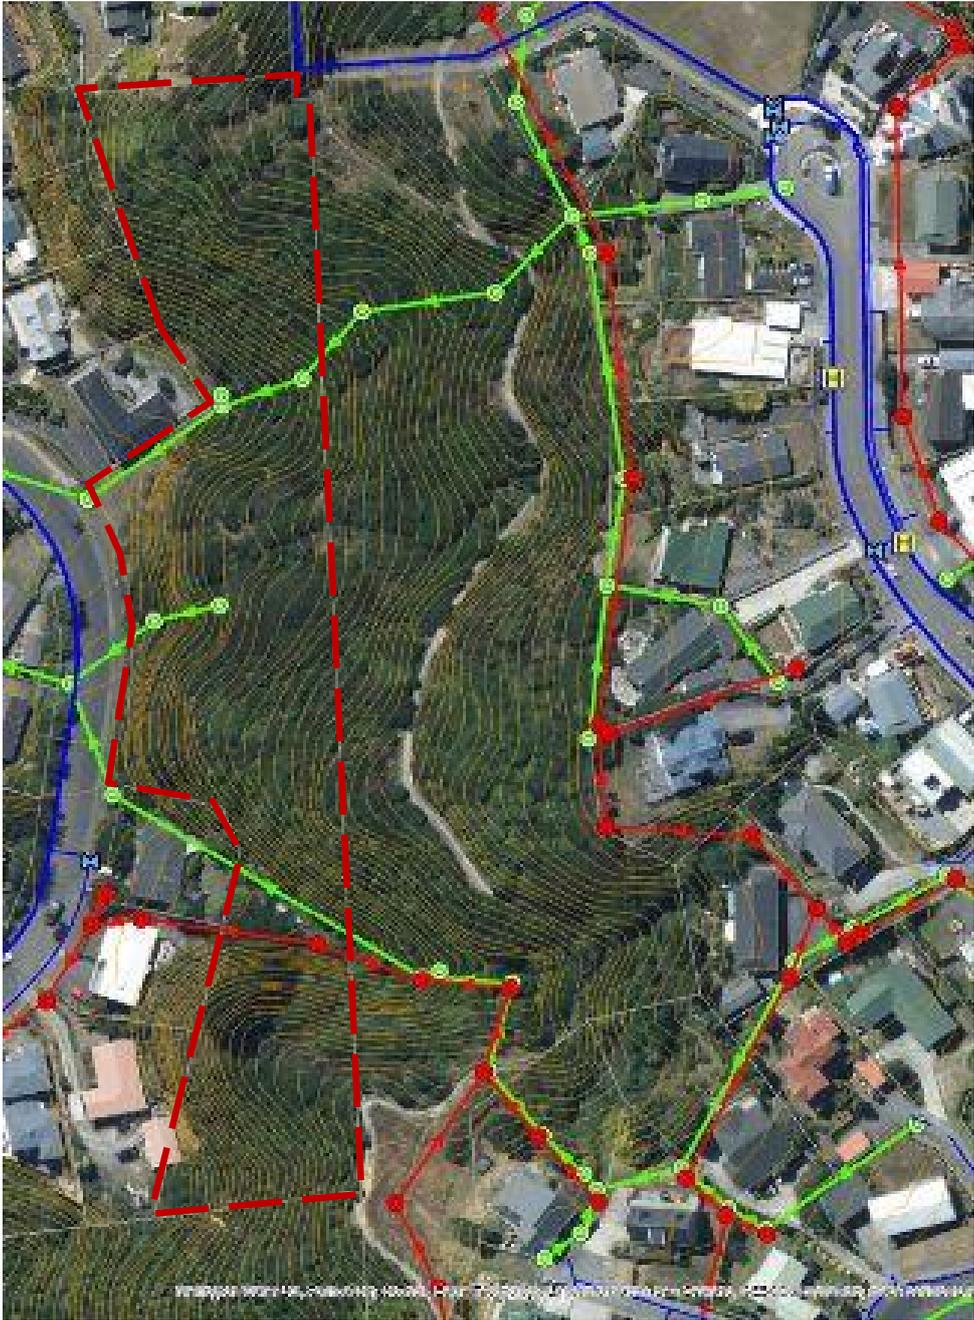
FIGURE 2

Title Boundaries

Site Contour and Buried Services (PCC GIS Mapping - Current)

A public stormwater sump is located between these two ridgelines 50% of the site width in from the Solway Place frontage - the top of the northern cut batter is clearly visible - lying above, and adjacent to the sump - the top of the southern earth cut batter lies further into the site and is covered in dense scrub.

The land to the rear of No 5 Solway Place comprises earthfill for the full width of our property

It is supported by a 1.5 metre high crib wall along its western edge and overlies public sewer and stormwater pipes to which access is already a right for Council maintenance access.

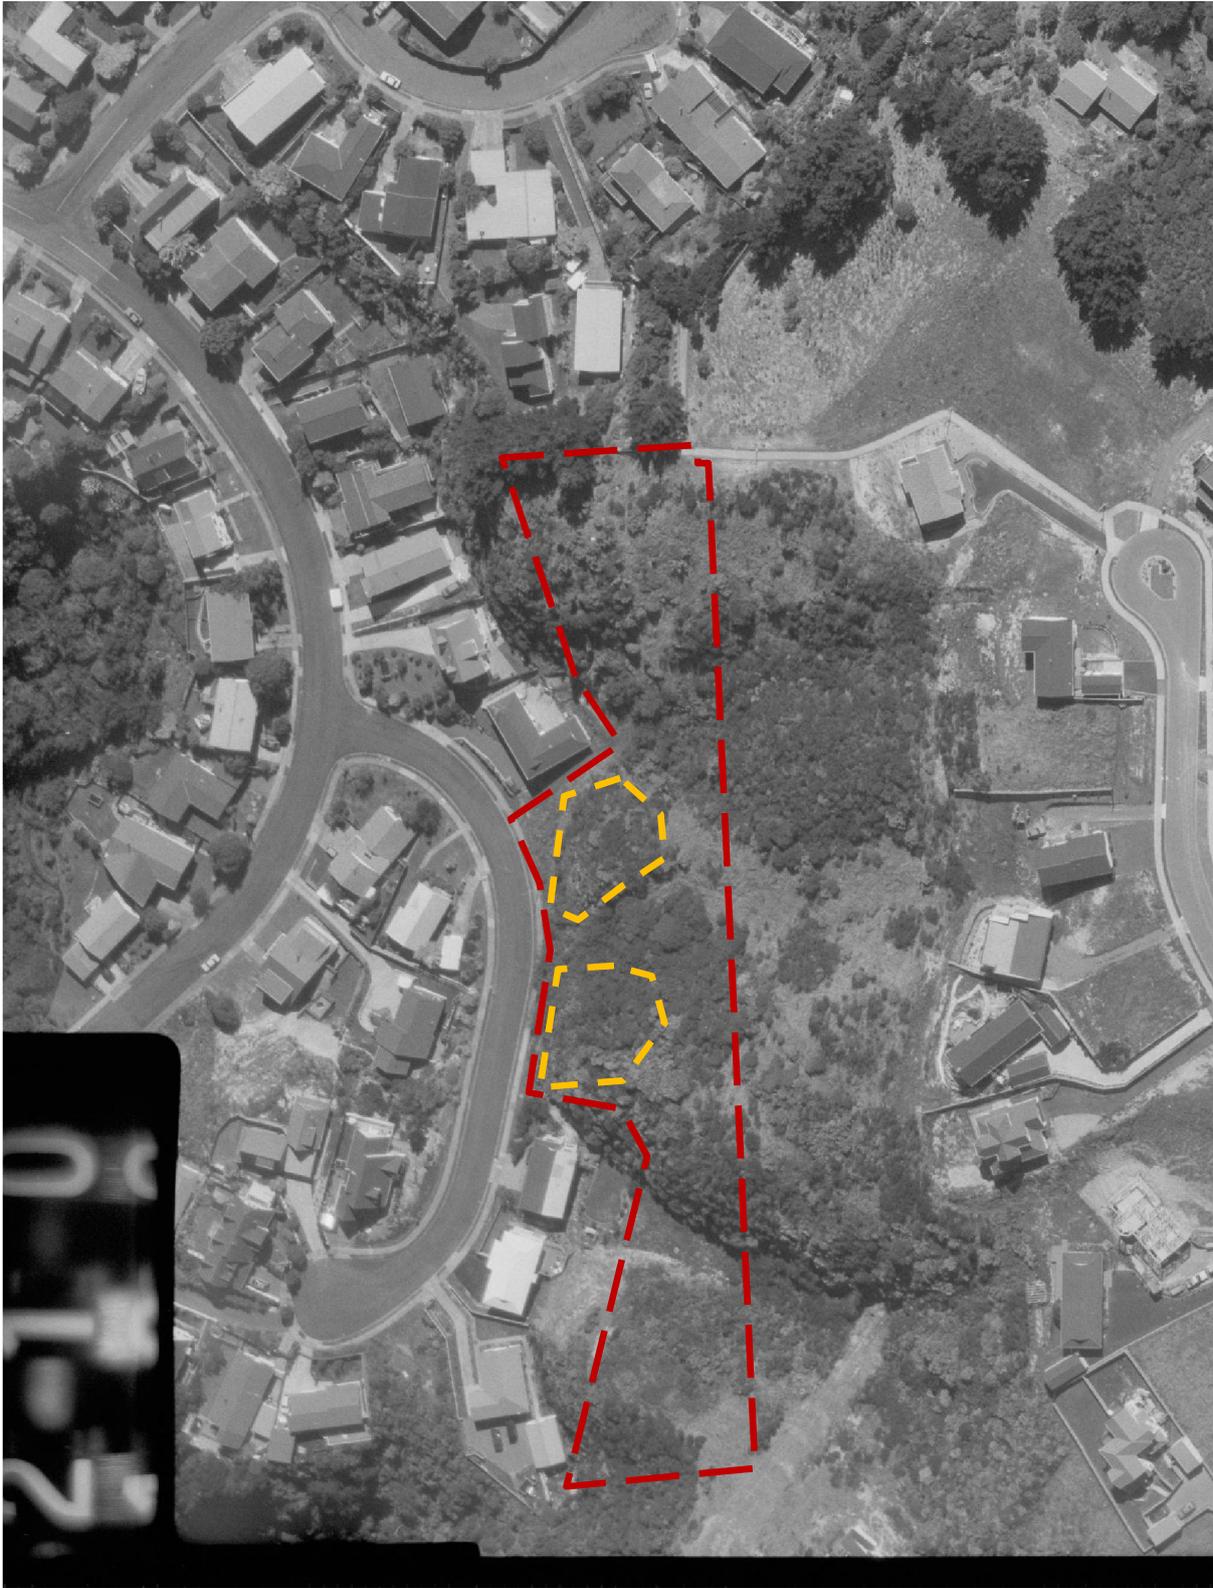
FIGURE 3

Title Boundaries

Earthworked Batters

SITE AERIAL 1995

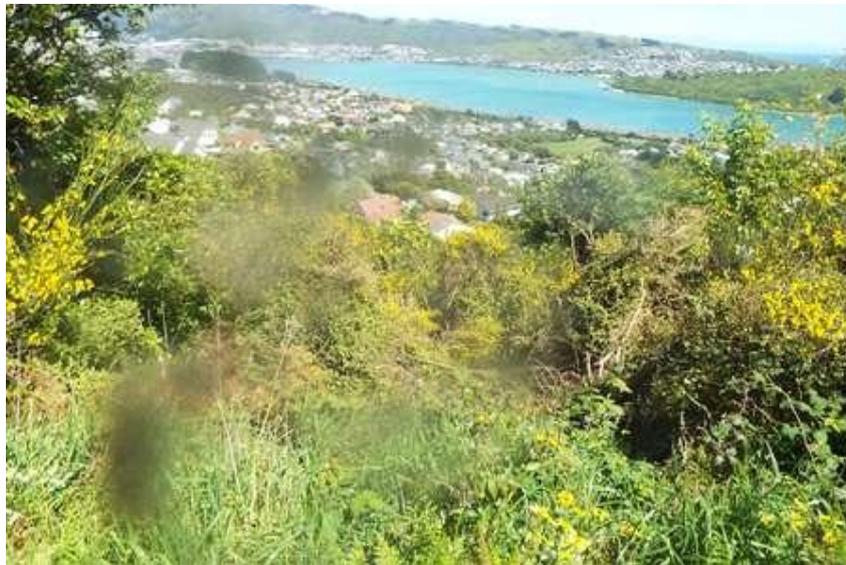
View Down from PCC Reserve

While groundcover has regenerated, it currently comprises mainly long grasses, broom, gorse and wandering dew. The ground cover is easily observed from the public access at the top north-east corner of the site and could in no manner be described as "significant vegetation" - please refer to ***appended photographs***.

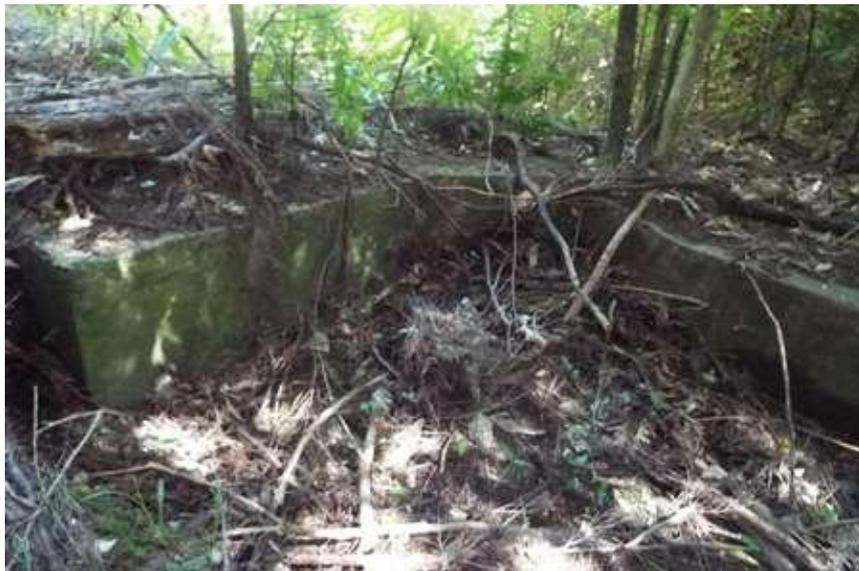
Sump in Centre of Site
