In the matter of the Proposed Porirua District Plan

**Statement of evidence of Alistair Osborne on behalf of Porirua City Council
(Flood Hazard Modelling)**

Date: 10 February 2023

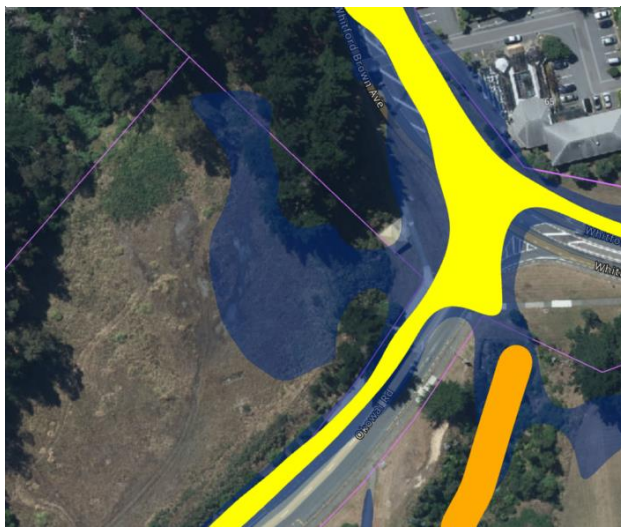
Figure 2 Current flood hazard mapping

- 14 Regarding the matter in 13.1, the “natural” hazard aspect of the flood layer relates to flooding that results from an extreme rainfall event rather than the natural or constructed nature of the flooded location..
- 15 Regarding the matter in 13.2, a detailed review of the site has confirmed this location is elevated with steep topography. The mapping should be changed at this location as shown in Figure 1 and Figure 2 images below.

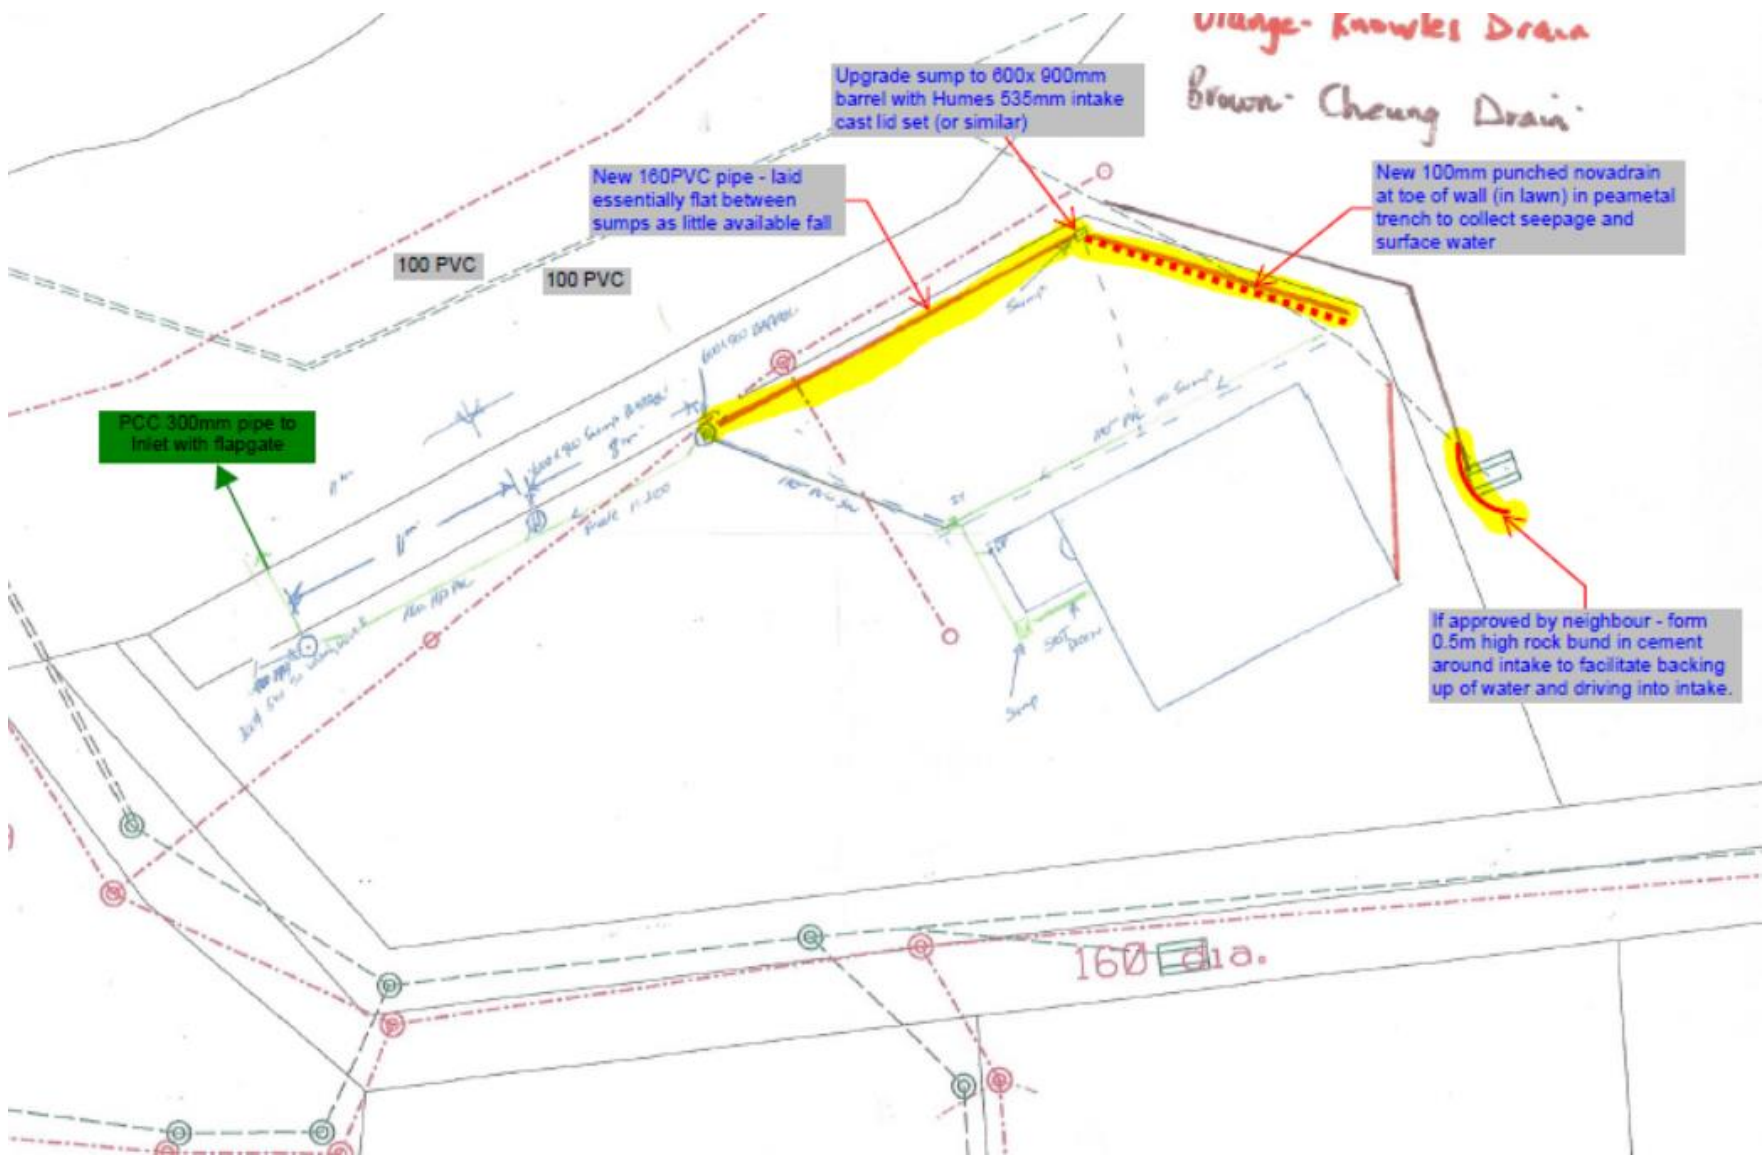
Figure 3 Proposed drainage solution at 300c Paremata Rd (source: 300c Paremata Road existing drainage improvements)

- 19 It is considered that this has eliminated any flood hazard and risks as is evident with on the ground conditions.
- 20 A review of the as-built plan covering the works described by the submitter along with the investigation¹ upon which the works were based has shown that the stormwater assets installed at the property extend along the boundary between 300c Paremata Rd and 300b Paremata Rd (refer to Figure 3 below).

- 21 The as-built plan shows the pipes installed were no larger than 160mm in diameter.
- 22 The investigation upon which the works were based notes that ponding will occur on the property if the PCC drain, into which the new pipes are connected, is at capacity (full), or if the Inlet (Pauatahanui Inlet) restricts flow. The investigation reports that sea level rise will restrict the ability of the system to drain the property.

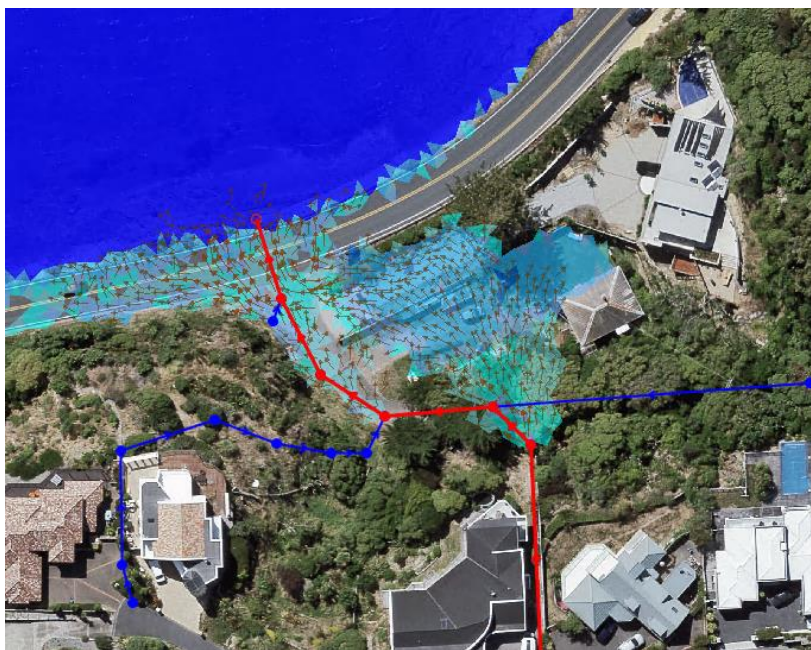
Figure 4 Modelled stormwater overflows at 18 The Layline

- 26 The modelled flooding that extends onto 300c Paremata Road is based on an extreme storm event, the 100-year ARI (with climate change, including sea level rise) event, and is a result of the stormwater network surcharging upstream of the property in 18 The Layline (refer to Figure 4 below).

27 The nature of this flooding (originating south of the property) shows that the installed network described by the submitter, extending along the western and northern boundary of the site, would not capture or alleviate the flooding generated from the surcharging network shown in the image above.

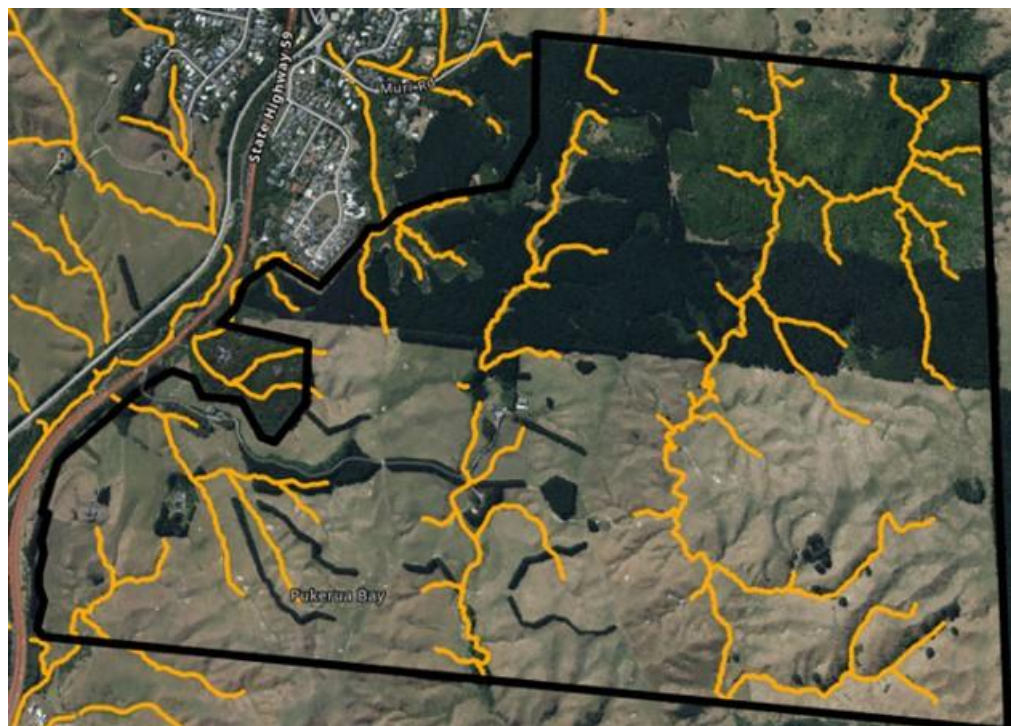
Figure 5 Current flood hazard mapping for the Northern Growth Area

32 Submission OS 74.73 by Greater Wellington Regional Council reports that current the PDP does not include ponding zones and overland flow paths in the Northern Growth Area. Their position is that areas covered by these flood hazard components will be subject to flooding so these components should be shown in the PDP. This is to ensure the PDP has regard to the Proposed RPS Change 1 Policy 29.

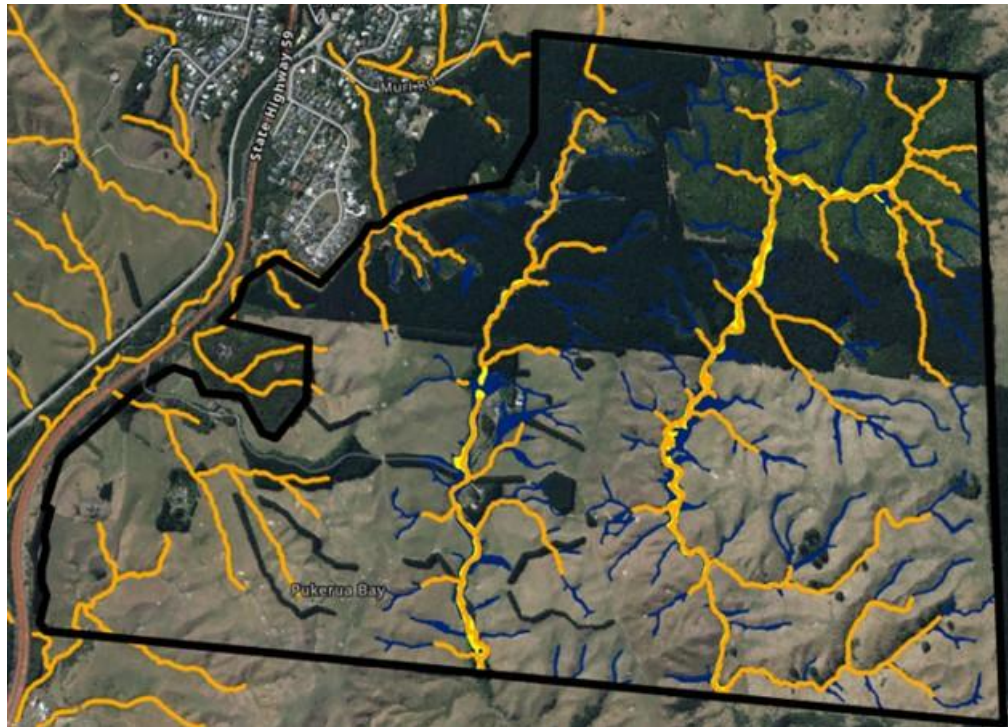
Figure 6 Proposed flood hazard mapping for the Northern Growth Area

33 This is correct and suitable modelling will be undertaken to enable the development of ponding zones and overland flow paths for the Northern Growth Areas for inclusion in the PDP.

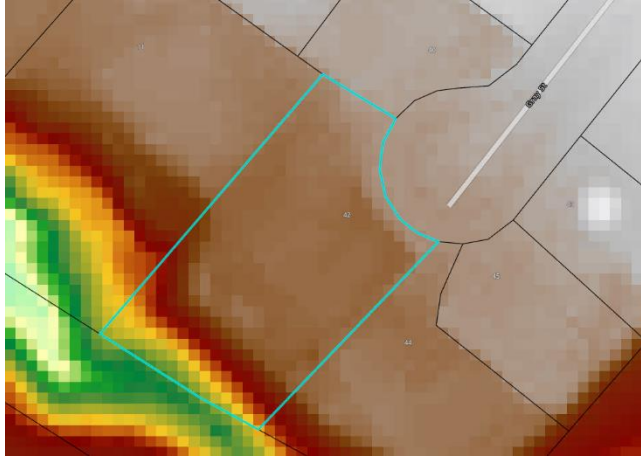
Figure 7 Elevation at 42 Gray St

37 The first concern is that the model topography does not capture the site earthworks that took place at the time of the subdivision development, that lead to a portion of 42 Gray being filled to create a level building platform. This is not the case, and the modelled topography does capture the level building platform across 42 Gray St, above the stream gully at the rear of the property. This is shown in the Figure 7 below where the minimal variation in colour across the

highlighted section indicates minimal variation in elevation (that is, a level surface). This matches the surface seen in the aerial photograph and Google Streetview photo of the site (refer to Figure 8 and Figure 9 below).

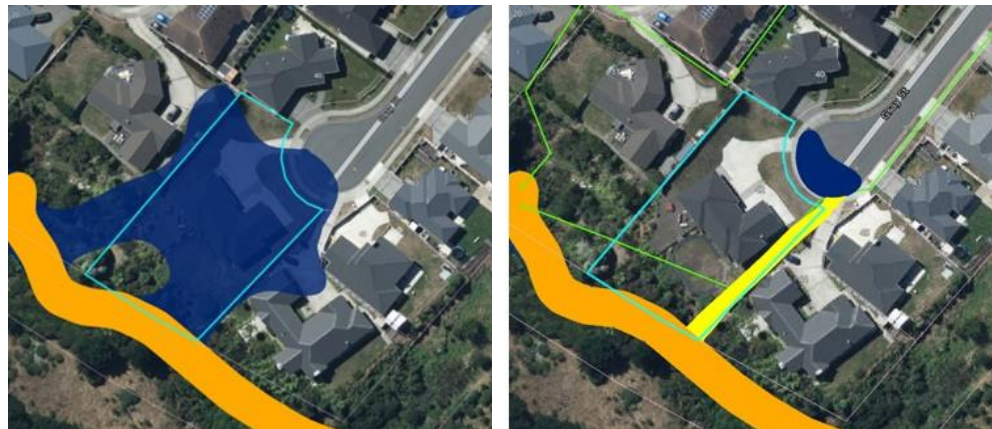
Figure 11 Proposed flood hazard mapping

- 42 As a result of the review of this property and associated modelling, it is proposed to change the flood hazard mapping to remove the majority of flooding across 42 Gray St. However, it has been noted that an overland flow path should be included at this location to ensure there is a clear path for water to flow from the cul-de-sac to the gully on the southern edge of the property, in the event of network blockages or an inability to carry runoff from an extreme event.

43 The current and proposed changes to the flood hazard mapping are shown in Figure 12 and **Error! Reference source not found.** below.

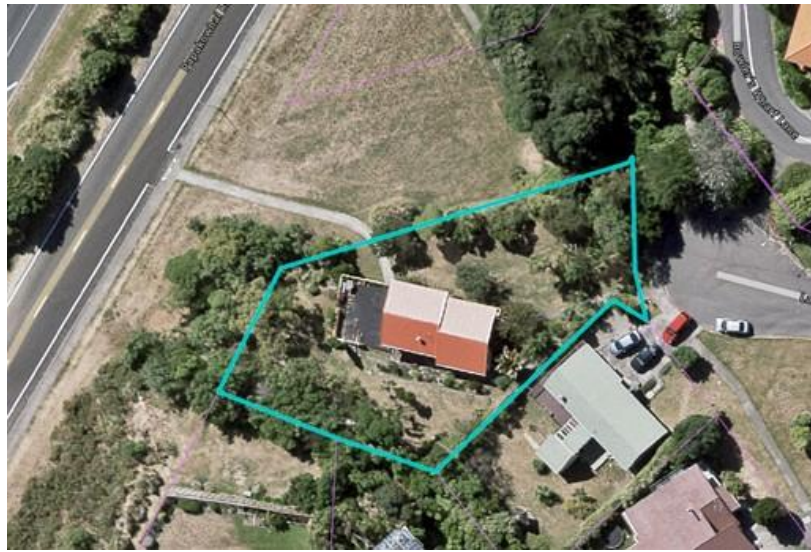
Figure 12 Aerial photo PCC Urban Aerials (2016)

- 51 With regard to the comment on the out-of-date topography, I am unaware of the of any significant changes to the topography in the area of 21 Langell Pl, that would impact the flood mapping. The three images in Figures 12 - 14 below show an aerial photograph of the area, the modelled topography based on 2013 LiDAR, and the topography data collected in 2015 (which was not available at the time of modelling). There does not appear to any significant difference between them that would indicate out-of-date information.

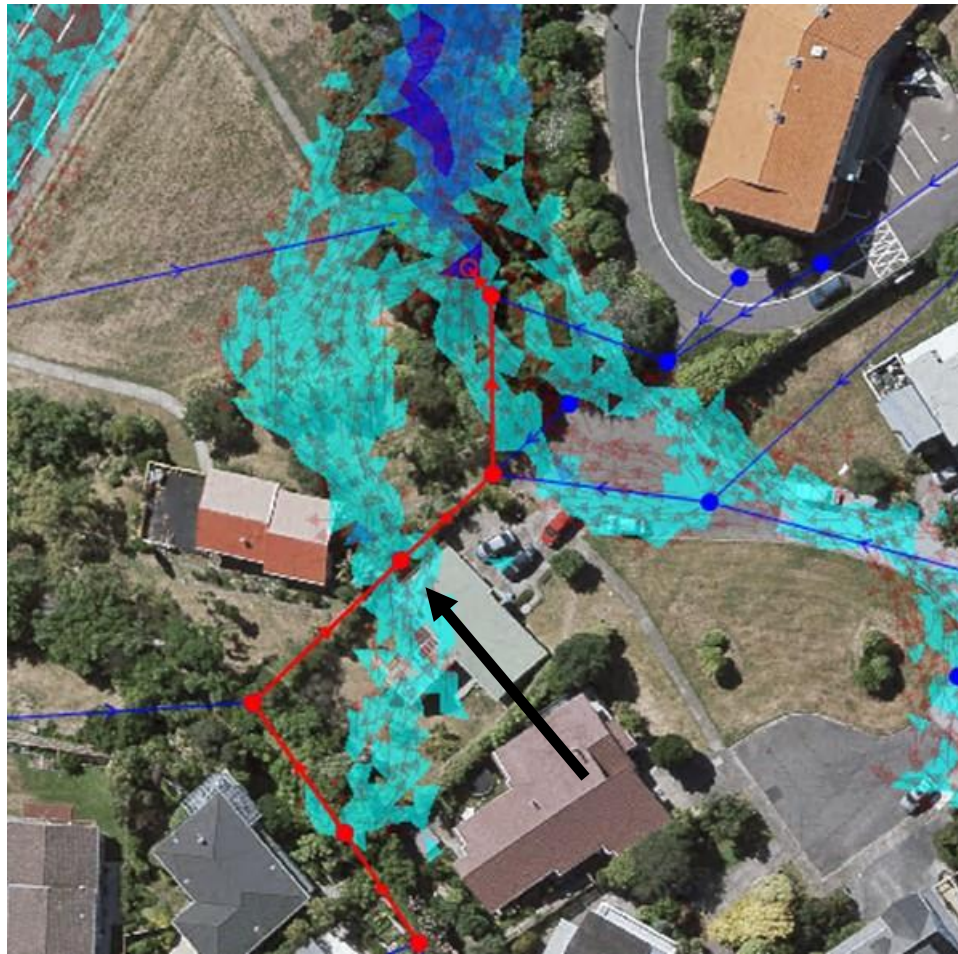
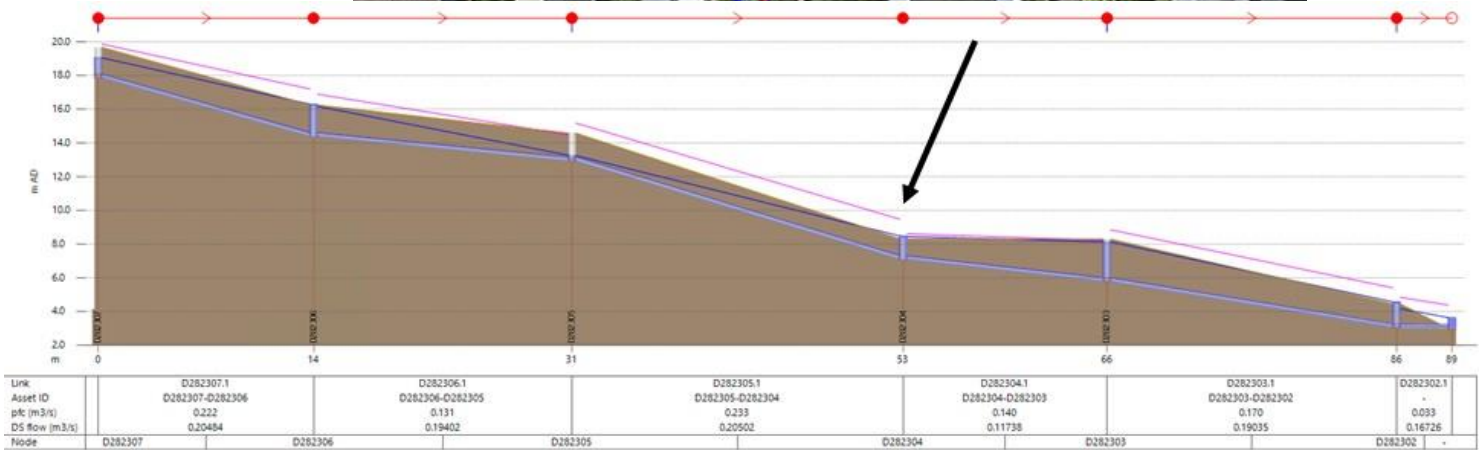
Figure 15 Nodes surcharging onto the front portion of 21 Langwell Pl.

52 In relation to the D Suzi Grindell's point that the flood mapping is exaggerated at the front of the section and that it does not generally flood and the existing installed drainage system is adequate, it is noted that the mapped flooding hazards are based on modelling of an extreme event (100-year ARI) with allowance for climate change, including 1 metre of sea level rise. In this event the Wellington Water stormwater model shows that the current network does not have capacity to contain the storm runoff. The image in Figure 15 below shows a stormwater manhole on the southern side of the 21 Langwell Pl property surcharging and spilling water that flows north across 21 Langwell Pl. This is combined with overland flow originating from an upstream manhole on 6 Thurso Gr that also surcharges during the modelled event.

53 As a result, the flooding seen on 21 Langwell Pl is not due to flooding in the Langwell Pl cul-de-sac and cleaning the drain grates will not impact it – though it is encouraged. In addition to this the Wellington Water stormwater models assume a clean system with no blockages or
