**SUBMISSION – Porirua Proposed District Plan
PUKERUA BAY– MT WELCOME STATION
Pukerua Bay, Porirua**

Client: Pukerua Property Group Limited - November 2020

Urban Design Report

Title: Preliminary Geotechnical Investigation and Natural Hazard Assessment					
Date	Version	Description	Prepared by:	Reviewed by:	Authorised by:
7/6/2019	1	Draft report	TH	NCP	CJHH
30/7/2019	2	Draft report v2	TH	NCP	CJHH
22/8/2019	3	Final report v3	TH	NCP	CJHH

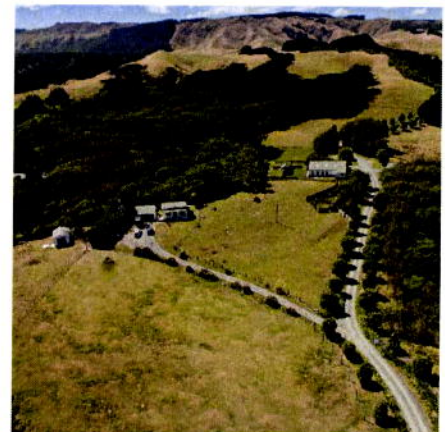
Figure 14: The driveway providing access to buildings on the site.

A driveway runs between Stage Highway One to a large house located on the neighbouring property east of the site.

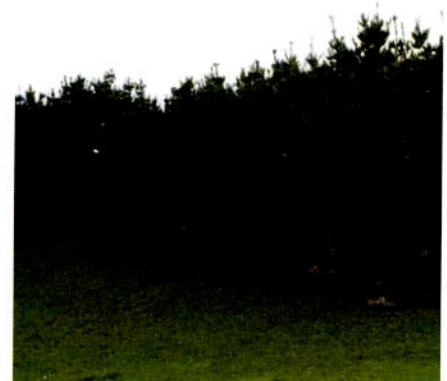
Figure 17: There are a lot of insignificant pine trees on the site.

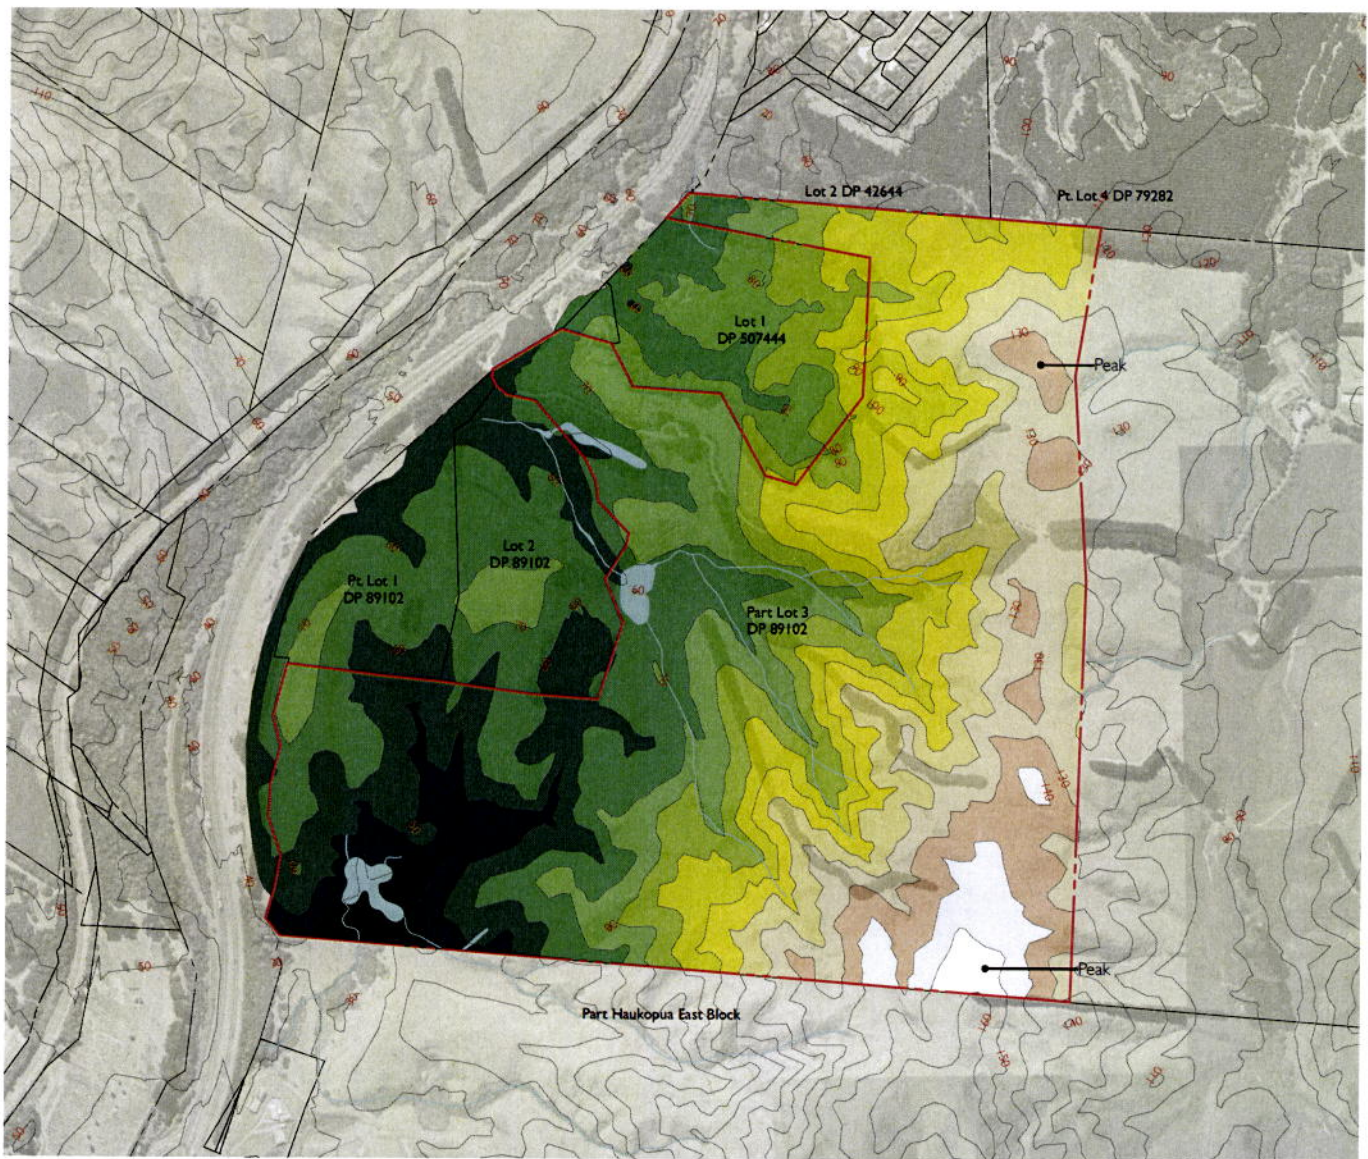
Figure 18: Contour Map (10m contours)

The site possess steadily undulating terrain throughout. The peaks that offer views out to Kapiti Island and the South Island are 130-160m above sea level, and are located on the eastern side of the site. The lowest points of the site are South-west of the site ear State Highway 1, with the lowest point being 30m above sea level.

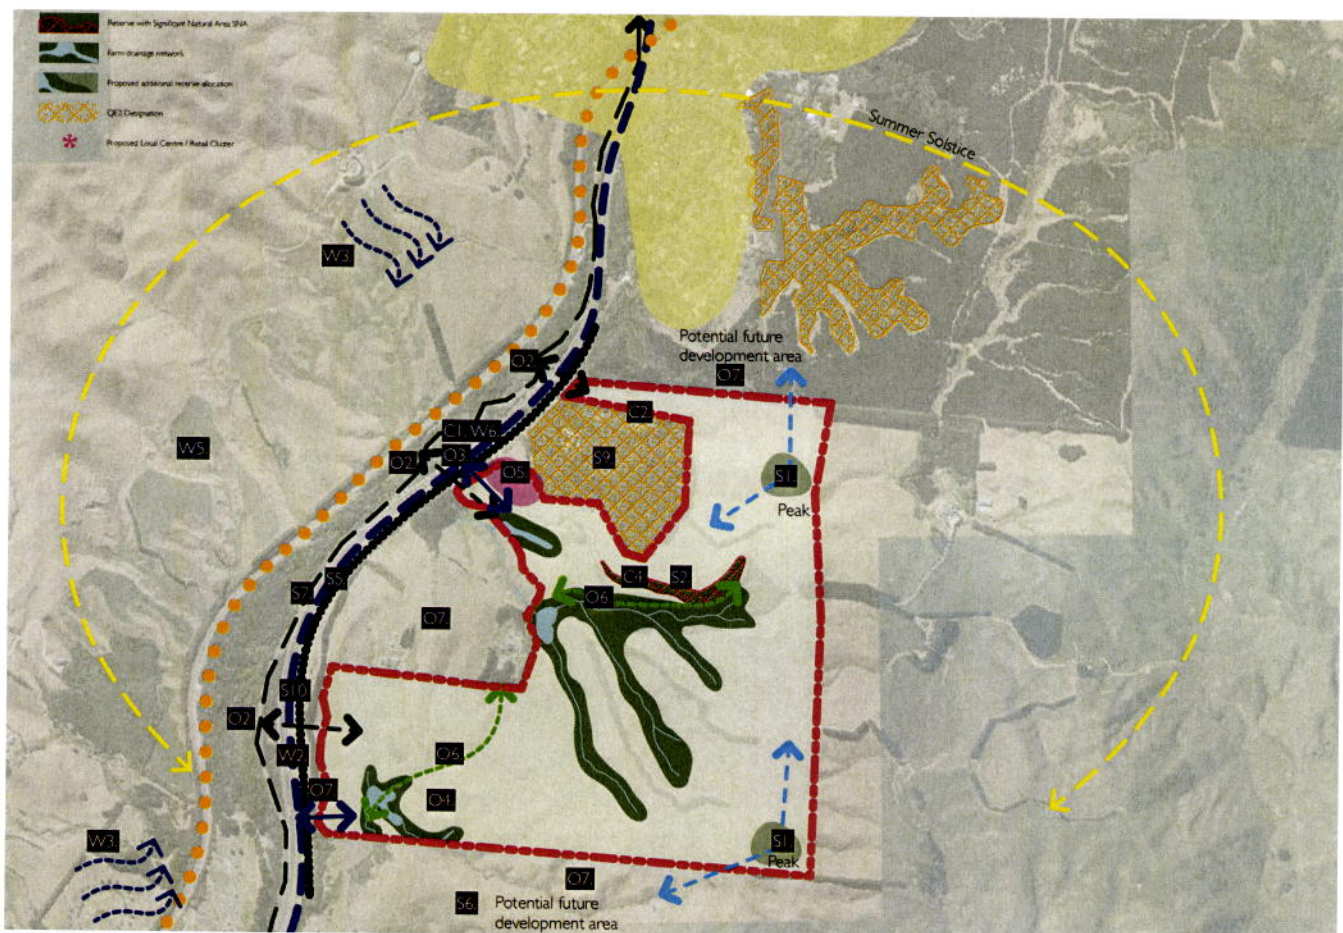
Figure 20: Strengths, Weaknesses, Opportunities, and Constraints diagram

- W1.** Like most other urban areas in the city, the site's undulating topography will require retaining walls, batters, and potentially stepped buildings.
- W2.** Noise from the existing road network could possibly impact lots near the western boundary. Although this will recede over time with Transmission Gully.
- W3.** Exposed high wind zones.
- W4.** Pukerua Bay Settlement has a limited amount of retail and educational amenities.
- W5.** Hills to the west will cause overshadowing during winter.
- W6.** Access into the site is difficult, especially in peak hour traffic. SH1 currently creates severance to the existing cycle and walking tracks.

- C1.** Currently connectivity to SH1 is limited to one intersection due to contour constraints.
- C2.** The shape and location of the neighbouring QEII protection area will cause geometrical difficulties north of the site.
- C3.** The site's undulating topography is likely to impact the connectedness of the development.
- C4.** Location of the Significant Natural Area will have an impact on the design.

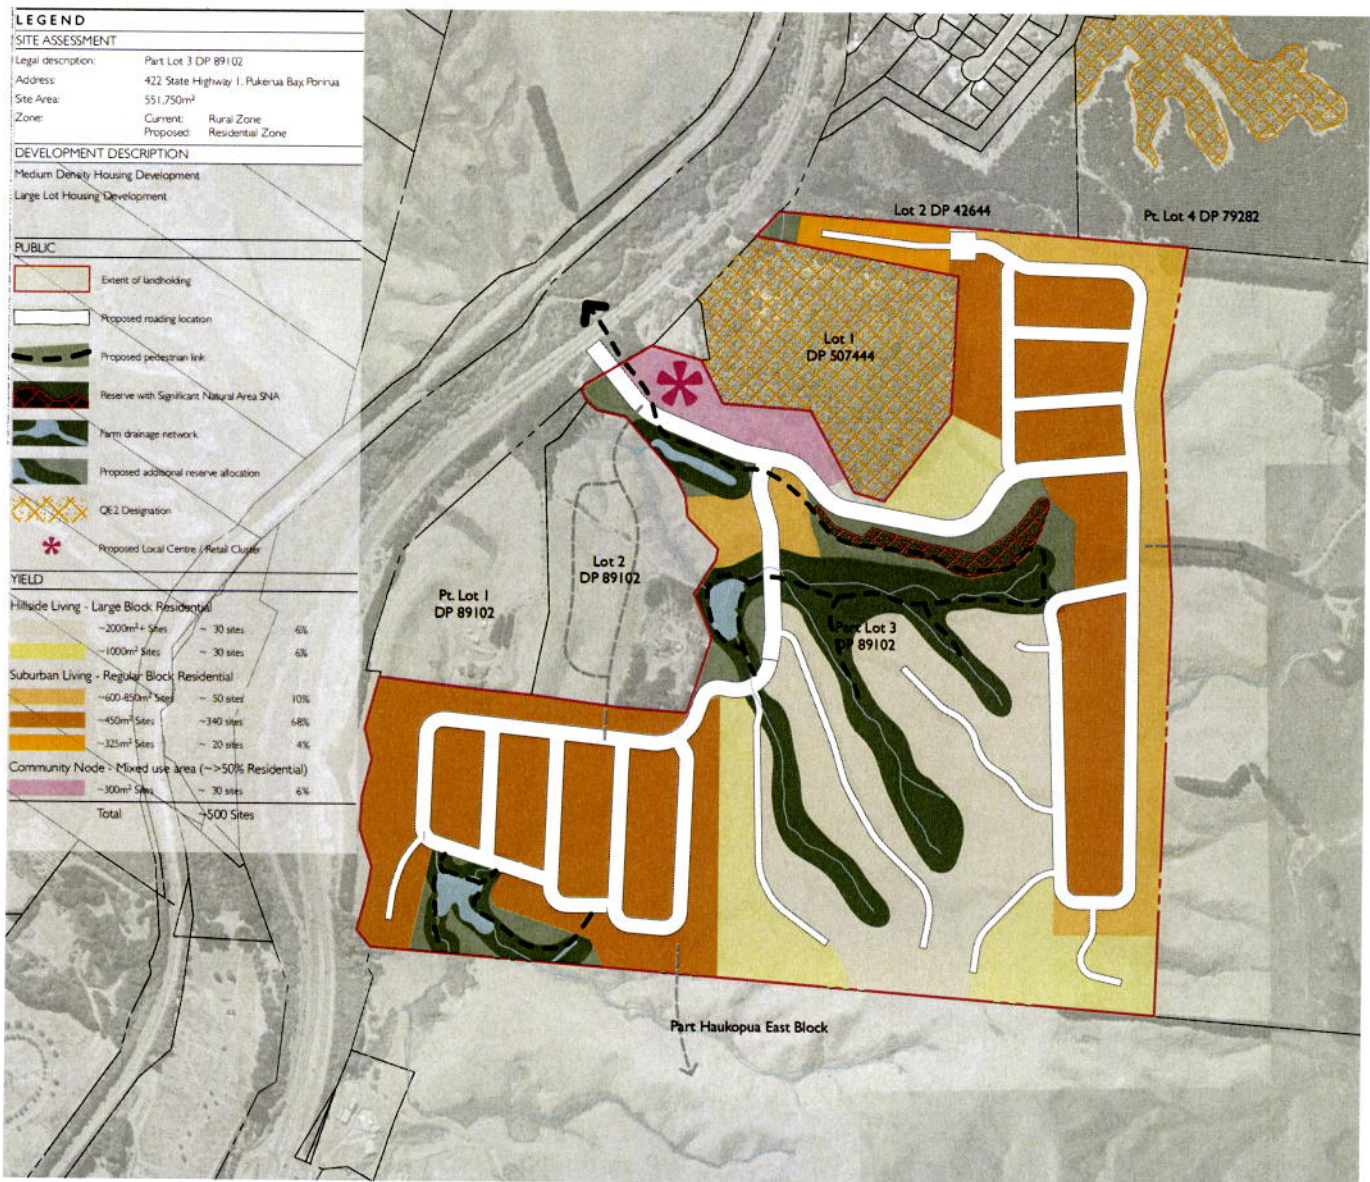
Figure 21: Illustrative Masterplan
konstrukt

A high quality community living environment will be achieved through well-designed modern dwellings, attractive streets, large green open spaces, and visual amenity. Following best practice place making principles the design embraces the authentic and complex landscape features of the site, shaping a unique hillside character.

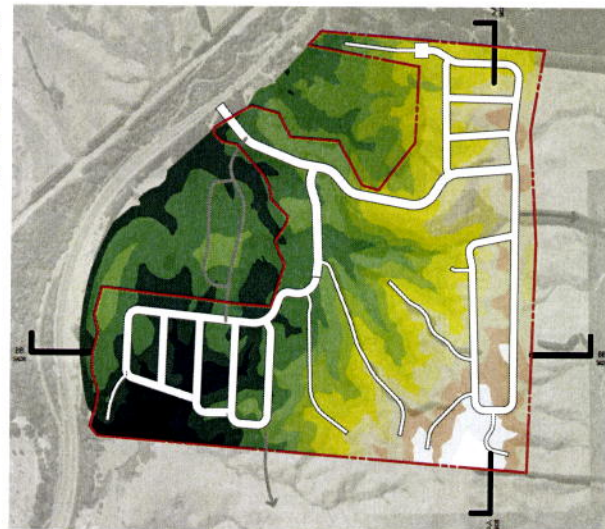
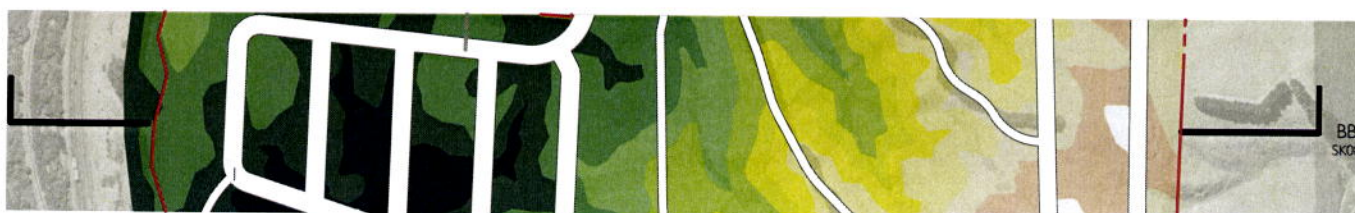
Figure 22: Topography Analysis and Sections.

- It is proposed that the undulating terrain is adjusted in areas to create lots suitable for residential dwellings. The following sections illustrate the planned earthworks in relation to the existing contours.

AA SK08 SITE SECTION A

BB SK08 SITE SECTION B

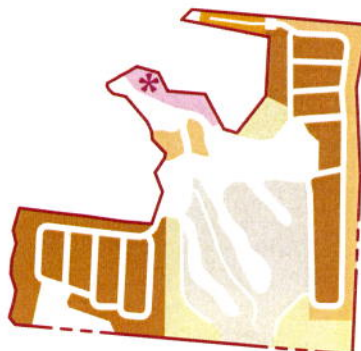
Figure 30: Proposed land use plan

- Porirua has a housing shortage
- It is near to an existing settlement with public transport connections and access to amenities.
- The reasonably steep site is more suited to residential lots than other uses.
- High amenity area – residential zoning will mean more people will be able to enjoy the site features i.e. views, landscape component.
- The development consist of 500 lots. The western end of the site is more gentle in topography in comparison to the remainder of the site, therefore it has been allocated higher density lots.

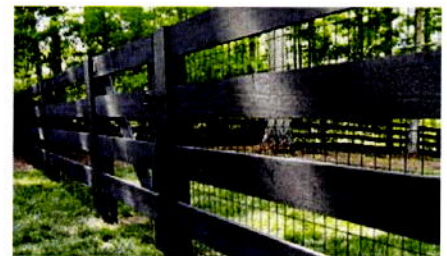
Figure 41: Black post and rail fencing with black wire mesh between green fingers and properties.

- Include plenty of windows
- Indoor/outdoor flow
- Prefer planted batters over retaining walls
- Black post and rail fencing with black wire mesh will be utilized at the interface between the edges of green fingers and backs of properties for continuity and passive surveillance.

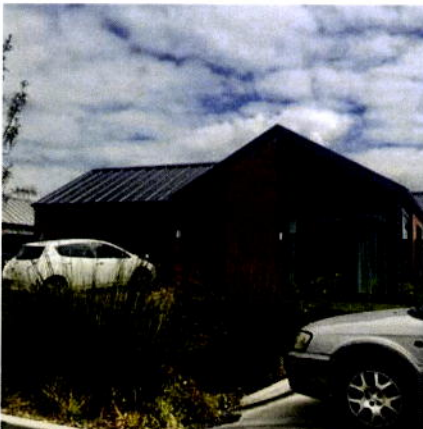
Figure 34: Suburban living: cross-gabled roof, depth in facade, recessed garage, vertical lines accentuated

- Strong roof forms such as gabled or single pitch.
- Simplify by grouping/arranging elements together vertically.
- Push and pull the form to create depth.
- Use contrast in colour and materiality to enhance the sense of depth.

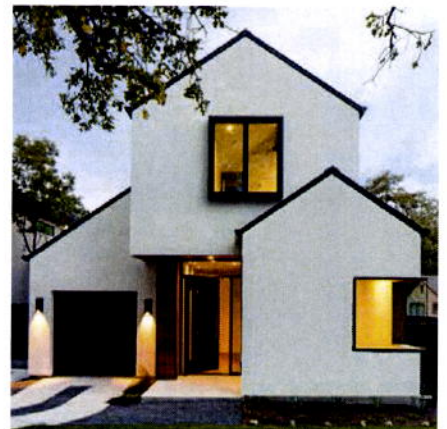
Figure 35: Suburban living: double storey home with simple but bold geometrical forms, contrast, and depth.

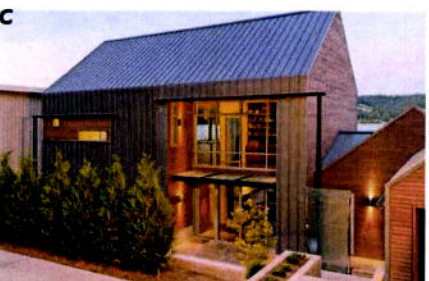
Figure 36: Hillside living: gabled roof, materiality inspired by countryside, muted colours.

- Form influenced by the landscape
- Strong roof forms such as gabled or single pitch.
- Using traditional and rustic cladding materials including weatherboards, stained timber, stone and bricks.
- Using natural and recessive colour palette with contrasting features.

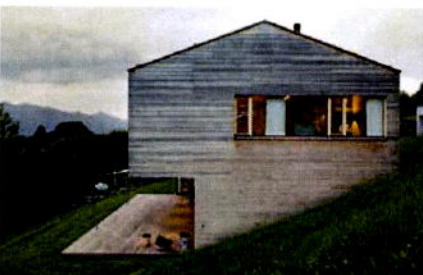
Figure 37: Hillside living: gabled roof, home nestled into the slope - cladding has a rustic aesthetic

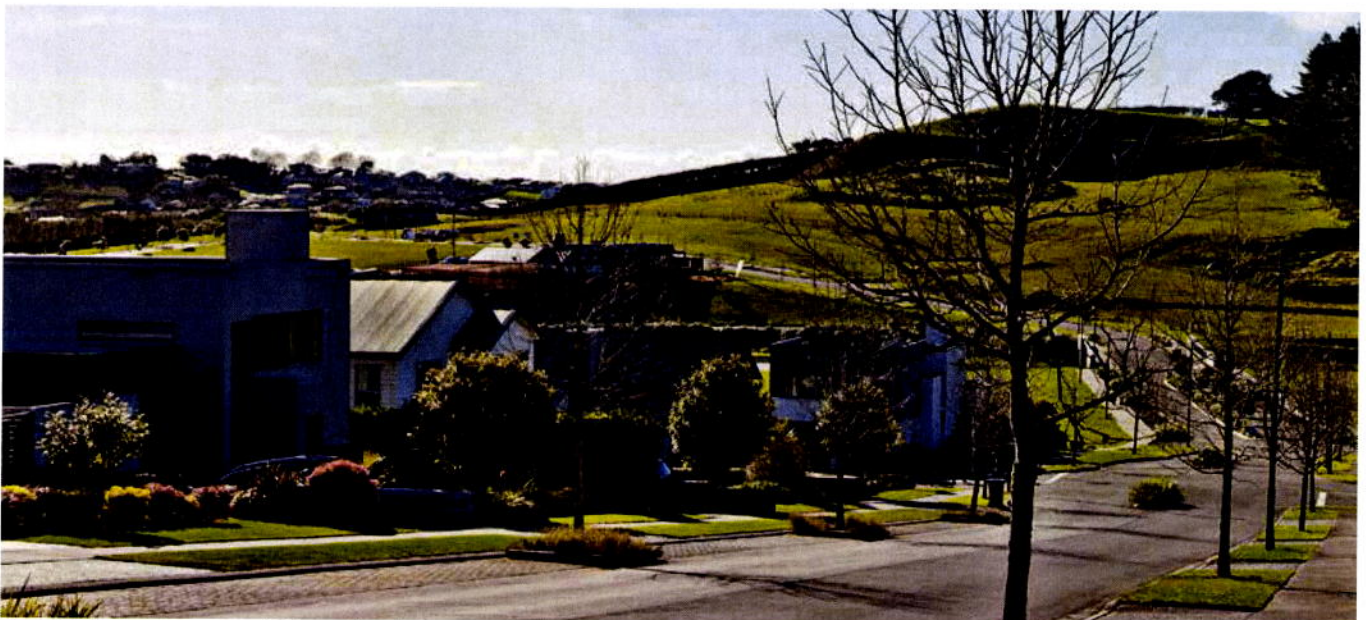
Figure 42: Suburban streetscape with fronts of housing fronting the street with large windows for passive surveillance.

Residential lots should have their fronts facing public spaces such as streets and reserves, and their backs facing other backs of properties. This is for visual amenity, privacy, and CPTED reasons. As this is a core urban design principle, it is recommended that future design work focuses on achieving this principle where the terrain makes it possible. The interface between public open space and backs of lots, recommend that post and rail with wire mesh fencing is used alongside high quality landscaping and hedging.

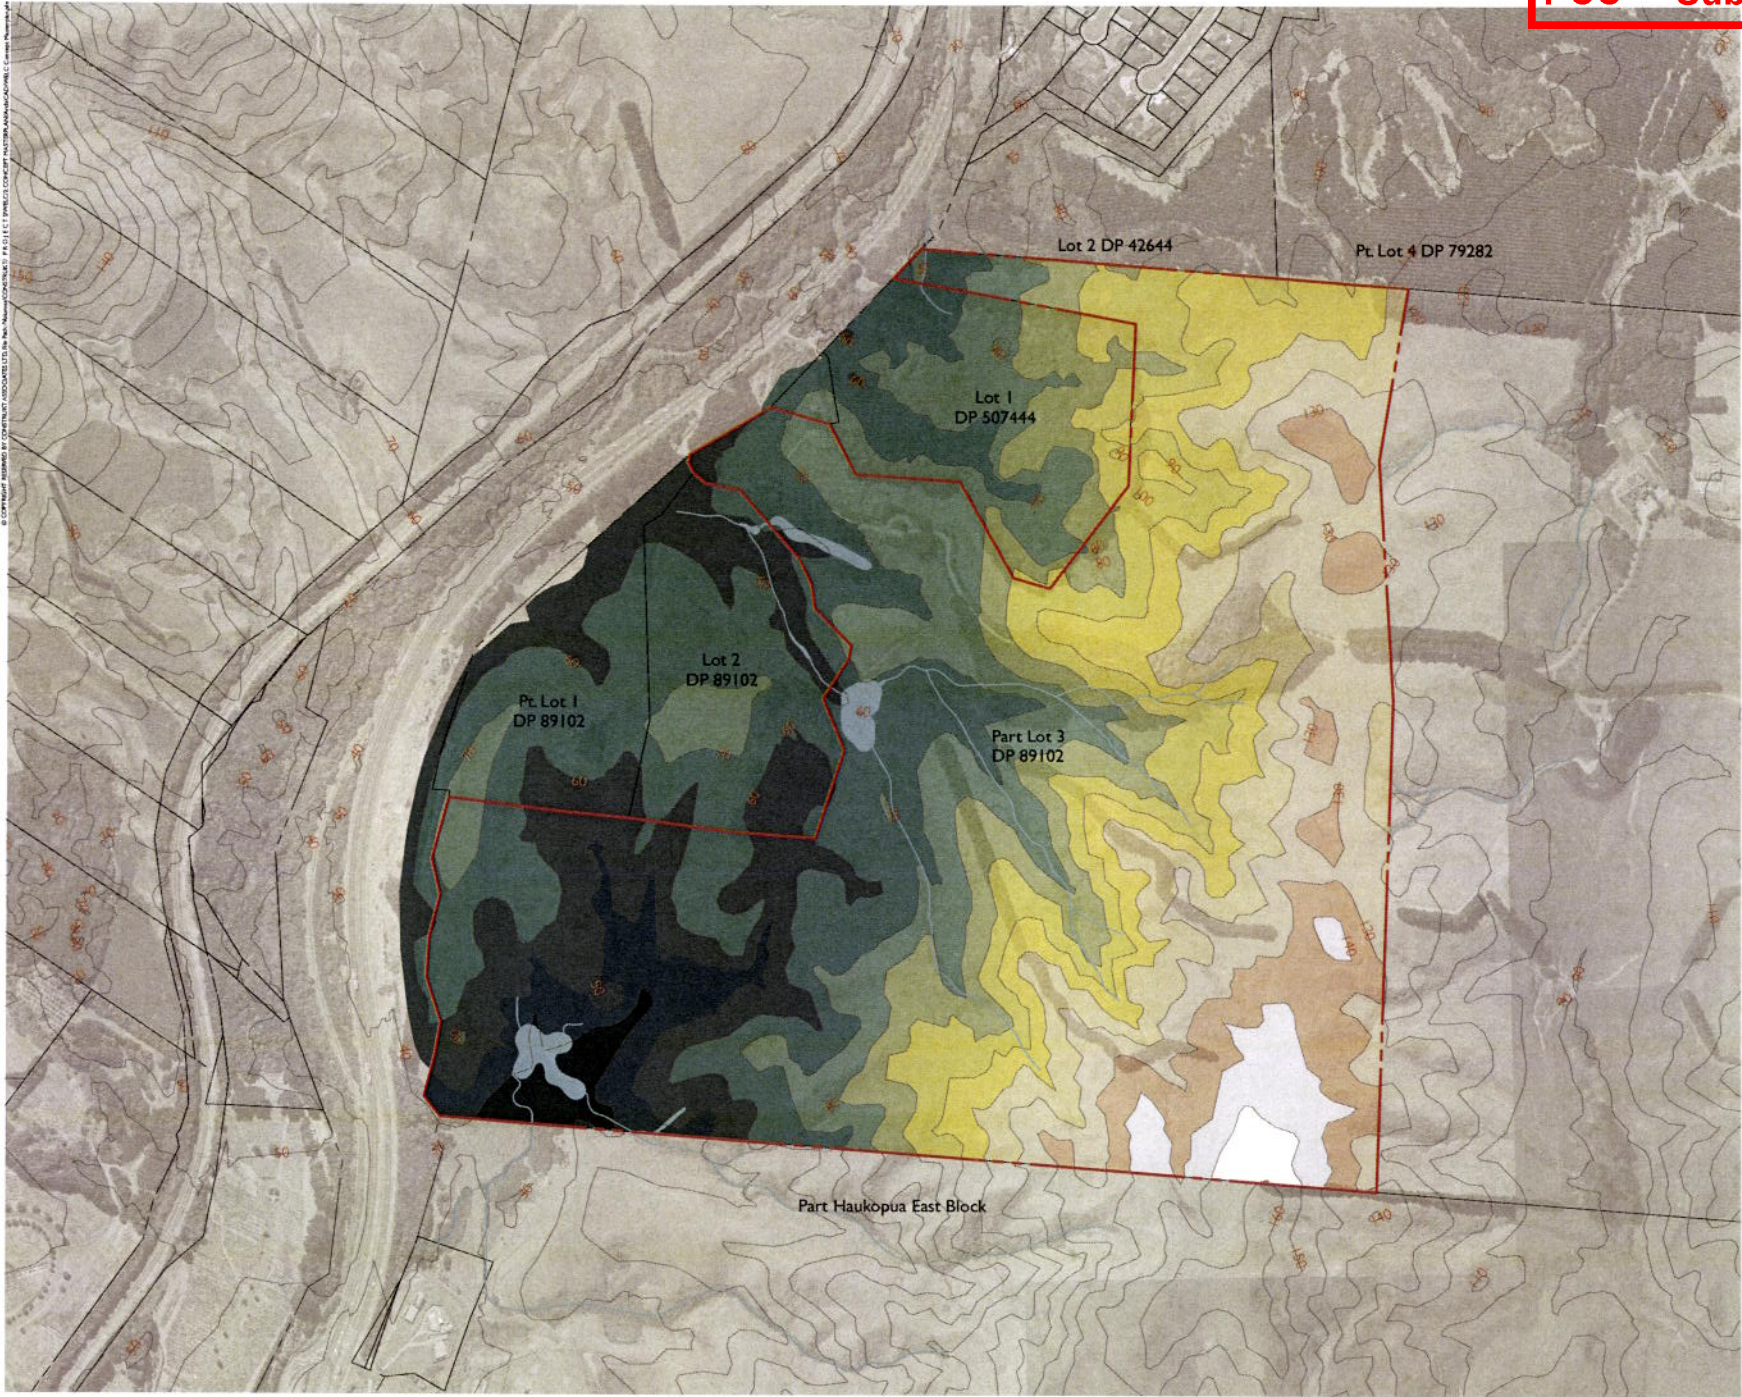
SITE ASSESSMENT	
Legal description:	Part Lot 3 DP 89102
Address:	422 State Highway 1, Pukerua Bay Porirua
Site Area:	551,750m ²
Zone:	Current: Rural Zone Proposed: Residential Zone

DEVELOPMENT DESCRIPTION	
Medium Density Housing Development	
Large Lot Housing Development

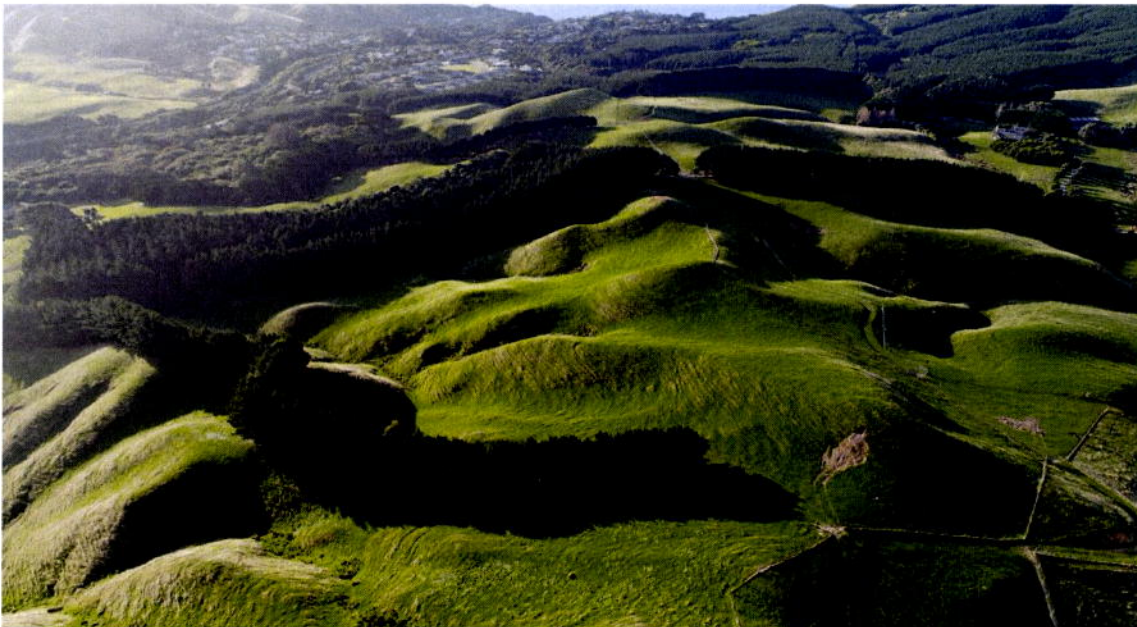
Figure 3.1: Aerial view looking north across Mt. Welcome Station toward Pukerua Bay.

The proposed area for development is approximately 55 ha (0.55 km²) and located on elevated, west-facing slopes. The land is moderately steep to steep (20° to 45°), undulating hillside topography. A north-south orientated main ridge marks the eastern extent of the site, and is the highest area of the development (between 120 and 150 m RL). The south west corner of the site is the lowest area (between 30 and 40 m RL). A number of west trending gullies form both narrow and broad ridge features. Some gullies are deep with up to 50 m vertical relief, and saturated ground is typically found at the base of these gullies and in low lying areas.

Access to the site is from State Highway 1 along a farm track cut into the slope and climbs up to the main ridge and the eastern extent. Several small dwellings and sheds are located within the site adjacent to the main entrance. The site is currently used for deer grazing with localised cover of established pine trees functioning as a shelter belt along some ridges.

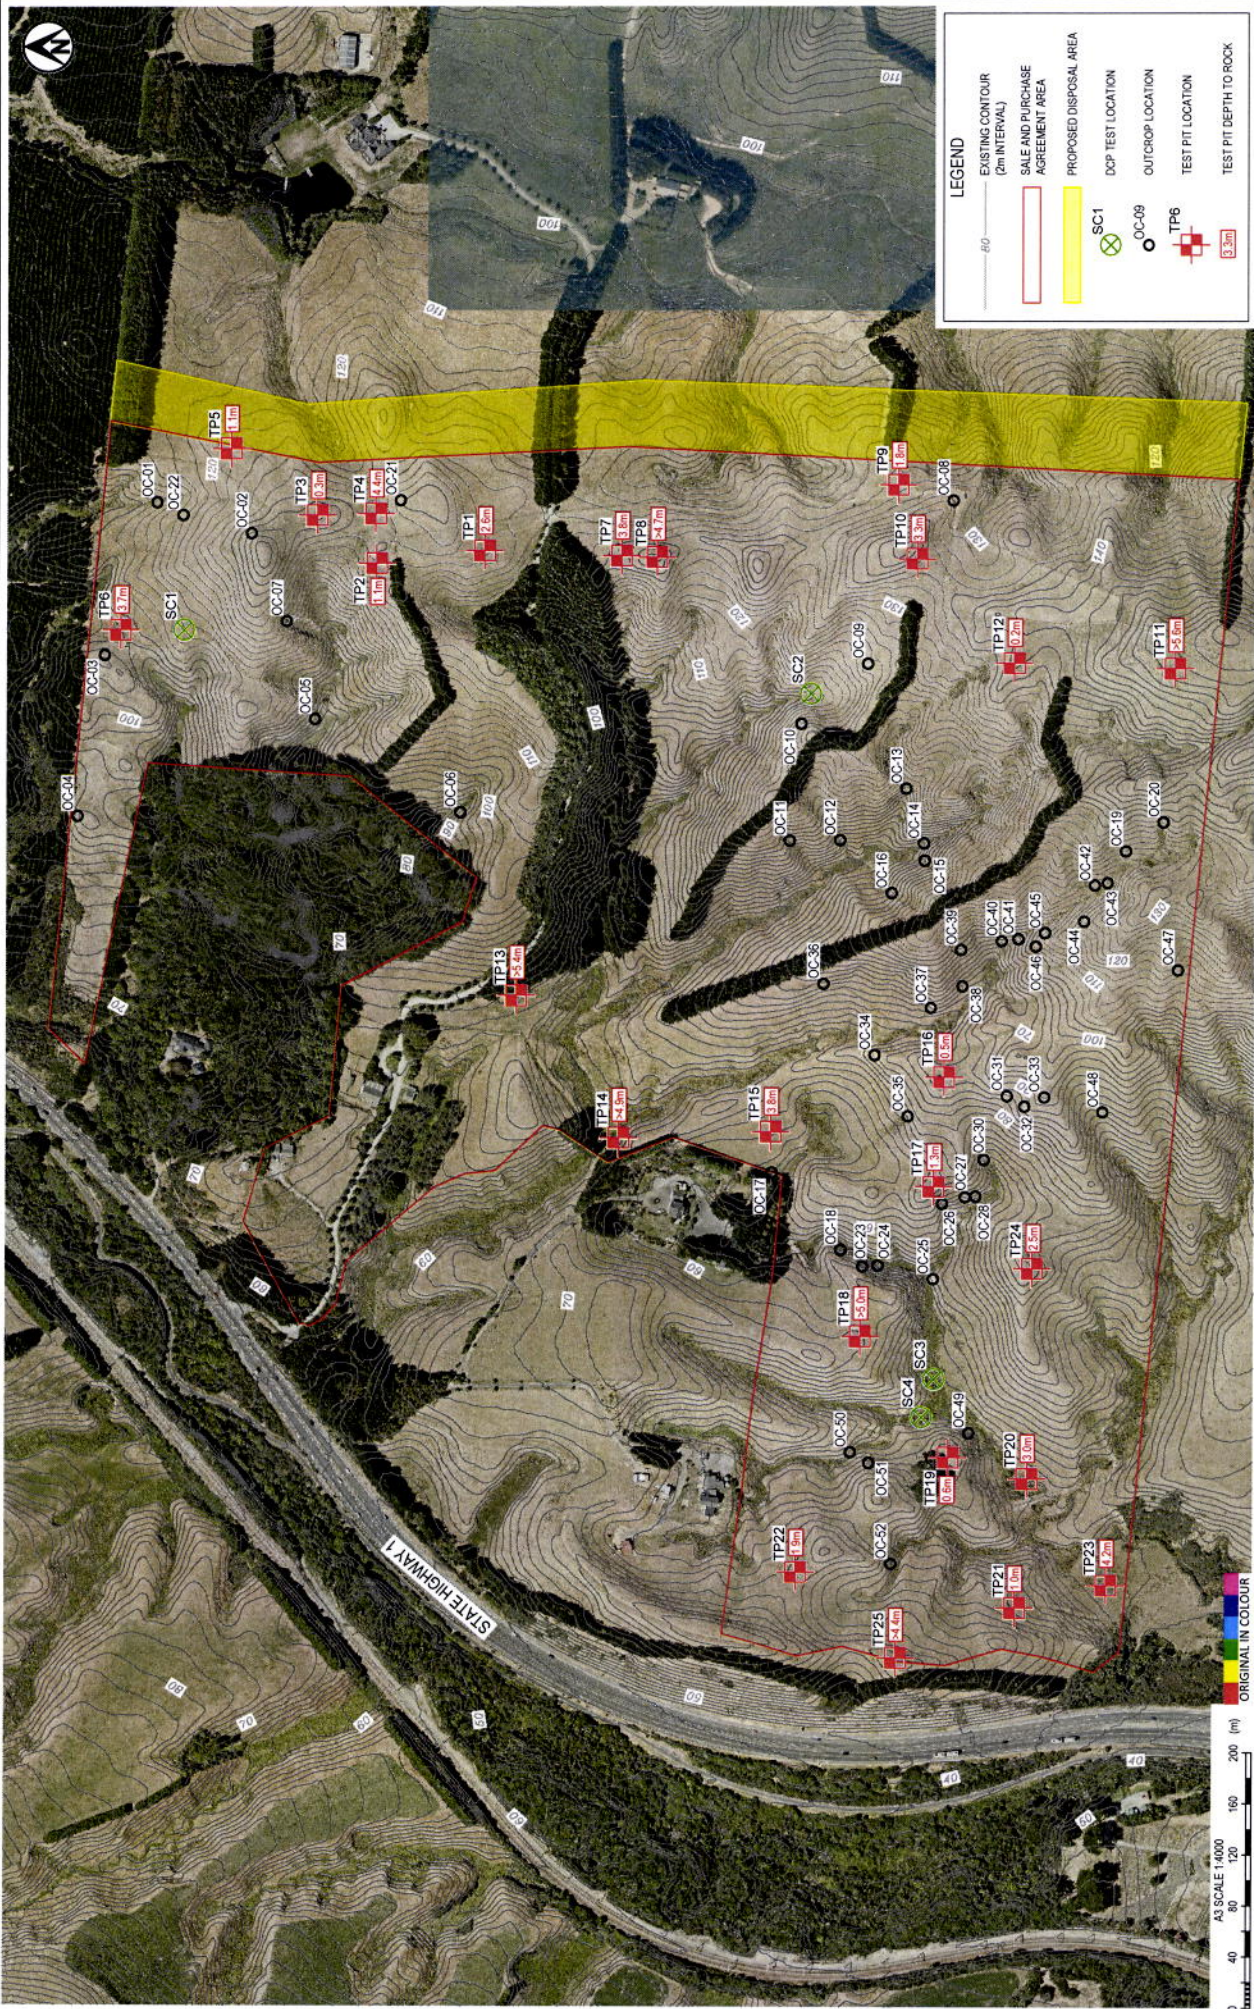
PROJECT No: 1010566		CLIENT	CLASSIC DEVELOPMENTS NZ LTD.	
DESIGNED	TH	PROJECT	MT WELCOME STATION	
DRAWN	JC	TITLE	FIELD INVESTIGATION	
CHECKED		SCALE (A3)	1:4000	FIG No
APPROVED	DATE			FIGURE B1
				REV 1

- Figure B1: Field investigation
- Table B1: Summary of mapping results
- Table B2: Summary of test pit and DCP results
- Test pit logs
- DCP results
- Geotechnics Laboratory Test Report, 6 June 2019

The excavation of twenty five (TP01 – TP25) test pits was undertaken by Goodman Contractors Ltd. on 16 and 17 May 2019, under the supervision of a T+T engineering geologist. In all cases, the test pits were taken to either a maximum depth achievable or 'refusal' which occurred due to encountering rock. The ability to excavate the overburden soils was noted by the engineering geologist and the test pits were logged to NZGS 'Field Description of Soil and Rock' guidelines.

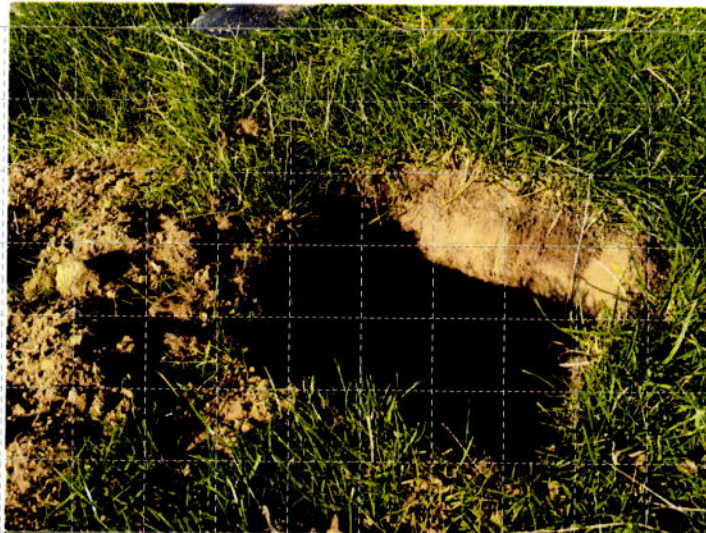
SKETCH / PHOTO:

COMMENTS: Termination in HW Rock.

Hole Depth
0.35m

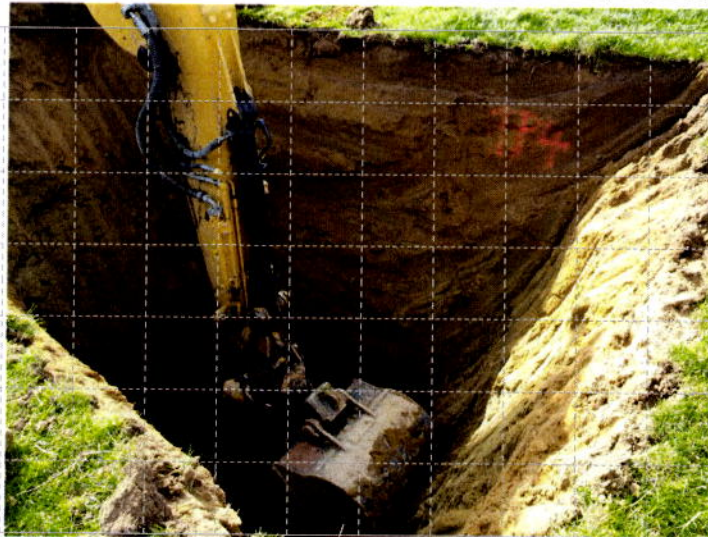
SKETCH / PHOTO:

COMMENTS: Termination in HW Rock.

Hole Depth
4.6m

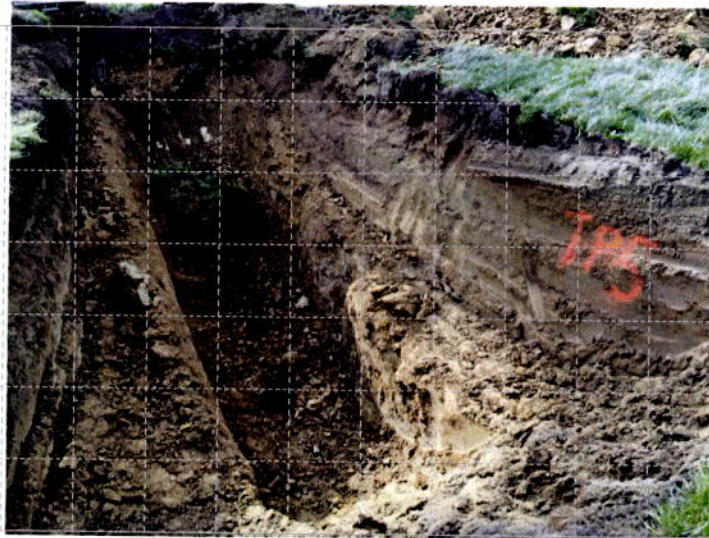
SKETCH / PHOTO:

COMMENTS: Termination in HW Rock.

Hole Depth 2.1m

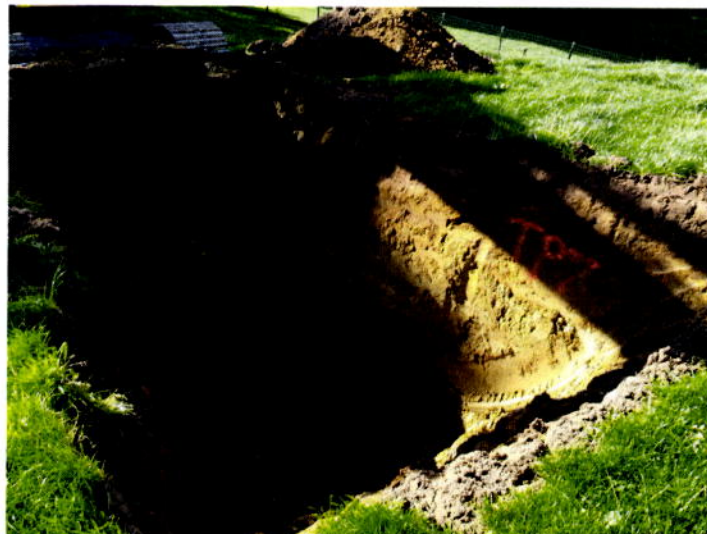
SKETCH / PHOTO:

COMMENTS: Termination in HW Rock

Hole Depth 3.8m

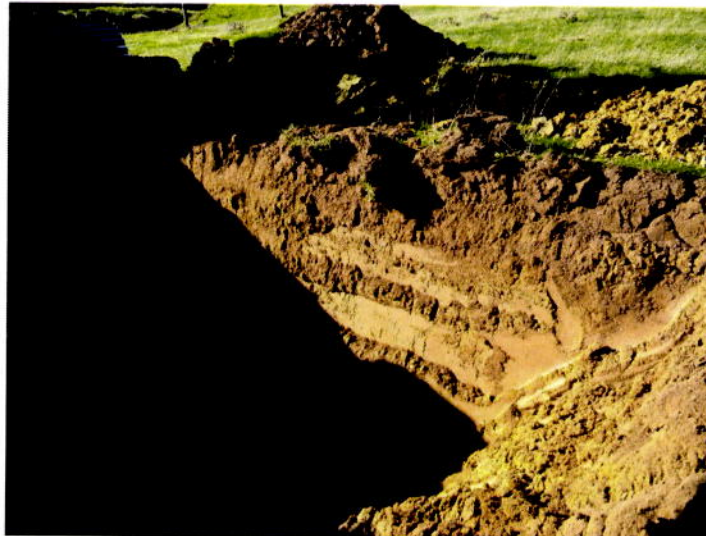
SKETCH / PHOTO:

COMMENTS: Termination due to machine limit

Hole Depth
4.7m

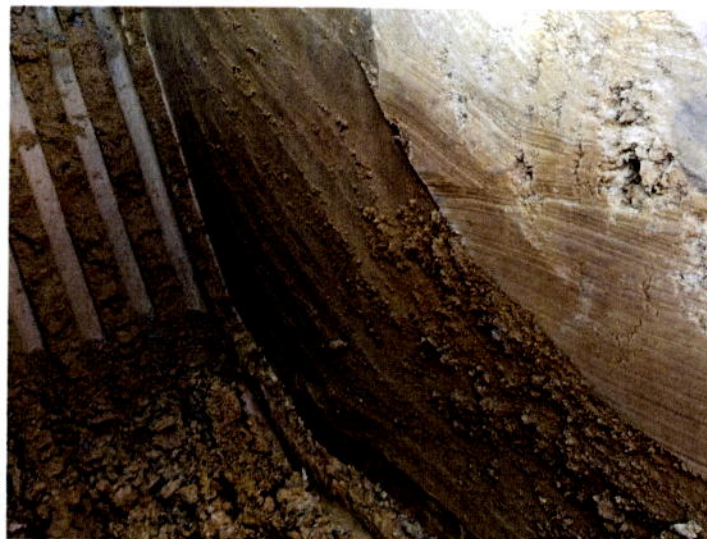
SKETCH / PHOTO:

COMMENTS: Termination in HW Rock

Hole Depth
4.2m

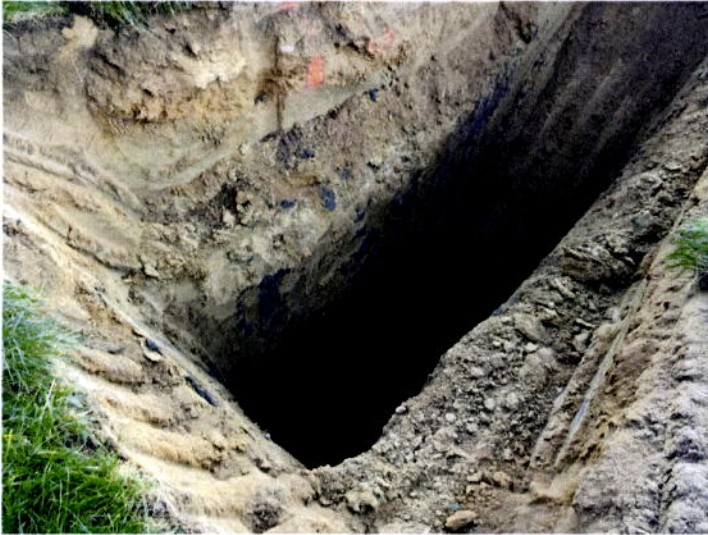
SKETCH / PHOTO:

COMMENTS: Termination due to machine limit

Hole Depth
5.4m

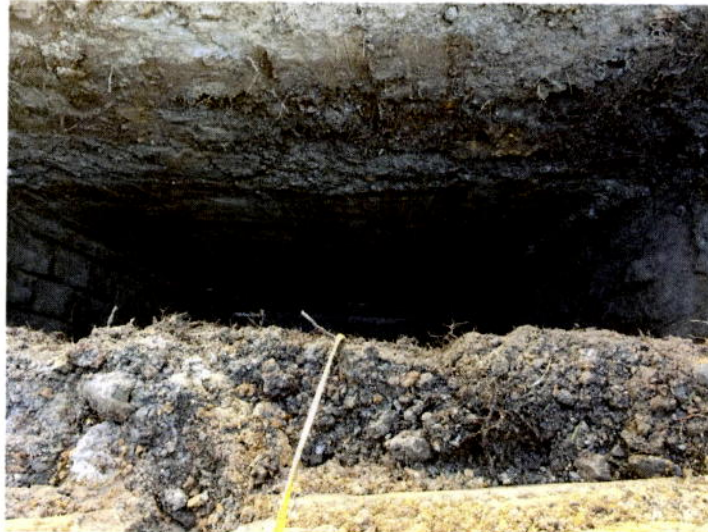
SKETCH / PHOTO:

COMMENTS: Termination due to machine limit

Hole Depth
4.9m

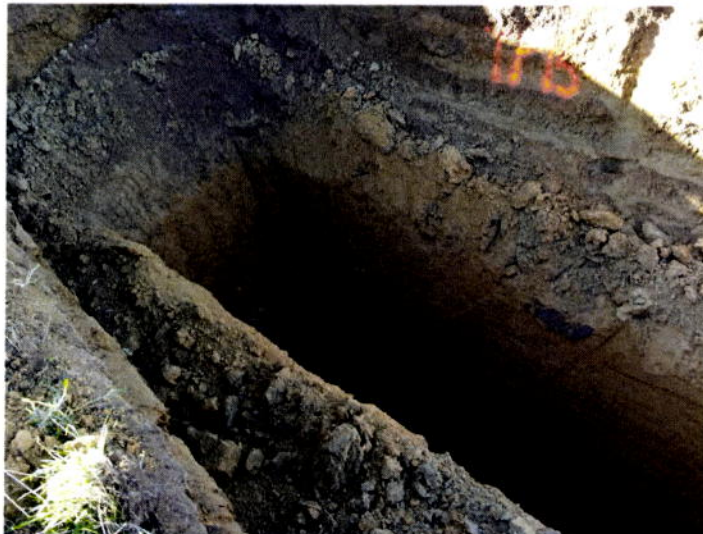
SKETCH / PHOTO:

COMMENTS: Termination in HW Rock

Hole Depth
3.8m

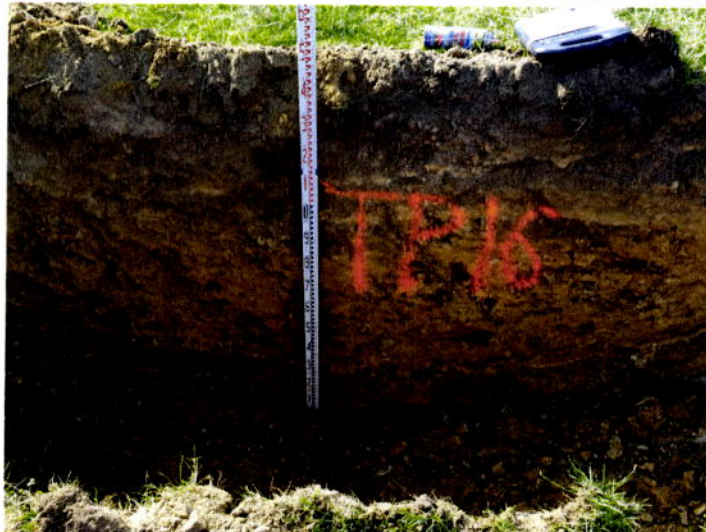
SKETCH / PHOTO:

COMMENTS: Termination in HW Rock

Hole Depth
1.1m

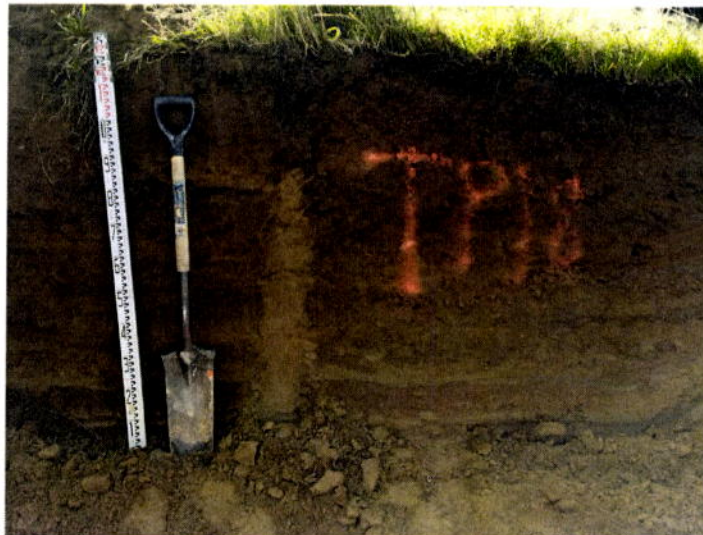
SKETCH / PHOTO:

COMMENTS: Termination due to machine limit

Hole Depth
5.2m

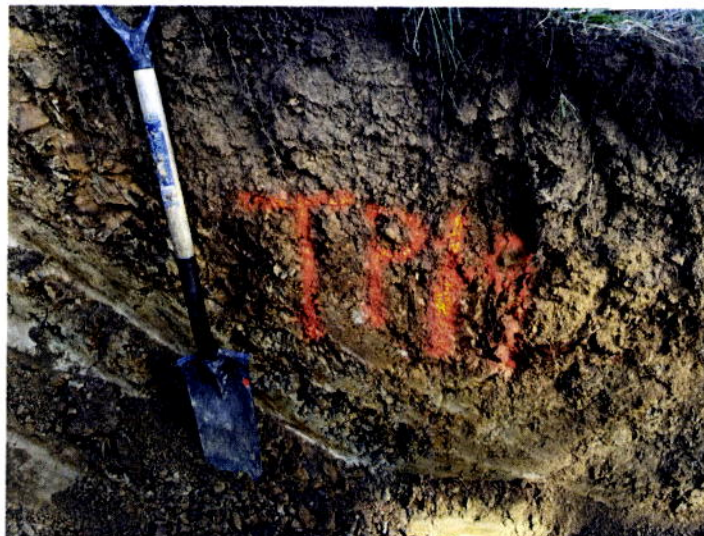
SKETCH / PHOTO:

EXCAVATION TESTS			ENGINEERING DESCRIPTION				GEOLOGICAL							
PENETRATION	SUPPORT	WATER	SAMPLES, TESTS	SAMPLES	RL (m)	DEPTH (m)	GRAPHIC LOG	SOIL NAME, PLASTICITY OR PARTICLE SIZE CHARACTERISTICS, COLOUR, SECONDARY AND MINOR COMPONENTS	MOISTURE CONDITION	WEATHERING	STRENGTH/DENSITY CLASSIFICATION	ESTIMATED SHEAR STRENGTH (kPa)	DEFECTS, STRUCTURE, COMMENTS	UNIT
1 2 3														
							TS	Topsoil (as described previously)	M		S			
						0.5		Sandy fine to coarse GRAVEL; yellow brown. Loose, moist, well graded, angular.			L			Colluvium Deposits
					52	1.0		Highly weathered grey brown SILTSTONE. Very weak, very closely spaced defects, excavating to coarse gravel.	HW					Torlesse Terrane
								1.3m: Effective refusal					1.30m: J, 74° dip, 305° 1.30m: B, 63° dip, 293° 1.30m: J, 73° dip, 44° 1.30m: J, 59° dip, 234°

COMMENTS: Termination in HW Rock

Hole Depth
1.3m

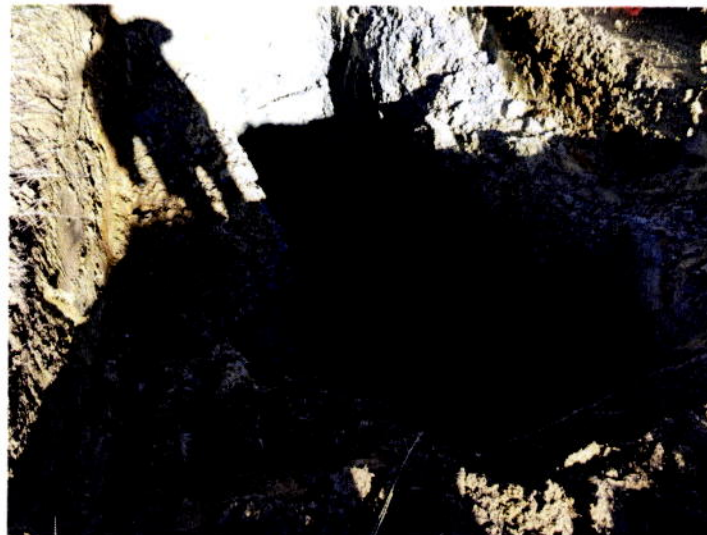
SKETCH / PHOTO:

EXCAVATION TESTS		ENGINEERING DESCRIPTION				GEOLOGICAL								
PENETRATION	SUPPORT	WATER	SAMPLES, TESTS	SAMPLES	RL (m)	DEPTH (m)	GRAPHIC LOG	SOIL NAME, PLASTICITY OR PARTICLE SIZE CHARACTERISTICS, COLOUR, SECONDARY AND MINOR COMPONENTS	MOISTURE CONDITION	WEATHERING	STRENGTH/DENSITY CLASSIFICATION	ESTIMATED UNIT STRENGTH (kPa)	DEFECTS, STRUCTURE, COMMENTS	UNIT
1 2 3								Topsoil (as described previously)	M		S			TS
					36	0.5		Sandy SILT with some clay; yellow brown. Soft, moist, low plasticity.						Loess
		17/05/2019			35	1.0		Sandy fine to medium GRAVEL with some organics, grey brown. Loosely packed, moist, well graded. Gravel: angular MW greywacke.	M-W		L			Cvd
					35	1.5		Silty fine SAND; grey brown. Loose, moist-wet, poorly graded.						Alluvial Deposits
					34	2.0		Silty fine to coarse GRAVEL with some sand and organics; blue grey. Loosely packed, wet, well graded. Gravel: sub-rounded slightly weathered greywacke.	W				2.5m: Gravel becoming tightly packed

33	3.0		Moderately to highly weathered grey brown fine SANDSTONE. Weak to moderately strong, closely spaced defects, Mn staining on defect planes. Excavating to small cobbles.	MW	HW				Tonisse
					33	3.5		3.2m: Effective refusal

COMMENTS: Termination in MW Rock

Hole Depth
3.2m

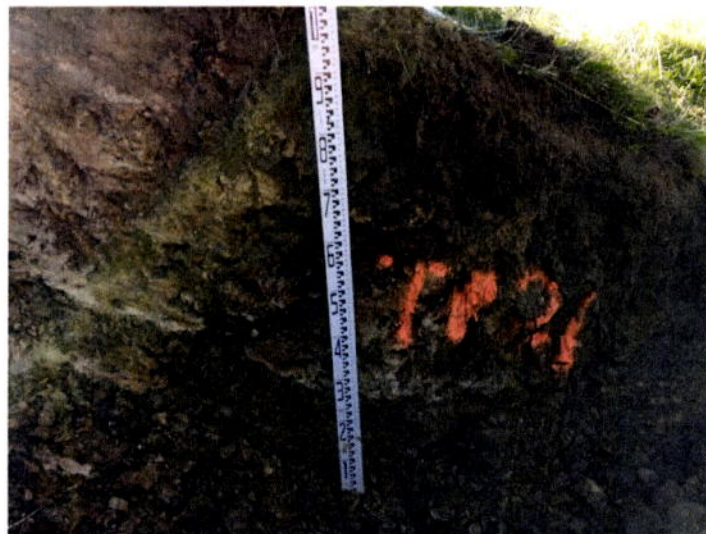
SKETCH / PHOTO:

EXCAVATION TESTS			ENGINEERING DESCRIPTION				GEOLOGICAL							
PENETRATION	SUPPORT	WATER	SAMPLES, TESTS	SAMPLES	RL (m)	DEPTH (m)	GRAPHIC LOG	SOIL NAME, PLASTICITY OR PARTICLE SIZE CHARACTERISTICS, COLOUR, SECONDARY AND MINOR COMPONENTS	MOISTURE CONDITION	WEATHERING	STRENGTH/DENSITY CLASSIFICATION	ESTIMATED SHEAR STRENGTH (kPa)	DEFECTS, STRUCTURE, COMMENTS	UNIT
1 2 3								Topsoil (as described previously) Highly weathered grey brown SILTSTONE. Very weak, very closely spaced defects, zeolite and clay veneers on joint surfaces. Excavates to fine gravel.	M	S				Topsoil
					49	0.5			HW					Torlesse Terrane
						1.0		1m: Effective refusal					1.00m: J, 42° dip, 202° 1.00m: J, 68° dip, 50° 1.00m: B, 78° dip, 138°

COMMENTS: Termination in HW Rock

Hole Depth
1m

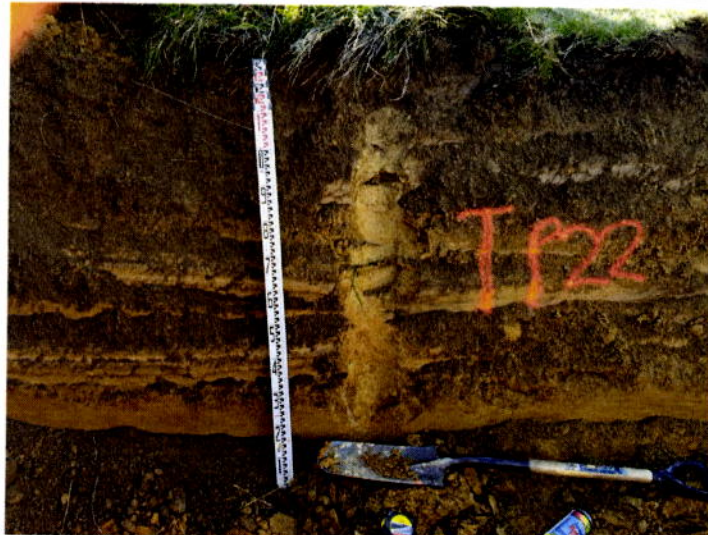
SKETCH / PHOTO:

EXCAVATION TESTS			ENGINEERING DESCRIPTION			GEOLOGICAL							
PENETRATION	SUPPORT	WATER	SAMPLES, TESTS	RL (m)	DEPTH (m)	GRAPHIC LOG	SOIL NAME, PLASTICITY OR PARTICLE SIZE CHARACTERISTICS, COLOUR, SECONDARY AND MINOR COMPONENTS	MOISTURE CONDITION	WEATHERING	STRENGTH/DENSITY CLASSIFICATION	ESTIMATED SHEAR STRENGTH (kPa)	DEFECTS, STRUCTURE, COMMENTS	UNIT
1-3							Topsoil (as described previously)	M		S			TSoil
				64	0.5		Clayey SILT with some sand; yellow brown. Firm-stiff, moist, high plasticity.			F-St			
			TP22 0.9 m @ 0.9m	63	1.0		Clayey SILT with some gravel; yellow brown. Stiff, moist, moderate plasticity. Gravel: fine, angular highly weathered Siltstone.			St			Loess
					2.0		Highly weathered grey brown SILTSTONE. Weak, very closely spaced defects, zeolite coating on joint surfaces. Excavating to fine gravel.			HW			Torlesse
							2.2m: Effective refusal

COMMENTS: Termination in HW Rock

Hole Depth
2.2m

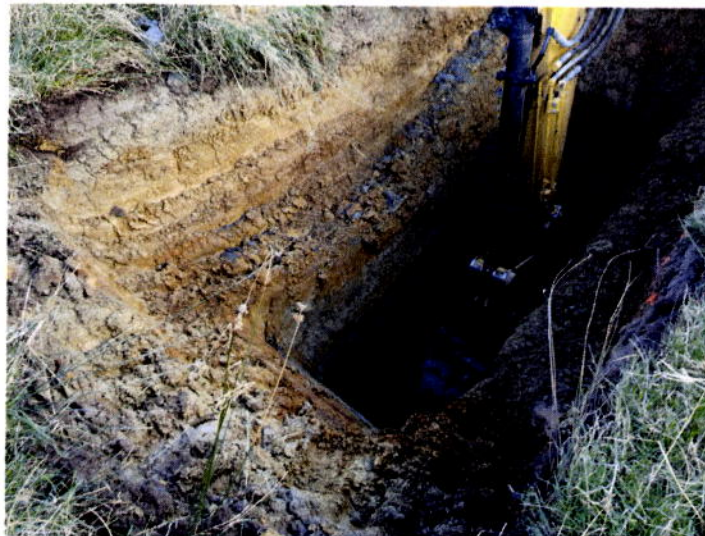
SKETCH / PHOTO:

EXCAVATION TESTS		ENGINEERING DESCRIPTION				GEOLOGICAL							
PENETRATION	SUPPORT	WATER	SAMPLES, TESTS	SAMPLES	RL (m)	DEPTH (m)	GRAPHIC LOG	SOIL NAME, PLASTICITY OR PARTICLE SIZE CHARACTERISTICS, COLOUR, SECONDARY AND MINOR COMPONENTS	MOISTURE WEATHERING CONDITION	STRENGTH-DENSITY CLASSIFICATION	ESTIMATED SHEAR STRENGTH (kPa)	DEFECTS, STRUCTURE, COMMENTS	UNIT
1 2 3					33		TS	Topsoil (as described previously)	M	S			Top
						1		Silty fine SAND with some gravel; grey brown. Loosely packed, moist, poorly graded.		L			Alluvial Deposits
					32	2		Sandy fine to medium GRAVEL with some silt; grey brown. Loosely packed, moist, well graded. Gravel: subrounded highly weathered greywacke.					
					31								Alluvial Deposits
					30	3		Sandy SILT with some organics; blue grey. Soft, moist-wet, low plasticity.	M-W	S			
					29			Silty fine SAND with some organics; blue grey. Loosely packed, moist-wet, poorly graded.		L			Alluvial Deposits

28	4		Sandy fine to coarse GRAVEL with small cobbles; yellow brown. Tightly packed, moist, well graded. Gravel: sub-rounded to rounded moderately weathered greywacke.	M				
						5		Moderately weathered to highly weathered yellow brown fine SANDSTONE. Weak to moderately strong, very closely spaced defects. Excavates to fine gravel.					Tit

4.3m: Effective refusal

COMMENTS: Termination in MW Rock

Hole Depth
4.3m
