**SUBMISSION – Porirua Proposed District Plan
PUKERUA BAY– MT WELCOME STATION
Pukerua Bay, Porirua**

Client: Pukerua Property Group Limited - November 2020

Urban Design Report

Title: Preliminary Geotechnical Investigation and Natural Hazard Assessment					
Date	Version	Description	Prepared by:	Reviewed by:	Authorised by:
7/6/2019	1	Draft report	TH	NCP	CJHH
30/7/2019	2	Draft report v2	TH	NCP	CJHH
22/8/2019	3	Final report v3	TH	NCP	CJHH

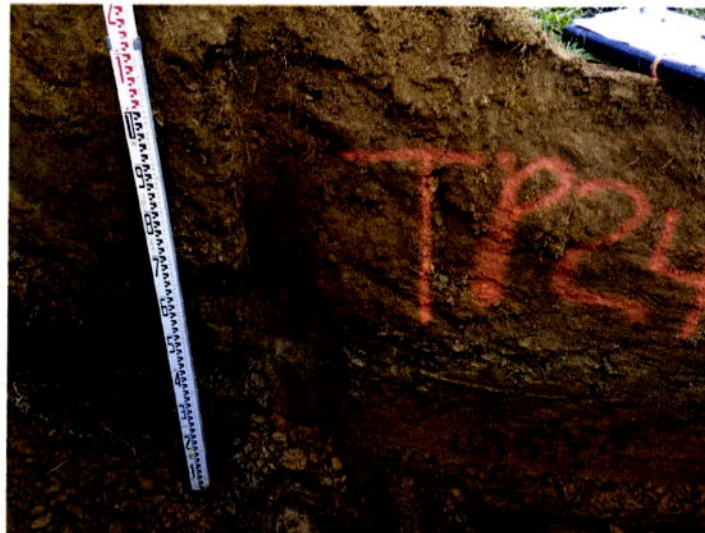
SKETCH / PHOTO:

EXCAVATION TESTS		ENGINEERING DESCRIPTION				GEOLOGICAL			
PENETRATION -1 -2 -3	SUPPORT WATER	SAMPLES, TESTS	SAMPLES	RL (m) DEPTH (m) GRAPHIC LOG	SOIL NAME, PLASTICITY OR PARTICLE SIZE CHARACTERISTICS, COLOUR, SECONDARY AND MINOR COMPONENTS	MOISTURE CONDITION WEATHERING	STRENGTH/DENSITY CLASSIFICATION ESTIMATED UNIT WEIGHT (kPa)	DEFECTS, STRUCTURE, COMMENTS	UNIT
				74	Topsoil (as described previously)	D			T Soil

0.5	Silty fine SAND with minor organics; yellow brown. Loosely packed, dry, poorly graded.		L		Dune Deposits
				73	Clayey SILT with minor organics; yellow grey. Stiff, moist, high plasticity.	D-M	St

1.5	Sandy SILT with some clay; yellow brown. Stiff, dry, poorly graded.	D			Loess
				72					
				2.5	Highly weathered yellow brown SILTSTONE. Very weak, very closely spaced defects, Mn staining and clay veneers on defect faces. Excavating to medium gravel.	HW			Torlesse

2.9m: Effective refusal

COMMENTS: Termination in HW Rock

Hole Depth
2.9m

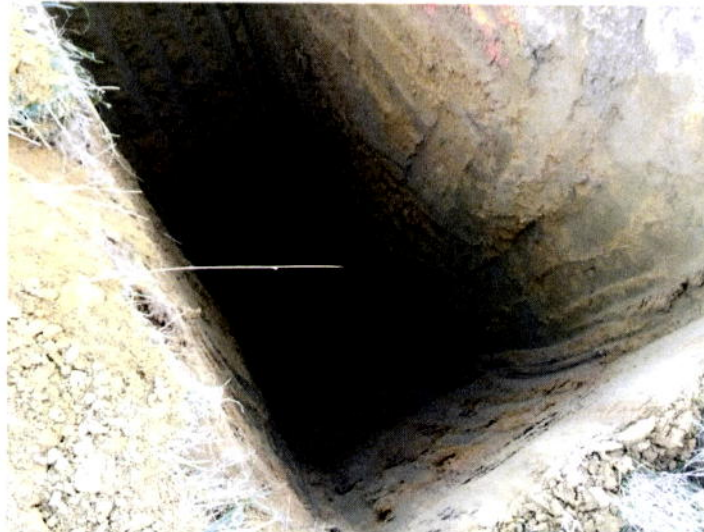
SKETCH / PHOTO:

EXCAVATION TESTS		ENGINEERING DESCRIPTION				GEOLOGICAL								
PENETRATION	SUPPORT	WATER	SAMPLES, TESTS	SAMPLES	RL (m)	DEPTH (m)	GRAPHIC LOG	SOIL NAME, PLASTICITY OR PARTICLE SIZE CHARACTERISTICS, COLOUR, SECONDARY AND MINOR COMPONENTS	MOISTURE CONDITION	WEATHERING	STRENGTH DENSITY CLASSIFICATION	ESTIMATED SHEAR STRENGTH (kPa)	DEFECTS, STRUCTURE, COMMENTS	UNIT
1 2 3					68	0.0		Topsoil (as described previously)	D	S				Top
					67	0.5		Silty fine SAND with minor clay; brown. Loosely packed, moist, well graded.	M	L				Dune Deposits
					65	2.5		Silty fine SAND with some clay; grey brown. Loosely packed, dry, poorly graded.	D					
					64	4.4		4.4m: Machine limit

COMMENTS: Termination due to machine limit

Hole Depth
4.4m

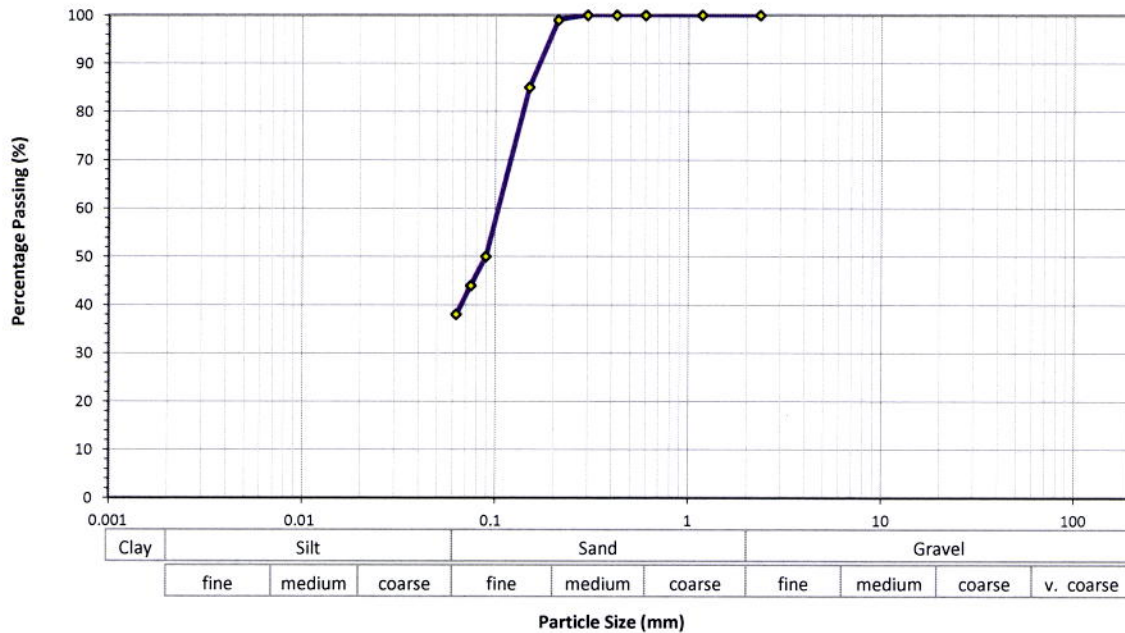
Sieve Size (mm)	Percentage Passing (%)	Sieve Size (mm)	Percentage Passing (%)	Sieve Size (mm)	Percentage Passing (%)	Sieve Size (mm)	Percentage Passing (%)
150	-	26.5	-	4.75	-	0.300	100
100	-	19.0	-	3.35	-	0.212	99
75.0	-	16.0	-	2.36	100	0.150	85
63.0	-	13.2	-	1.18	100	0.090	50
53.0	-	9.50	-	0.600	100	0.075	44
37.5	-	6.70	-	0.425	100	0.063	38

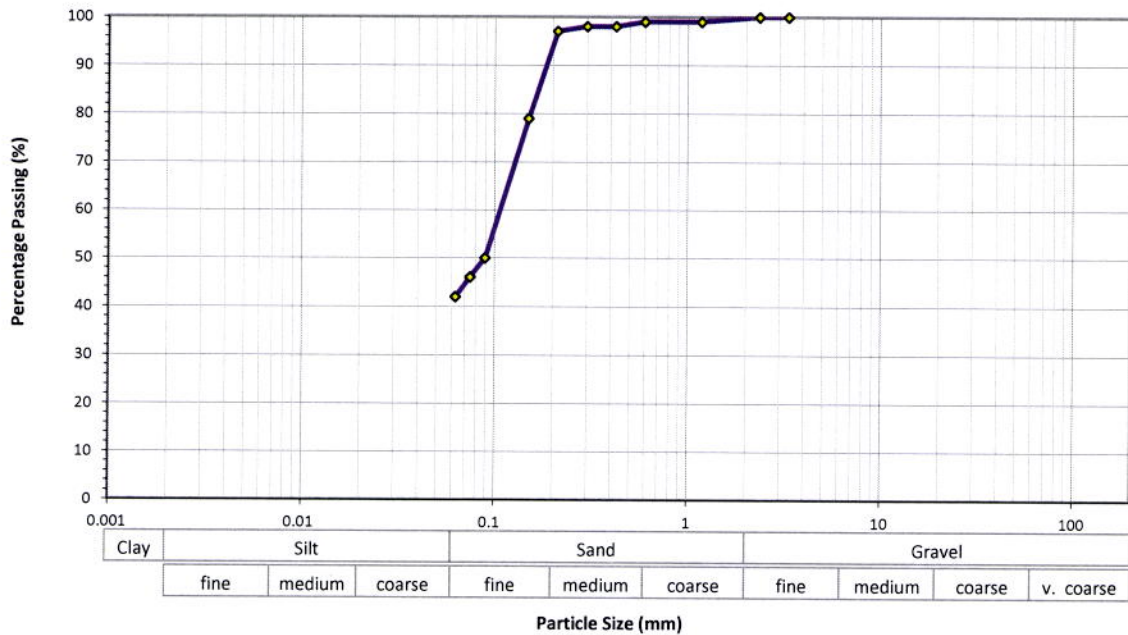
Sieve Size (mm)	Percentage Passing (%)	Sieve Size (mm)	Percentage Passing (%)	Sieve Size (mm)	Percentage Passing (%)	Sieve Size (mm)	Percentage Passing (%)
150	-	26.5	-	4.75	-	0.300	98
100	-	19.0	-	3.35	100	0.212	97
75.0	-	16.0	-	2.36	100	0.150	79
63.0	-	13.2	-	1.18	99	0.090	50
53.0	-	9.50	-	0.600	99	0.075	46
37.5	-	6.70	-	0.425	98	0.063	42

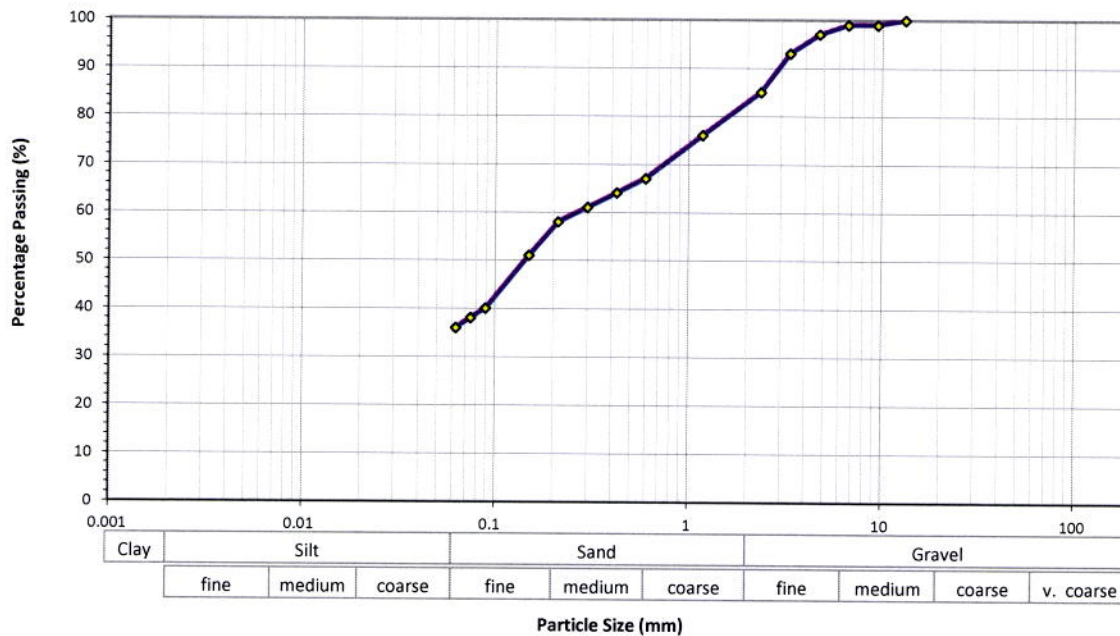
Sieve Size (mm)	Percentage Passing (%)	Sieve Size (mm)	Percentage Passing (%)	Sieve Size (mm)	Percentage Passing (%)	Sieve Size (mm)	Percentage Passing (%)
150	-	26.5	-	4.75	97	0.300	61
100	-	19.0	-	3.35	93	0.212	58
75.0	-	16.0	-	2.36	85	0.150	51
63.0	-	13.2	100	1.18	76	0.090	40
53.0	-	9.50	99	0.600	67	0.075	38
37.5	-	6.70	99	0.425	64	0.063	36

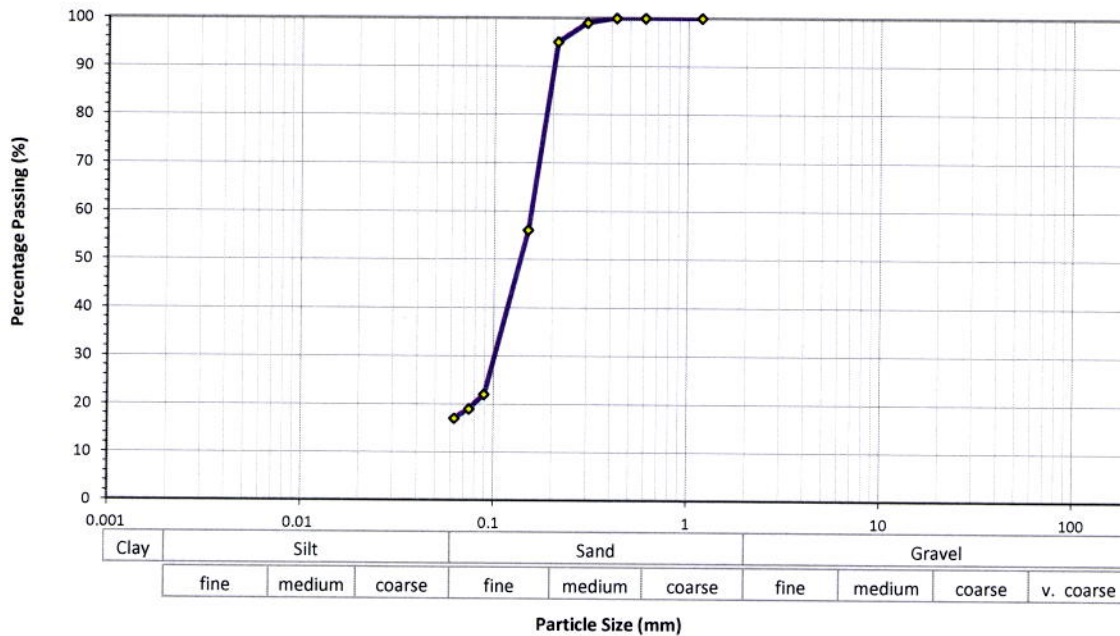
Sieve Size (mm)	Percentage Passing (%)	Sieve Size (mm)	Percentage Passing (%)	Sieve Size (mm)	Percentage Passing (%)	Sieve Size (mm)	Percentage Passing (%)
150	-	26.5	-	4.75	-	0.300	99
100	-	19.0	-	3.35	-	0.212	95
75.0	-	16.0	-	2.36	-	0.150	56
63.0	-	13.2	-	1.18	100	0.090	22
53.0	-	9.50	-	0.600	100	0.075	19
37.5	-	6.70	-	0.425	100	0.063	17

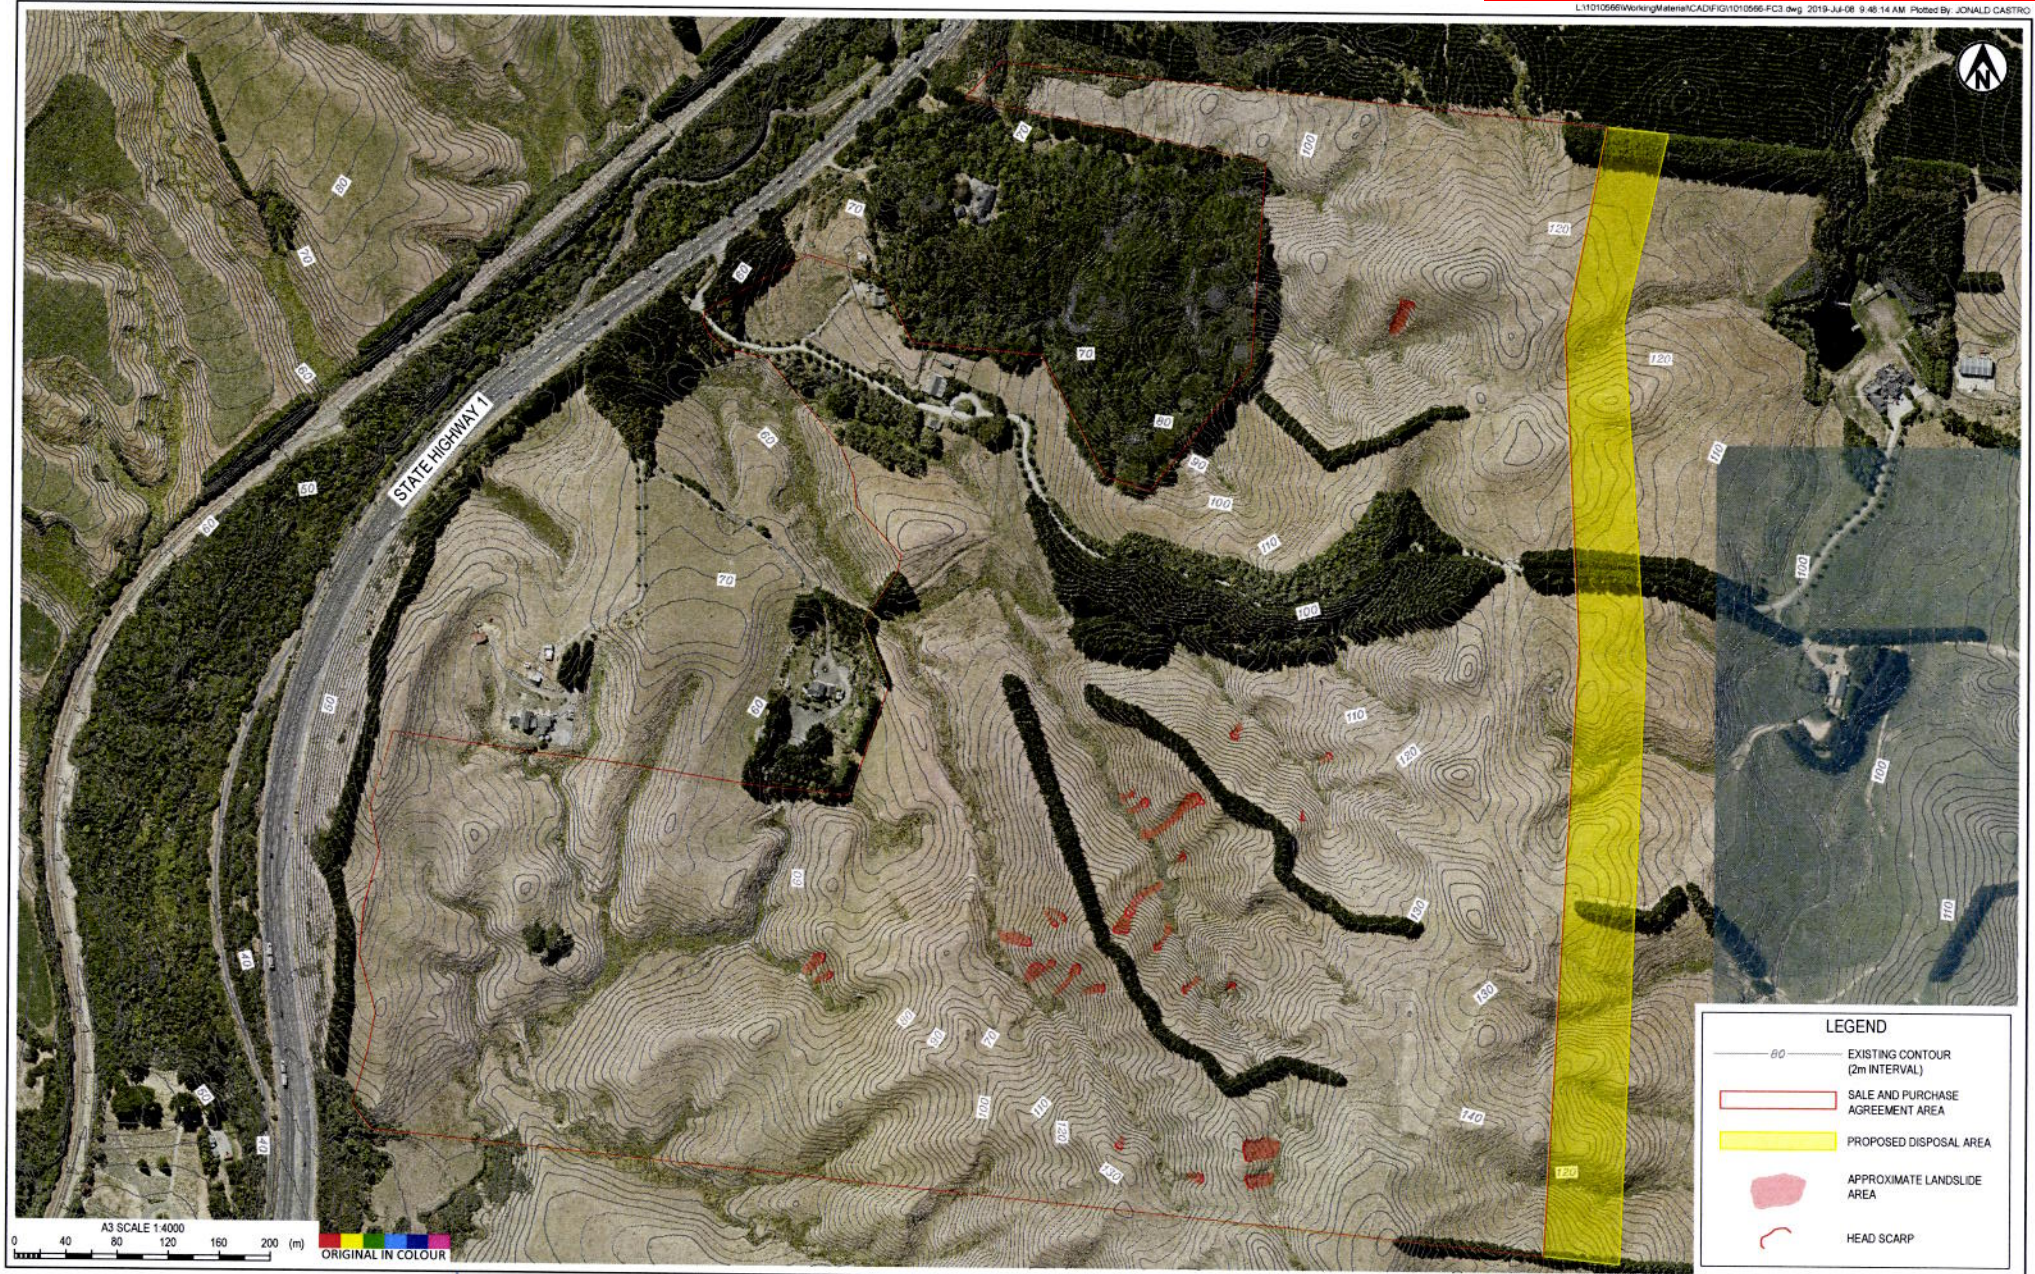
NOTES:
 1. THE AREAS OF INSTABILITY SHOWN ON THIS PLAN WERE IDENTIFIED DURING DESK STUDY AND PRELIMINARY MAPPING OBSERVATIONS.

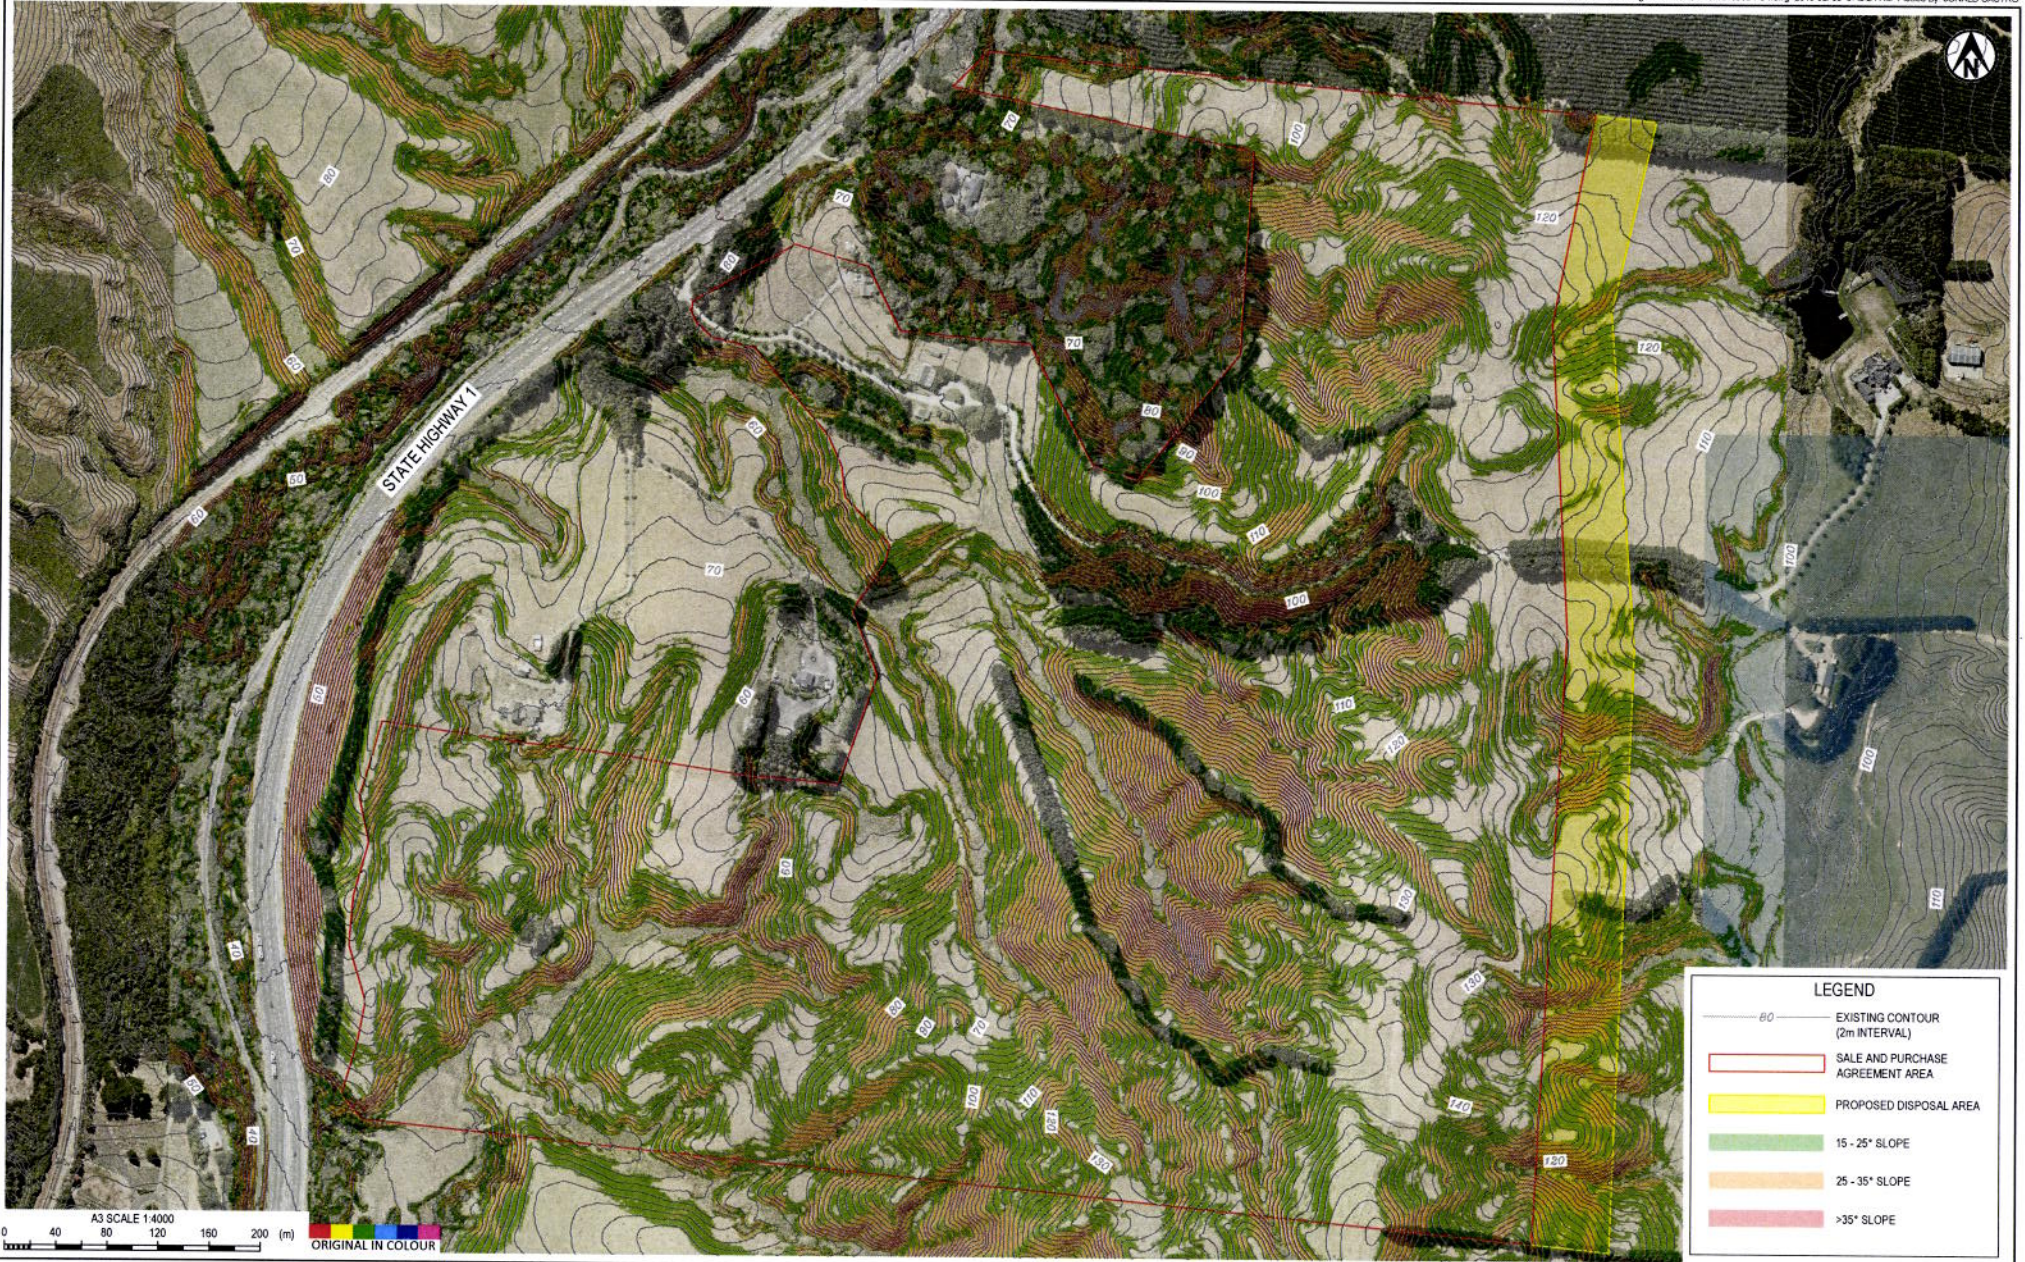
LEGEND	
	EXISTING CONTOUR (2m INTERVAL)
	SALE AND PURCHASE AGREEMENT AREA
	PROPOSED DISPOSAL AREA
	15 - 25° SLOPE
	25 - 35° SLOPE
	>35° SLOPE

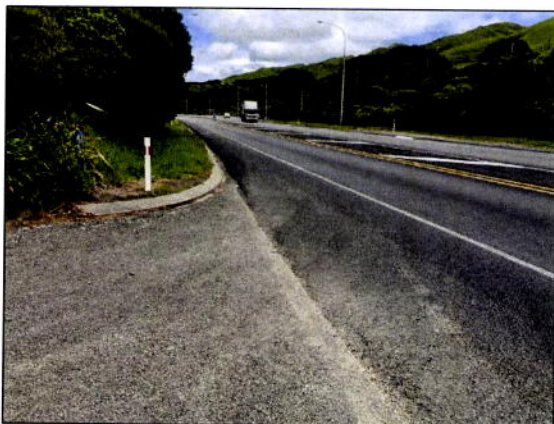
Photo 2
View to SW showing sight-line
from existing Mt Welcome
Station access
(November 2018)

- an intersection provided in the vicinity of the existing access would be able to comply with the relevant PCC and NZTA requirements; and
- overall, vehicular access is able to be formed in a manner which would avoid any significant adverse effects upon either the safety or the efficiency of the existing SH1 route in the post-TG operating environment.

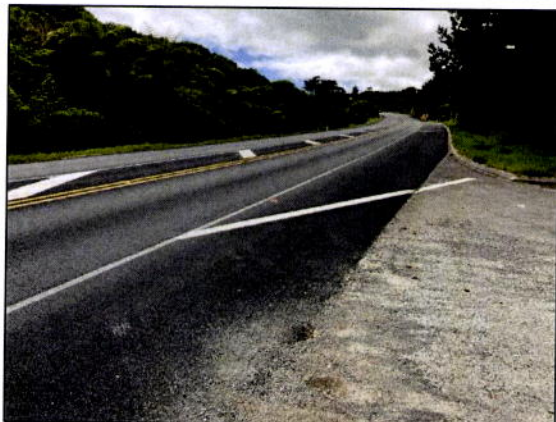
Photo 3
View to NE showing sight-line
from existing Mt Welcome
Station access
(November 2018)

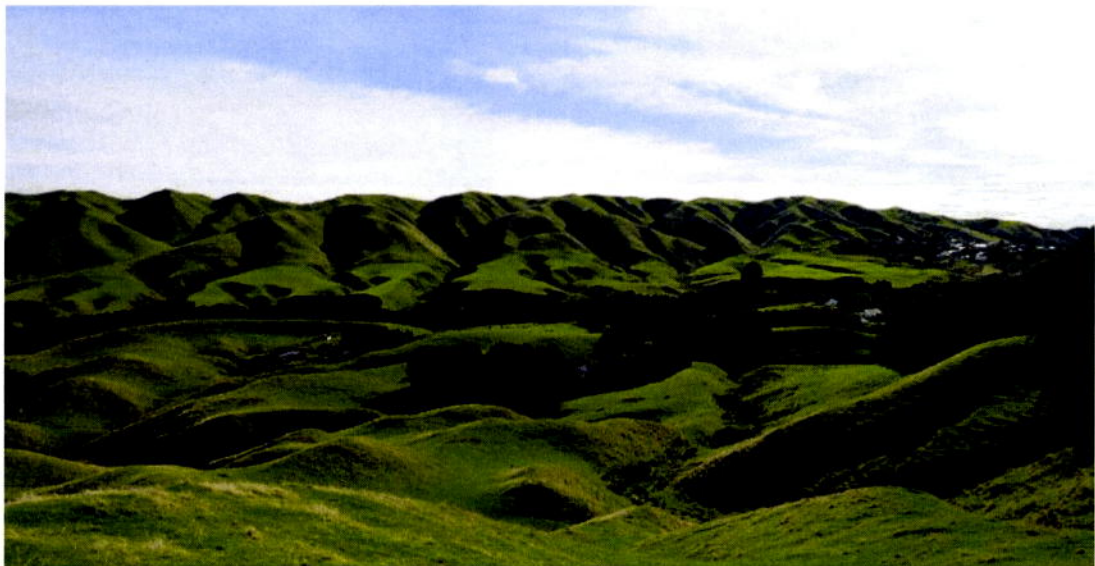
Figure 5. General view over Mt Welcome Station

Mt Welcome Station is a block of farmland with an undulating hillside and steep ridges (Figure 5). The steepest ridges are in the northeast, while the land is lower closer to the highway. Farm drainage networks run in the gullies between the ridges and are also found in the lower-lying areas. The vegetation is predominantly grassland with some pine trees along the ridges. Small rock outcrops are dotted across the landscape and erosion from the steeper slopes shows crumbling sandstone. The land is currently used as grazing for livestock, mainly sheep and deer.

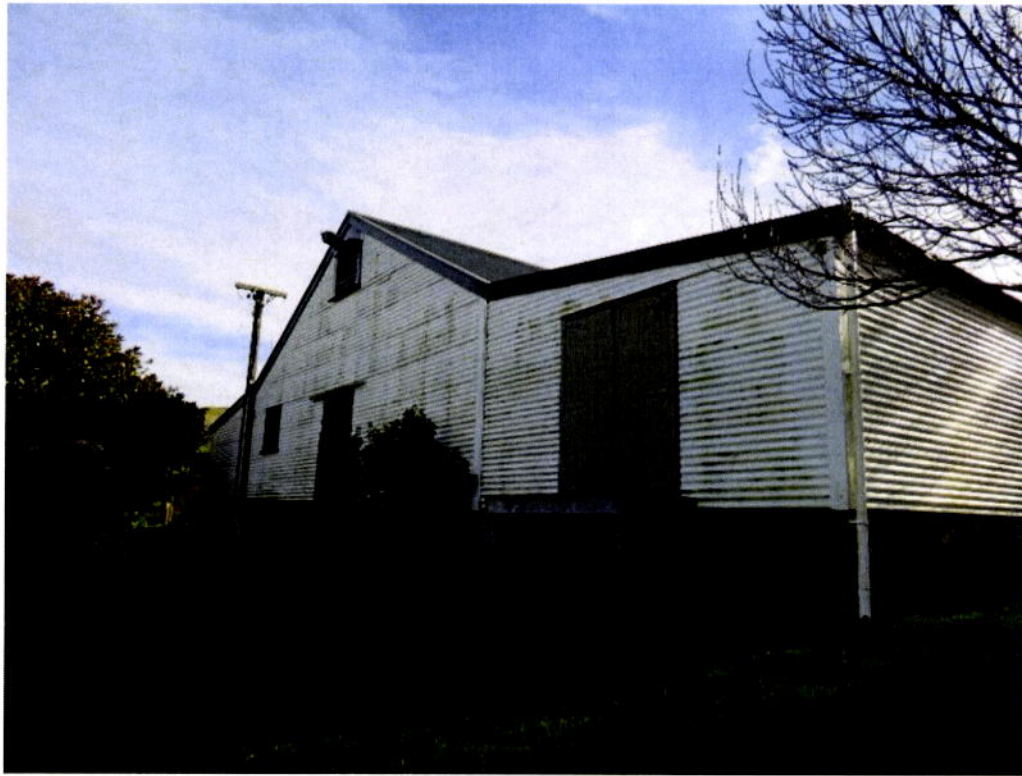
Figure 8. The Wool Shed

There are three buildings on the site located along the driveway in the area proposed for mixed use residential development in Figure 2 (shaded pink). They include a cottage (proposed for removal) and a woolshed (Figure 8). As previously noted, the structures do not appear on any pre-1900 maps, but the cottage is shown in a 1940 survey plan, while the cottage and the wool shed both appear on the 1942 aerial (Figure 6). The current landowner, Rick Lucas, does not know when they were built. As bush clearance and farm development appear to have occurred sometime after 1896, they are considered likely to be of 20th century date. The third building, south of the wool shed, was a later addition to the property.

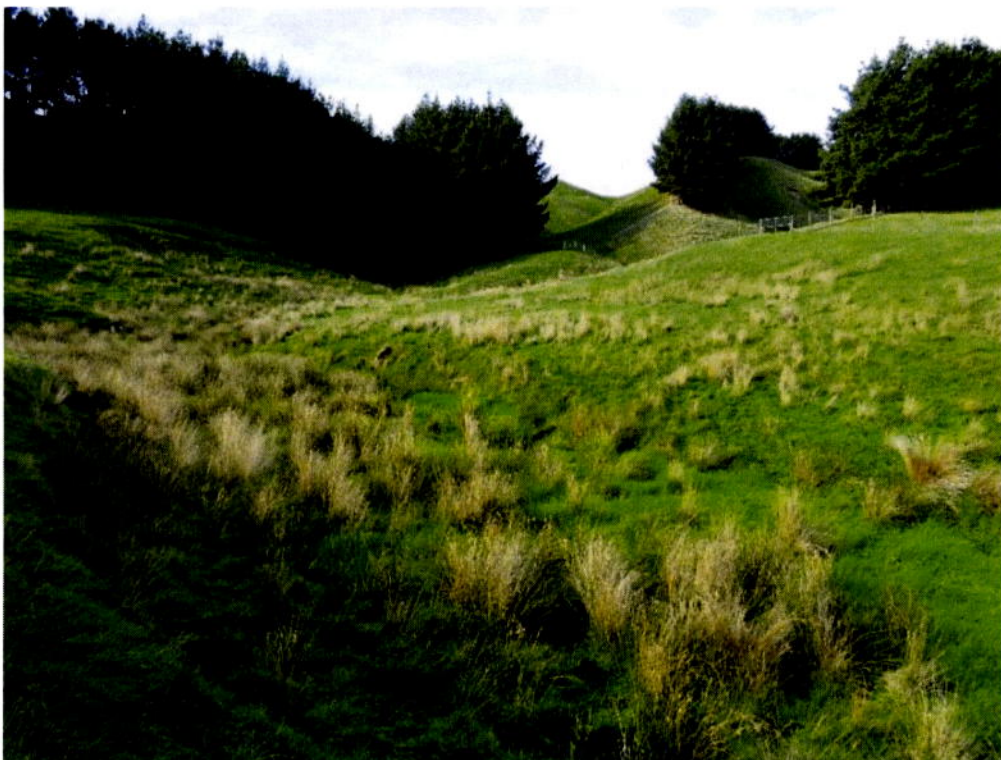
Figure 11. Farm drainage network in northwest of Part Lot 3 in Figure 2

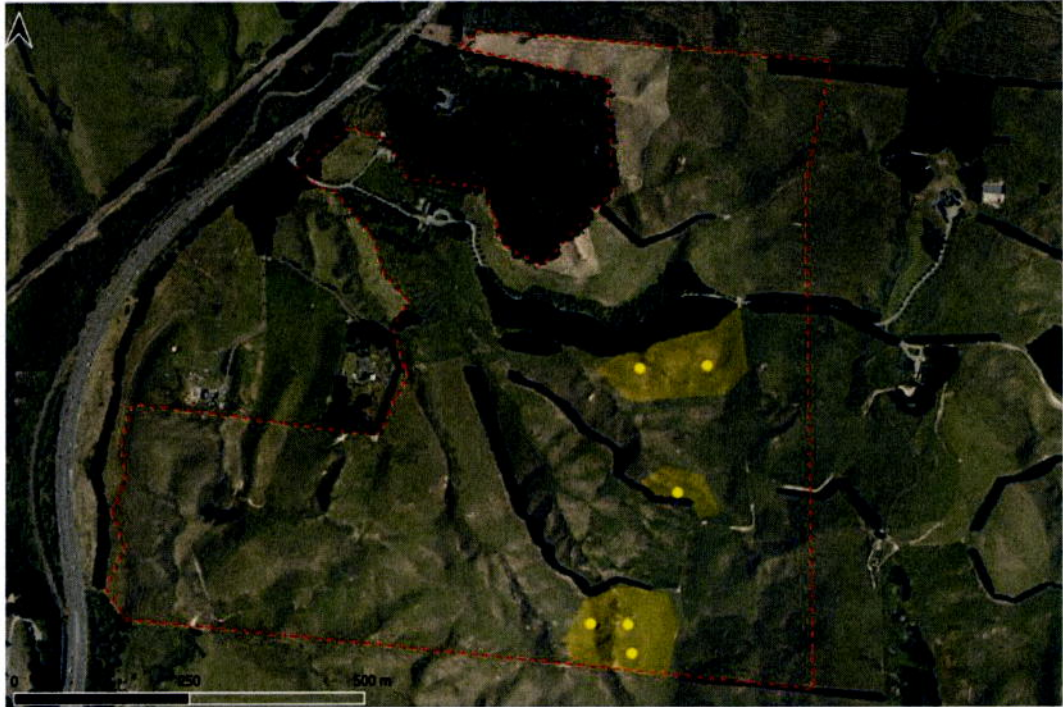
Figure 14. Locations of depressions on ridges (determined by GPS), recorded as yellow dots

The landscape within the property mainly comprises high ridges that slope down to the west, separated by gullies that drain into the lower farm drainage network in the lower-lying land. Ridges are suitable locations for food storage pits, as they drain naturally, while flat and wide gullies or plains that are sheltered are suitable for crop gardens. However, generally the gullies and lower areas seen at Mt Welcome Station would not have provided ideal conditions for crop cultivation. Some depressions were noted in the southeastern part of the property which could potentially be archaeological features (Figure 14 and Figure 15). However, holes/depressions resulting from deer rooting were witnessed all over the property and these depressions also have the potential to have been made by farm stock.

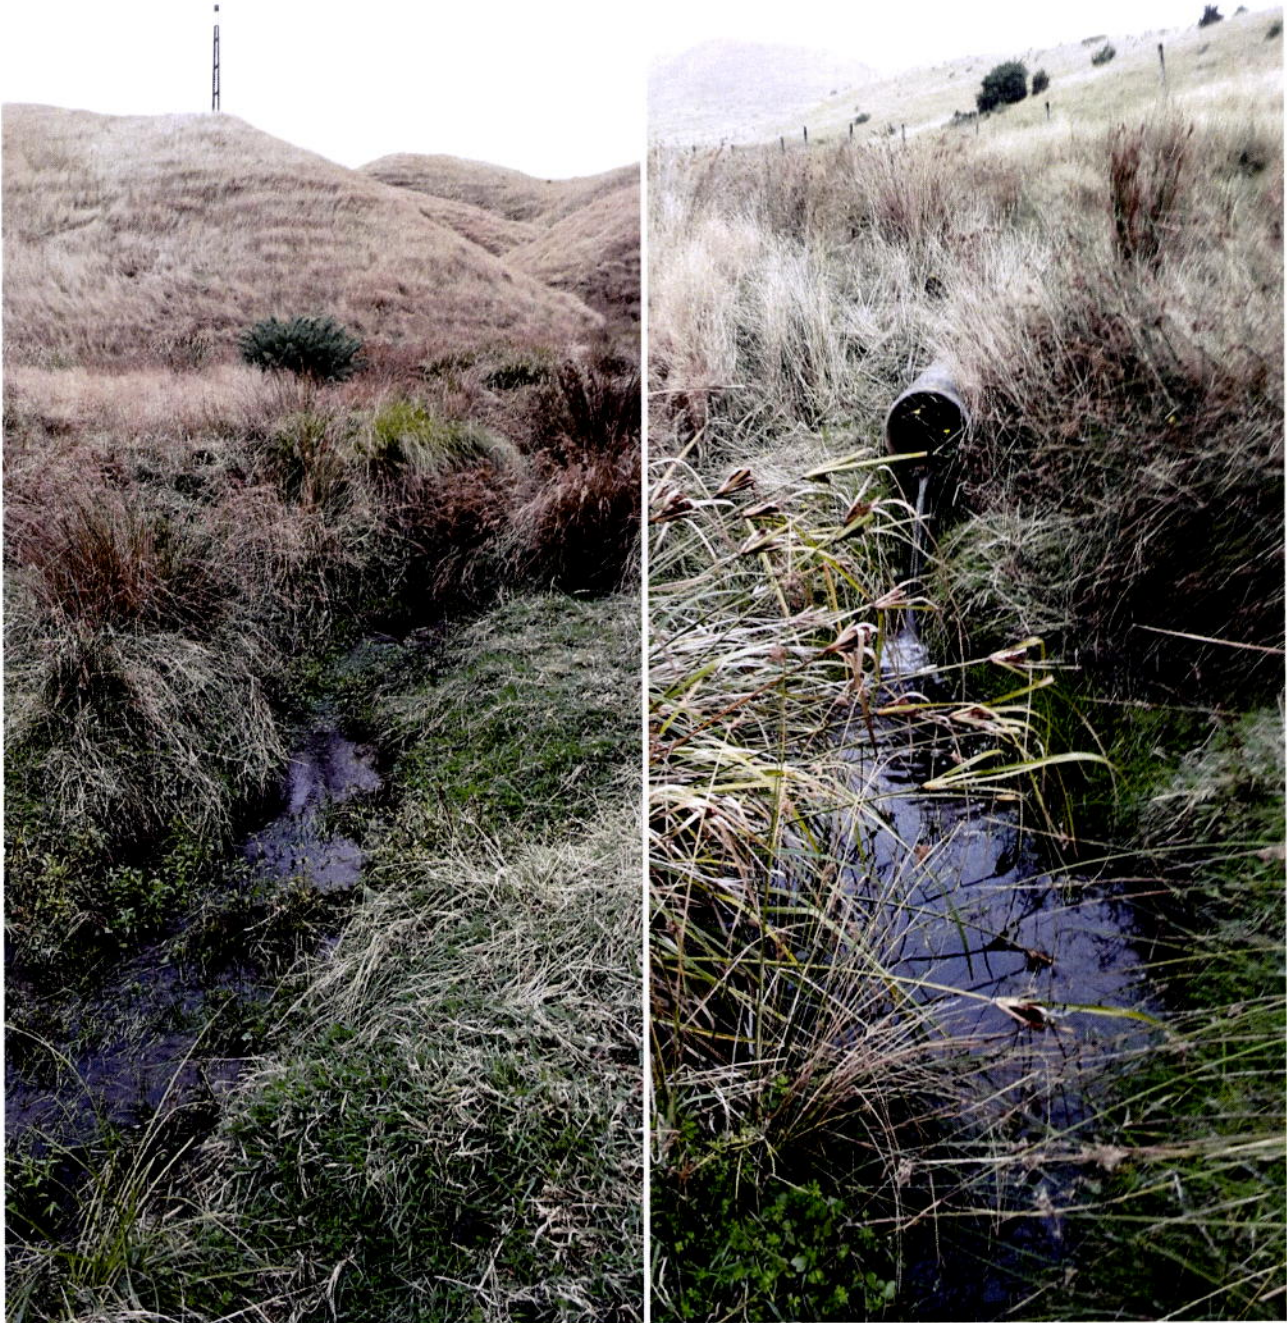
Figure 1: (upper) The lower reach of the stream at the southwestern boundary of the site (lower) a perched culvert beneath a farm track in the same stream.

There are two stream catchments on site. Both have been extensively modified and degraded, through a loss of canopy cover, increased sedimentation, stock damage and the installation of perched culverts. The 'Active Bed' of the streams are generally <1 m wide, with the exception of isolated pools and sections of scouring at culvert inlet/outlets. There is a significant opportunity for restoration and enhancement of the streams through the correction of the perched culverts, exclusion of stock and by providing for appropriate riparian planting.

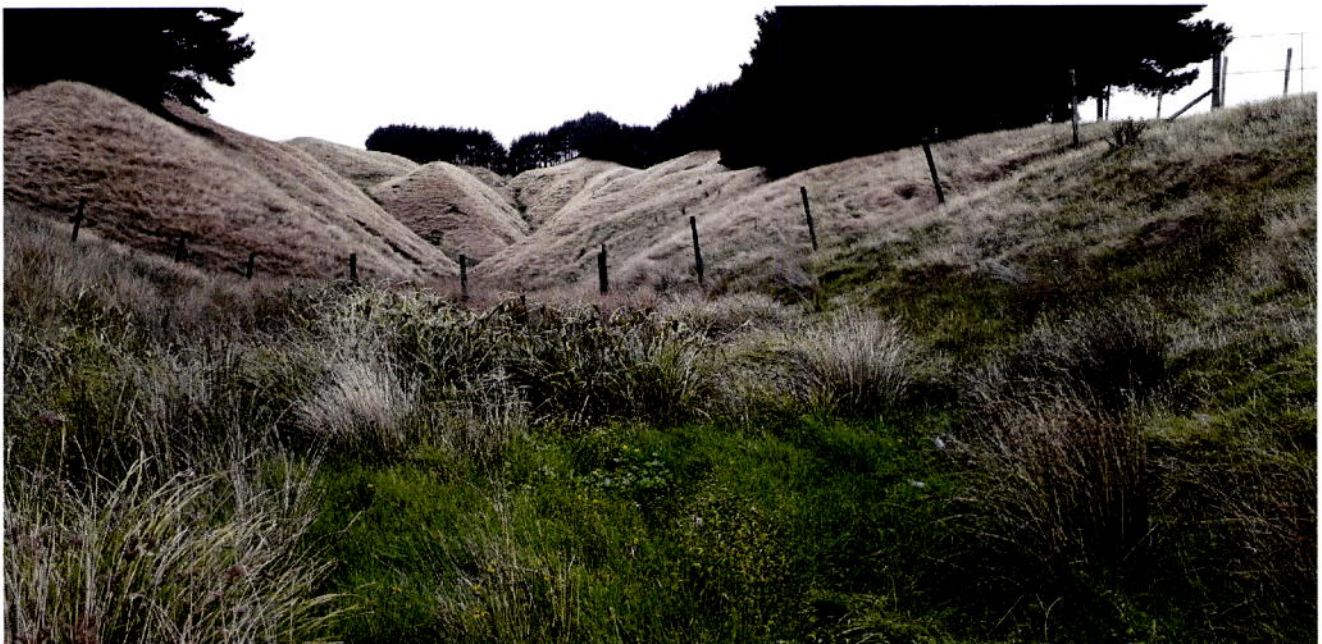
Figure 2: A representation of the lower gully slopes throughout the site which are dominated by a mix of wetland obligate and facilitative plant species.

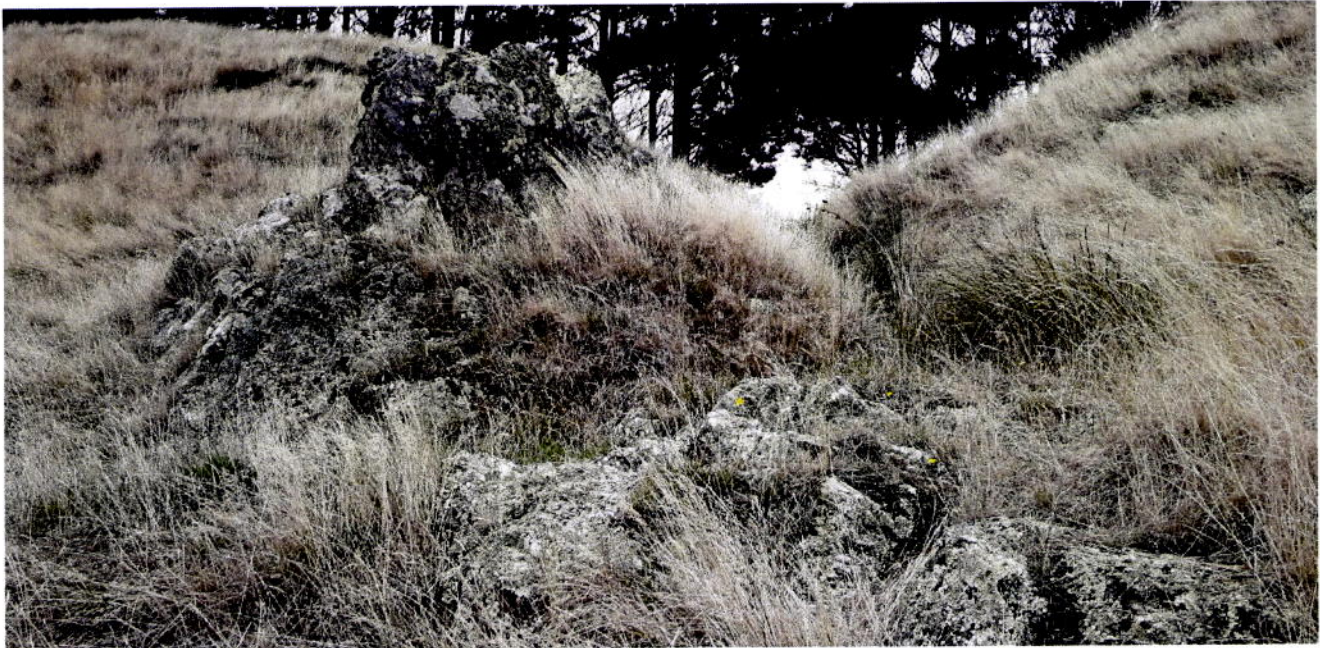
Figure 3: A rocky outcrop with rank grass - habitat for native grassland skinks.

There are some relatively small areas of rank grass, and debris that provide suitable habitat for native skinks. All New Zealand lizards are absolutely protected under the Wildlife Act 1953 and consequently a Wildlife Act Authority from Department of Conservation is required to undertake activities within New Zealand herpetofauna habitat that may result in a significant impact on a species or habitat.
