TREC REI 7-6

PROPERTY INSPECTION REPORT FORM

<i>Name of Client</i>	07/13/2022 9:30 am <i>Date of Inspection</i>
<i>Address of Inspected Property</i>	
Christopher Stewart <i>Name of Inspector</i>	TREC #25470 <i>TREC License #</i>
<i>Name of Sponsor (if applicable)</i>	<i>TREC License #</i>

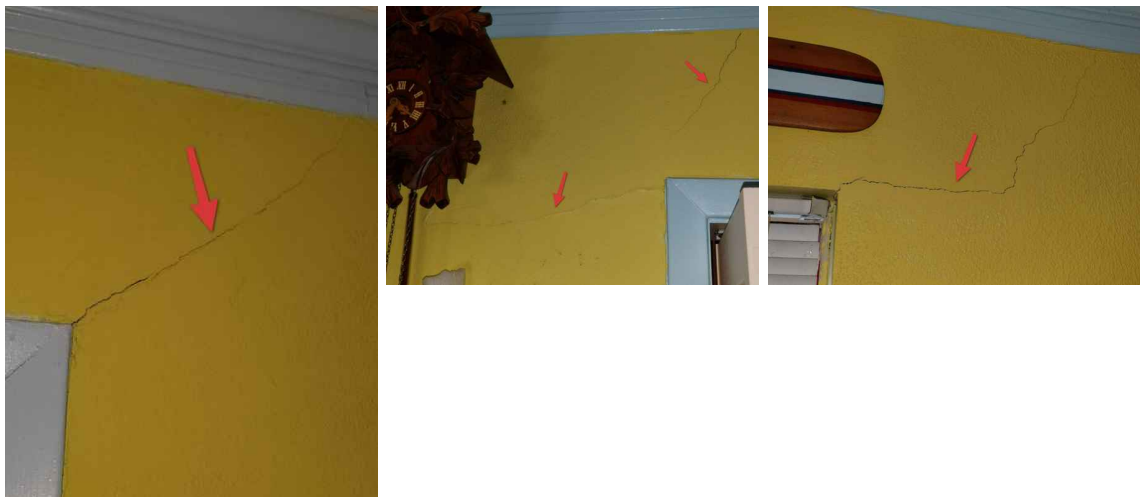
1: Interior Drywall Cracks

Interior drywall cracks and/or stress indicators found in one or more places.

Recommendation: Contact a foundation contractor.

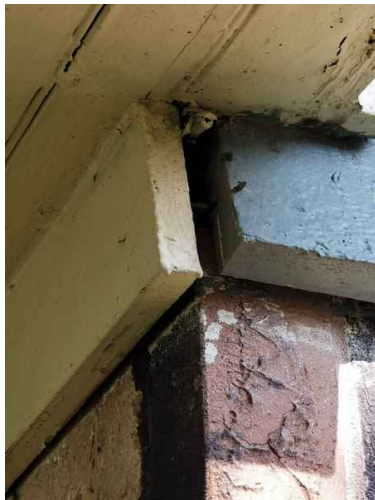
2: Frieze board separations were observed.

Frieze board separations were observed in one or more places.

Recommendation: Contact a qualified handyman.

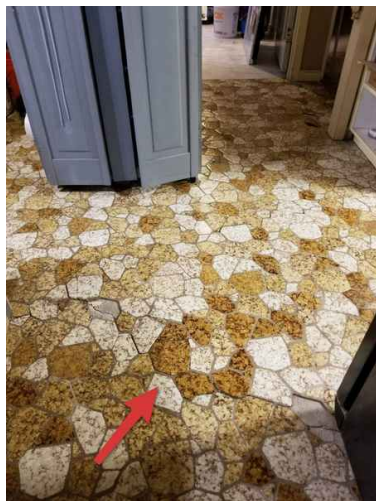
4: Floor slopes and/or unlevelness were observed.

Floor slopes and/or unlevelness was observed between the kitchen and the laundry room.

Recommendation: Contact a foundation contractor.

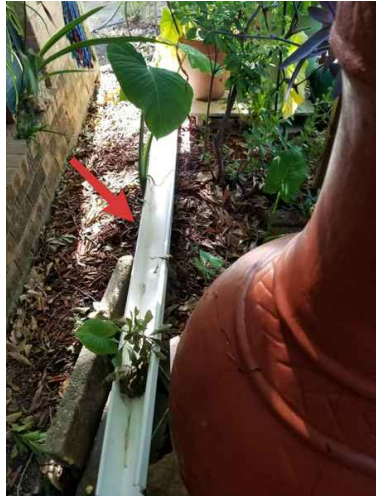
One or more gutters have been removed and should be reinstalled to prevent water from collecting next to the foundation wall.

Note: The gutter downspouts should discharge water at least thirty-six inches (36") away from the foundation perimeter beam. Storm water should be encouraged to flow away from the structure at the points of discharge.

Recommendation: Contact a qualified professional.

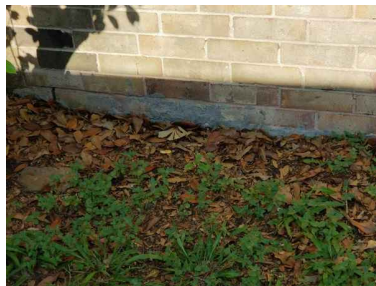
2: Negative Grading

Grading is sloping towards the home in some areas. This could lead to water intrusion and foundation issues. Recommend qualified landscaper or foundation contractor regrade so water flows away from home.

Recommendation: Contact a qualified landscaping contractor

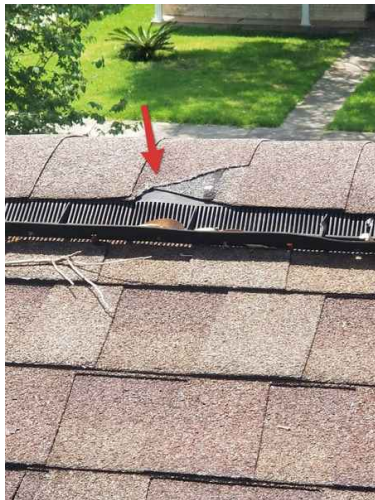
1: Ridge Cap Shingles Damaged.

One or more of the ridge cap shingles were observed to be damaged.

Recommendation: Contact a qualified roofing professional.

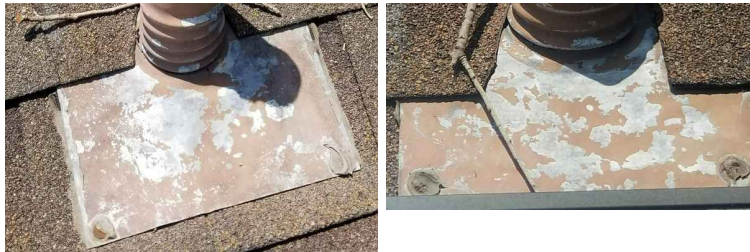
One or more flashings need to be painted to prevent rust and/or UV damage.

Recommendation: Contact a qualified roofing professional.

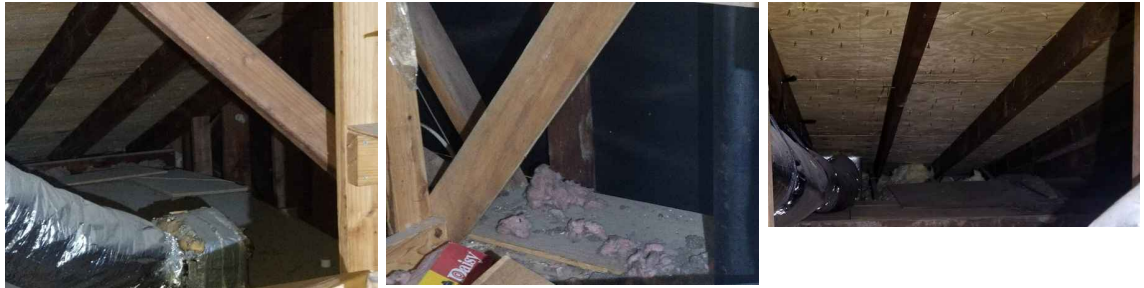
1: Insufficient Insulation

Insulation depth was inadequate. Recommend a qualified attic insulation contractor install additional insulation.

Recommendation: Contact a qualified insulation contractor.

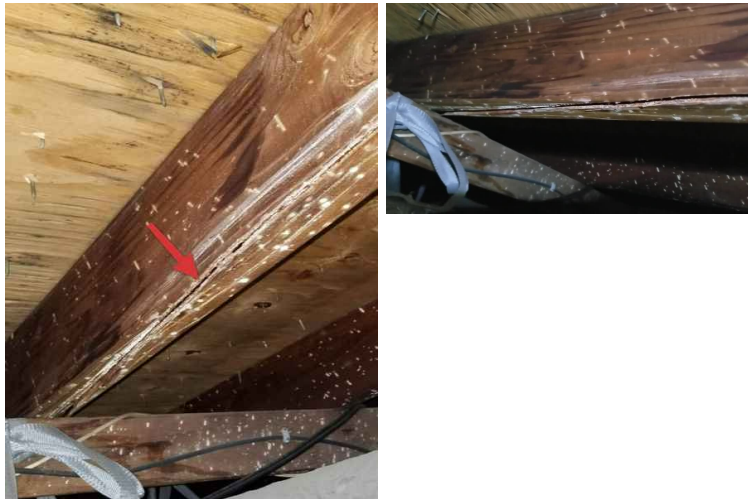
2: Split Rafter

Split rafter(s) were observed in the attic area.

Recommendation: Contact a qualified roofing professional.

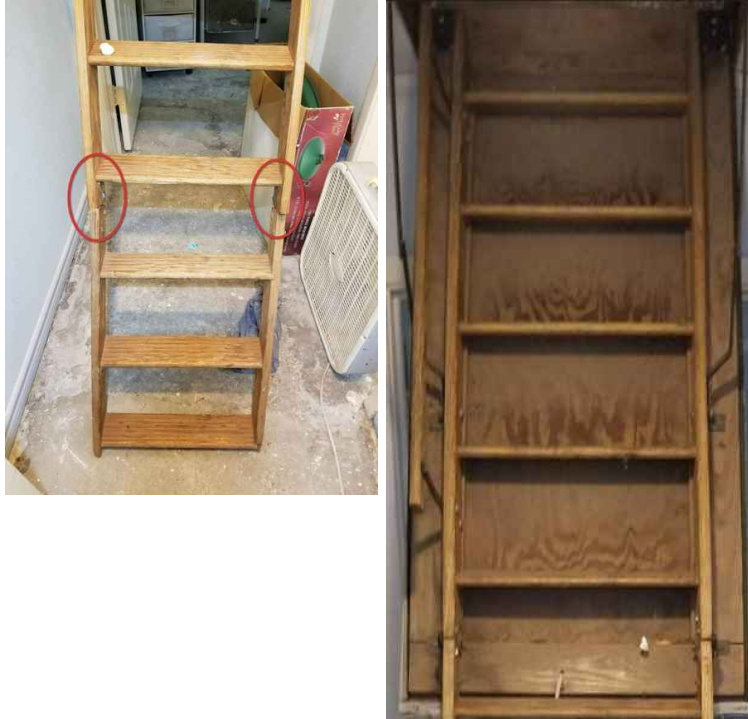
4: Attic ladder components damaged

The attic ladder appears to be in poor condition and improvements or replacement is recommended for reasons of safety.

Note: The hatch door is not insulated at this time. This is an "As Built" condition that does not meet current energy standards. It is recommended to insulate the hatch door / opening after taking possession / ownership

Note: There was no weather-stripping observed around the attic ladder opening. This is an "As Built" condition that does not meet current energy standards. It is recommended to weather-strip the hatch opening after taking possession / ownership of the property.

Recommendation: Contact a qualified handyman.

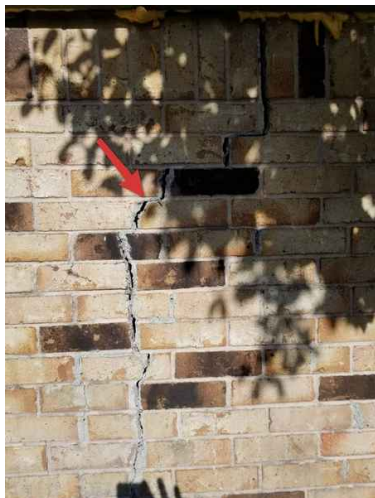
1: Cracks - Major

Major cracking observed in wall structure. This could be from moisture intrusion at the structure and/or soil movement. Recommend a qualified structural engineer evaluate and advise on course of action.

Recommendation: Contact a qualified structural engineer.

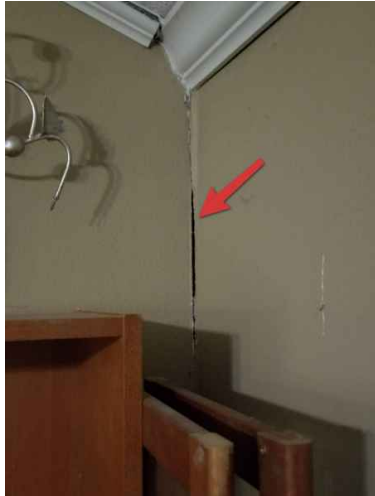
2: Interior wall joint cracks observed.

Interior wall joint cracks were observed in one or more locations.

Recommendation: Contact a qualified professional.

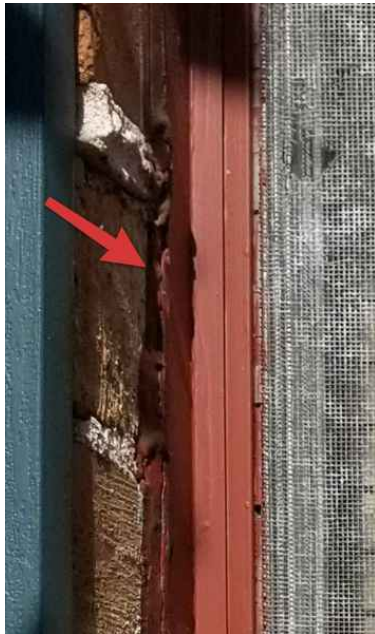
3: Caulking Improvements

Caulking improvements are recommended for the area between the exterior veneer and the window/door frames. It is recommended to use an elastomeric caulking.

Recommendation: Contact a qualified professional.

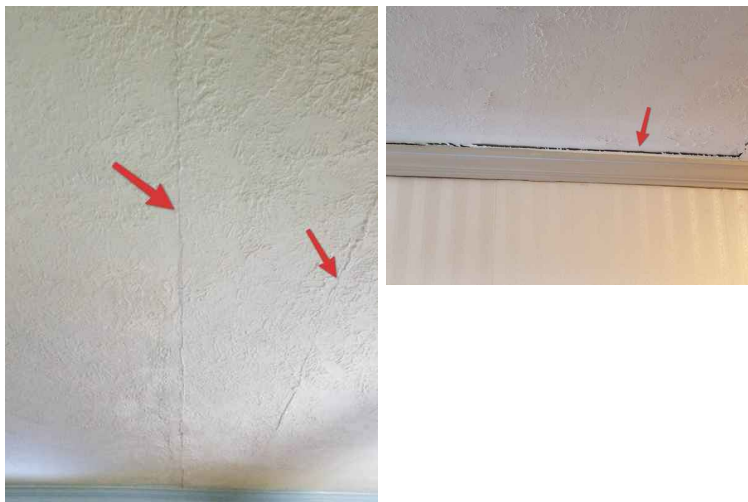
2: Ceiling stress or joint cracks were observed.

Ceiling stress or joint cracks were observed.

Recommendation: Contact a qualified professional.

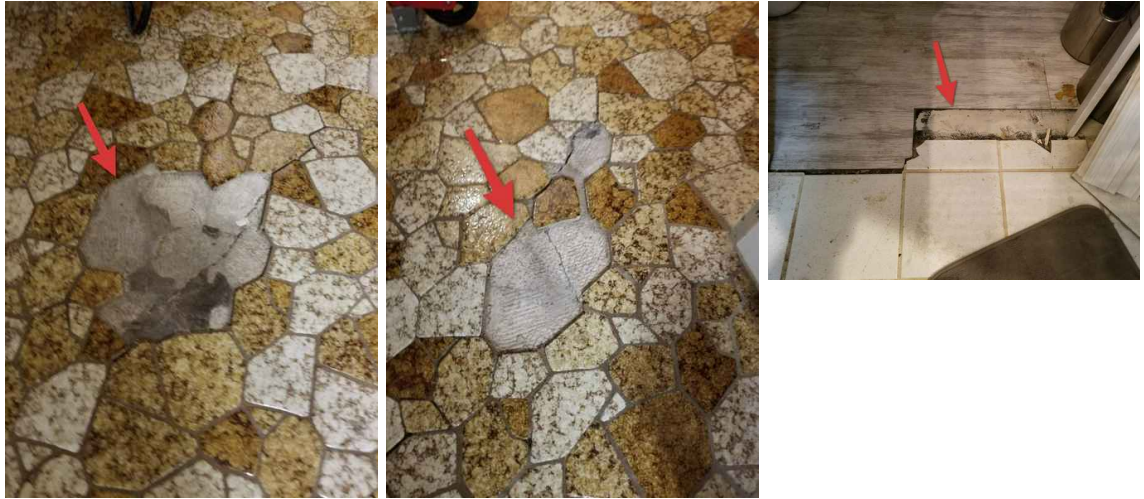
3: The floor covering is worn and/or damaged in one or more locations of the home.

The floor covering is worn and/or damaged in one or more locations of the home.

Recommendation: Contact a qualified flooring contractor

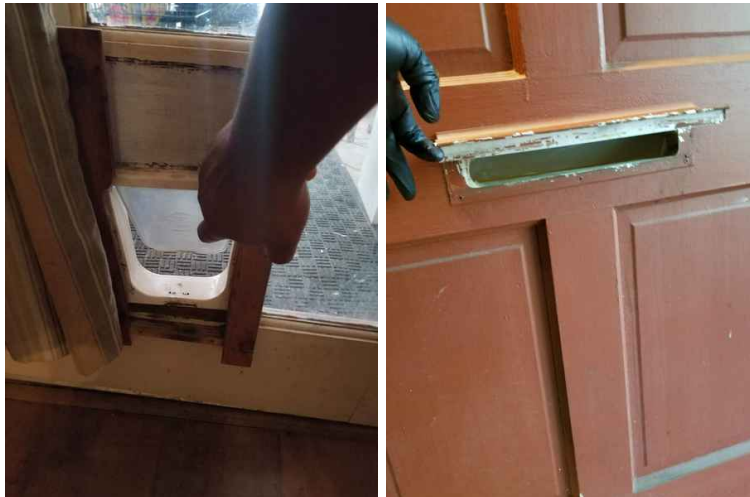
1: Pet door observed in back door

There is a pet door observed in the backdoor and a letter box/mail slot in the front door. This could allow moister, rodents, and insects into the property.

Recommendation: Contact a qualified handyman.

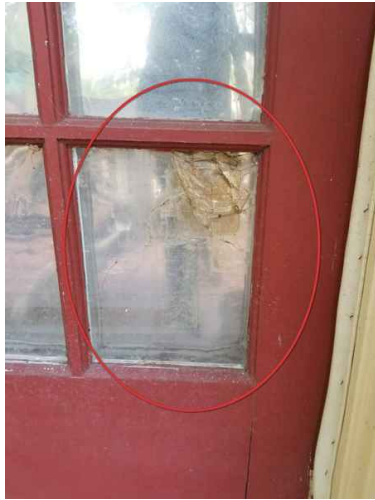
3: Broken glass

The inspector observed a broken pane of glass on the exterior side door.

Recommendation: Contact a qualified professional.

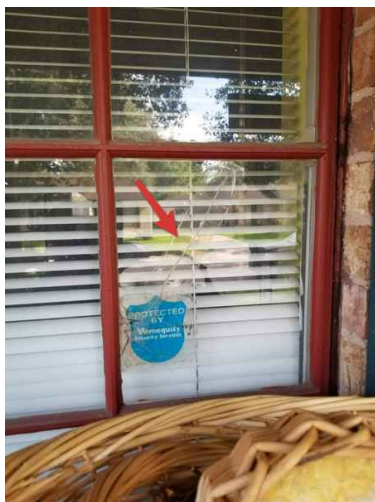
1: Cracked and/or broken window glass was observed.

Cracked and/or broken window glass was observed.

Recommendation: Contact a qualified window repair/installation contractor.

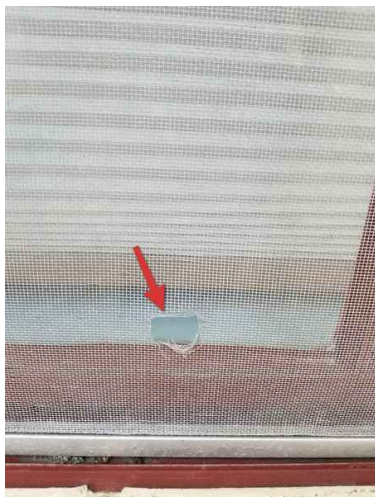
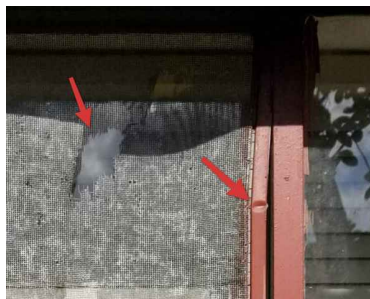
2: Damaged Window Screens

One or more of the window screens were observed to be damaged.

Recommendation: Contact a qualified window repair/installation contractor.

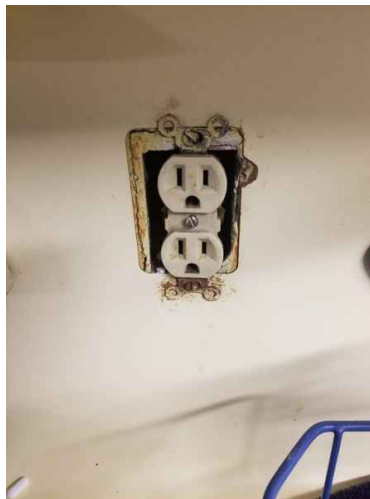
2: Cover Plates Missing

One or more receptacles are missing a cover plate. This causes short and shock risk. Recommend installation of plates.

Recommendation: Contact a qualified electrical contractor.

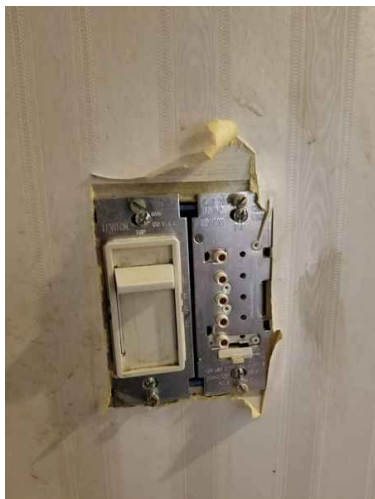
4: The switch is missing its cover plate.

One or more light switches is missing its cover plate.

Recommendation: Contact a qualified electrical contractor.

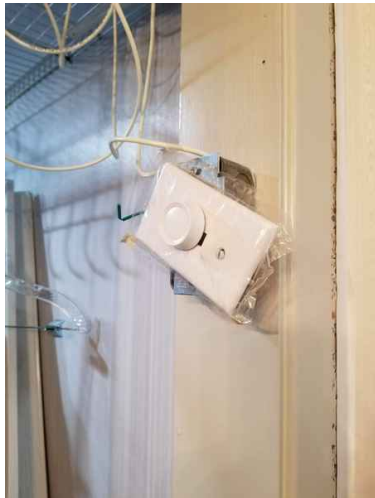
6: Dimmer switch improperly installed

One or more dimmer switches is improperly installed.

Recommendation: Contact a qualified professional.

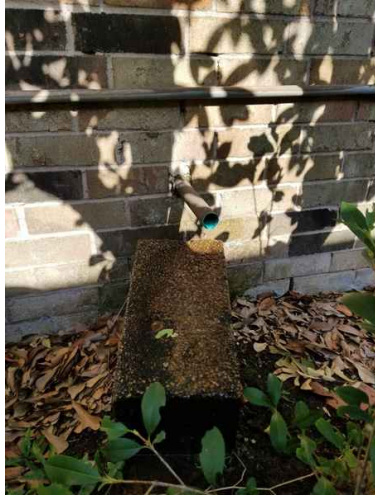
The secondary condensate drain line is leaking water, indicating the primary drain line is being bypassed. This usually indicates that servicing is needed.

Recommendation: Contact a qualified HVAC professional.
