ADVANCED PROPERTY INSPECTORS PLLC

RESIDENTIAL REPORT

MAY 16, 2022

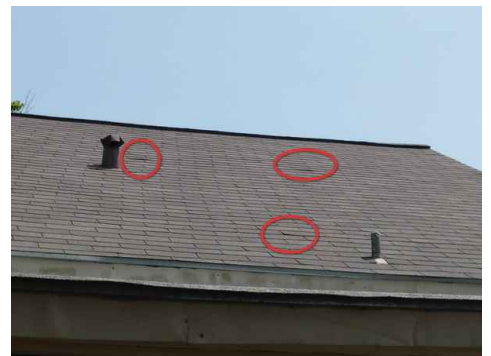
One or more shingles were observed to be lifting.

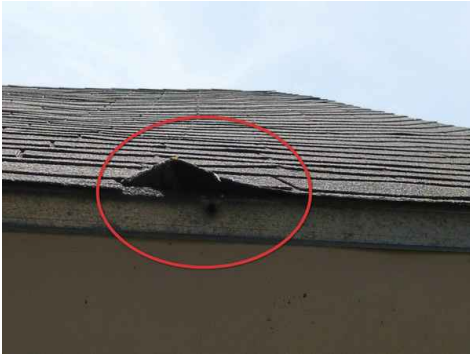
2.1.2 Coverings

DAMAGED SHINGLES

One or more shingles were observed to be damaged.

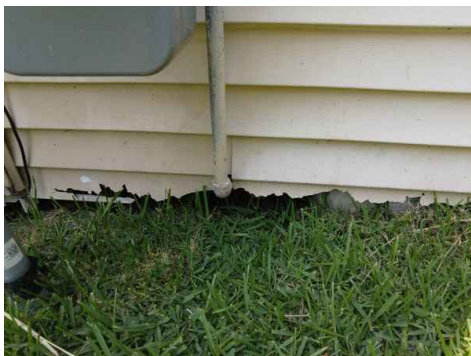
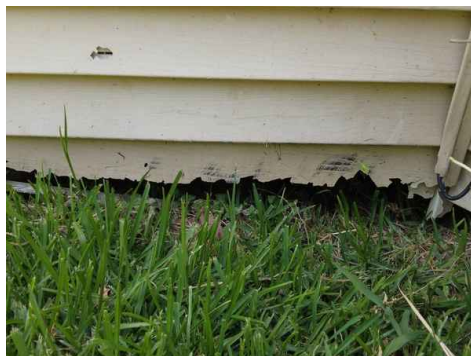
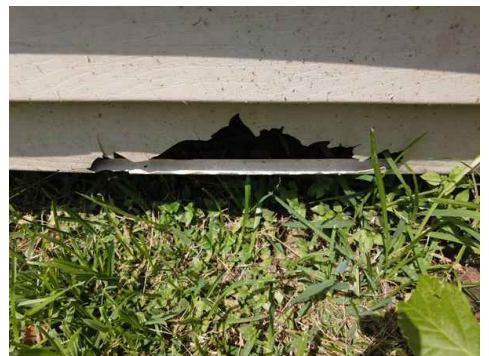
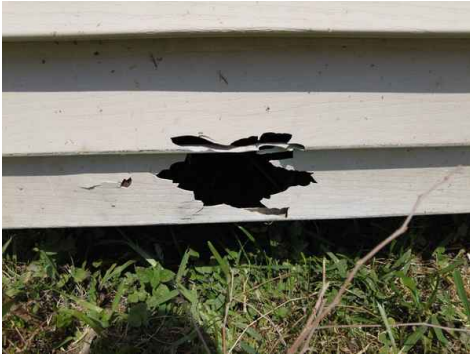
DAMAGED SIDING OBSERVED

Damaged siding observed in one or more locations along the bottom of the exterior walls. Possibly due to contact with lawn care equipment.

Contact a qualified siding specialist.

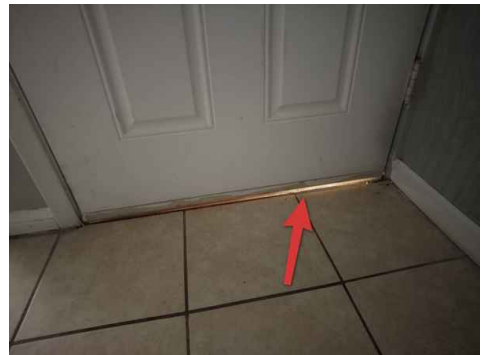
3.2.1 Exterior Doors

WEATHER-STRIPPING IMPROVEMENTS.

Weather-stripping improvements are recommended. There is a visible separation between the floor and the bottom of the door. This could allow moisture or insects to enter the property.

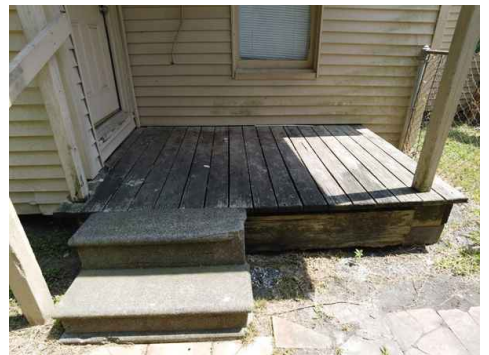
3.4.1 Decks, Balconies, Porches & Steps

DECK - WATER SEALANT REQUIRED

Deck is showing signs of weathering and/or water damage. Recommend water sealant/weatherproofing be applied.

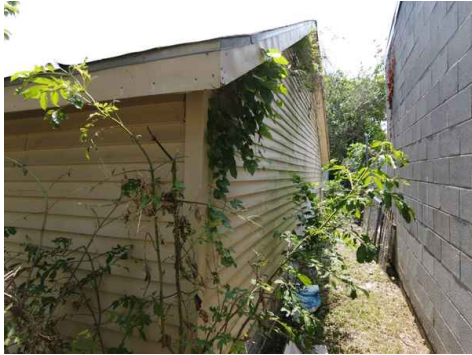
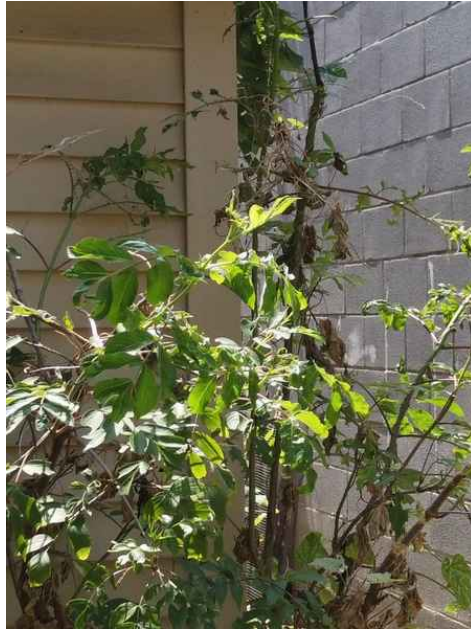
3.6.1 Vegetation, Grading, Drainage & Retaining Walls

VEGETATION IN CONTACT WITH SIDING.

Vegetation observed to be in contact with the exterior siding in one or more locations. Recommend trees and bushes be cut down or trimmed back so they are not in contact with the siding. This may cause moisture or insect intrusion.

Contact a qualified landscaping contractor

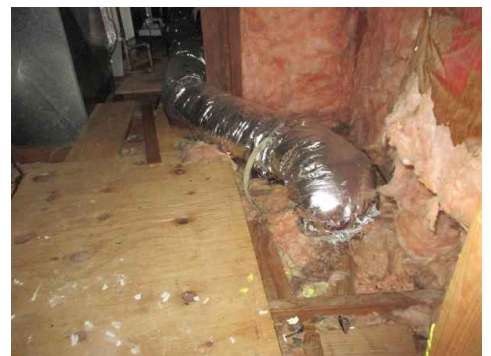
The duct work in the attic area does not appear to be properly suspended and separated to help prevent condensation from developing. It is recommended to separate and suspend the duct work with supports in minimum intervals of 4-feet that have a minimum width of 1.5-inches.

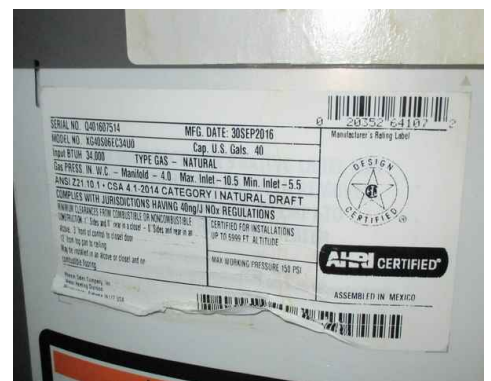
GAS SERVICE OFF

Note: The gas service was turned off to the structure at the time of this inspection. I was unable to check the gas operation of this component at this time. A limited visual survey will be performed and if any deficiencies are found they will be listed within this section.

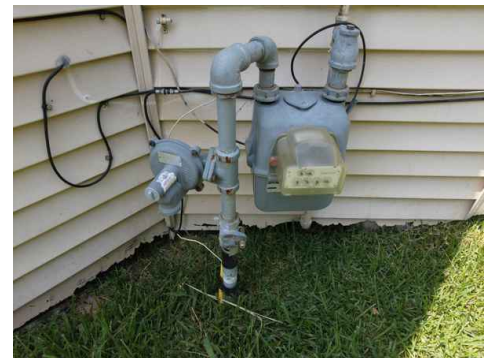
GAS SHUT OFF

Gas was off at the main. Recommend local utility company turn on and check all gas appliances prior to deadlines.

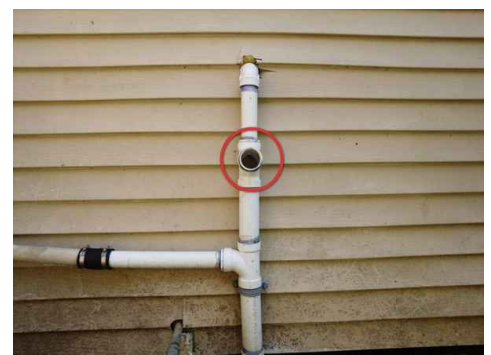
7.2.1 Drain, Waste, & Vent Systems

CLEANOUT COVER IS MISSING.

The exterior wall cleanout cover is missing. Recommend replacing the cover.

Contact a qualified plumbing contractor.

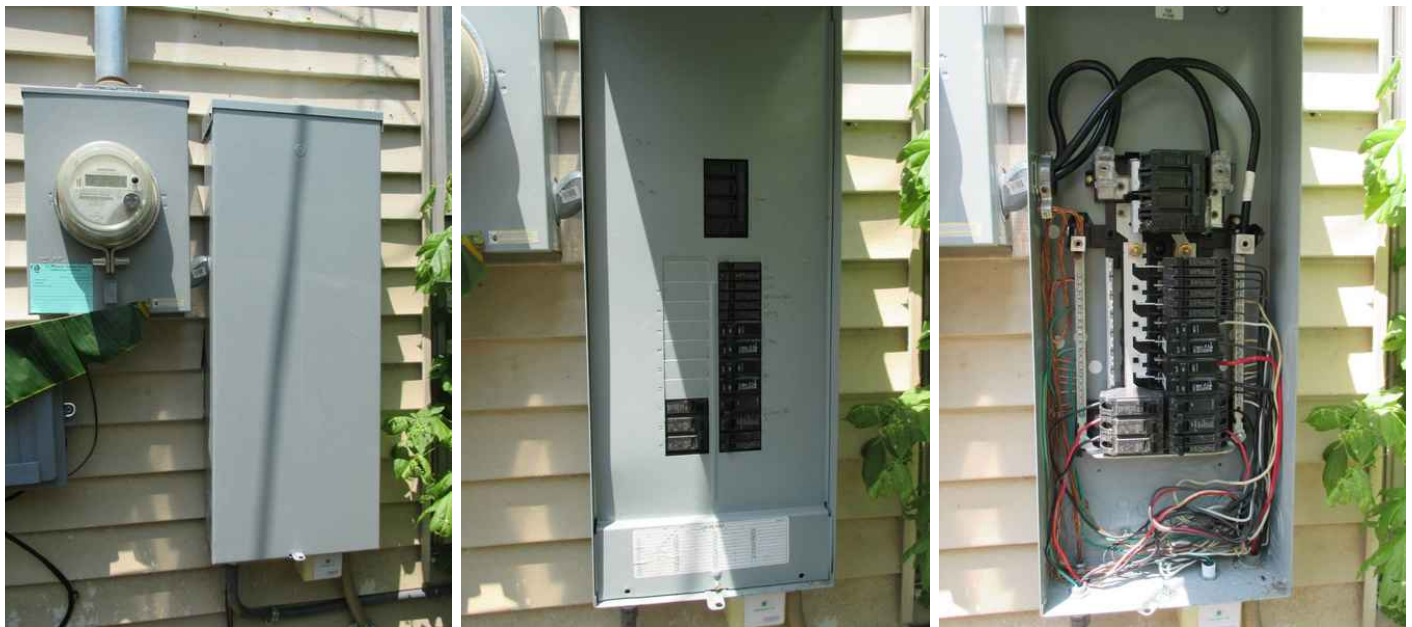
Main & Subpanels, Service & Grounding, Main Overcurrent Device: Performing In Satisfactory Condition

All components were found to be performing and in satisfactory condition on the day of the inspection.

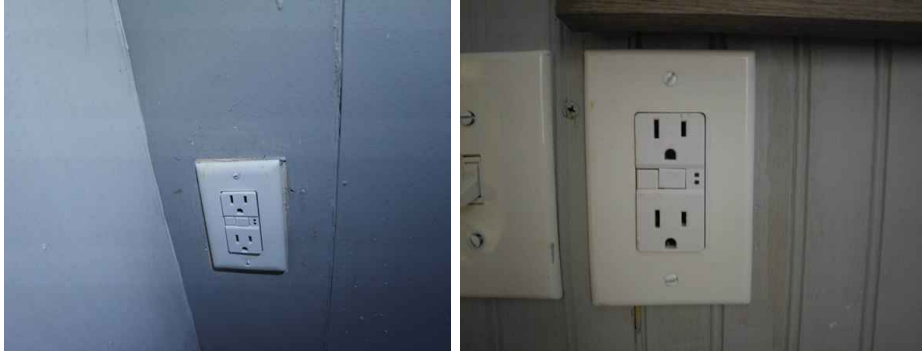
GFCI & AFCI: GFCI Devices

GFCI devices observed in the kitchen and bathrooms

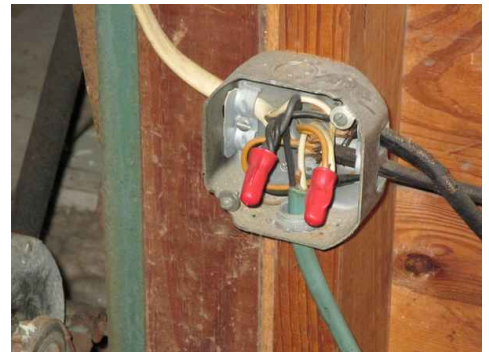
Open electrical junction box(es) were observed in the attic area. All open junction box(es) in the attic should be properly enclosed.

Contact a qualified electrical contractor.

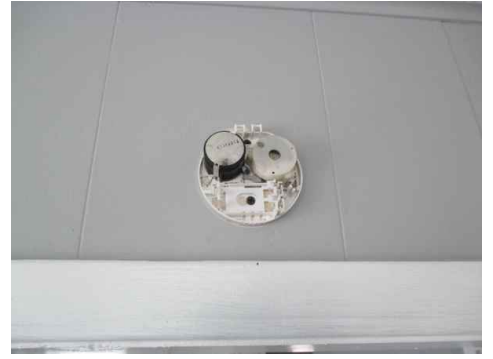
MISSING SMOKE DETECTOR COVER

One or more smoke detector covers are missing. Recommend replacing cover.

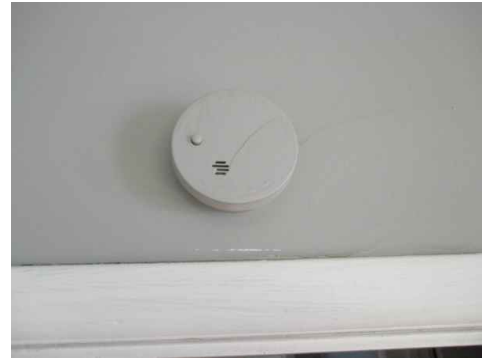
8.6.2 Smoke Detectors

PAINTED SMOKE DETECTOR

One or more smoke detectors have been painted.

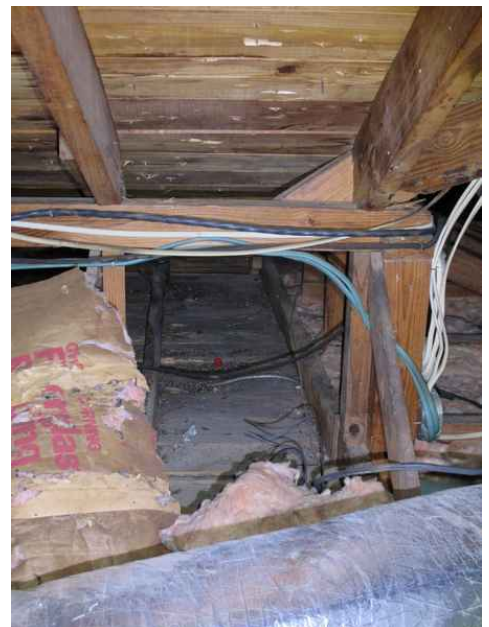
IMPROPER INSTALLATION

Attic insulation was improperly installed. Recommend a qualified insulation contractor evaluate and correct.

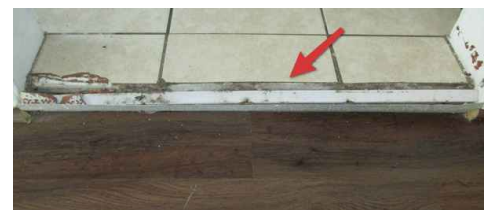
DAMAGED TRANSITION

A damaged transition piece between the kitchen and living room was observed. This could create a tripping hazard. Recommend repairing or replacing as soon as possible.

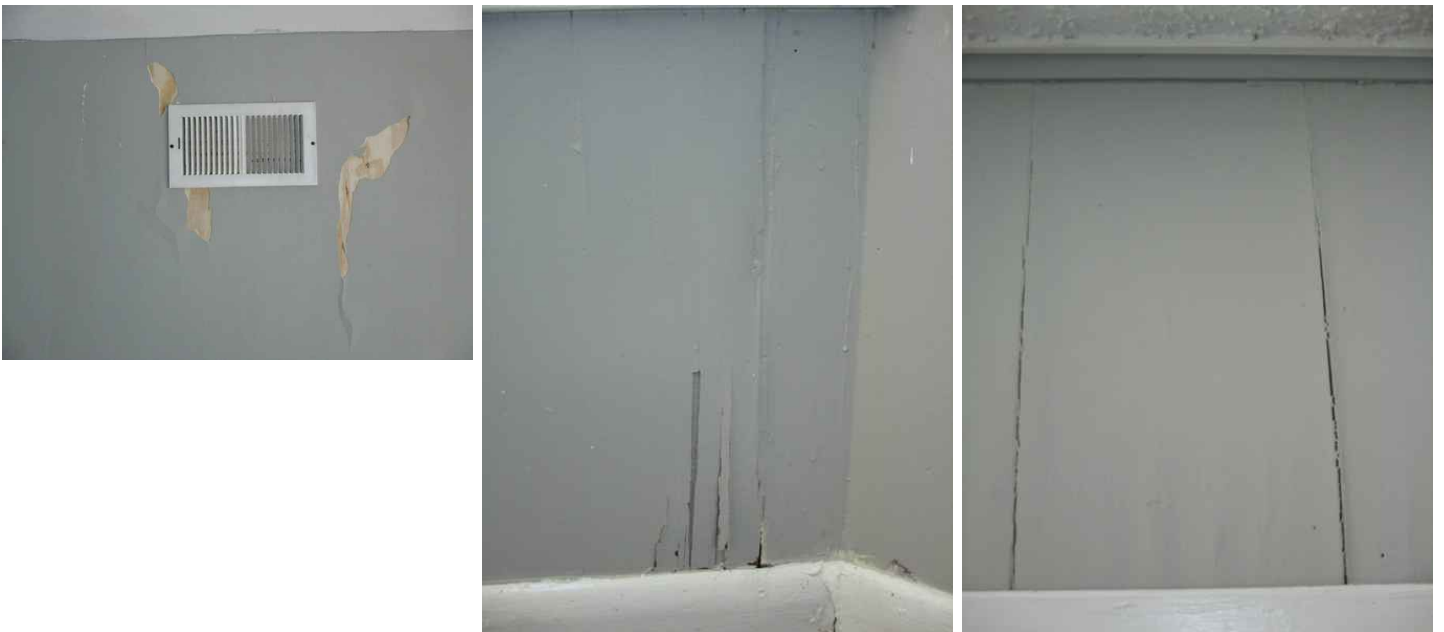
10.4.1 Walls

PAINT CRACKING

Wall paint was cracking in one or more areas. Recommend a qualified painter evaluate and apply a new coat.

Contact a qualified painting contractor.

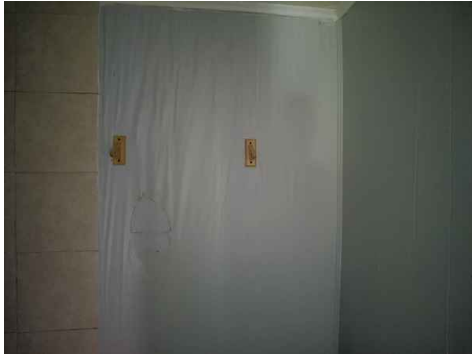
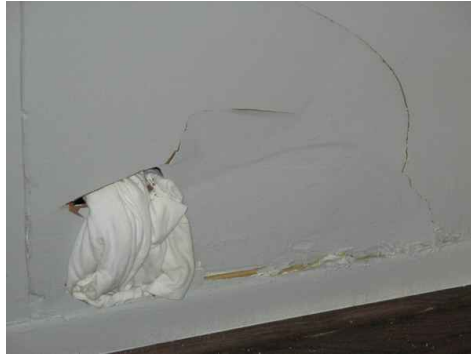
10.4.2 Walls

DAMAGE

Wall damage observed in one or more locations

Contact a qualified professional.

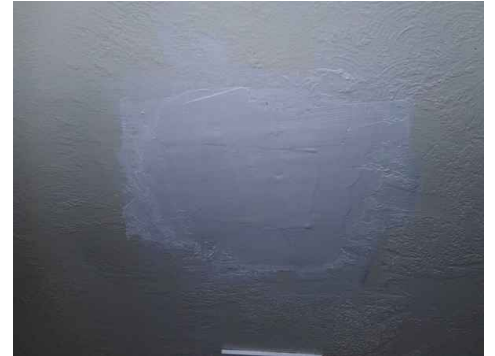
10.5.1 Ceilings

REPAIR

Previous signs of repair.

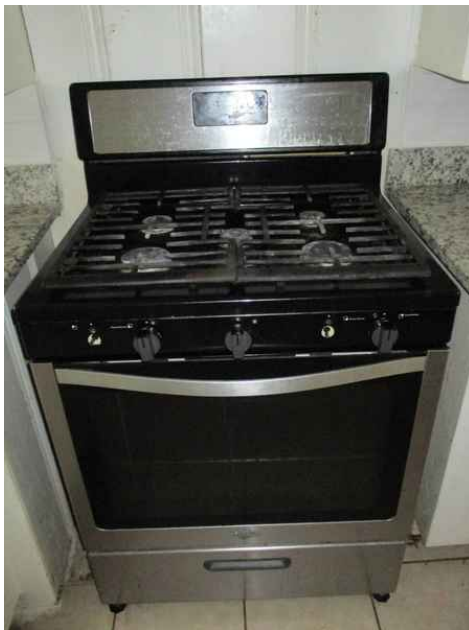
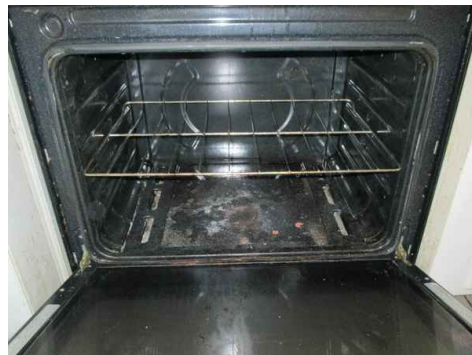
UTILITIES OFF

Note: The gas service was turned off to the structure at the time of this inspection. I was unable to check the gas operation of this component at this time. A limited visual survey will be performed and if any deficiencies are found they will be listed within this section.

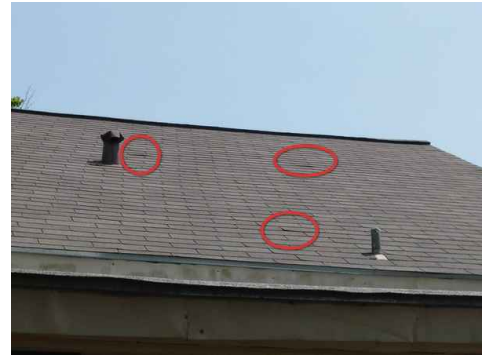
One or more shingles were observed to be lifting.

Contact a qualified roofing professional.

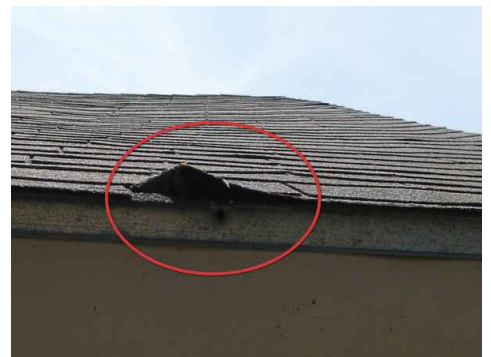
2.1.2 Coverings

DAMAGED SHINGLES

One or more shingles were observed to be damaged.

Contact a qualified roofing professional.

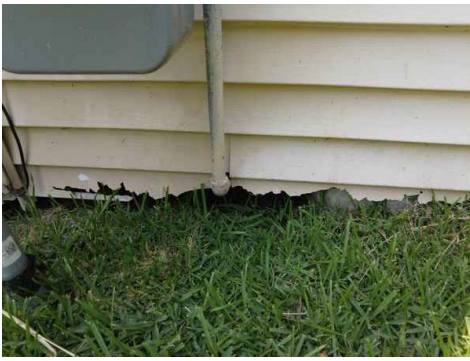
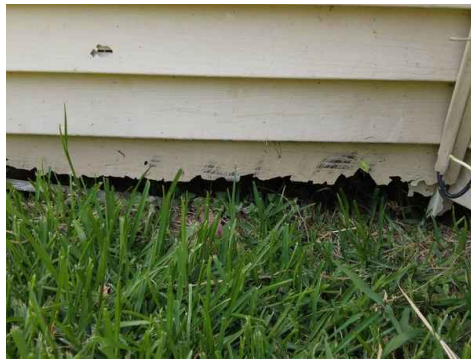
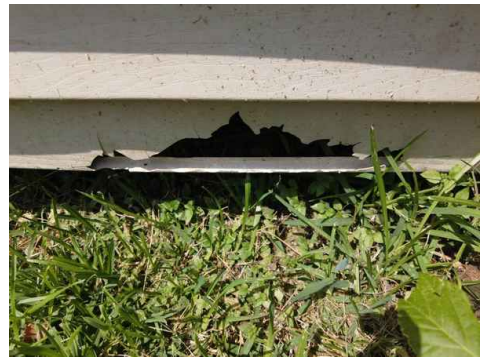
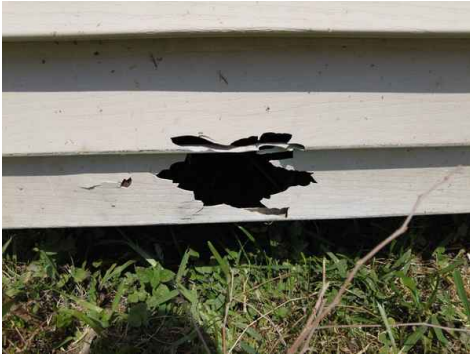
DAMAGED SIDING OBSERVED

Damaged siding observed in one or more locations along the bottom of the exterior walls. Possibly due to contact with lawn care equipment.

Contact a qualified siding specialist.

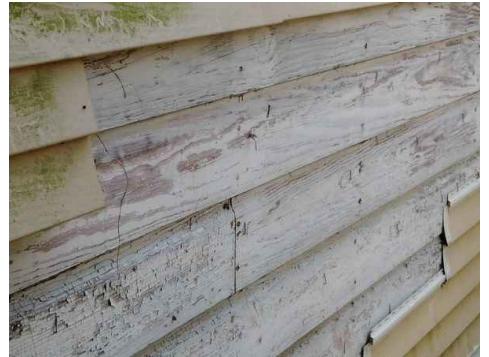
3.1.2 Siding, Flashing & Trim **MISSING SIDING**

A large section of siding is missing on the back side of the garage. The siding should be replaced as soon as possible to prevent further moisture intrusion.

Recommendation
Contact a qualified siding specialist.

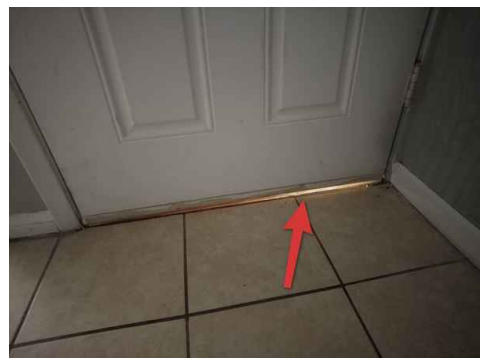
3.2.1 Exterior Doors

WEATHER-STRIPPING IMPROVEMENTS.

Weather-stripping improvements are recommended. There is a visible separation between the floor and the bottom of the door. This could allow moisture or insects to enter the property.

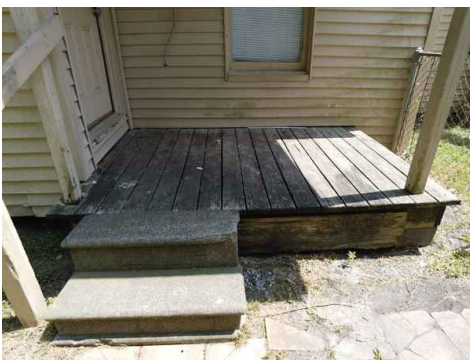
3.4.1 Decks, Balconies, Porches & Steps

DECK - WATER SEALANT REQUIRED

Deck is showing signs of weathering and/or water damage. Recommend water sealant/weatherproofing be applied.

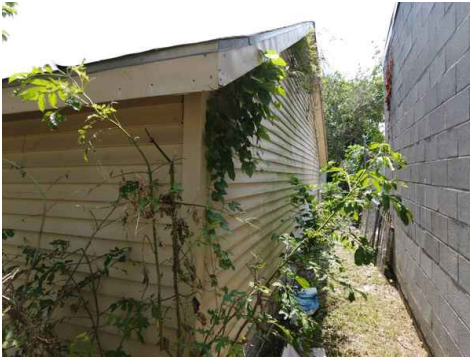
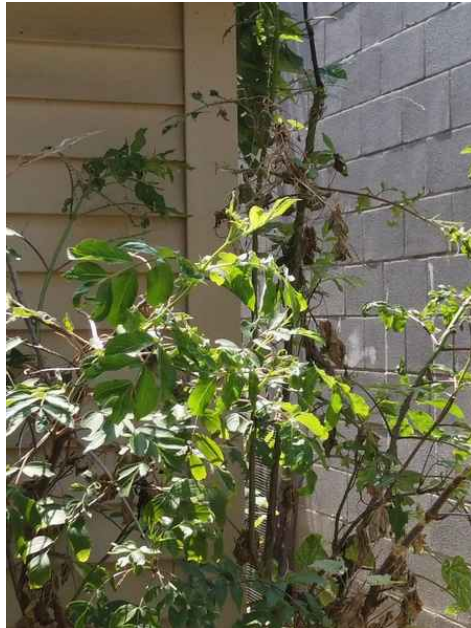
3.6.1 Vegetation, Grading, Drainage & Retaining Walls **VEGETATION IN CONTACT WITH SIDING.**

Vegetation observed to be in contact with the exterior siding in one or more locations. Recommend trees and bushes be cut down or trimmed back so they are not in contact with the siding. This may cause moisture or insect intrusion.

Contact a qualified landscaping contractor

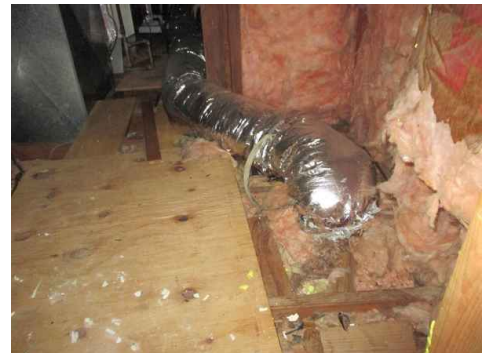
5.3.1 Distribution Systems **SUPPLY DUCT LAYING ON FLOOR**

The duct work in the attic area does not appear to be properly suspended and separated to help prevent condensation from developing. It is recommended to separate and suspend the duct work with supports in minimum intervals of 4-feet that have a minimum width of 1.5-inches.

Contact a qualified heating and cooling contractor

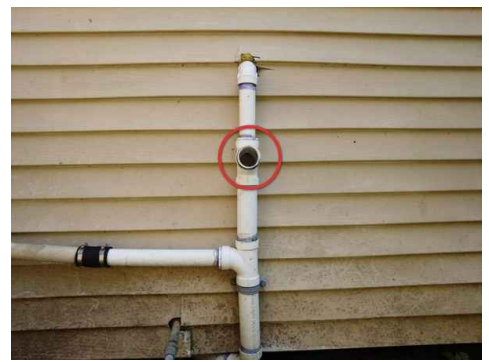
7.2.1 Drain, Waste, & Vent Systems **CLEANOUT COVER IS MISSING.**

The exterior wall cleanout cover is missing. Recommend replacing the cover.

Recommendation
Contact a qualified plumbing contractor.

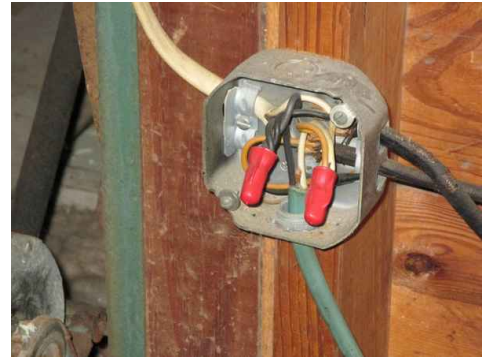
8.4.1 Lighting Fixtures, Switches & Receptacles **OPEN ELECTRICAL JUNCTION BOX**

Open electrical junction box(es) were observed in the attic area. All open junction box(es) in the attic should be properly enclosed.

Recommendation
Contact a qualified electrical contractor.

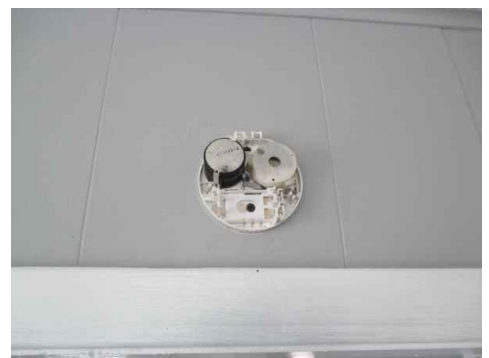
8.6.1 Smoke Detectors **MISSING SMOKE DETECTOR COVER**

One or more smoke detector covers are missing. Recommend replacing cover.

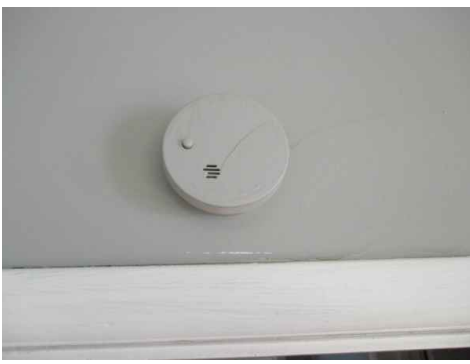
8.6.2 Smoke Detectors **PAINTED SMOKE DETECTOR**

One or more smoke detectors have been painted.

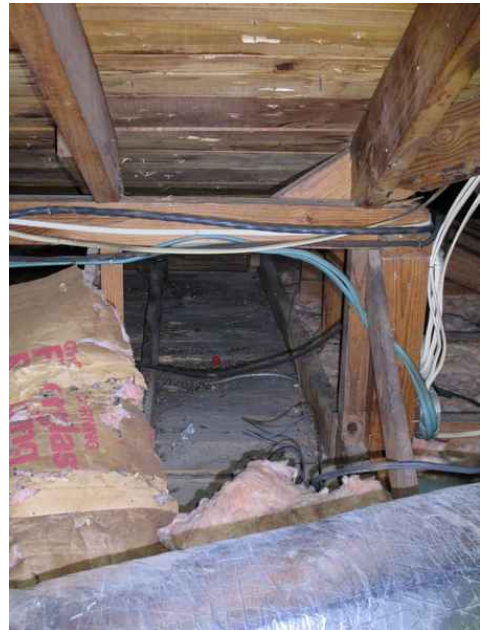
IMPROPER INSTALLATION

Attic insulation was improperly installed. Recommend a qualified insulation contractor evaluate and correct.

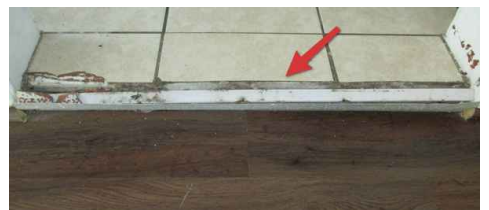
DAMAGED TRANSITION

A damaged transition piece between the kitchen and living room was observed. This could create a tripping hazard. Recommend repairing or replacing as soon as possible.

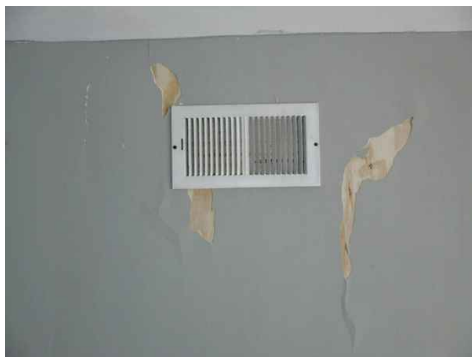
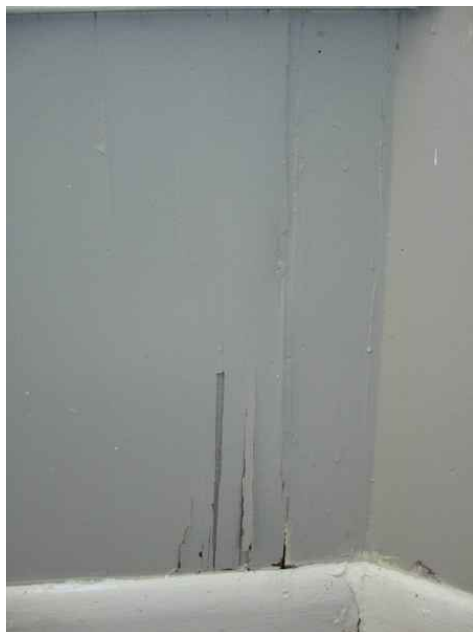
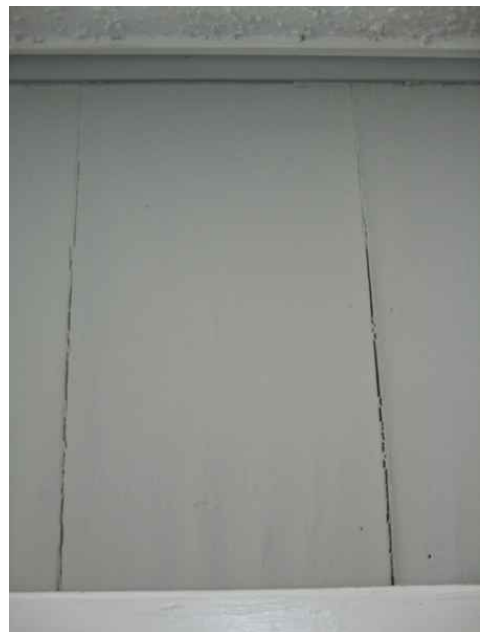
10.4.1 Walls

PAINT CRACKING

Wall paint was cracking in one or more areas. Recommend a qualified painter evaluate and apply a new coat.

Contact a qualified painting contractor.

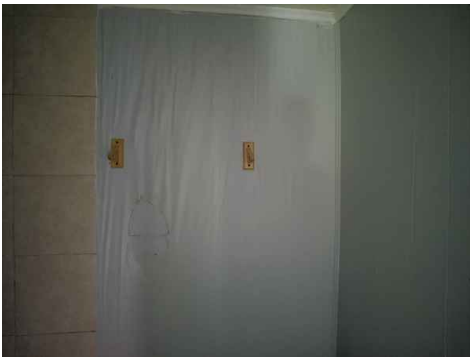
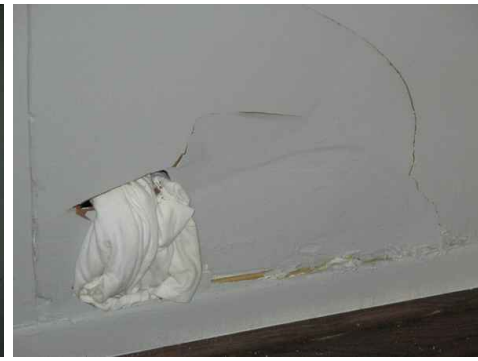
10.4.2 Walls

DAMAGE

Wall damage observed in one or more locations

Contact a qualified professional.

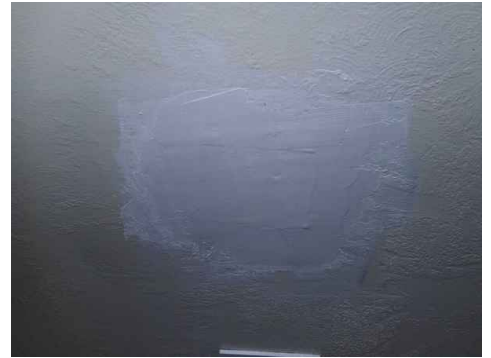
10.5.1 Ceilings

REPAIR

Previous signs of repair.

Contact a qualified professional.
