ADVANCED PROPERTY INSPECTORS PLLC

TREC REI 7-6

### **ADDITIONAL INFORMATION PROVIDED BY INSPECTOR**

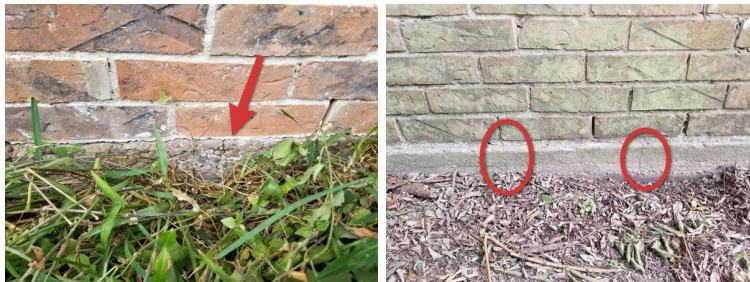
**1: Crack in the foundation wall**

The inspector noted a crack in the foundation wall on the east side of the building.

Recommendation: Contact a qualified professional.

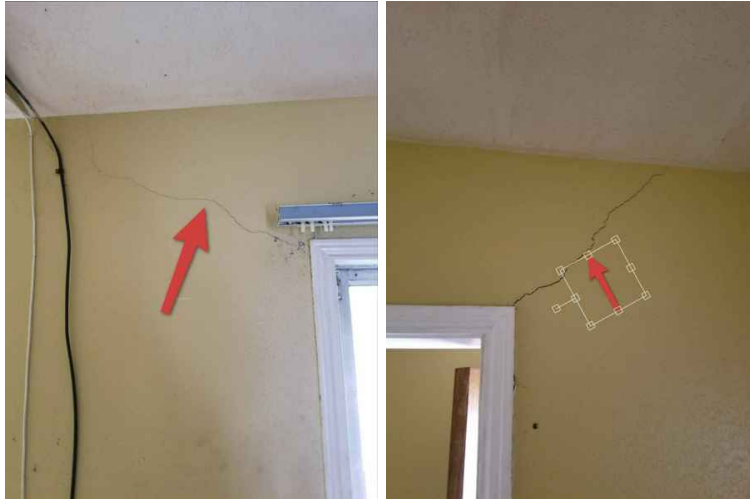
**3: Interior Drywall Cracks**

Interior drywall cracks and/or stress indicators.

Recommendation: Contact a foundation contractor.

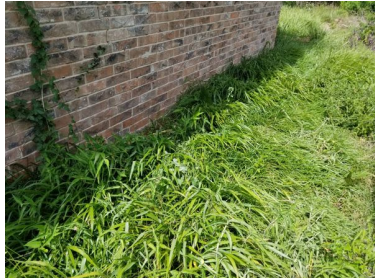
Overgrown vegetation too close to the foundation wall. Recommend cutting and removing all high grass in contact with the foundation wall.

Recommendation: Contact a qualified professional.

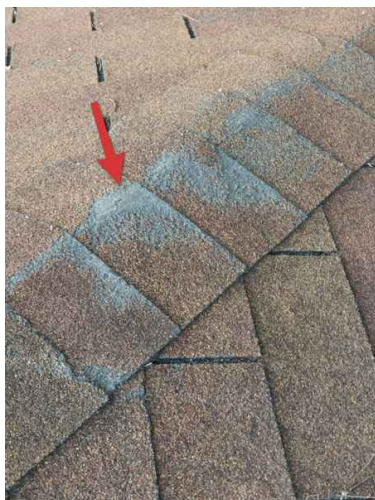
The asphalt shingle roof shows signs of delamination. Delamination is separation of the surface layer of asphalt. Recommend a qualified roofing contractor evaluate and repair to prevent further deterioration that results in leaking and moisture intrusion.

Recommendation: Contact a qualified roofing professional.

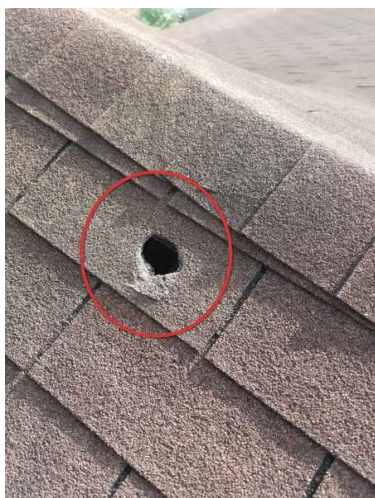
**3: Hole**

There is a hole in the roof covering. Recommend a qualified roof contractor repair or replace the roof covering to prevent moisture, rodent, and insect intrusion.

Recommendation: Contact a qualified roofing professional.

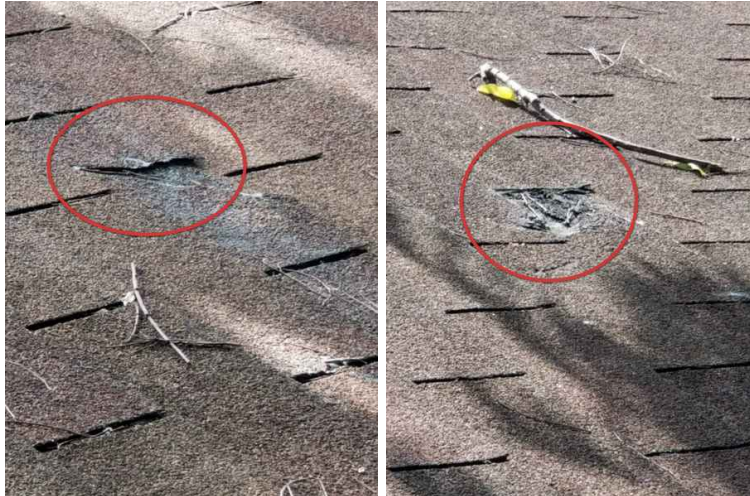
**4: Tiles Cracked/Broken**

Roof had cracked/broken tiles. Recommend a qualified roof contractor repair or replace to prevent moisture intrusion and/or mold.

Recommendation: Contact a qualified roofing professional.

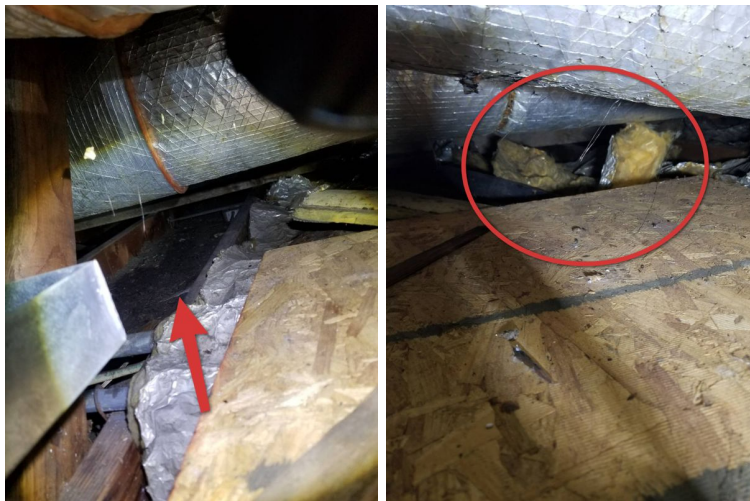
**1: Damaged or Missing Insulation**

The attic insulation appears to either be missing or damaged in one or more places.

Recommendation: Contact a qualified professional.

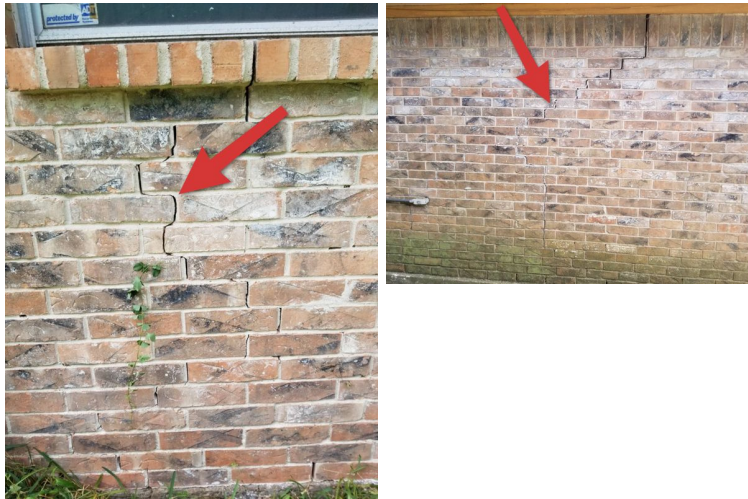
**1: Cracks - Major**

Major cracking observed in the exterior wall structure. This could be from moisture intrusion at the structure and/or soil movement. Recommend a qualified structural engineer evaluate and advise on course of action.

Recommendation: Contact a qualified structural engineer.

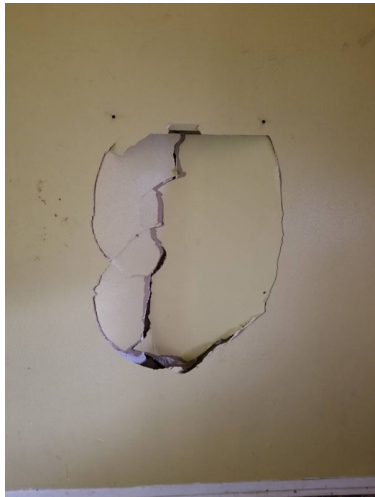
### 2: Hole In The Wall

Large hole in the wall located behind the front door.

Recommendation: Contact a qualified professional.

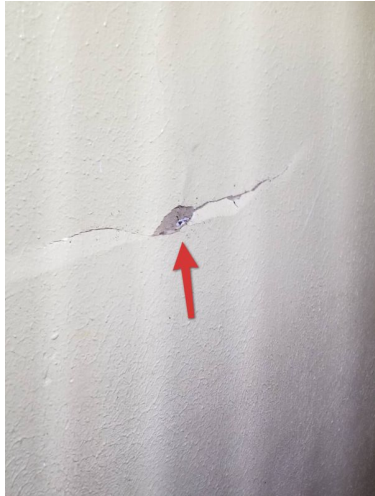
### 3: Wall damage

Wall damage observed on the wall in the main hallway

Recommendation: Contact a qualified professional.

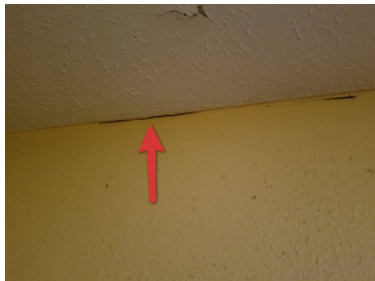
#### 4: Caulking Improvements Needed

Caulking improvements are needed in one or more place on the interior walls.

Recommendation: Contact a qualified professional.

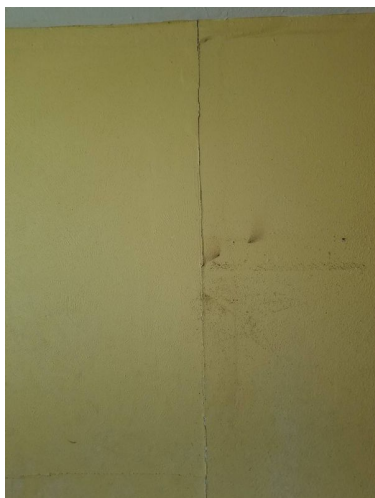
#### 5: Tape Joints

Cracks in the tape joints observed in one or more bedrooms.

Recommendation: Contact a qualified professional.

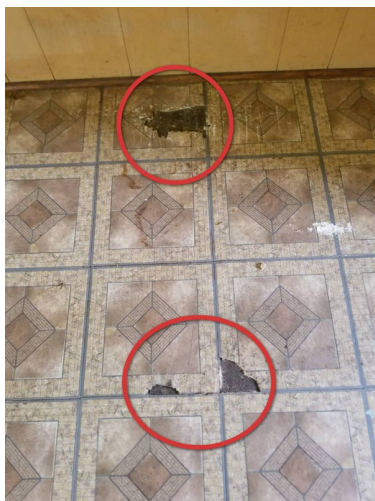
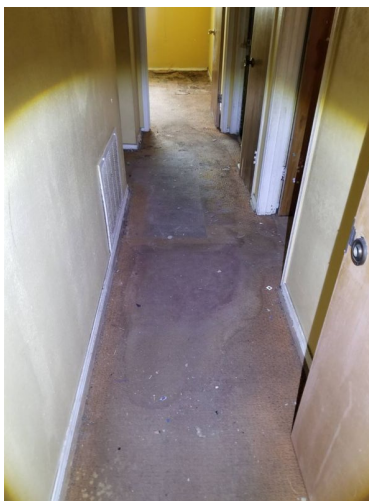
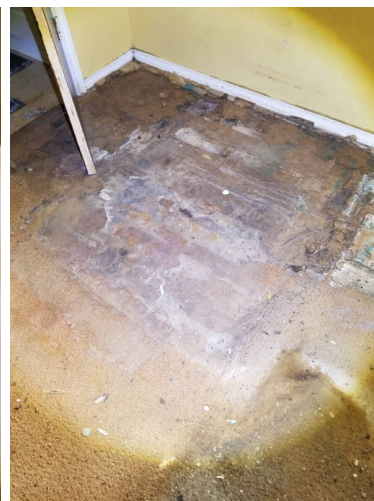
**1: Flooring - Severe Wear**

Floors have severe surface wear in many areas. Recommend a qualified flooring contractor evaluate & remedy.

Recommendation: Contact a qualified professional.

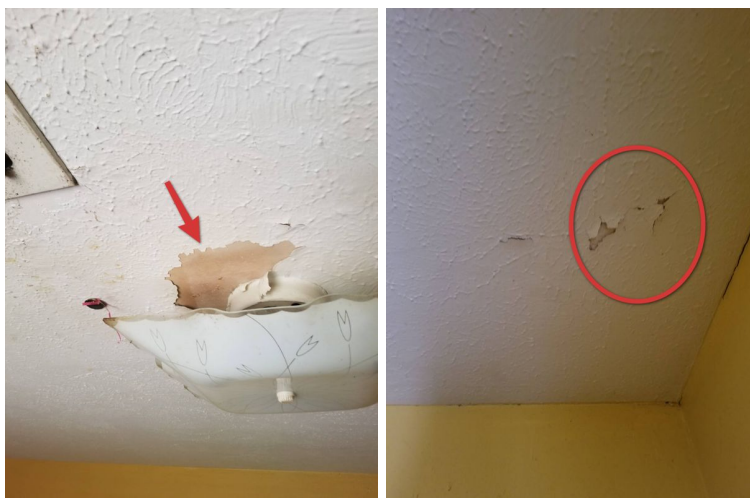
**3: Worn Ceiling Finish**

Ceiling finish is chipped or worn away in one or more places. Recommend repainting ceiling to help protect and preserved ceiling material.

Recommendation: Contact a qualified professional.

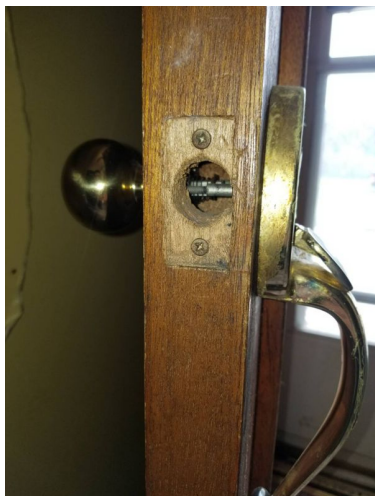
Door doesn't latch properly. Recommend handyman repair latch and/or strike plate.

Recommendation: Contact a qualified handyman.

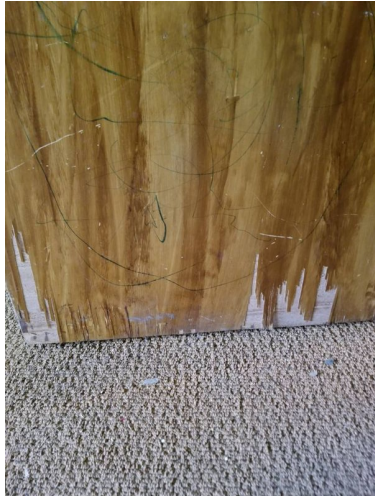
**2: Paint/Refinish Needed**

Door finish is worn. Recommend refinish and/or paint to maximize service life.

Recommendation: Recommended DIY Project

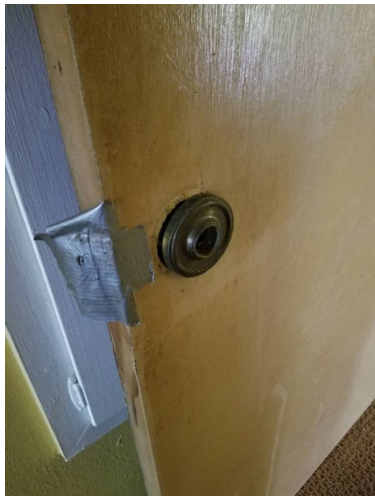
**3: Missing Door Knob**

The door knob is missing to the main hallway door.

Recommendation: Contact a qualified professional.

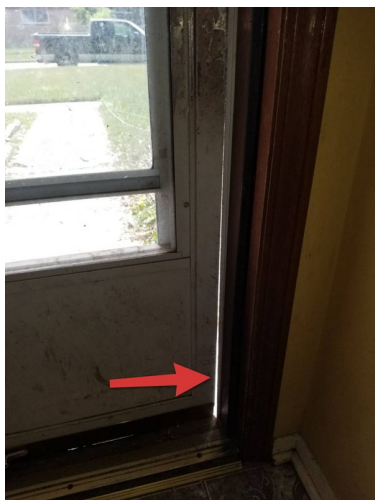
**4: Noticeable Gap**

Noticeable Gap in screen door. Door doesn't appear to sit square in the frame. Recommend having a handyman repair door.

Recommendation: Contact a qualified professional.

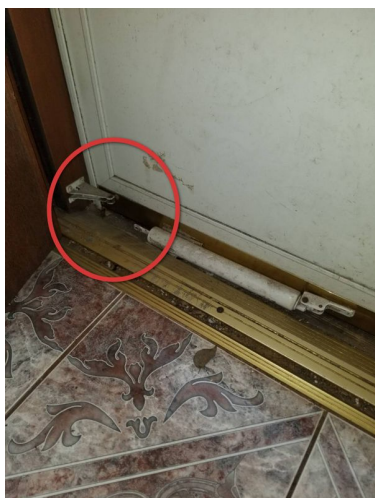
**5: Self Closing Henge**

The self closing henge on the front screen door is not connect to the door frame.

Recommendation: Contact a qualified professional.

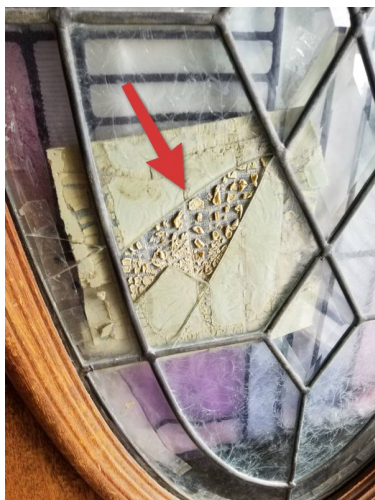
**6: Broken Glass Panle on Front Door**

Broken glass panle on the front door was observed. This is a safety hazard and should be replace immediately.

Recommendation: Contact a qualified professional.

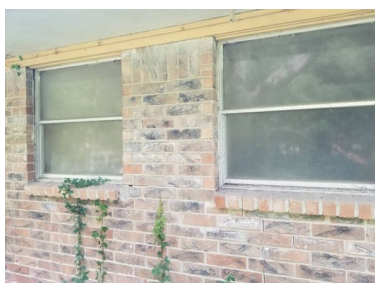
**1: Missing Screen(s)**

One or more windows are missing a screen. Recommend replacement.

Recommendation: Contact a qualified window repair/installation contractor.

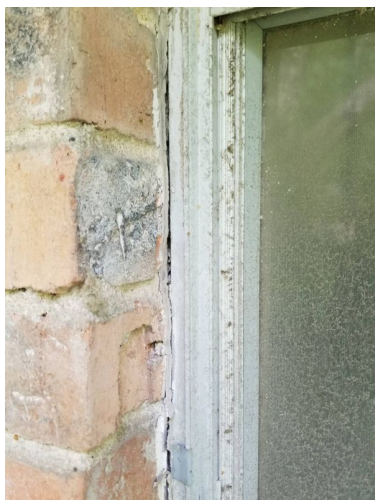
**2: Caulking Improvements Needed**

Caulking/sealing improvements are needed around one more more windows. Recommend repairing. Caulking helps keep moisture and insects out of the home.

Recommendation: Contact a qualified professional.

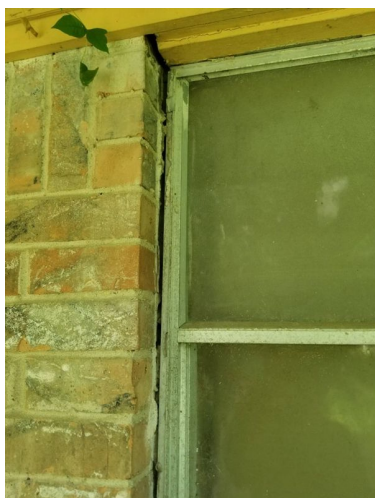
**3: Large Separation**

Large separation observed at one or more windows.

Recommendation: Contact a qualified professional.

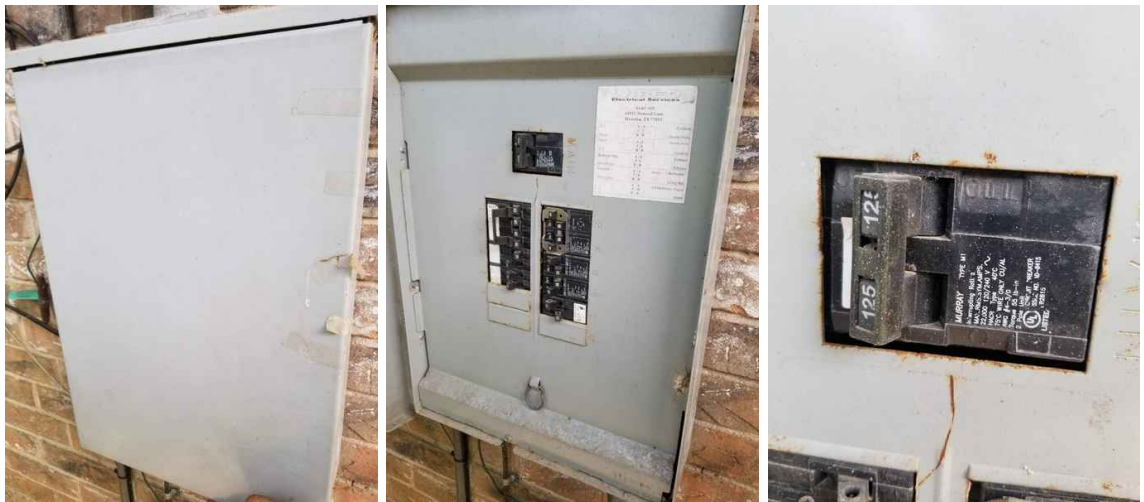
Panel Box

The buyer should have the electrical system checked by a Qualified Licensed Electrician. The observations made to support the rendering of this opinion are listed but not limited to the following:

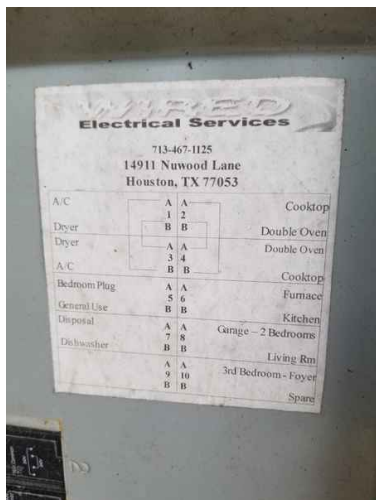
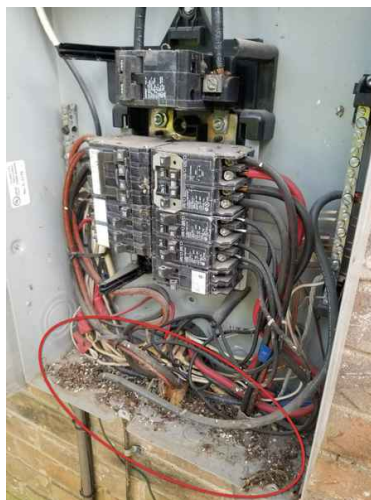
Dirt/Debris

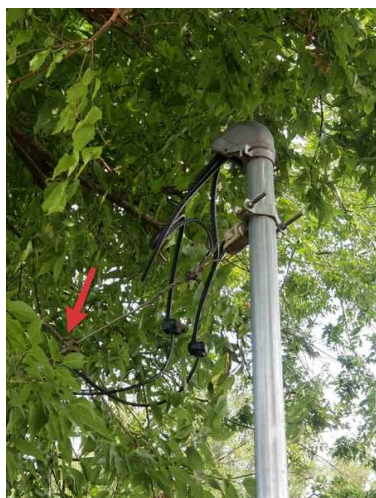
**1: Tree Limbs**

Tree limbs are too close or are touching the service entrance conductors. Recommend trimming all trees they come in contact with the service entrance conductors.

Recommendation: Contact a qualified lawn care professional.

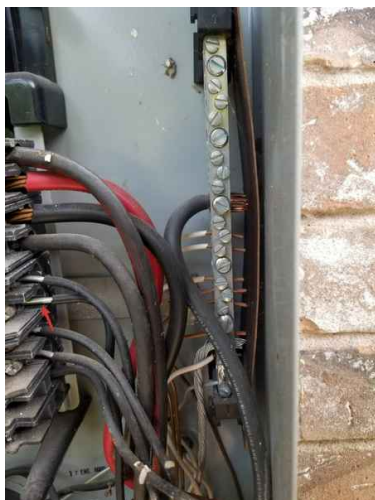
**2: Anti-oxidant Gel**

There was no anti-oxidant gel observed on the exposed aluminum conductor terminations.

Recommendation: Contact a qualified electrical contractor.

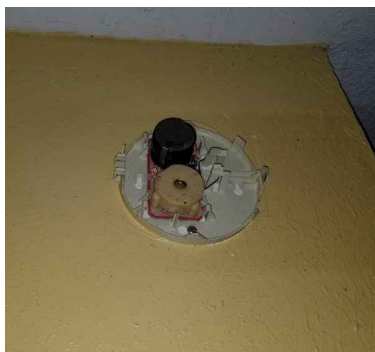
**4: Smoke Detector Cover Missing**

One or more smoke detectors is missing it's cover.

Note: The smoke detectors in place at the time of inspection are older. It is recommended to replace the older smoke alarms for reasons of safety.

Recommendation: Contact a qualified professional.

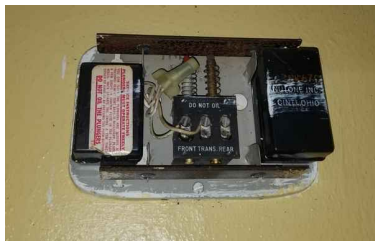
**5: Doorbell Chime Cover Missing.**

The doorbell chime cover was observed to be missing.

Recommendation: Contact a qualified professional.

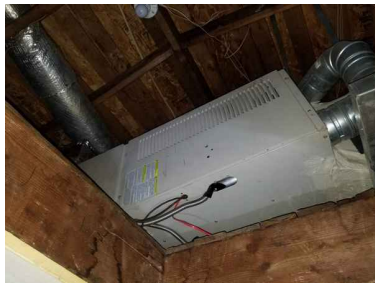
**1: Gas Supply Sediment Trap**

The heater gas supply line is not equipped with a sediment trap just before the gas appliance connector. This condition does not meet current installation requirements and should be corrected.

Recommendation: Contact a qualified plumbing contractor.

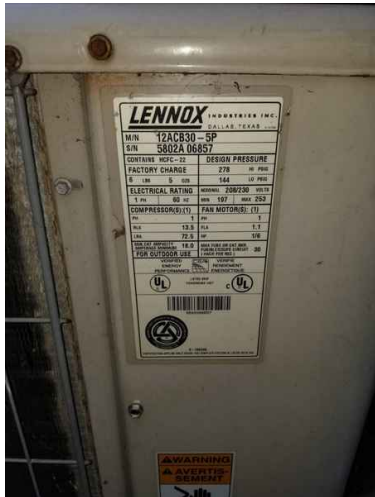
**1: System Requires Cleaning**

The HVAC system needs to be checked and serviced by a Qualified / Licensed HVAC Technician. The observations made to support the rendering of this opinion are listed but may not be limited to the following:

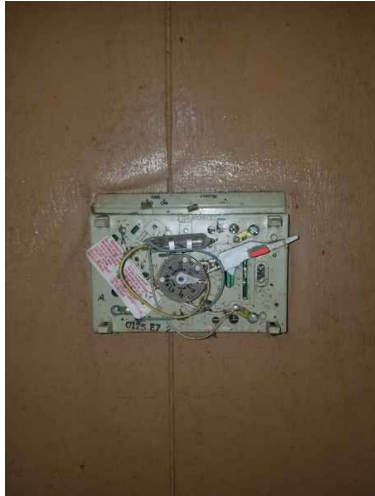
**3: Thermostat cover is damaged and/or missing.**

The thermostat cover is damaged and/or missing.

Recommendation: Contact a qualified HVAC professional.

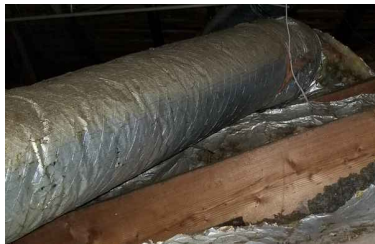
The duct work in the attic area does not appear to be properly suspended and separated to help prevent condensation from developing. It is recommended to separate and suspend the duct work with supports in minimum intervals of 4-feet that have a minimum width of 1.5-inches.

Recommendation: Contact a qualified professional.

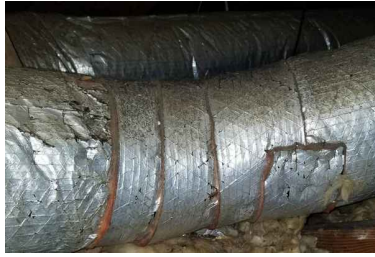
**2: Attic Ductwork Damaged**

Some of the attic area ductwork was observed to be damaged. This condition should be further evaluated and corrected as necessary.

Recommendation: Contact a qualified HVAC professional.

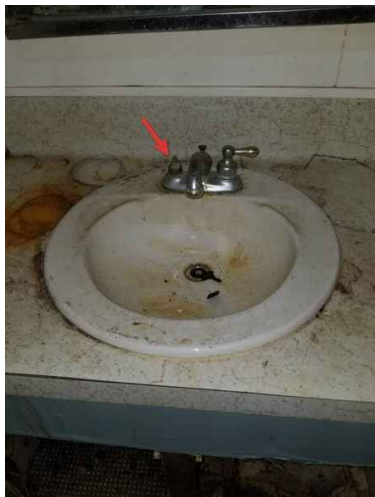
**2: Faucet Handle Damaged.**

The faucet handle is damaged or broken.

Recommendation: Contact a qualified plumbing contractor.

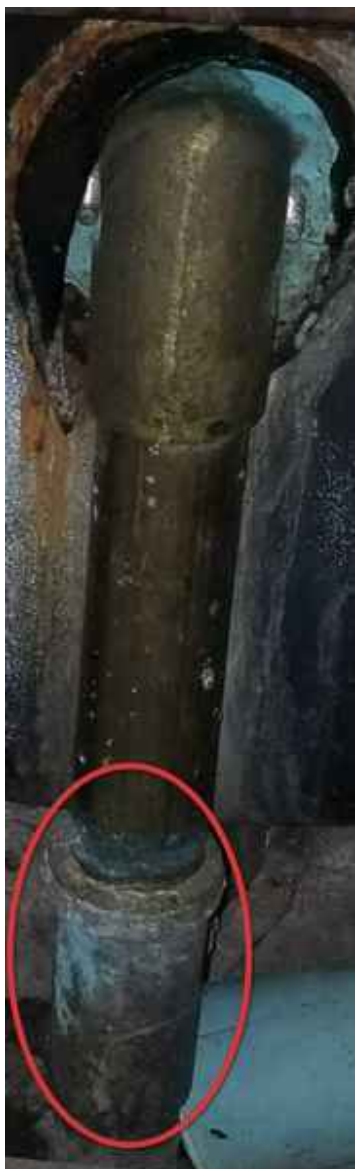
**1: Visible Rust or Corrosion**

The plumbing system has visible rust and corrosion on the exterior surfaces of the piping system. This is a good indicator that failures may occur in the near future. Further evaluation of the plumbing system is recommended.

Recommendation: Contact a qualified plumbing contractor.

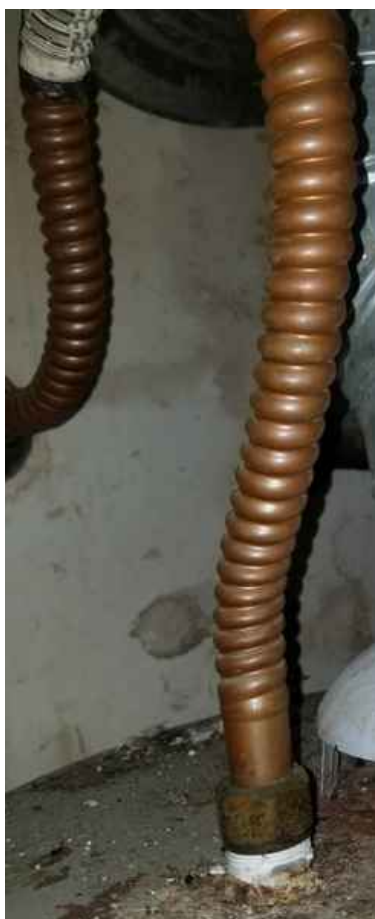
There is no shut off valve on the cold water supply line to the water heater. It is suggested that one be installed the next time the water heater is replaced.

Recommendation: Contact a qualified plumbing contractor.

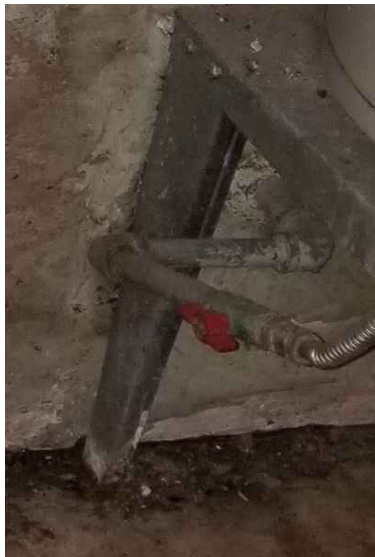
The water heater gas supply line is not equipped with a sediment trap just before the gas appliance connector. This condition does not meet current installation requirements and should be corrected.

Recommendation: Contact a qualified plumbing contractor.

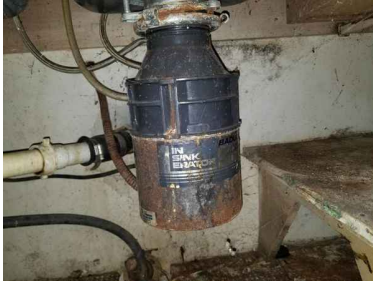
The disposer appears to have reached the end of its serviceable life expectancy.

Recommendation: Contact a qualified plumbing contractor.
