Waterford Waterway

Racine County, Wisconsin

Comprehensive Management Plan

February 2020

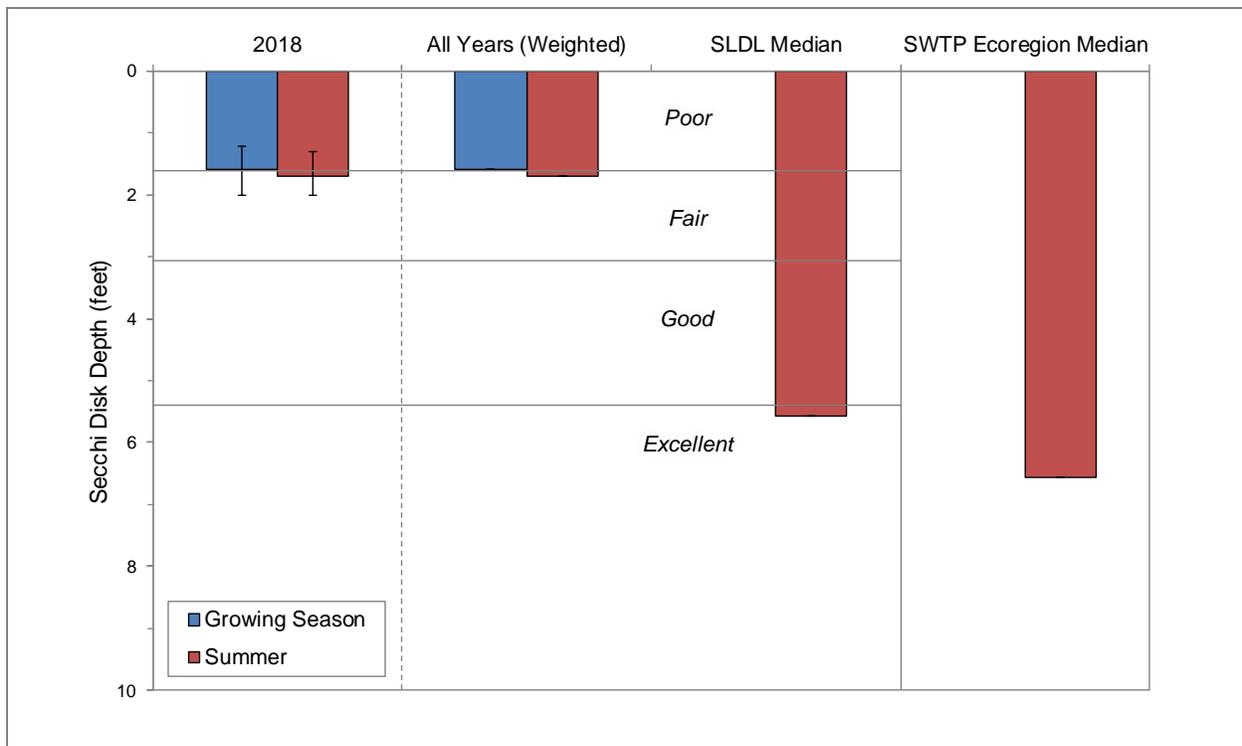
Figure 3.1-12. Secchi disc transparency depths in Waterford Lake, state-wide shallow lowland drainage lakes, and regional lakes. Mean values calculated with summer month surface sample data. Water Quality Index values adapted from WDNR PUB WT-913.

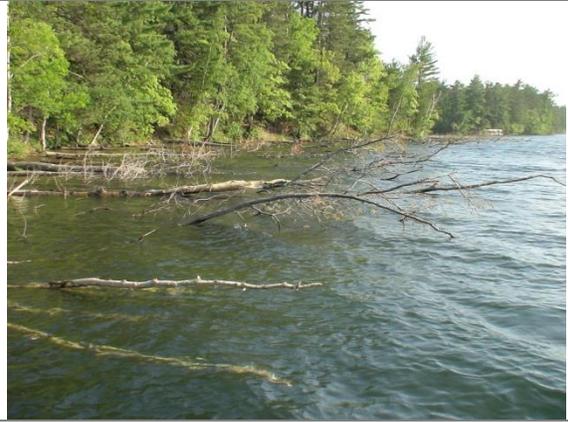
Photograph 3.3-1. Example of coarse woody habitat in a lake.

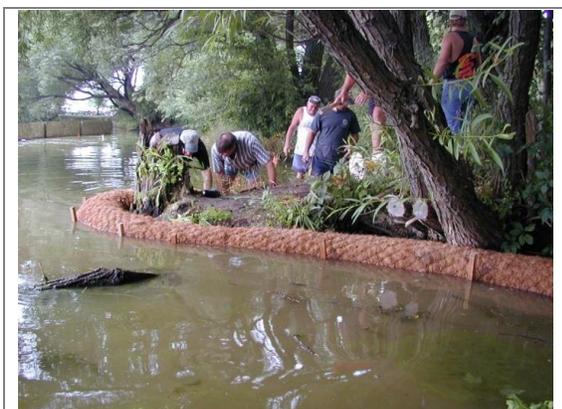
Photograph 3.3-2. Example of a biolog restoration site.

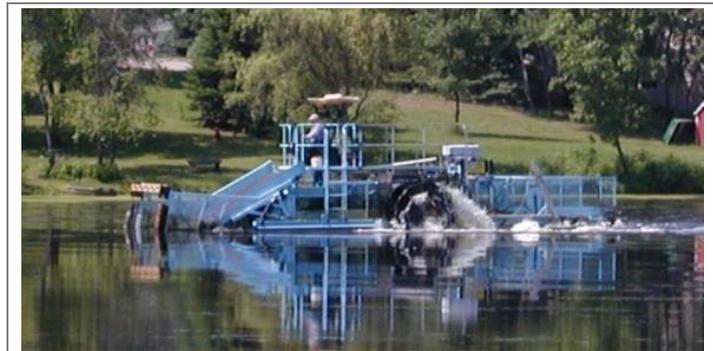
Aquatic plant harvesting is frequently used in Wisconsin and involves the cutting and removal of plants much like mowing and bagging a lawn. Harvesters are produced in many sizes that can cut to depths ranging from 3 to 6 feet with cutting widths of 4 to 10 feet. Plant harvesting speeds vary with the size of the harvester, density and types of plants, and the distance to the off-loading area. Equipment requirements

Photograph 3.4-3. Mechanical harvester.

do not end with the harvester. In addition to the harvester, a shore-conveyor would be required to transfer plant material from the harvester to a dump truck for transport to a landfill or compost site. Furthermore, if off-loading sites are limited and/or the lake is large, a transport barge may be needed to move the harvested plants from the harvester to the shore in order to cut back on the time that the harvester spends traveling to the shore conveyor. Some lake organizations contract to have nuisance plants harvested, while others choose to purchase their own equipment. If the latter route is chosen, it is especially important for the lake group to be very organized and realize that there is a great deal of work and expense involved with the purchase, operation, maintenance, and storage of an aquatic plant harvester. In either case, planning is very important to minimize environmental effects and maximize benefits.

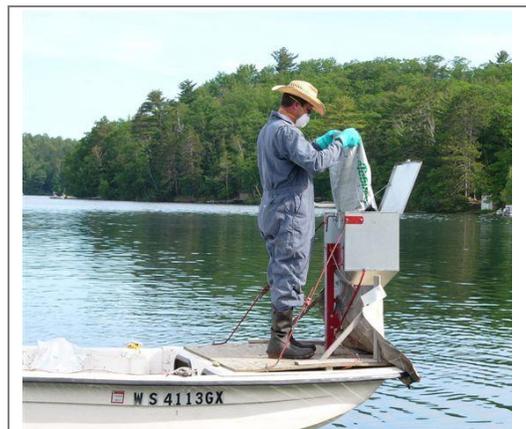
Photograph 3.4-4. Granular herbicide application.

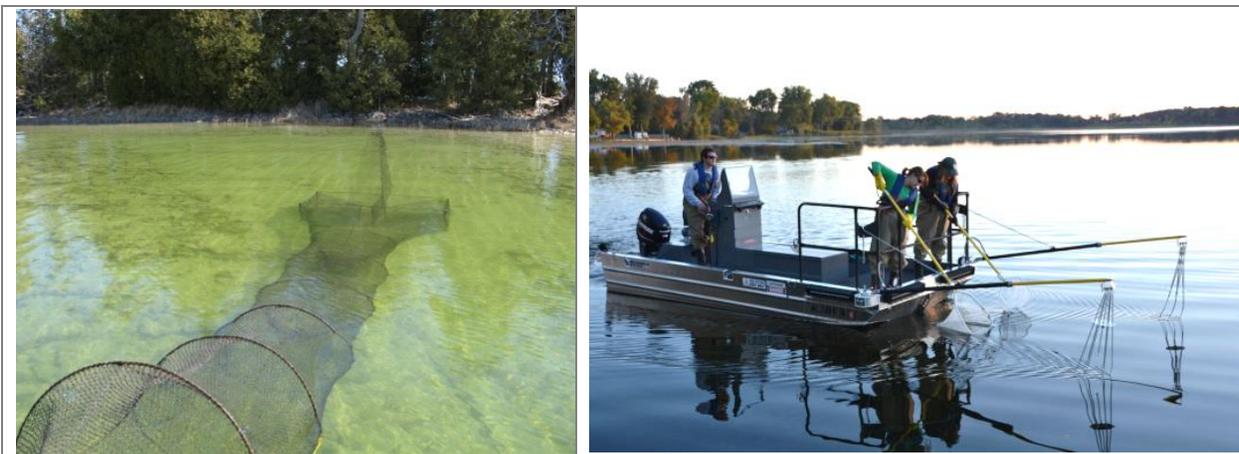
Photograph 3.6-1. Fyke net positioned in the littoral zone of a Wisconsin Lake (left) and an electroshocking boat (right).

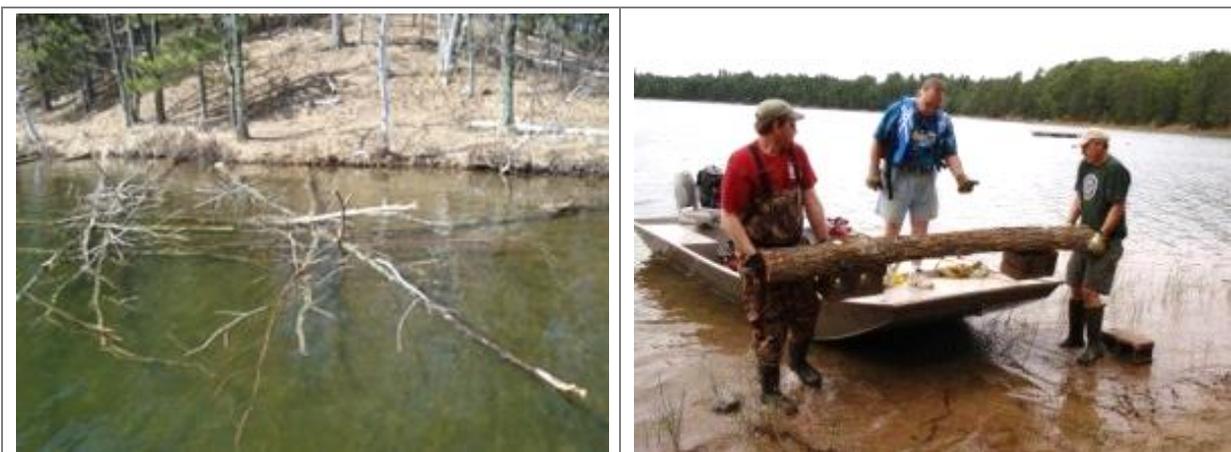
Photograph 3.6-3. Examples of fish sticks (left) and half-log habitat structures. (Photos by WDNR)
