2021 Eurasian Watermilfoil Delineation Survey

Lake Shamineau (#49-0127) Morrison County, MN

Surveyed September 9, 2021

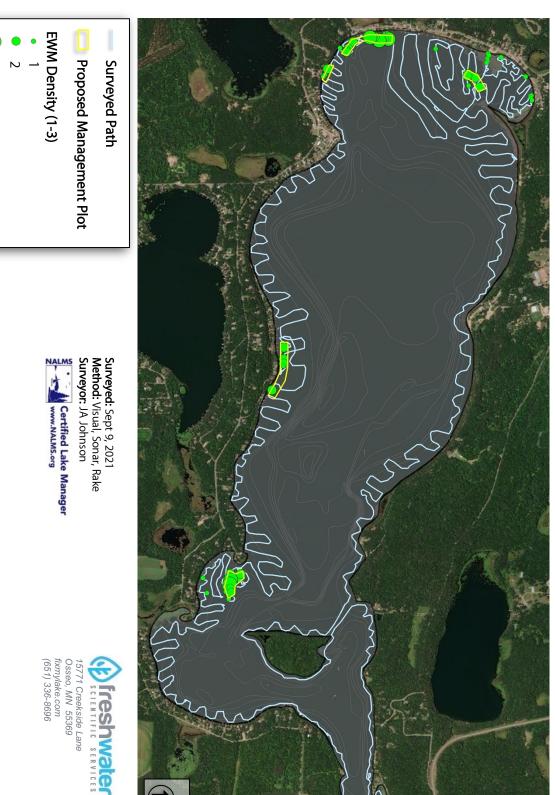
Lake Shamineau (#49-0127) 2021 Eurasian Watermilfoil Delineation Survey

Previously managed areas of EWM appear to be well controlled. However, we found several locations where the EWM density warrants treatment with herbicide. In particular, we found two new areas along the southern shore where EWM has established patches of denser growth. We have marked these areas for potential treatment and highly recommend treating these areas in the fall of 2021 to limit spread and minimize any herbicide damage to lilies and bulrush in the vicinity of plot 4.

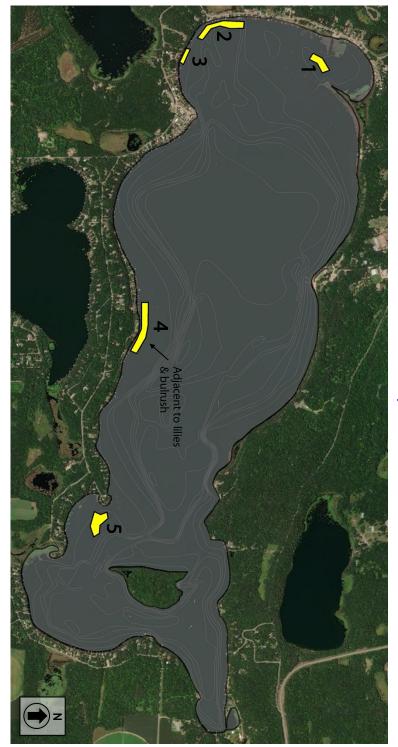
Lake Shamineau (#49-0127) 2021 Eurasian Watermilfoil Delineation Survey

Prop
osed Plots

Plot	Area (acres)	Avg Depth	EWM Density
_	2.0	5.4	1.7
2	3.7	7.6	2.4
ω	0.8	4.4	1.3
4	4.4	5.0	1.7
5	3.1	9.3	2.0

Total 14.0 acres

Surveyed: Sept 9, 2021 Method: Visual, Sonar, Rake Surveyor: JA Johnson

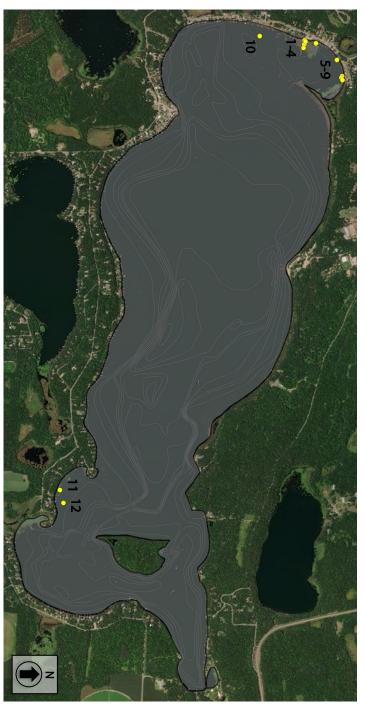
2021 Eurasian Watermilfoil Hand-Pull Locations Lake Shamineau (#49-0127)

0 **Hand-Pull Sites**

Point	Lat	Long	Depth
1	46.262140	-94.632240	3.0
2	46.262191	-94.632128	4.9
3	46.262121	-94.631842	4.6
4	46.262074	-94.631486	5.2
5	46.262914	-94.631962	4.3
6	46.264386	-94.630375	3.6
7	46.264757	-94.628764	3.9
8	46.264713	-94.628618	5.2
9	46.264790	-94.628394	3.9
10	46.259048	-94.632578	5.2
11	46.245970	-94.587259	4.9
12	46.246232	-94.585986	8.8

Surveyed: Sept 9, 2021 Method: Visual, Sonar, Rake Surveyor: JA Johnson

We have also included a map and table of potential hand-pull locations where only a few solitary EWM plants were found.
