Pool Inspection Report

On 7/1/2020

For the Property Located at: 1234 Main St. Bethesda Md 20817

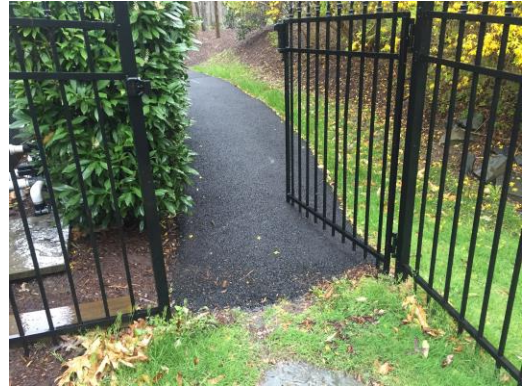
FENCE – GATE – BARRIERS:

OBSERVATIONS: The gates are not self-closing and or self-latching.
The house is the 4th wall of the fence and all the doors leading to the house do not have door alarms.
The fence gates needs repair to be an appropriate barrier to entry

RECOMMENDATIONS: The gates should be repaired and equipped with hardware to make them self-closing and latching.
Door alarms should be installed to protect the pool area from entry by young children.
Repair the fence gates to be an appropriate barrier

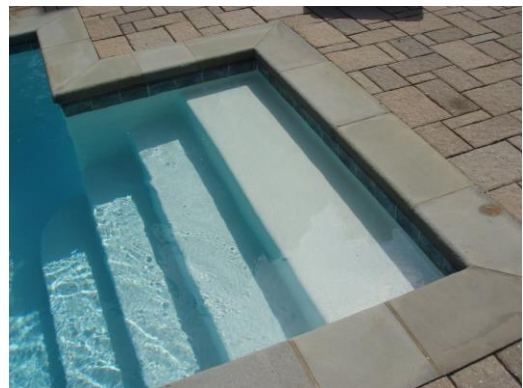
COPING - TILE:

OBSERVATIONS: The tile are in ok condition
23 feet of the coping stones are hollow.

RECOMMENDATIONS:
The coping should be repaired in the future as listed

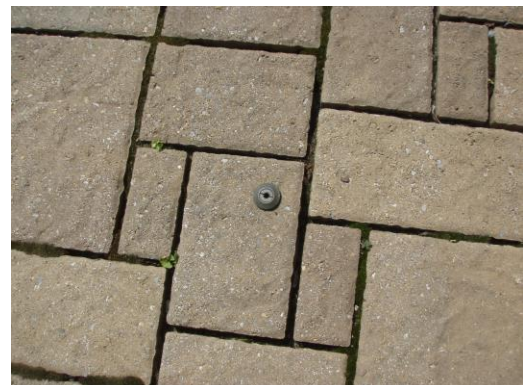
DECKING:

OBSERVATIONS: The deck is in ok condition

RECOMMENDATIONS:
Pressure washing and bleach will help remove moss

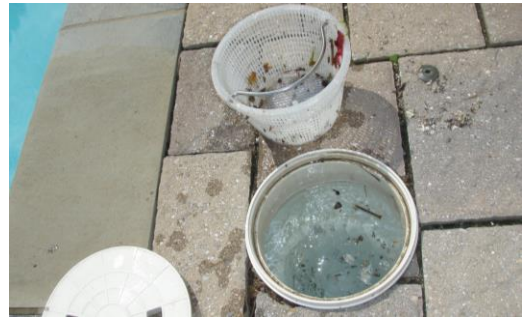
SKIMMER - WEIRS - BASKETS:

OBSERVATIONS: The skimmers were ok
The skimmer basket is cracked and should be replaced

RECOMMENDATIONS: Replace skimmer basket with a B-9 basket or equivalent

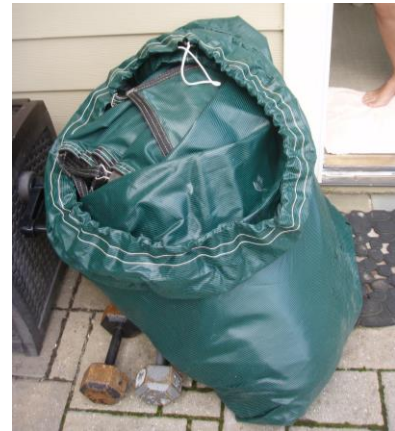
WINTER COVER - DECK HARDWARE:

OBSERVATIONS: The winter cover is in fair condition given its age

RECOMMENDATIONS: None
Do not store a mesh cover in a shed or garage on the ground. Mice will nest in the cover and eat the cover causing substantial damage.

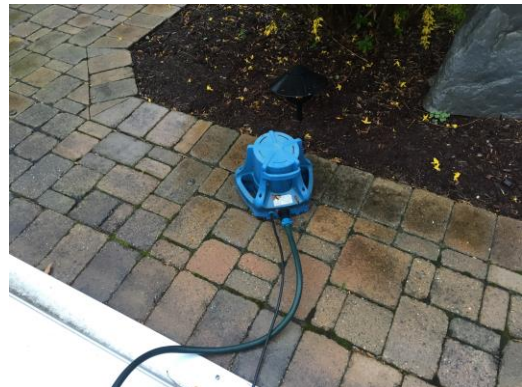
COVER PUMP:

OBSERVATIONS: The cover pump was in good condition.
located.

A submersible pump is used to remove the accumulation of rainwater from the pool to maintain the water level below the skimmer and tile, during the freezing times of the winter. It can be placed on the second step and turned on as needed unless it is the automatic type.

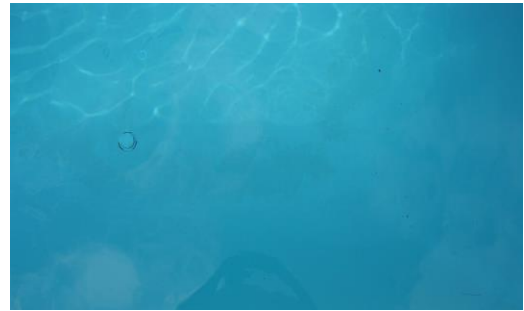
FINISH - SURFACE:

The plaster is in ok condition and is relatively smooth to the touch given its age.

The plaster shows some light staining to the surface in the deep end

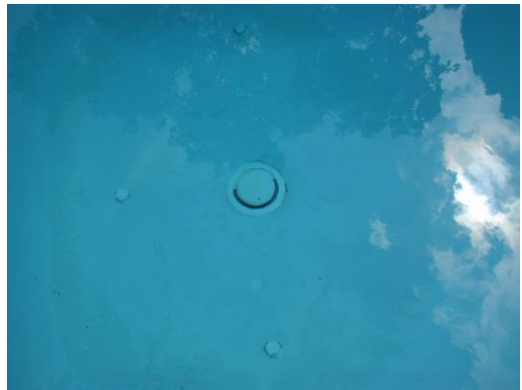
MAIN DRAIN(S) - SUCTION FITTINGS:

OBSERVATIONS: The drain covers look to be VGB compliant.

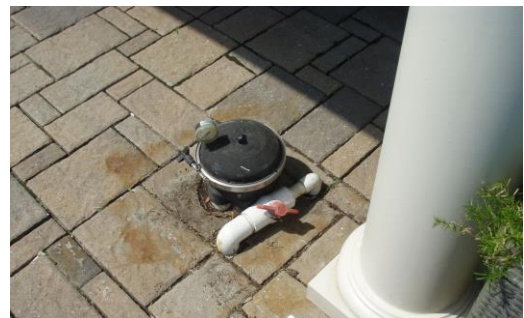
IN-FLOOR CLEANING SYSTEM:

OBSERVATIONS: The cleaning system seems to be working properly.

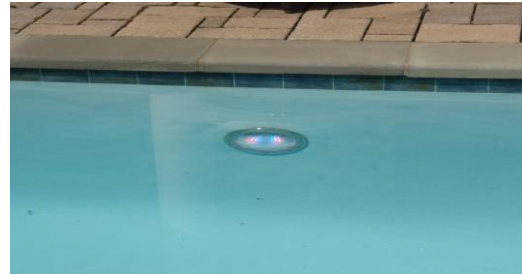
UNDERWATER LIGHTS:

OBSERVATIONS: The pool light was working properly. It is a color changing LED type light

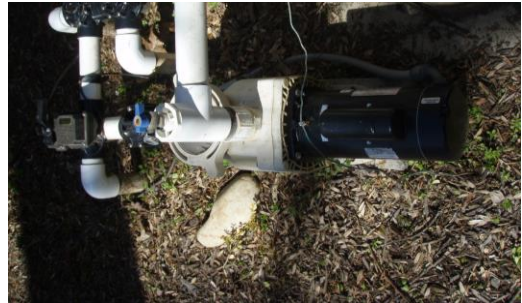
PUMP(S) – MOTOR(S):

OBSERVATIONS: The pump is working properly. Some corrosion on the motor is visible.

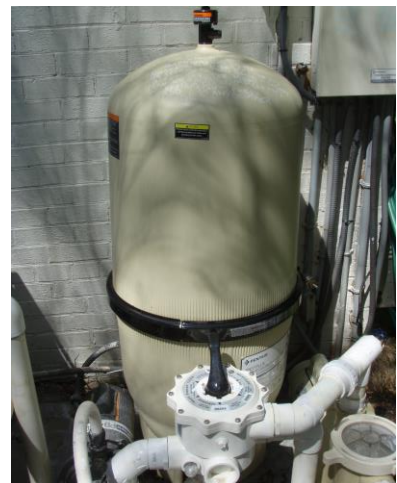
FILTER:

TYPE: DE SIZE: __ FNS 60 __

OBSERVATIONS: The filter is working properly.

RECOMMENDATIONS: None, Clean pressure is 16
The filter should be cleaned or backwashed when the pressure on the gauge increases 10 PSI over the clean starting pressure

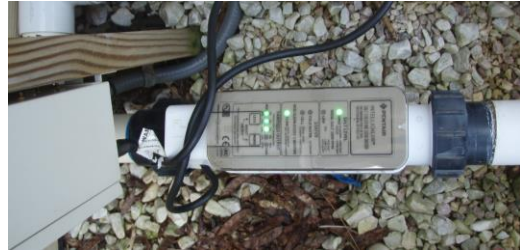
CHLORINE GENERATOR:

OBSERVATIONS: The Generator seems to be operating properly

The cell should be inspected monthly and chemically cleaned as needed.

The expected life of a cell is about 5 years so replacement may be needed soon.

Adjust the output on the unit based on your water test results and bather load.

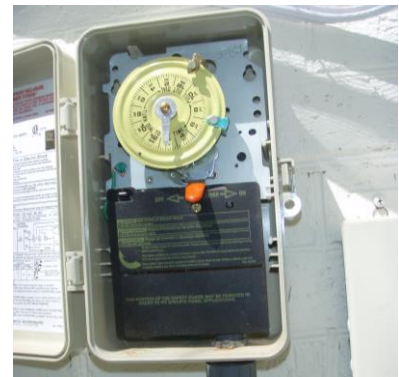
TIMER(S) - CONTROLLER:

OBSERVATIONS: The timer is in good condition.

Adjust time setting as needed. The pool should run 8-12 hours per day for proper filtration.

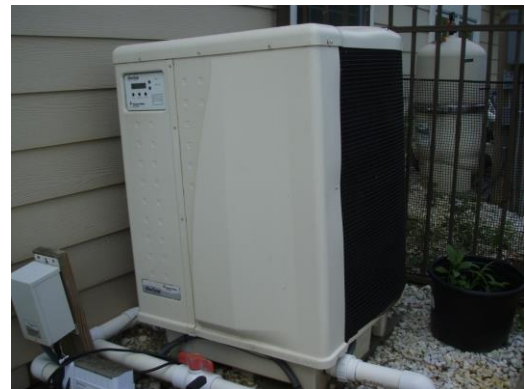
HEATER(S):

OBSERVATIONS: The heater was working properly. The heater raised the pool water temperature 2 degrees during the inspection.

RECOMMENDATIONS: None. Heat pumps on pools will condensate during running. This is normal and expected

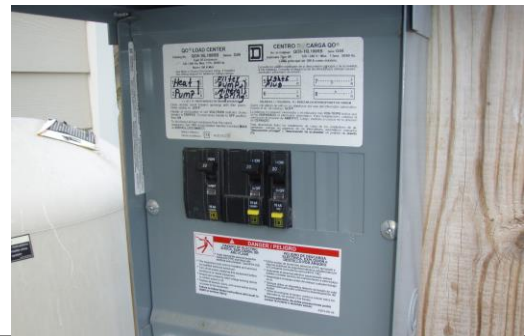
ELECTRICAL SYSTEM AND BONDING:

OBSERVATIONS: The Bonding wire is connected to the system components correctly
The GFCI is testing properly

RECOMMENDATIONS: The GFCI breakers should be tested monthly by pressing the yellow test button.

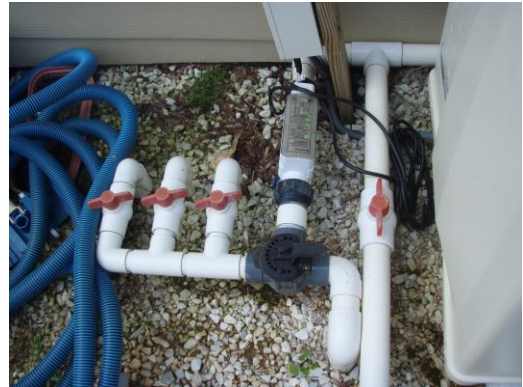
VALVES - PLUMBING - PIPES:

OBSERVATIONS: The pipes and valves were ok

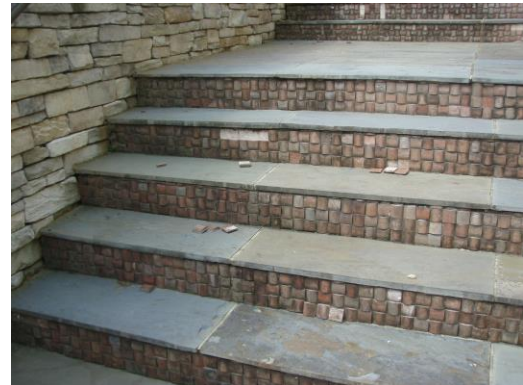
The tile on the face of the steps leading from the pool on both sides of the house are delaminating and are in need of repair.
