At the Repair Bench – Yaesu FTM-400 – May 2024

Sometimes, a repair does not only involve schematics, components, and solder. That was the case recently when a Yaesu FTM-400XDR (Figure 1) came in for repair. The FTM-400XDR is a dual-band 2m/70cm mobile radio with digital, data, APRS, and Bluetooth capability in addition to the usual analog modes.

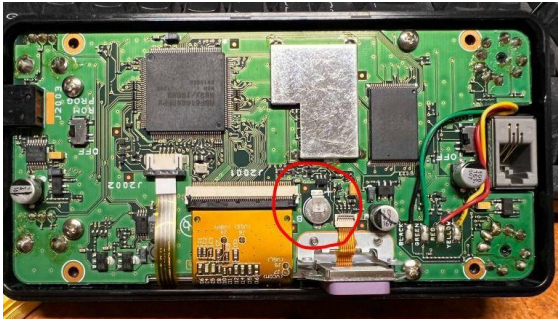
Figure 2 - Front panel coin cell location

Investigation of the radio service manual showed that the radio actually uses two batteries, which are actually coin cells – one each in the Front Panel module (Figure 2) and the Main module (Figure 3). In both locations, the cell is an industry standard ML614R-TT31 cell carrying a Yaesu replacement part number of Q9000895. This is a lithium-ion secondary cell with a 3.0V 2.5mAh

expired at the time of installation. It is not unreasonable to find these cells to be failing at three years of radio life. Upon opening the radio's Main module and measuring the mainboard cell, I found it to be at 2.58V. Next, I opened up the Front Panel module and measured that cell. The Front Panel module cell measured out at a very low 0.612V. It was obvious at this point that replacement of both of the cells was necessary, so I ordered them in. As it turned out, even though the FTM-400 uses two of these cells, Yaesu's USA service center *Standard Horizon* stocks only one of these cells. They get \$1.49 for each cell and about \$11.00 for the shipping, and said that the second cell would have to come from Asia and would entail additional shipping charges. Instead, I ordered a set of ten cells from an Asian supplier at a reasonable cost and with less than a two-dollar shipping fee. The only rub is that the cells, ordered in the middle of May, are not projected to arrive until almost the end of July, about the same lead time that Yaesu had offered.

OK – the batteries – or cells, to be more accurate – have arrived and have been installed. Now the voltages measured are as follows: 2.98V on the mainboard, and 3.02V on the front panel board. Hopefully, this repair will keep the memories in this radio operational for several years. These cells are lithium-ion secondary cells, which are rechargeable, and they do receive a charging current during radio operation. However, there is a finite limit to the number of discharge/charge cycles which the battery can experience before it will fail to accept additional

Replacement of the cells was straight-forward. I used my SMT soldering tweezer to heat both tabs of each original cell at the same time, simply lifting the cell clear once the solder flowed. The soldering tweezer was *not* used to install the new cell, as I did not want to place a short across a new cell. I simply placed each cell into its proper position onto the pre-tinned pads on its respective board, and then soldered it in place with my pencil iron. To simplify the installation, I pre-tinned the solder tabs and the PCB pads before placing the cells on their boards. Having done that, the final step was a simple reflow of the tinning solder.
