At the Repair Bench – NanoVNA – August 2022

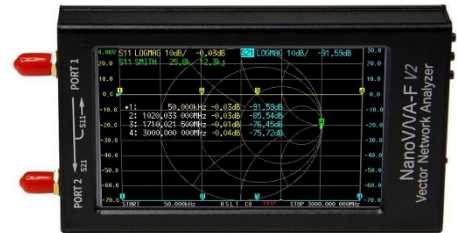
This particular NanoVNA is encased in a multi-piece 3-D printed plastic enclosure, which does a good job of protecting the unit. It would also serve to keep things in place post-repair. Rich had told me that the unit worked, even though there was no display on the screen, as he could connect it to his phone or PC and use the functions of the NanoVNA with no trouble via the software. I suspected that the problem was in the display backlight wiring.

We were fairly sure that the problem was a bad solder joint underneath the display, which was attached to the main PCB with some strong adhesive. The first question was whether or not I could successfully separate the display and the main board. I tried using some monofilament line to cut the adhesive, but the line kept breaking. Ultimately, I tried using some AWG24 solid copper wire, which did the trick nicely.

Once I had the unit open, I powered it up and started putting localized pressure on the end of the Kapton cable that connects the display to the main board. There are about twenty individual connections carried in that cable, so I had to determine which ones were faulty. It soon became evident that there were multiple joints open, as pressing on various connections would illuminate different LED's in the four-LED backlight system.

These wire connections are on a pitch or spacing of about 0.050", so I chose NOT to attack this job with a soldering iron. Instead, I fired up my hot air reflow gun and heated the area with the hot air while placing light pressure across the entire Kapton cable end. This approach was quite successful, restoring the unit backlight to full operation. The best part was that no undue damage was done to the Kapton cable, and I did not have to worry about solder bridges.

I flipped the display back in place, where the original adhesive bonded back together and held the display tightly. I then reassembled the plastic enclosure and the job was complete. Just for fun, I tried a calibration and then swept some coax, some lamp cord, and a couple of antennas. All worked as it should.
