At the Repair Bench – Henry 1KD-5 Amplifier - January 2023

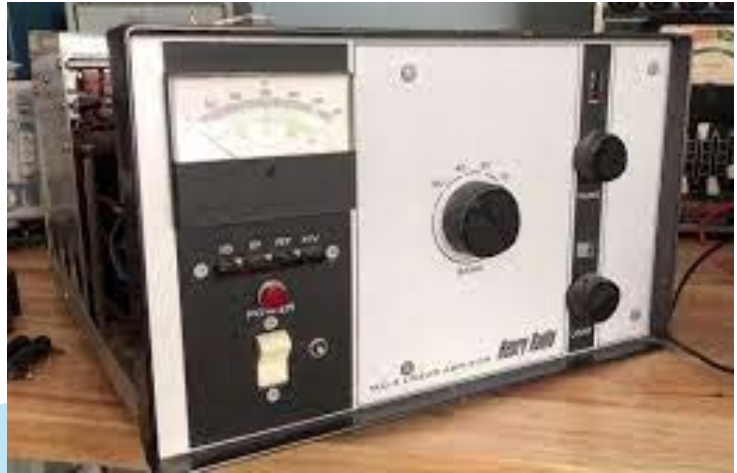
This was a circa 1977 model, heavier than you can believe, with a one-tube grounded-grid circuit. The tube is a 3Z500 tube of about four and a half inches diameter, nestled inside an external glass bell chimney. The tube socket is buried deep inside the unit, behind a board that carries the tuning coils for the amplifier.

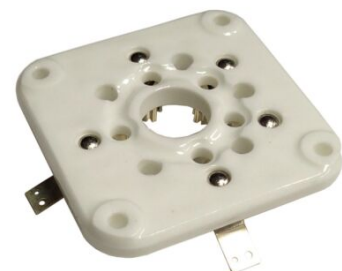
The problem was that the tube socket, a humongous ceramic thing about three inches square and about three-eighths of an inch thick, had fatigued with age and the effects of heat. The result was that the contacts that grip the tube pins had relaxed quite a bit – enough so that when they got hot, the circuit

would open until they cooled down, at which time the circuit would close and the process would repeat. Solution? A new tube socket.

I tracked down a source for the socket, but I had to wait for the socket to come in from China, and I had to order two of them at an exorbitant price to get the one that I needed. I buttoned up the amp and set it aside to wait for the part to come in.

At the solder station, I moved the ground lugs from the old tube socket to the new one. I also drilled the tube socket solder lugs as necessary for the heavy wire from the toroidal transformer to fit. Then it was time to reassemble the whole shooting match, which was quite a tedious task due to hardware locations and difficulty in

reaching some of the screws to install lock washers and nuts on them. I finally got the tube socket mounted, and then soldered its capacitor connections in place. I reinstalled the toroidal transformer and soldered its leads to the tube socket.

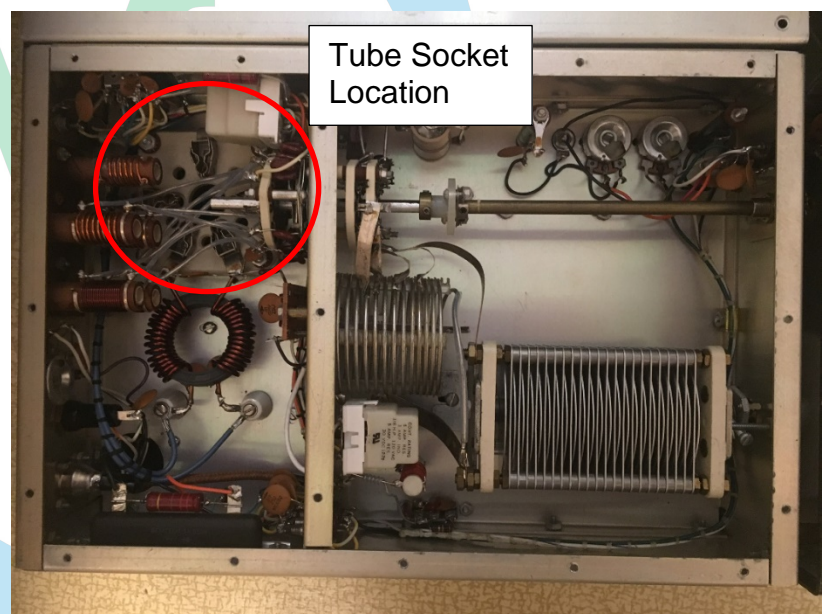
After removal of the sheet metal covers and shields, I had to laboriously remove the forced-air cooling system fan and motor. Next, it was necessary to dismount the tuning coil board and carefully move it out of the way. A large toroidal transformer was next to be removed for access to the tube socket, which had two of its heavy wire leads soldered to the tube socket terminals. My 240-watt soldering gun was required to desolder these connections. Now I was able to get to the tube socket and ground lug mounting hardware and remove the machine screws, lock washers, and nuts. Finally, again using my 240-watt gun, I was able to desolder the capacitors from the connecting tabs of the tube socket and lift the socket out.
