# RCA WO-33A Three-inch Oscilloscope Rejuvenation

Not too long ago, I picked up a well-used three-inch oscilloscope, an RCA WO-33A unit (Figure 1), with the expressed intention of converting this 'scope into another piece of test equipment, namely a graphic semiconductor curve tracer. The main working parts of the 'scope would remain untouched, but an additional small power supply and a circuit board would be added in to provide the new functions that I wanted. The oscilloscope had its rubber bezel, but it did not have a graticule. This did not make any difference, because the graticule is not specifically needed for the curve tracer to operate acceptably. Down the road, I may make a new graticule out of some colored acetate sheeting onto which I can imprint a grid and scale, but that is another project.

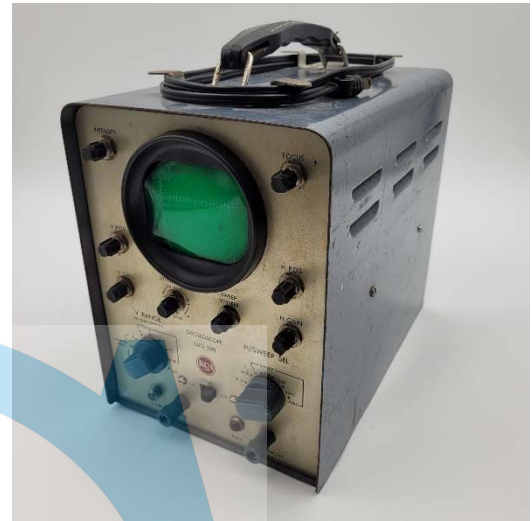
Figure 1 - RCA WO-33A oscilloscope (with graticule)

The 'scope had been, as already mentioned, very well used, and its overall condition reflected that fact. The non-polarized two-wire power cord was in bad shape, with cracks and splits in several points along its length. The faceplate had been splattered with light blue paint droplets, and the vertical input BNC jack on the front panel was bent and badly corroded, making it unusable as an input jack.

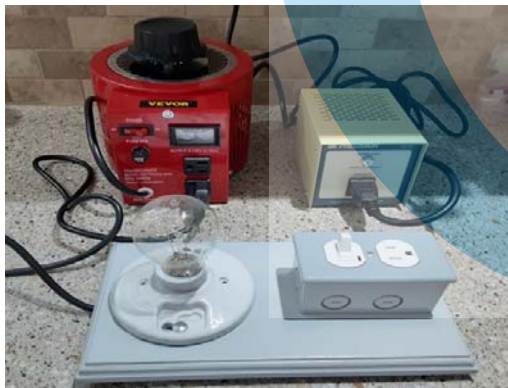
Figure 2 - Safety trinity

All of these were minor issues in the overall scheme of things. Far more important to me was the electrical condition of the unit. I removed the 'scope from its cabinet and I hooked it up to what I call my "safety trinity" (Figure 2) – my dim bulb current limiter, my Variac™, and my isolation transformer – to see what it would do. When I powered it on, the dim bulb went to full brightness and just stayed there, never dimming as it should have done if the 'scope were intact electrically. This indicated either a direct short circuit from line to neutral, or else some severe capacitor leakage.

Once all of the capacitors had been replaced and the new line cord and its associated safety capacitors were installed, I once again connected the ‘scope to the safety trinity and powered it up. This time, the bulb of the current limiter started out bright, and then rapidly faded to a more normal dim state. This was a good sign, showing that the current draw was at or near proper limits. I then took a reading of the actual current being drawn by the oscilloscope, and found it to be a very reasonable 438mA. Upon power-on, the initial current draw peaked at 1321mA, a not unexpected start-up surge. This data was important, because it enabled me to determine a proper fuse for installation as a protective device. In addition, it was right in line with the average power consumption of 50 watts that is stated in the Assembly Manual’s *Electrical Specifications* section, calculating out at about 51.465VA when the 438mA is multiplied by the measured 117.5VAC line voltage in my shop.

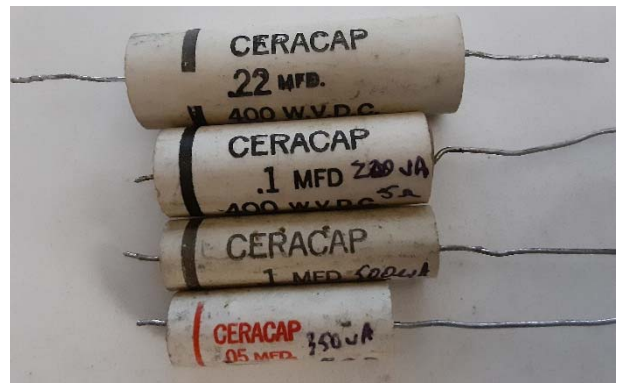
Figure 3 - CERACAP examples

Anyway, the capacitors that I believe were all factory components were all of a type – ceramic tubes with wax filling, all marked as being CERACAP devices (Figure 3) from American Radionic Company, Incorporated. Some research showed that American Radionic is still around today, located now in Palm Coast, Florida, some sixty miles south of Jacksonville, where they relocated after leaving Danbury, Connecticut in the late 1980's. Their AmRad line of motor-run capacitors are considered to be world-class products. However, in the 1950's and 1960's, they were a major supplier of wax and paper capacitors to consumer TV and radio manufacturers.

As is evident from the data in Table 1, all of the capacitors believed to be originals had significant leakage and had considerably higher than acceptable ESR values. As such, it was best that these capacitors were all replaced. The aggregate leakage of these capacitors was a contributor to the excessive current drawn by the 'scope on power-up.

In every case, the replacement capacitors were a fraction of the size of the original capacitors being replaced. I went through the unit methodically, replacing each and every CERACAP capacitor with a new film capacitor. There were two voltage ratings used among the original capacitors, 200V and 400V, with the exception, of course, of the one high-voltage device. The replacements were 250V and 400V types. In all cases except for the high-voltage capacitor, the original values were available and thus were installed. The 5µF high-voltage capacitor was replaced by a 4.7µF 1kV device. In all cases where spaghetti tubing had been used on the original capacitors, it was re-installed on the lead(s) of the replacement devices.

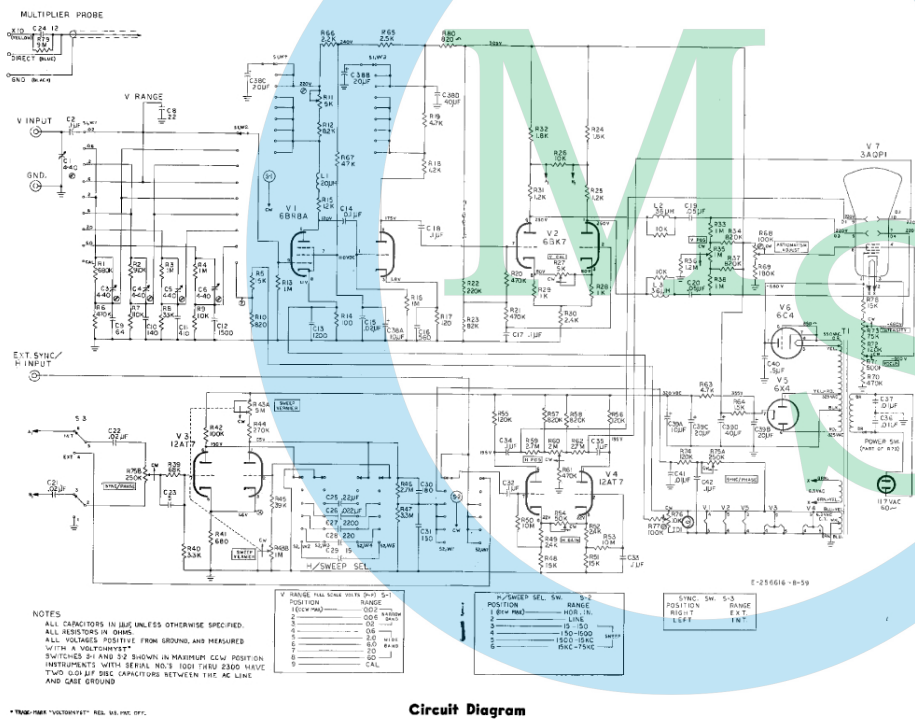
Figure 4 - WO-33A schematic diagram

Consulting the schematic (Figure 4) and the parts list in the Assembly Manual which was readily available online, I made a list of all of the capacitors used in the oscilloscope, and then I ordered in those which I did not have in stock. With the exception of that 5µF 1kV capacitor, I opted to use the Vishay MKT1813-series (Figure 5) of axial metallized polyester film capacitors throughout the unit, and I matched the type with a CDE/Illinois Capacitor MWR-series axial metallized polyester film device for the oddball capacitor in the bunch.

It should be noted here that this oscilloscope, which carries serial number 1426, is not compliant with the schematic diagram provided in the Assembly Manual for this unit. According to the notes that apply to the schematic, units bearing serial numbers from 1001 through 2300 should have a pair of 0.01µF ceramic disc capacitors installed, one from each lead of the power cord to chassis ground at the power cord input to the oscilloscope. These capacitors, identified as capacitors C36 and C37, were not present.

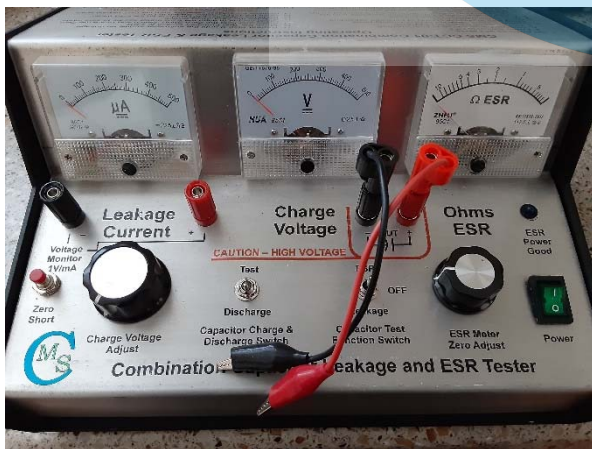
Figure 7 - Capacitor leakage and ESR tester

After replacement of the capacitors, I decided to investigate the exact condition of the capacitors that I had removed. I did this using a capacitor tester of my own design and build (Figure 7), which tests capacitors for leakage and for ESR. What I found, detailed in Table 1, is quite revealing.

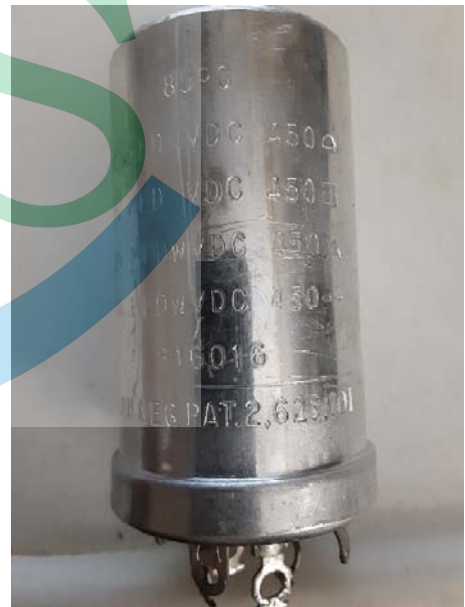
Figure 8 - Original C38 capacitor

locations C38A-D and C39A-D. C38 is in the 6BR8A pentode/triode vacuum tube vertical input amplifier circuit, while C39 is used as the incoming power filtering capacitors immediately subsequent to rectification by the 6X4 dual-diode vacuum tube. The original capacitors in these locations were unmarked as to manufacturer or date, but they were marked with a patent number and a part number (Figure 8). A quick Google search on the patent number showed that the patent was a 1952 (23 December 1952) application, made by Jerome J Kurland and Joseph J Kurland. Some more research showed that these two gentlemen were the co-owners of a company called Illinois Condenser Company of Chicago, Illinois. From that information, one would have to conclude that these capacitors were manufactured by the Illinois Condenser Company.

As can be concluded from the values in the table above, the electrolytic capacitor sections all exhibited extremely high leakage. High leakage is quite typical of electrolytics, but generally not to the extent seen here. This leakage, taken together with the leakage of the film capacitors, was clearly enough to cause the excessive current draw seen in the initial power-up test.

The replacement devices are the product of CE Manufacturing of Tempe, Arizona. CE Manufacturing produces a fairly extensive product range of multi-section can-type electrolytic filter capacitors, intended primarily as replacements for guitar amplifiers and older radio receivers. I have used their capacitors in several refurbishing projects over the past few years, always with great success. They are drop-in replacements as far as size, pinout, and appearance are all concerned.

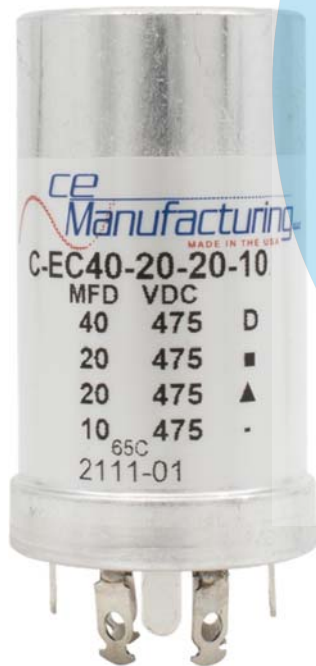
Figure 9 – Capacitor label

On capacitors of this type, the individual sections are identified by a symbol (▲, ■, or ●) adjacent to each terminal. In a four-section device, the fourth terminal is unmarked or marked with a line or dashes (--). In most cases, a legend is marked or labeled on the body of the

capacitor (Figure 9), indicating which section carries which ratings, both as to capacity and as to voltage. The capacitor shell is the common negative side of the internal capacitors.

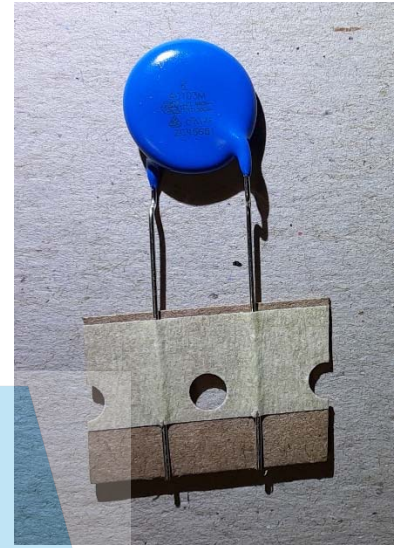
Figure 10 - 0.01µF safety capacitor

The “X1-440V/Y2-300V” designation indicates that this capacitor can be used in the X1 circuit configuration at voltages up to 400VAC, and in the Y2 circuit configuration at voltages up to 300VAC. The X1 configuration is that in which the capacitor is placed across the power line, from one lead to the other, while the Y2 configuration is that in which the capacitor is placed in

the circuit from one line cord lead or the other to the chassis or ground. In this oscilloscope, the capacitors C36 and C37 are used in the Y2 placement.

Continuing with the capacitor specifications shown for the safety capacitors, the “±20%” is the tolerance of the capacitor, or the variation from the nominal value within which the capacitor will fall. Thus, the 0.01µF capacitor will be found to be within the range of 0.008µF to 0.012µF. Finally, the “Y5V” is the designator for the dielectric used in construction of the capacitor. Disc capacitor dielectrics are assigned alphanumeric codes that describe the properties of that dielectric compound. Each of the three characters conveys a specific meaning. In this case, the “Y” indicates that the lowest temperature for which this capacitor is rated is -30°C (-22°F). The “5” indicates that the highest temperature for which this capacitor is rated is +85°C (+185°F). Finally, the “V” tells us that the amount of capacitance change over the temperature range is +22% to -82% of the nominal value. A table of the common dielectrics and their meanings can be found in the article *Capacitor Markings and Identification*, a part of my *Basic Electronics Series*, which can be found on my website at <https://www.ad2cs.com/electronics-articles-and-publications>. Please feel free to browse through the website and have a look at the many articles and publications found there.

The 'scope required replacement of its power cord because of the condition of the existing cord, as mentioned earlier. I replaced the cord with a two-prong polarized power cord, placing the *LINE* lead in series with the power switch, identified only as “POWER SWITCH” and ganged to the 75kΩ *INTENSITY* potentiometer R73. At that time, I also added the two 0.01µF capacitors from the power cord leads to the chassis. The capacitors I used are X1-440V/Y2-300V ±20% Y5V ceramic disc safety capacitors (Figure 10). Safety capacitors are specially designed so as to fail, when failure occurs, in the “open” state rather than failing “shorted”. This is important in any capacitor placed across the power

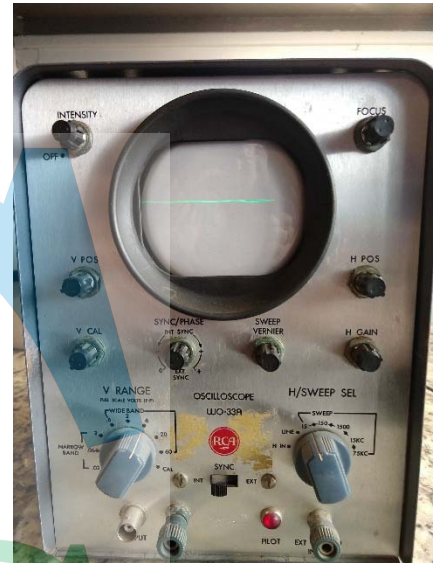
Figure 12 - Working oscilloscope

With the repairs and cleaning completed, it was time to pay some attention to the external appearance of the unit. This turned out to be a relatively minor issue, as the blue paint which had been splattered across the front panel, the upper surface, and the left side panel all came off with some acetone on a soft cloth. The remainder of the stains and debris on the enclosure all came off with some denatured alcohol and another soft cloth, using an old toothbrush to scrub the corners and crevices. A final wipe-down of the front panel with the denatured alcohol finished the clean-up of the unit, though I still need to find a way to safely remove some tape residue without damaging the RCA logo, as can be seen in the Figure 12 photo.

At this point, the RCA WO-33A oscilloscope is operating in accordance with its design standards (Figure 12), and is ready for its final conversion to its new purpose and life as a semiconductor device curve tracer. The next step is to design and construct both the power supply and the curve tracer interface board. Once they have been designed and bread-boarded, I will have the PCB's manufactured. After that, I can install them into the oscilloscope enclosure, mounting them to the chassis rails. I will write another article describing those processes as they progress to completion. For now, I will say farewell!
