ASSESSMENT OF RESIDENTS PERCEPTIONS OF PEDESTRIAN OVERHEAD BRIDGES IN CALABAR METROPOLIS CROSS RIVER STATE-NIGERIA

Emri, Samuel Inaku

Department of Urban and Regional Planning, University of Cross River State, Calabar-Nigeria

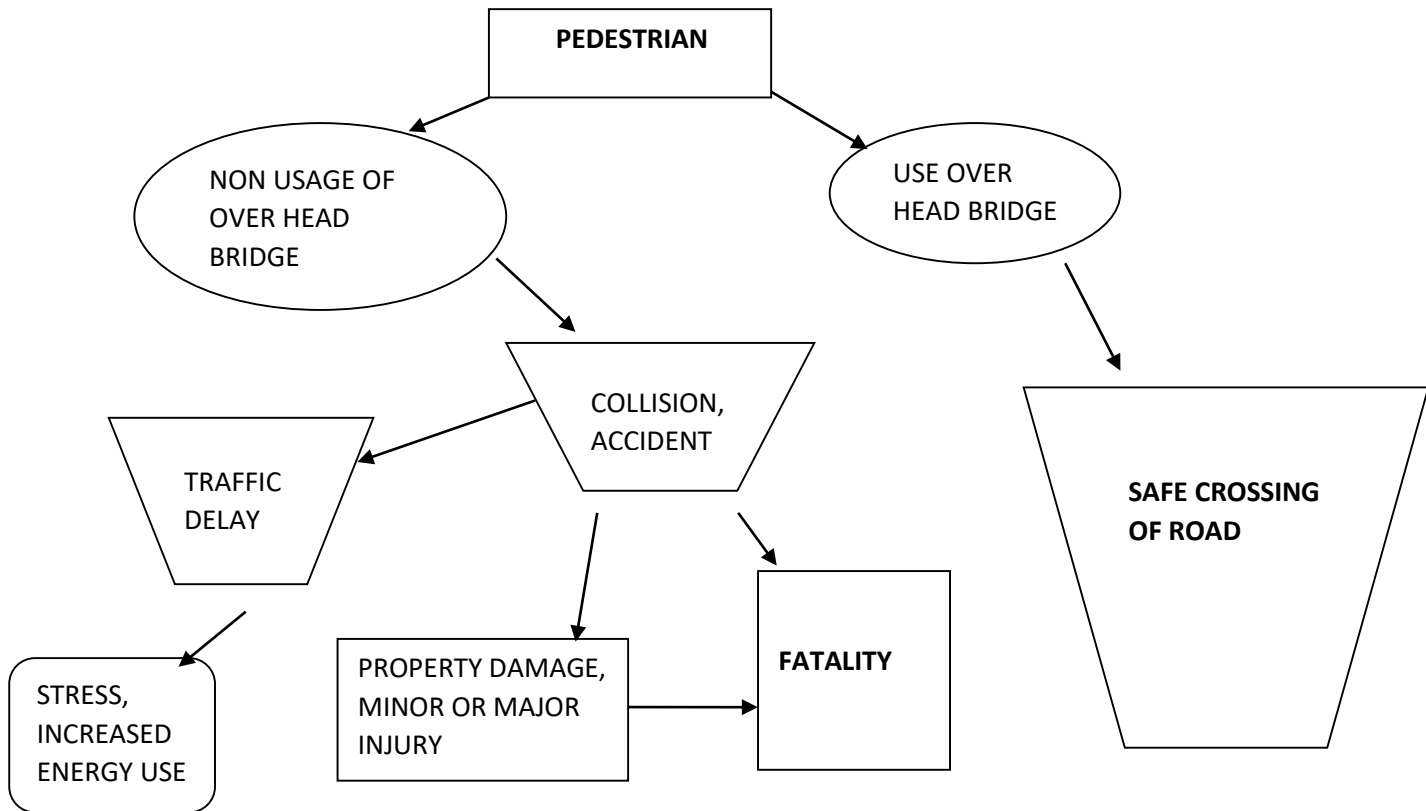
Figure 1: Pedestrian Safety System Approach

The concept as illustrated in figure 1, shows that to cross a road two methods are involved, level crossing and using the overhead bridge. Each has consequences, while crossing at grade may ultimately leads to fatality using the overhead bridge remain the only safe way to safety when crossing the road. See figure1.

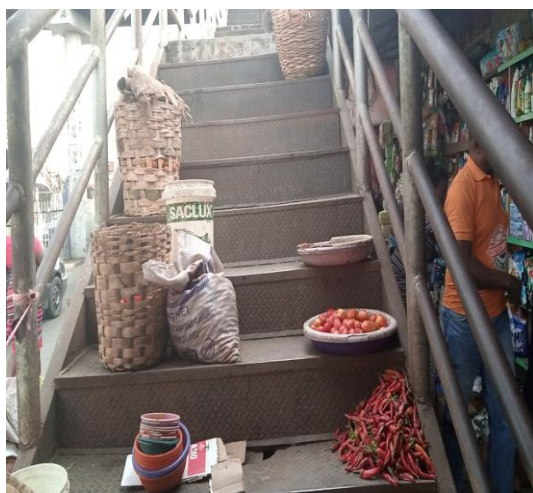
The bridge legs are being used to display goods as well as warehouse by traders at both Watt and Marian Market. This has subsequently prevented the public from accessing the pedestrian bridges at these locations. The unauthorized convention of the circulation use into storage/commercial use is unacceptable and should be discouraged. The facility is meant to facilitate safety (movement) of human beings and not a storage facility for traders. See Plate 1, 2 and 3.

Plate 1: Legs of the pedestrian bridge blocked with goods at Watt Market

4. The bridge should be cleared of all obstacles. The bridge legs being used as a warehouse by traders at both Watt and Marian Market is unacceptable and should be discouraged. The facility is to facilitate movement of human beings and not a storage facility.

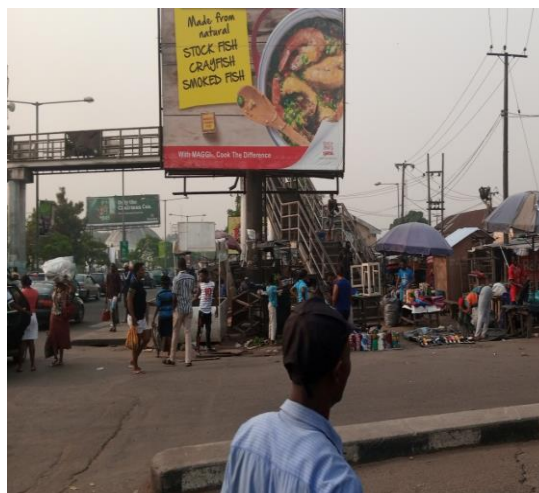
Plate 2: Pedestrian bridge leg blocked with goods at Marian Market

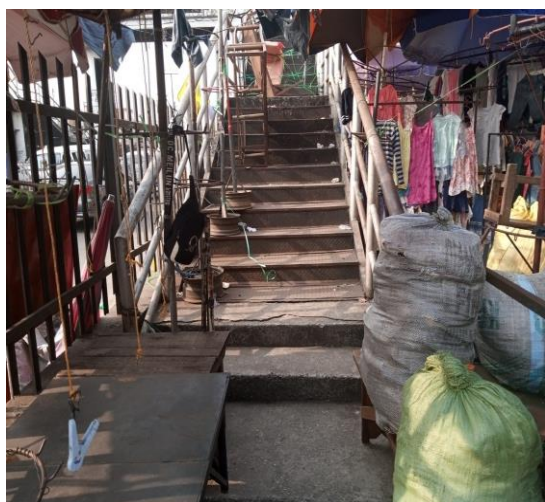
Plate 3: Pedestrian bridge leg use as warehouse at Watt Market

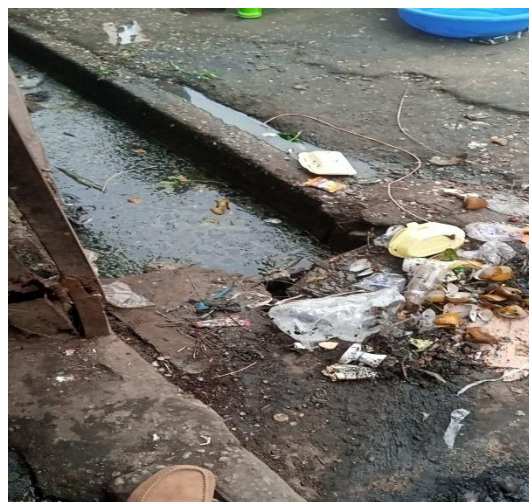
Plate 4: Blocked drainage/filthy environment at the leg of the pedestrian bridge at Watt Market

The environment around the pedestrian bridge is quite filthy due to the activities of traders in the market. It was observed that place is littered with left over unwanted goods, their package, waste water are freely thrown on the ground. The

drainages are filled with cabbage from their commercial activity. The blocked drainage is not only an eyesore the stagnated water ooze and filled the air with poignant odor. See Plate 4

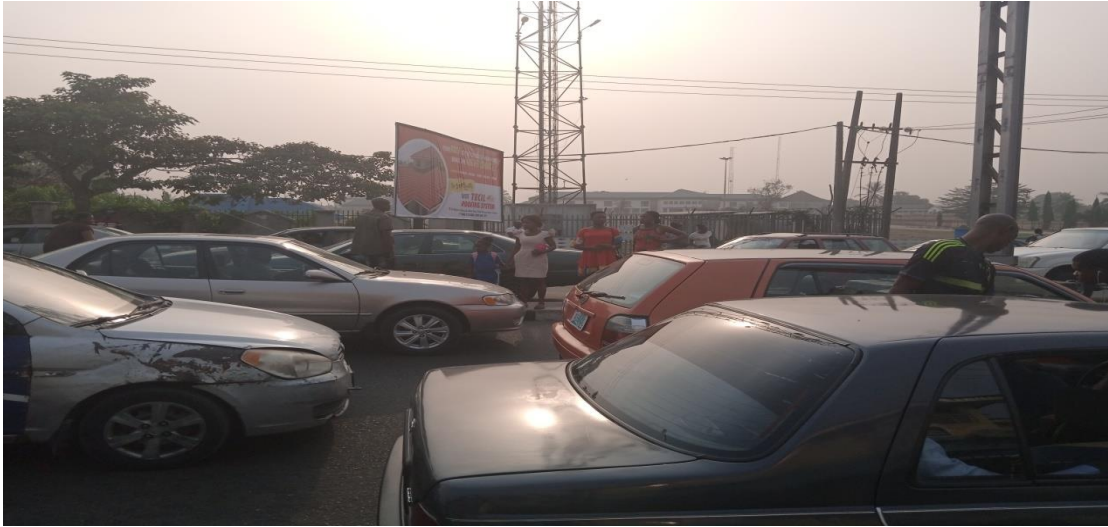
Plate 5: Gridlock due to cross at grade level at Ndidem Iso by Marian Market

1. The chain is said to be as strong as its weakest link. The weakest link that has makes the functionality of these facilities to be at the lowest ebb is the absence of enforcement. It will be necessary to enforce the usage of the facilities to achieve efficiency and offenders apprehended and such violators should be made to pay a prescribe fee as fine or even go through corporal punishment.
2. Vandalized portion of the barricades should be rehabilitated in the interim. However, replacement of angular bars as barricade with concrete dwarf wall as median strip will be more appropriate as solution to the issue of vandalism.
3. The public should be sensitized on the reason for them to use the bridge as against crossing the road at level crossing. The risk of crossing the
