Transportation Setting

Operational Analysis

Serramonte Boulevard/Collins Avenue Master Plan
Figure 1 – Study Area and Lane Configurations

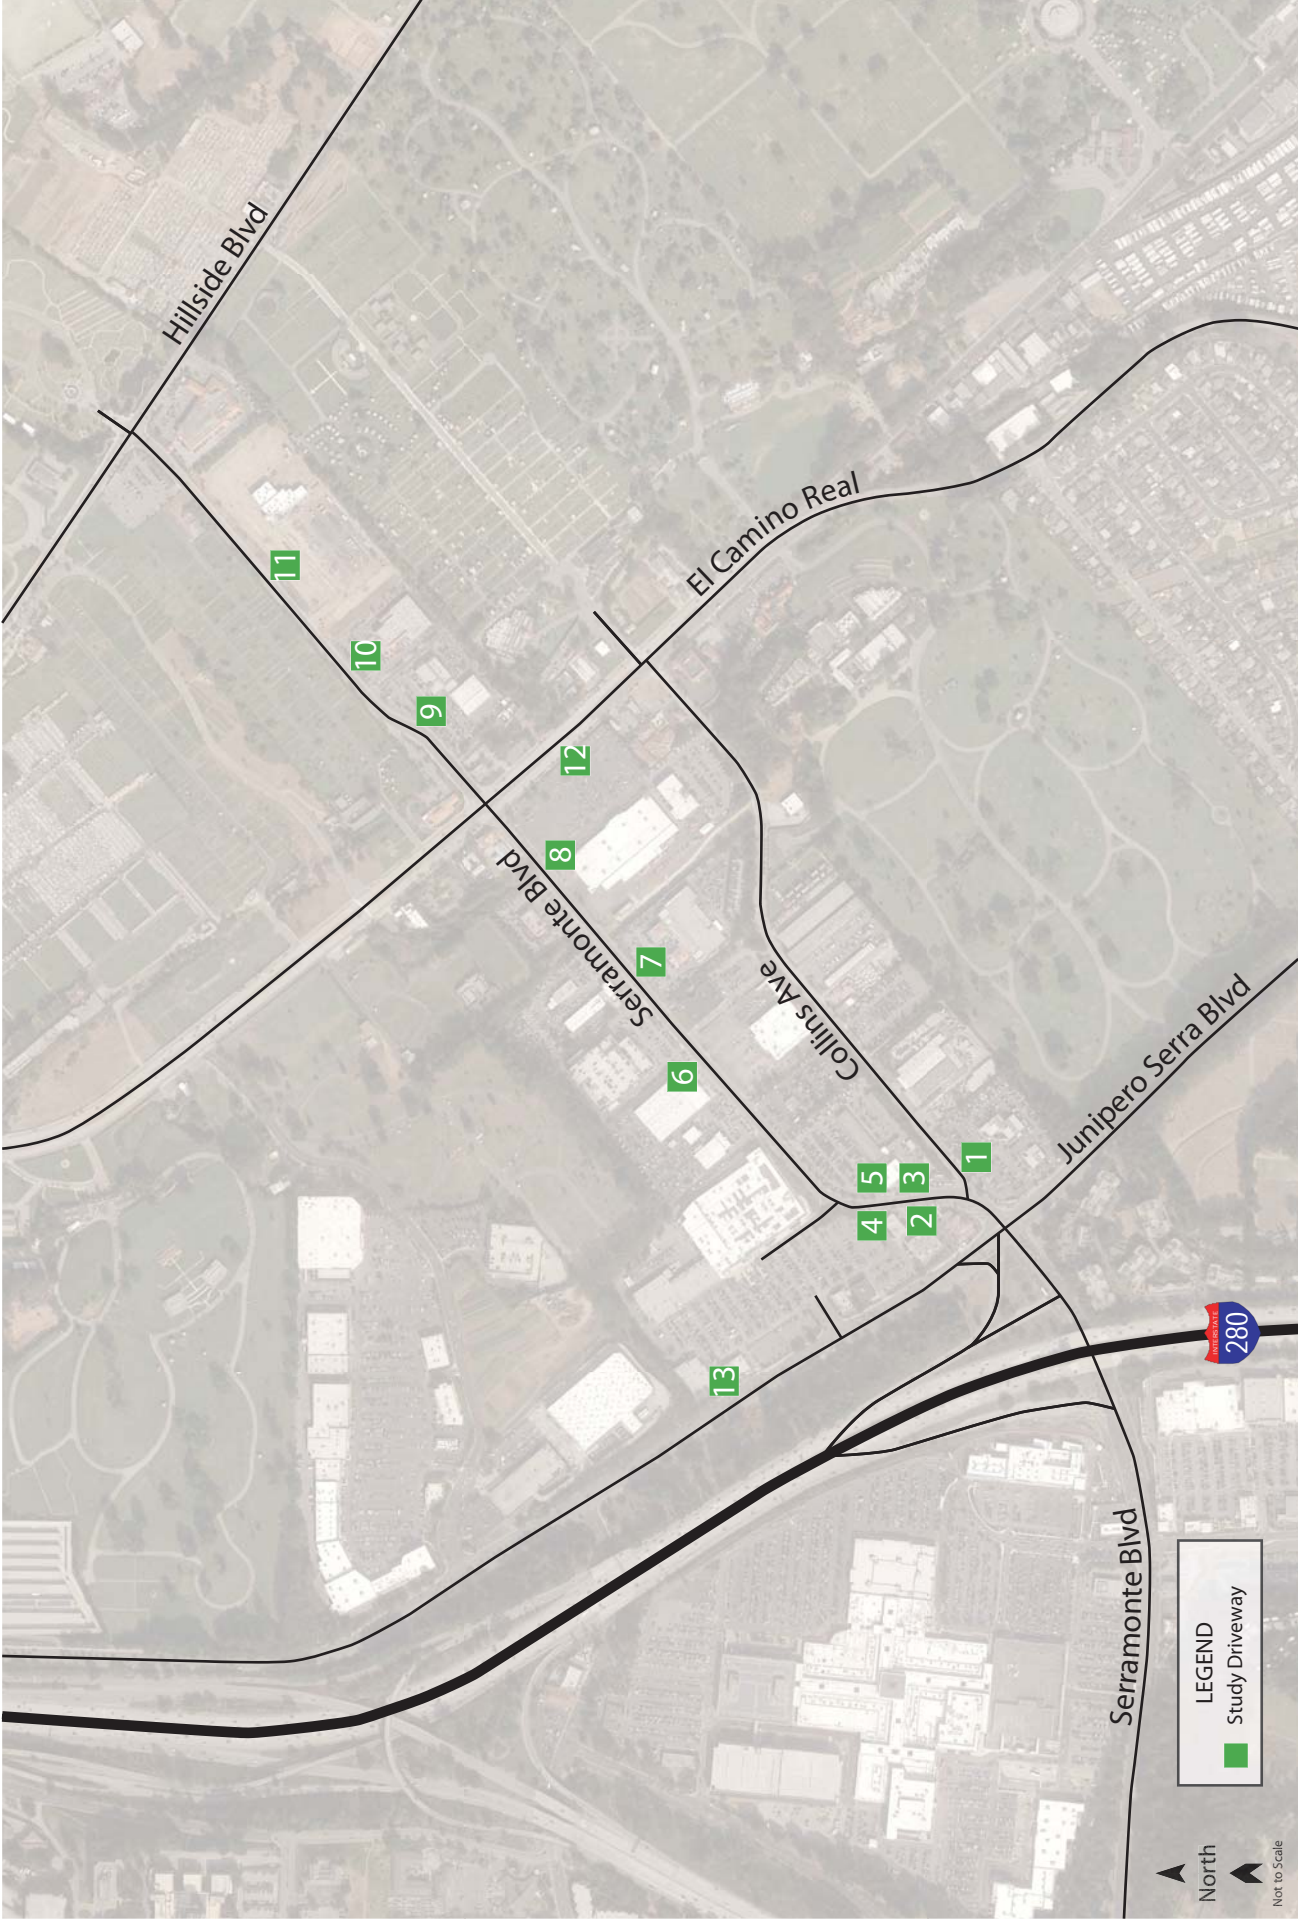
Serramonte Boulevard/Collins Avenue Master Plan
Figure 4 – Study Driveway Locations

The location of the study driveways is shown in Figure 4. The existing traffic volumes at the study driveways are shown in Figure 5 for the weekday peak periods and in Figure 6 for the weekend peak periods.

1. **Hyundai Auto Dealership Driveway** is located south of the intersection Serramonte Boulevard and Collins Avenue on Collins Avenue.
2. **Ford Auto Dealership Driveway** is located on the south side of Serramonte Boulevard approximately 100 feet east of the intersection of Serramonte Boulevard and Collins Avenue.

3. **Starbucks Driveway** is located on the north side of Serramonte Boulevard approximately 150 feet east of the intersection of Serramonte Boulevard and Collins Avenue.

4. **Serramonte Boulevard Serra Center Driveway** is located on the north side of Serramonte Boulevard approximately 125 west of the stop controlled intersection of Serramonte Boulevard and Serra Center Driveway.

5. **Ford Auto Dealership Driveway** is located on the south side of Serramonte Boulevard across from the Serra Center Driveway (Driveway #4) approximately 150 feet west of the stop controlled intersection of Serramonte Boulevard and Serra Center Driveway.

6. **Stewart Chevrolet Auto Dealership** is located on the north side of Serramonte Boulevard approximately 800 feet east of the intersection of Serramonte Boulevard and Serra Center Driveway.

7. **Serramonte Subaru Driveway** is located on the south side of Serramonte Boulevard approximately 850 feet west of the intersection of Serramonte Boulevard and El Camino Real. The driveway is approximately 50 feet wide.

8. **Serramonte Boulevard Kohl's Driveway** is located on the south side of Serramonte Boulevard approximately 300 feet west of the intersection of Serramonte Boulevard and El Camino Real.

9. **Honda of Serramonte Driveway** is located on the south side of Serramonte Boulevard approximately 350 feet east of the intersection of Serramonte Boulevard and El Camino Real. The driveway is approximately 60 feet wide.

10. **Acura of Serramonte Driveway** is also located on the south side of Serramonte Boulevard approximately 750 feet east of the Serramonte Boulevard and El Camino Real intersection.

11. **Car Max Driveway** is also located on the south side of Serramonte Boulevard approximately 1,100 feet east of the Serramonte Boulevard and El Camino Real intersection.

12. **El Camino Real Kohl's Driveway** is located on El Camino Real approximately a 325 feet south of the intersection of Serramonte Boulevard and El Camino Real. The driveways is approximately 50 feet wide.

13. **Serra Center Driveway** is located on east side of Junipero Serra Boulevard north of the signalized Serra Center Driveway on Junipero Serra Boulevard. The signalized driveway was analyzed as a study intersection.

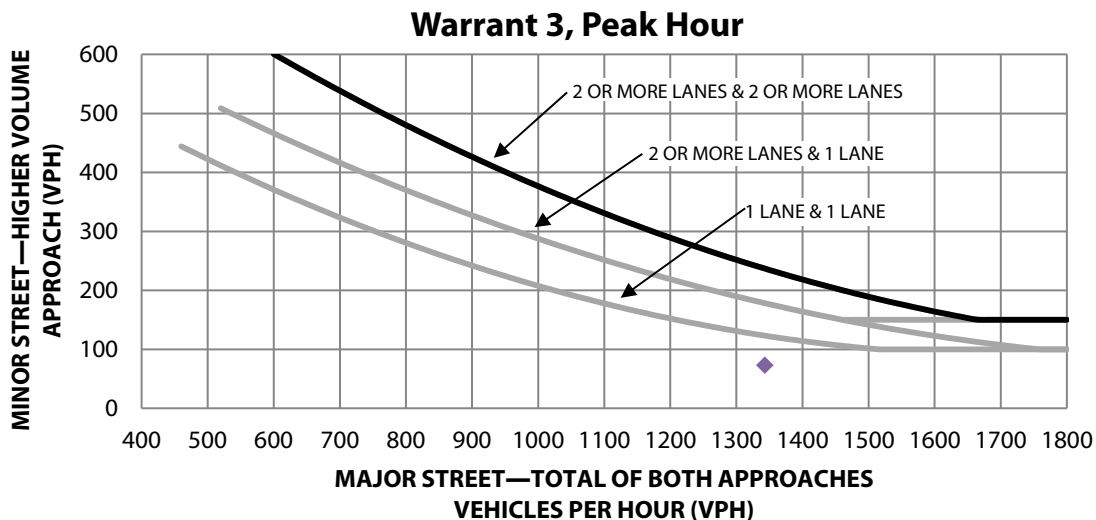
Major Street	Minor Street
Street Name	Serramonte Blvd	Collins Ave
Direction	E-W	E-W
Number of Lanes	2	2
Approach Speed	30	25
Population less than 10,000?	No	
Date of Count:	Thursday, November 30, 2017	
Scenario:	AM Existing

Warrant 3 Met?: Met when either Condition A or B is met	No
Condition A: Met when conditions A1, A2, and A3 are met	Not Met
<i>Condition A1</i> The total delay experienced by traffic on one minor street approach (one direction only) controlled by a STOP sign equals or exceeds four vehicle-hours for a one lane approach, or five vehicle-hours for a two-lane approach Minor Approach Delay: 0.28 vehicle-hours	Not Met
<i>Condition A2</i> The volume on the same minor street approach (one direction only) equals or exceeds 100 vph for one moving lane of traffic of 150 vph for two moving lanes Minor Approach Volume: 73 vph	Not Met
<i>Condition A3</i> The total entering volume serviced during the hour equals or exceeds 800 vph for intersections with four or more approaches or 650 vph for intersections with three approaches Total Entering Volume: 1416 vph	Met
Condition B The plotted point falls above the curve	Not Met

collected to further analyze the need for a signal at the intersection. The intersection of Serramonte Boulevard and Collins Avenue does not satisfy the conditions of Warrant 3 during any peak period.

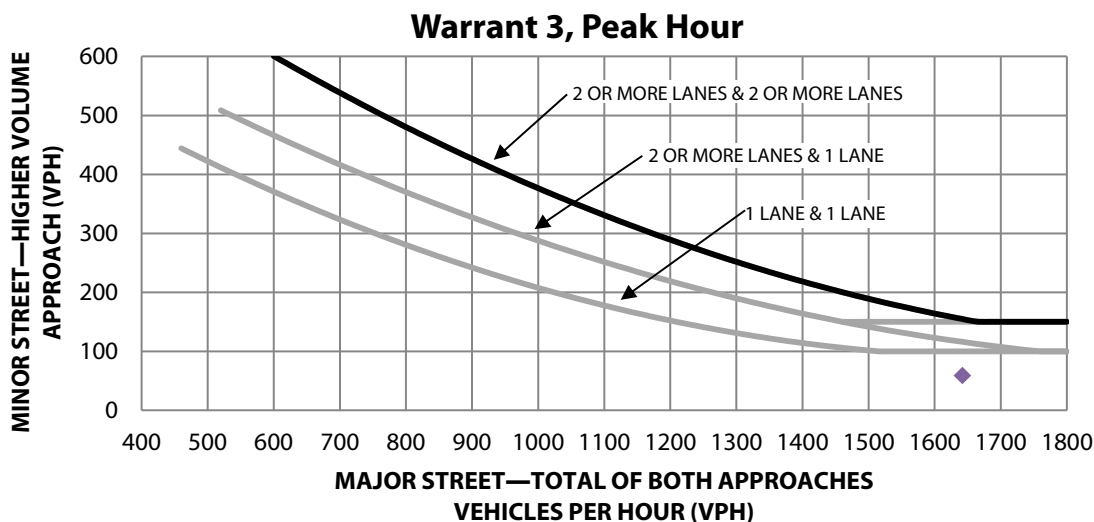
Serramonte Blvd/Collins Ave Master Plan
Serramonte Blvd & Collins Ave

Major Street	Minor Street
Street Name	Serramonte Blvd	Collins Ave
Direction	E-W	E-W
Number of Lanes	2	2
Approach Speed	30	25
Population less than 10,000?	No	
Date of Count:	Thursday, November 30, 2017	
Scenario:	Wknd PM Existing

Warrant 3 Met?: Met when either Condition A or B is met	No
Condition A: Met when conditions A1, A2, and A3 are met	Not Met
<i>Condition A1</i> The total delay experienced by traffic on one minor street approach (one direction only) controlled by a STOP sign equals or exceeds four vehicle-hours for a one lane approach, or five vehicle-hours for a two-lane approach Minor Approach Delay: 0.25 vehicle-hours	Not Met
<i>Condition A2</i> The volume on the same minor street approach (one direction only) equals or exceeds 100 vph for one moving lane of traffic of 150 vph for two moving lanes Minor Approach Volume: 59 vph	Not Met
<i>Condition A3</i> The total entering volume serviced during the hour equals or exceeds 800 vph for intersections with four or more approaches or 650 vph for intersections with three approaches Total Entering Volume: 1701 vph	Met
Condition B The plotted point falls above the curve	Not Met

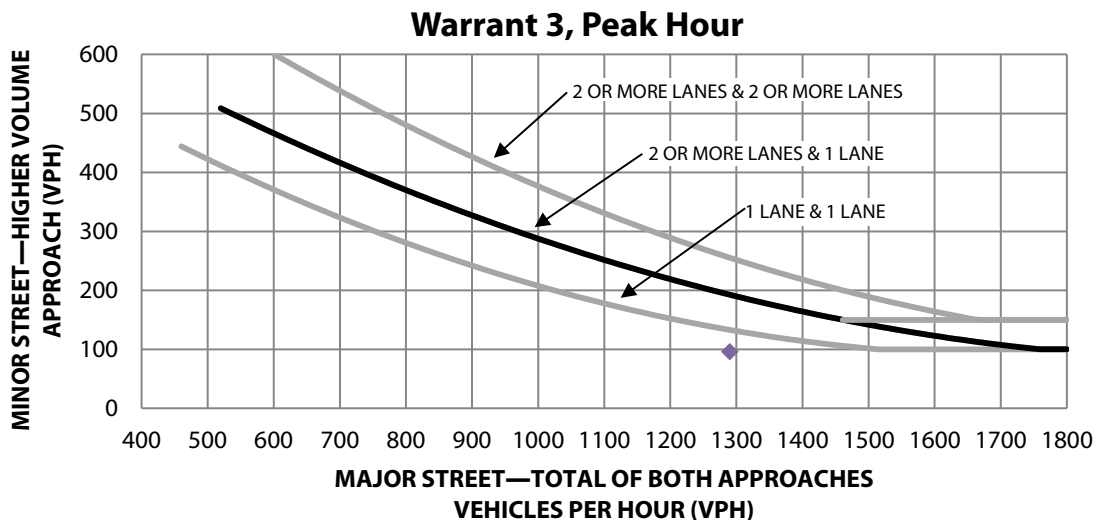
Serramonte Blvd/Collins Ave Master Plan
Serramonte Blvd & Serra Center Driveway

Major Street	Minor Street
Street Name	Serramonte Blvd	Serra Center Driveway
Direction	E-W	N-S
Number of Lanes	2	1
Approach Speed	30	25
Population less than 10,000?	No	
Date of Count:	Thursday, November 30, 2017	
Scenario:	AM Existing

Warrant 3 Met?: Met when either Condition A or B is met		No
Condition A: Met when conditions A1, A2, and A3 are met		Not Met
<i>Condition A1</i> The total delay experienced by traffic on one minor street approach (one direction only) controlled by a STOP sign equals or exceeds four vehicle-hours for a one lane approach, or five vehicle-hours for a two-lane approach Minor Approach Delay: 0.29 vehicle-hours		Not Met
<i>Condition A2</i> The volume on the same minor street approach (one direction only) equals or exceeds 100 vph for one moving lane of traffic of 150 vph for two moving lanes Minor Approach Volume: 96 vph		Not Met
<i>Condition A3</i> The total entering volume serviced during the hour equals or exceeds 800 vph for intersections with four or more approaches or 650 vph for intersections with three approaches Total Entering Volume: 1386 vph		Met
Condition B The plotted point falls above the curve		Not Met

The intersection of Serramonte Boulevard and Serra Center Driveway satisfies Warrant 3 during all peak periods except during the a.m. peak period. Additional data collection should be completed to review Warrant 1 and Warrant 2 prior to recommending the installation of a traffic signal at this intersection. Similarly, a signal warrant was met for all peak periods at the intersection of El Camino Real and Collins Avenue. Additional data should be

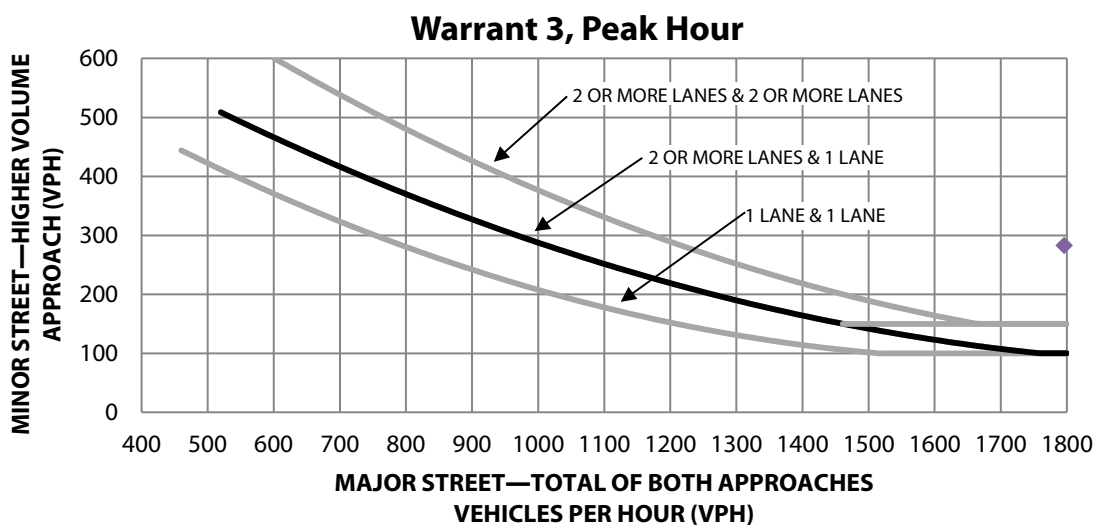
Serramonte Blvd/Collins Ave Master Plan
Serramonte Blvd & Serra Center Driveway

Major Street	Minor Street
Street Name	Serramonte Blvd	Serra Center Driveway
Direction	E-W	N-S
Number of Lanes	2	1
Approach Speed	30	25
Population less than 10,000?	No	
Date of Count:	Saturday, December 2, 2017	
Scenario:	Wknd Midday Existing

Warrant 3 Met?: Met when either Condition A or B is met		Yes
Condition A: Met when conditions A1, A2, and A3 are met		Not Met
<i>Condition A1</i> The total delay experienced by traffic on one minor street approach (one direction only) controlled by a STOP sign equals or exceeds four vehicle-hours for a one lane approach, or five vehicle-hours for a two-lane approach Minor Approach Delay: 1.39 vehicle-hours		Not Met
<i>Condition A2</i> The volume on the same minor street approach (one direction only) equals or exceeds 100 vph for one moving lane of traffic of 150 vph for two moving lanes Minor Approach Volume: 283 vph		Met
<i>Condition A3</i> The total entering volume serviced during the hour equals or exceeds 800 vph for intersections with four or more approaches or 650 vph for intersections with three approaches Total Entering Volume: 2079 vph		Met
Condition B The plotted point falls above the curve		Met

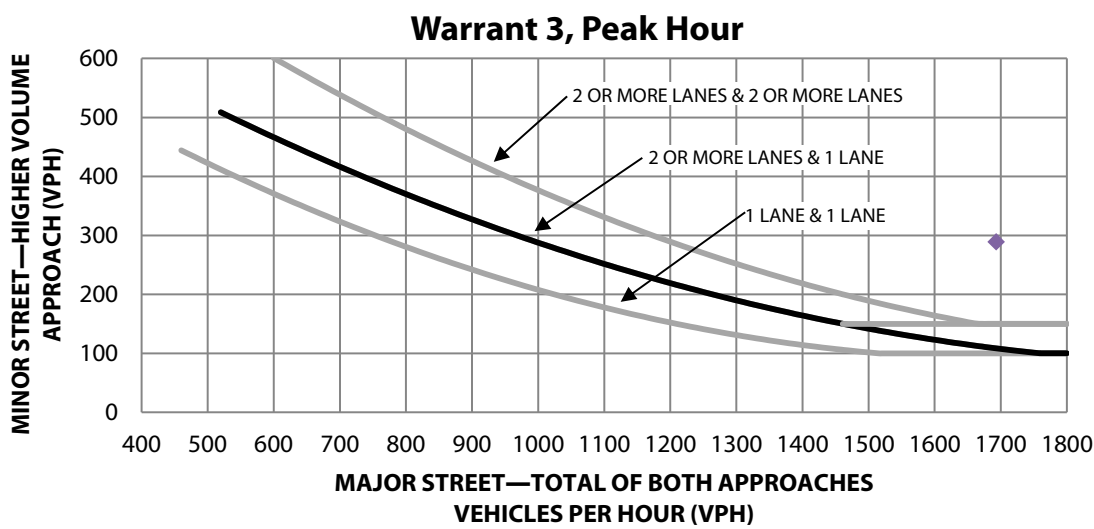
Serramonte Blvd/Collins Ave Master Plan
Serramonte Blvd & Serra Center Driveway

Major Street	Minor Street
Street Name	Serramonte Blvd	Serra Center Driveway
Direction	E-W	N-S
Number of Lanes	2	1
Approach Speed	30	25
Population less than 10,000?	No	
Date of Count:	Saturday, December 2, 2017	
Scenario:	Wknd PM Existing

Warrant 3 Met?: Met when either Condition A or B is met		Yes
Condition A: Met when conditions A1, A2, and A3 are met		Not Met
<i>Condition A1</i> The total delay experienced by traffic on one minor street approach (one direction only) controlled by a STOP sign equals or exceeds four vehicle-hours for a one lane approach, or five vehicle-hours for a two-lane approach Minor Approach Delay: 1.48 vehicle-hours		Not Met
<i>Condition A2</i> The volume on the same minor street approach (one direction only) equals or exceeds 100 vph for one moving lane of traffic of 150 vph for two moving lanes Minor Approach Volume: 289 vph		Met
<i>Condition A3</i> The total entering volume serviced during the hour equals or exceeds 800 vph for intersections with four or more approaches or 650 vph for intersections with three approaches Total Entering Volume: 1982 vph		Met
Condition B The plotted point falls above the curve		Met

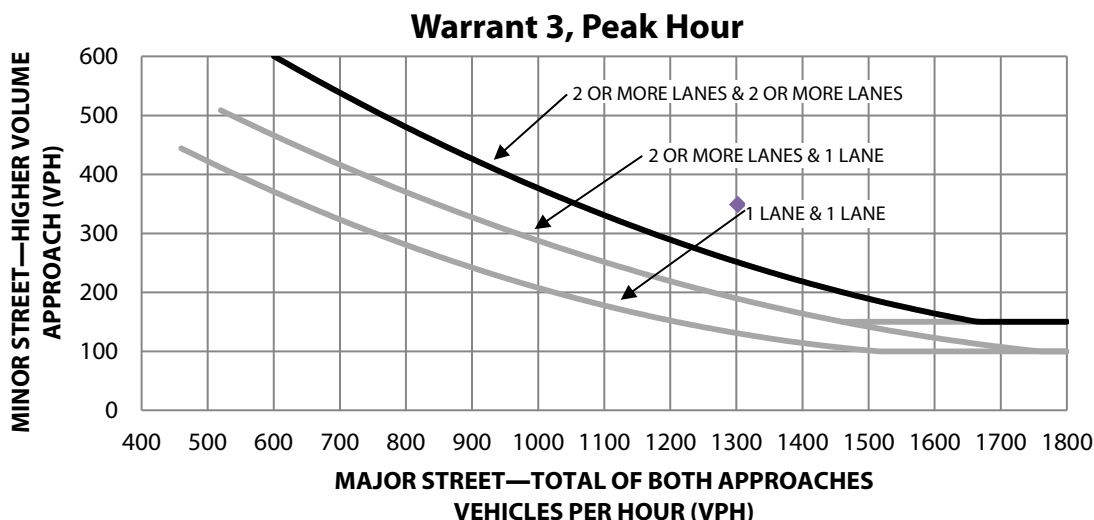
Serramonte Blvd/Collins Ave Master Plan
El Camino Real & Collins Avenue

Major Street	Minor Street
Street Name	El Camino Real	Collins Avenue
Direction	N-S	E-W
Number of Lanes	3	2
Approach Speed	40	25
Population less than 10,000?	No	
Date of Count:	Thursday, November 30, 2017	
Scenario:	AM Existing

Warrant 3 Met?: Met when either Condition A or B is met	Yes
Condition A: Met when conditions A1, A2, and A3 are met	Not Met
<i>Condition A1</i> The total delay experienced by traffic on one minor street approach (one direction only) controlled by a STOP sign equals or exceeds four vehicle-hours for a one lane approach, or five vehicle-hours for a two-lane approach Minor Approach Delay: 1.05 vehicle-hours	Not Met
<i>Condition A2</i> The volume on the same minor street approach (one direction only) equals or exceeds 100 vph for one moving lane of traffic of 150 vph for two moving lanes Minor Approach Volume: 349 vph	Met
<i>Condition A3</i> The total entering volume serviced during the hour equals or exceeds 800 vph for intersections with four or more approaches or 650 vph for intersections with three approaches Total Entering Volume: 1657 vph	Met
Condition B The plotted point falls above the curve	Met

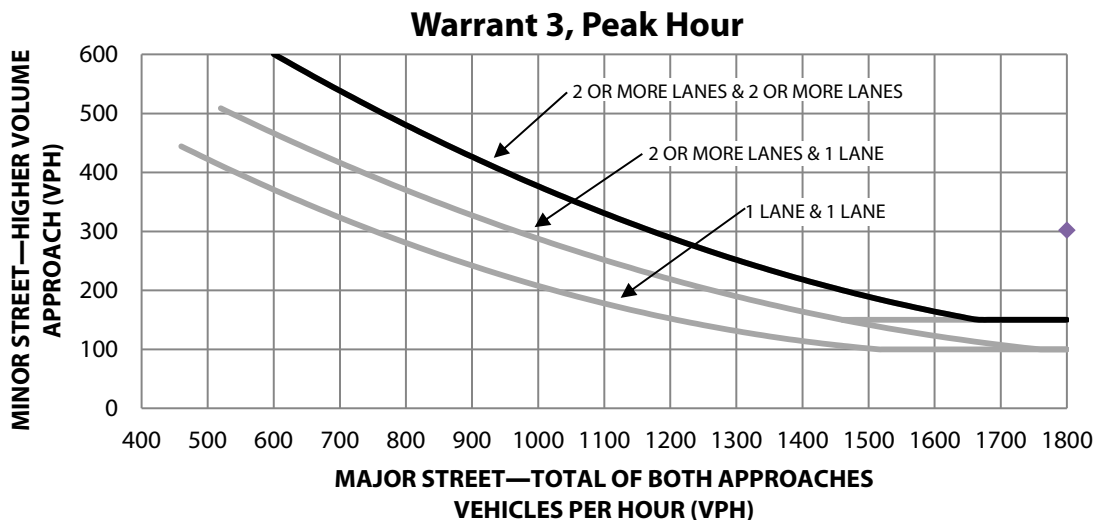
Serramonte Blvd/Collins Ave Master Plan
El Camino Real & Collins Avenue

Major Street	Minor Street
Street Name	El Camino Real	Collins Avenue
Direction	N-S	E-W
Number of Lanes	3	2
Approach Speed	40	25
Population less than 10,000?	No	
Date of Count:	Thursday, November 30, 2017	
Scenario:	PM Existing

Warrant 3 Met?: Met when either Condition A or B is met	Yes
Condition A: Met when conditions A1, A2, and A3 are met	Not Met
<i>Condition A1</i> The total delay experienced by traffic on one minor street approach (one direction only) controlled by a STOP sign equals or exceeds four vehicle-hours for a one lane approach, or five vehicle-hours for a two-lane approach Minor Approach Delay: 0.95 vehicle-hours	Not Met
<i>Condition A2</i> The volume on the same minor street approach (one direction only) equals or exceeds 100 vph for one moving lane of traffic of 150 vph for two moving lanes Minor Approach Volume: 302 vph	Met
<i>Condition A3</i> The total entering volume serviced during the hour equals or exceeds 800 vph for intersections with four or more approaches or 650 vph for intersections with three approaches Total Entering Volume: 2343 vph	Met
Condition B The plotted point falls above the curve	Met
