# **ATTACHMENT B - SUMMARY OF TRAFFIC VOLUMES COLLECTED IN 2017**

The following summarizes recent traffic volume data collected in Colma as well as Kittelson's observations from field reviews.

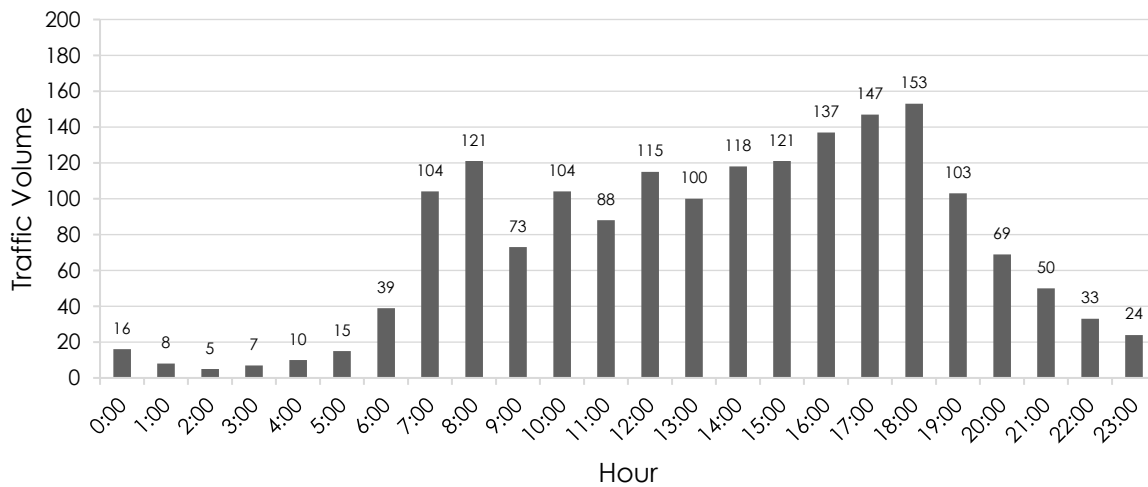
**Figure 1: Traffic Volume Information for F Street**

F Street is a east-west corridor, and the segment in between El Camino Real and Hillside Boulevard is the study corridor. The corridor has cemeteries on the south side, and residential development on the north side. The corridor branches off of El Camino Real with a steep up grade and then levels off. The entire segment has brick surface, on-street parking and sidewalk on both the sides. The visibility of the 'stop ahead' warning signs could be improved given the adjacent trees. There are 'stop ahead' warning signs on the pavement augmenting the street signs. There is a horizontal curve on F Street on the approach to Hillside Boulevard. The traffic volume information for this corridor is shown in Figure 1. This information helps in understanding the hourly vehicular traffic patterns on the corridor throughout the day.

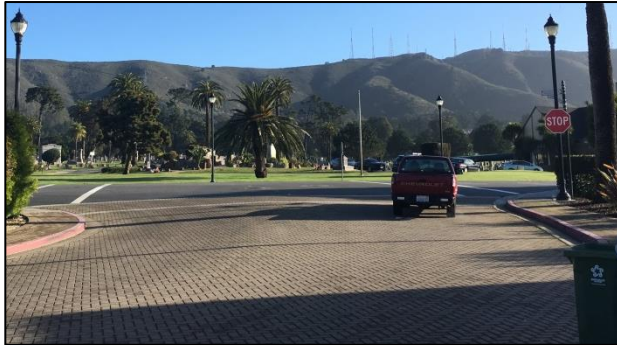
Lack of intersection markings (i)

F Street has no pavement markings. Lane delineation could be helpful near the Hillside Boulevard intersection because of the presence of horizontal curve at the approach. The community input included comments on vehicle speeds. Adding pavement markings allocate and define roadway space. Adding right edge lines or parking "T"s visually narrow the travel lanes which could reduce vehicle drift and support lower travel speeds along the corridor.

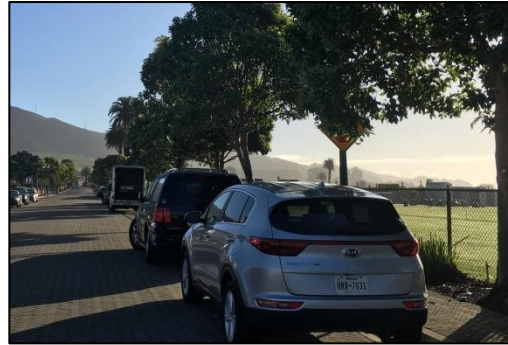
Some stop signs, warning signs, and streetname signs are obscured by vegetation. Others are placed at a relatively low height. Signing examples are shown in Figure 2.

Obscured sign (ii)

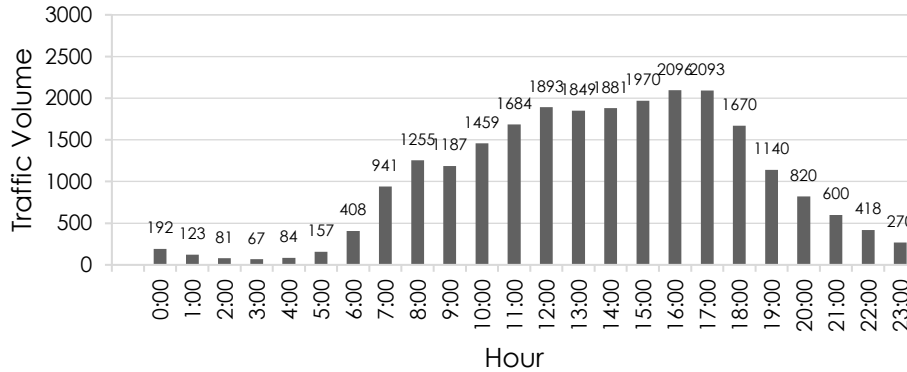
**Figure 3: Traffic Volume Information for El Camino Real**

El Camino Real (ECR), State Highway 82, is a north-south through the Town of Colma. The corridor has cemeteries on the east and west sides until Colma Boulevard and industrial and/or commercial developments around Serramonte Boulevard/ECR intersection. ECR has a posted speed of 35 mph in South San Francisco area that changes to 40 mph in the Town of Colma. The hourly traffic volume information for this corridor is shown in Figure 3. This information helps in understanding the hourly vehicular traffic patterns on the corridor throughout the day.

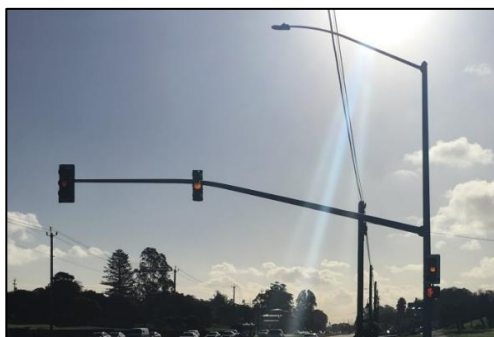
**Figure 4: Limited Signal Visibility**

The traffic signals at ECR intersections do not have reflective backplates on the signal heads. This limits the traffic signal visibility during the daytime.

Community members provided comments about cars traveling on ECR not yielding to pedestrians. Examples of the limited signal visibility is shown in Figure 4.

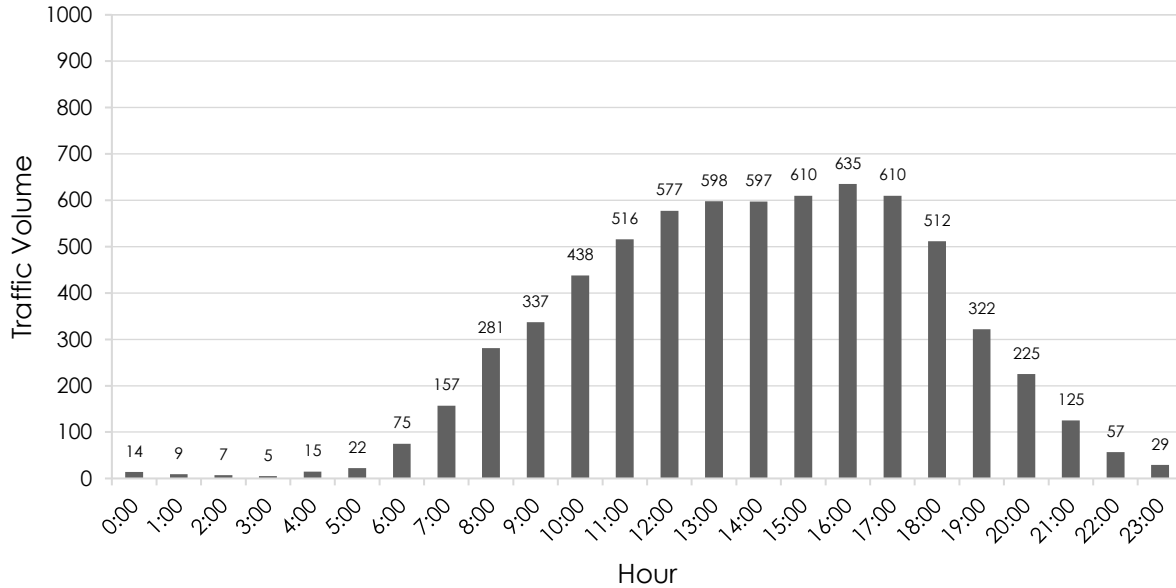
**Figure 5: Traffic Volume Information for Colma Boulevard**

Colma Boulevard is an east-west study corridor between ECR and Junipero Serra Boulevard (JSB) . The corridor has cemeteries near the ECR intersection and commercial development to the west approaching JSB. The corridor has four lanes at ECR that widens at the JSB intersection. The roadway is inclined going west from ECR and vehicle speeds are higher traveling east, down hill toward ECR. The corridor has sidewalk on the north side the entire length of the corridor and on both sides from the commercial development westward. The hourly traffic volume information this corridor is shown in Figure 5.

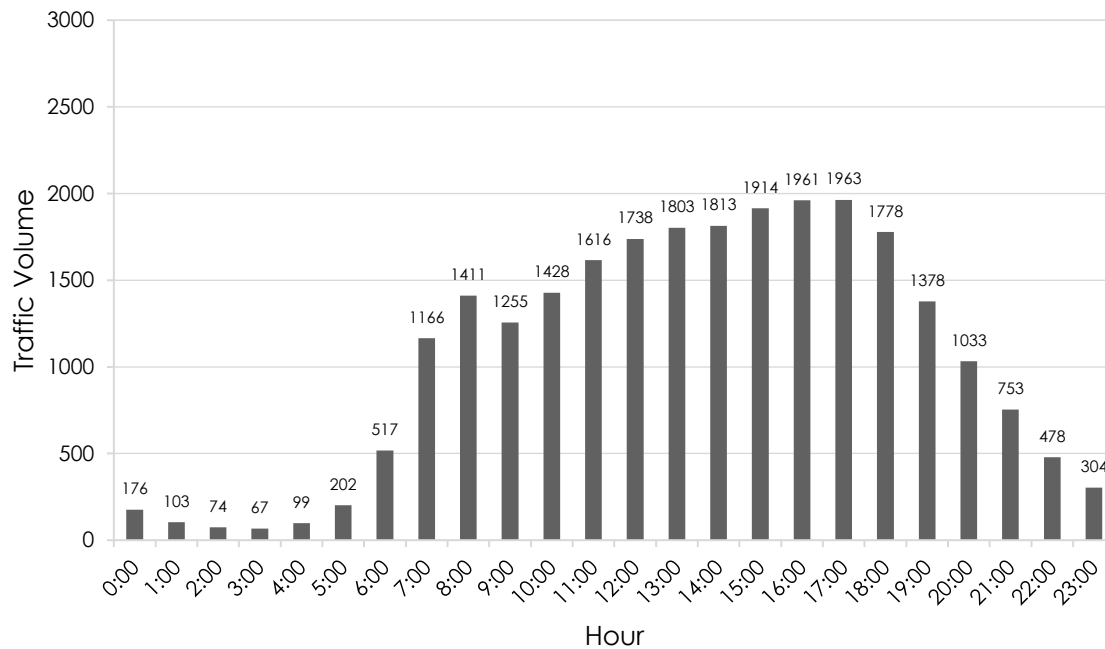
**Figure 6: Traffic Volume Information for Junipero Serra Boulevard**

JSB is a north-south study corridor running in parallel to ECR and I-280 running between the northern and southern town limits. The corridor has Sam Trans Bus stops and Colma BART Station on the north limit and commercial development at the Serramonte Center on the south corridor limit. Serramonte Boulevard interchanges with I-280 providing a freeway connection to the town. A northbound I-280 entrance ramp connects directly to JSB. The corridor segment has a rolling grade with up and downgrades. The corridor has sidewalk on the east side of the corridor until the Serramonte Boulevard/JSB intersection. The corridor has sidewalk on both sides from the Serramonte Boulevard/JSB intersection to the southern town limit. The hourly traffic volume information for this corridor is shown in Figure 6.

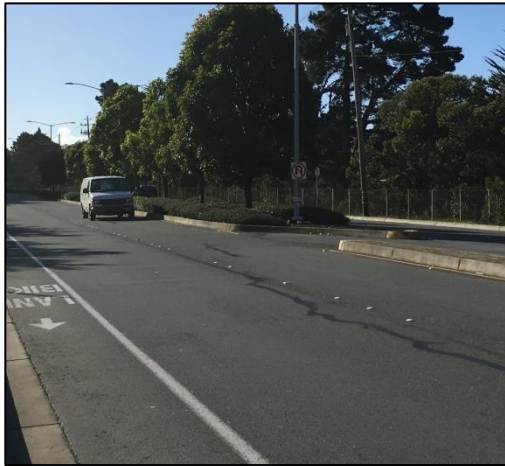
The crash data shows that improper turning was reported for 39% of crashes along this corridor. The driveways at the Extra Space storage driveway are not conspicuous and can go unnoticed by northbound JSB driver. Southbound drivers turning into left-in only turn pocket have limited sight distance to northbound vehicles on JSB.

Left-in only driveway access (vi)

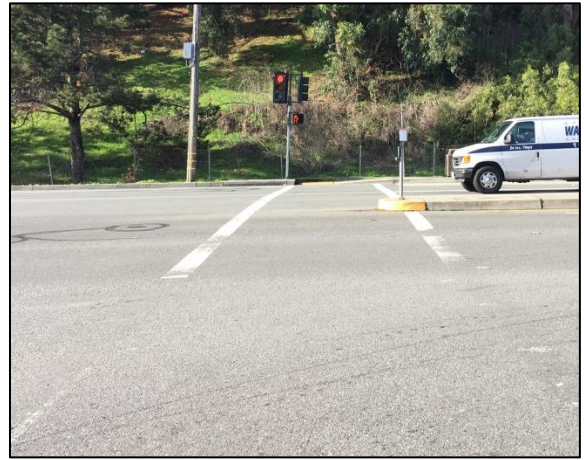
Pedestrian crossings are some times limited in visibility and drivers are inconsistent in yielding to the pedestrian crossings on the street because of the operating speeds. Community members provided input about the cars not yielding to pedestrians at some corridor locations.

Limited visibility of crosswalk (vii)

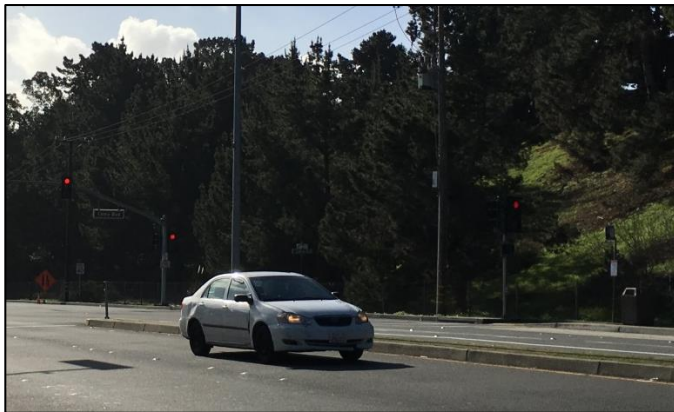
The traffic signals do not have reflective backplates limiting visibility of the signal display when drivers are heading in the direction of sun.

Limited signal visibility (viii)

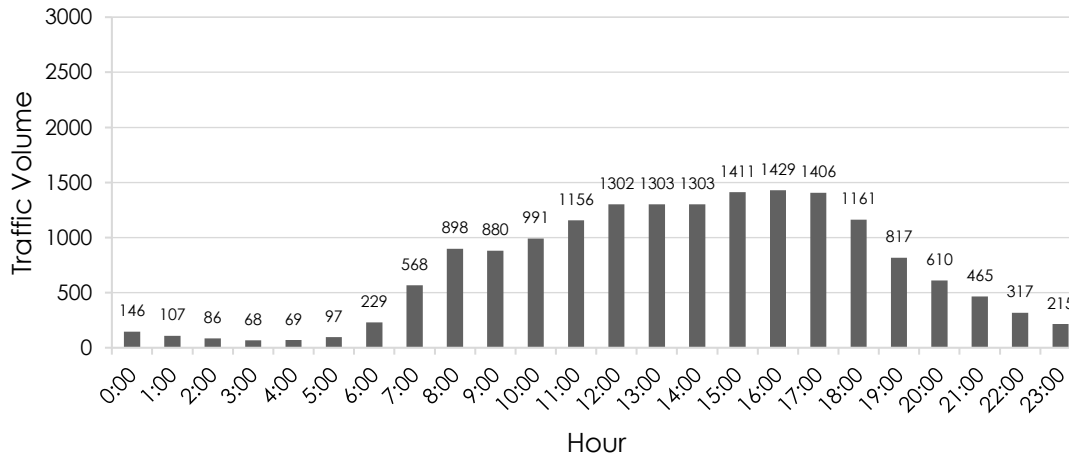
**Figure 8: Traffic Volume Information for Serramonte Boulevard**

Serramonte Boulevard is a east-west corridor providing access to I-280 and commercial development on either side of I-280. The study corridor is between JSB and Hillside Boulevard. The corridor has commercial development, i.e. shopping center near the JSB/Serramonte Boulevard and Collins intersection. The corridor later transitions to auto dealerships near the eastern limit. There is a casino at the Serramonte Boulevard terminus with Hillside Boulevard. The hourly traffic volume information for this corridor is shown in Figure 8.

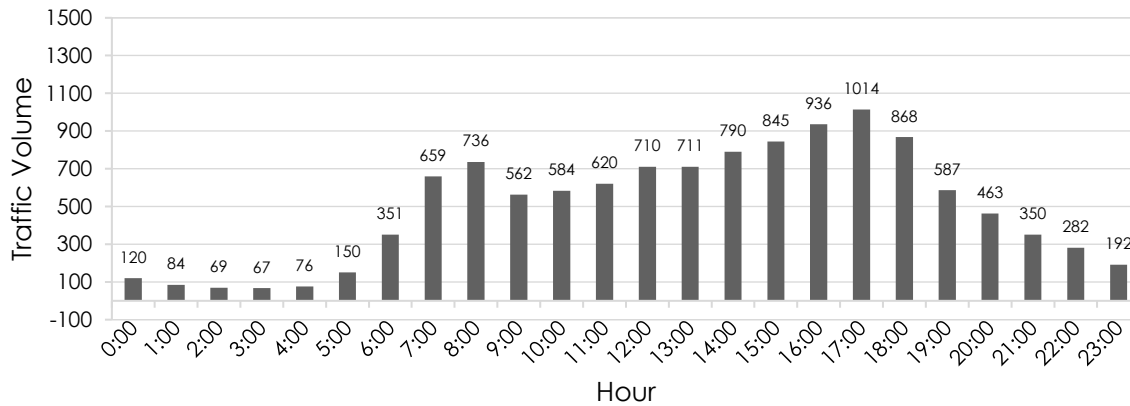
**Figure 9: Traffic Volume Information for Hillside Boulevard**

Hillside Boulevard is a north-south study corridor between the northern and southern town limits. The corridor has residential development and school zone at the north limit just beyond the Colma limit. Heading south into Colma, the land uses consist of cemeteries on either side of the corridor near F Street. The 'Lucky Chances' casino is near the Serramonte Boulevard intersection which is followed by cemeteries on either sides of the corridor until Lawndale Boulevard. The hourly traffic volume information for this corridor is shown in Figure 9.

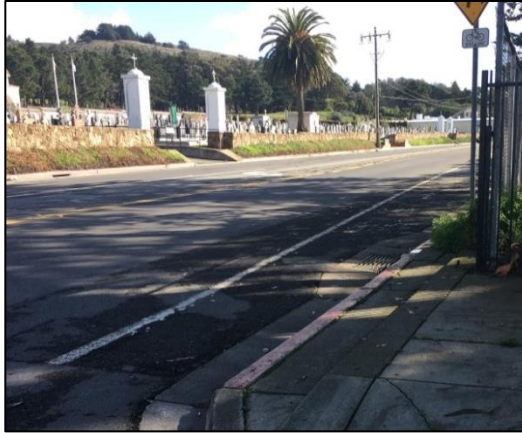
Pedestrian activity seems common along Hillside Boulevard particularly near the cemeteries with people needing to park on-street and walk to the cemeteries or other nearby businesses.

Undefined crossing (xi)

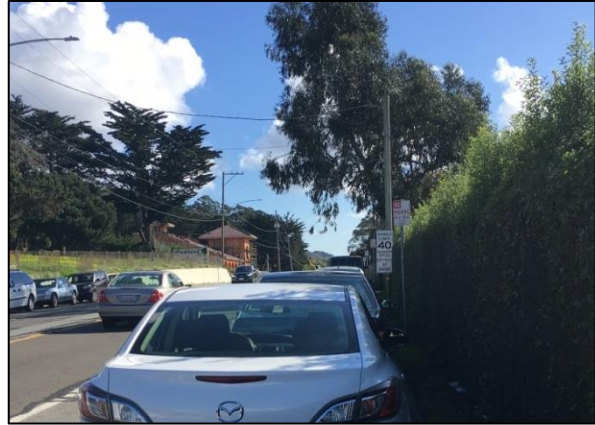
Some speed limit signs, and warning signs are obscured by vegetation. Others are placed at a relative low height relative to on-street parked cars and other roadside conditions. Examples of these conditions are shown in Figure 10.

Obscured sign (xii)

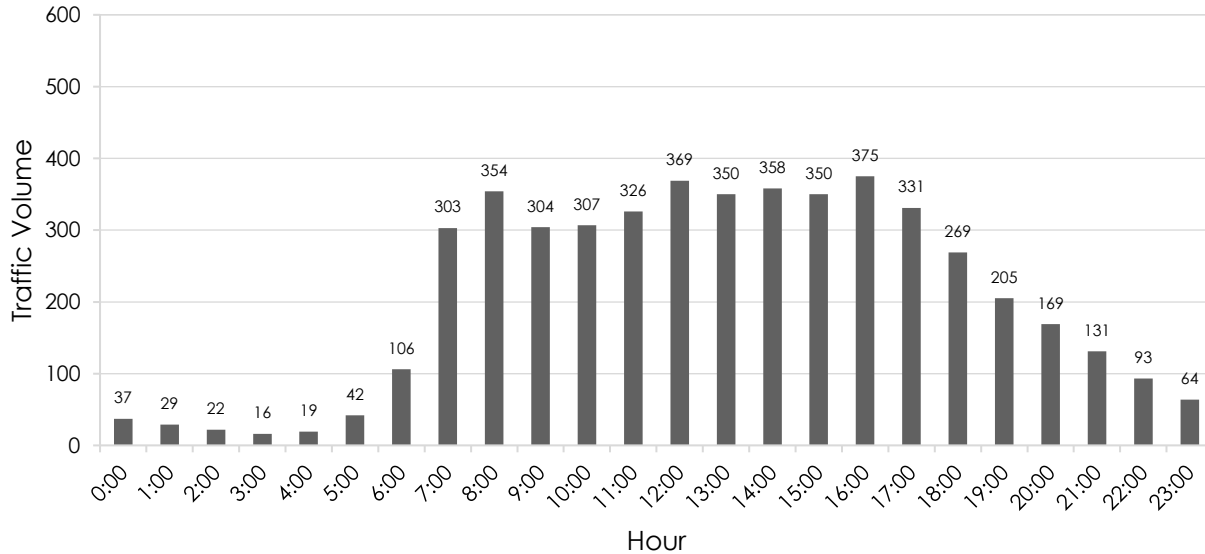
**Figure 11: Traffic Volume Information for Collins Avenue**

Collins Avenue is an east-west study corridor between Serramonte Boulevard and ECR. The corridor has industrial development with car dealerships near Serramonte Boulevard on the south side, and some car dealerships and a shopping center (i.e. Kohl's) near the ECR/Collins Avenue intersection on the north side of the corridor. There is on-street parking on one side of the corridor on the west side, and on both sides near the Serramonte Ford Body Shop along the Collins Avenue corridor. The hourly traffic volume information for this corridor is shown in Figure 11.

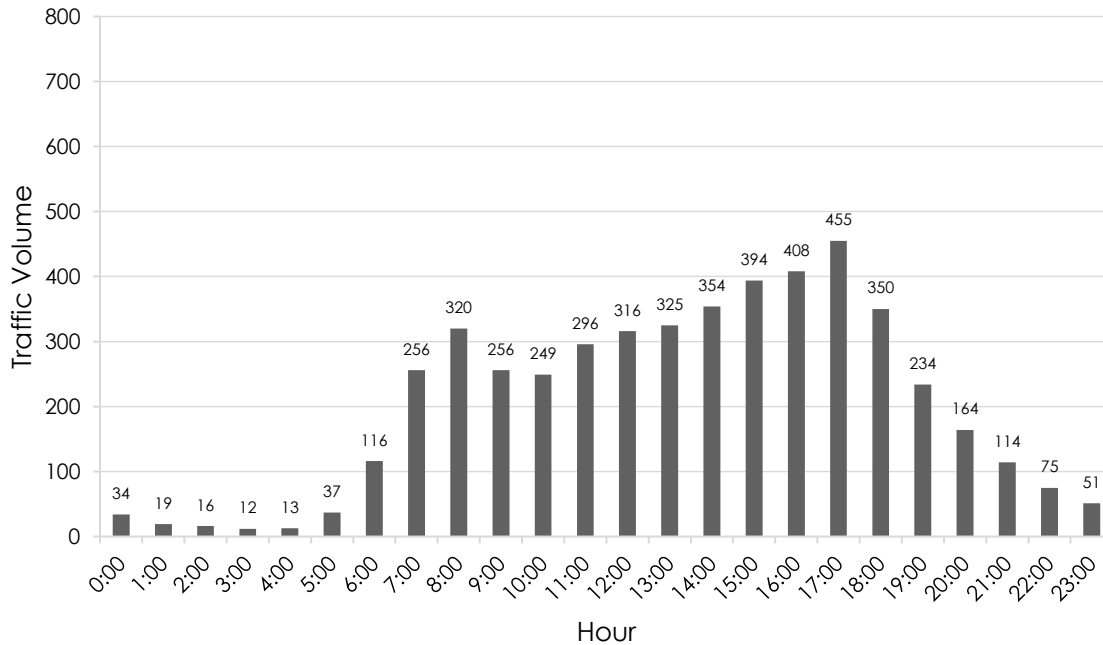
**Figure 12: Traffic Volume Information for Lawndale Boulevard**

Lawndale Boulevard is an east-west study corridor in between Hillside Boulevard and Mission Road. The corridor has residential development for about quarter length of the corridor and school for the other part of the corridor. ECR High School is on the south side near Mission Road. The roadway segment has a downgrade from Hillside Boulevard to Mission Road. The hourly traffic volume is shown in Figure 12.

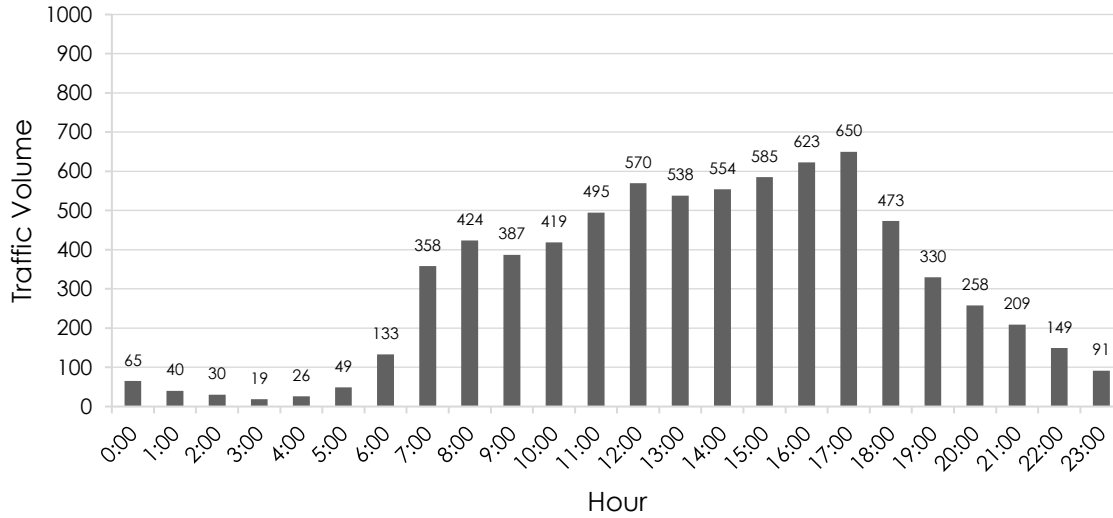
**Figure 13: Traffic Volume Information for Mission Road**

Mission Road is a north-south corridor that terminates at ECR on the north and Lawndale Boulevard on the south. Mission Road has residential development on the west side and cemeteries on the east side of the corridor. The crash data for this corridor showed speeding related crashes. This finding was also validated by the community input received. The hourly traffic volume information for this corridor is shown in Figure 13.
