PHASE I

ENVIRONMENTAL SITE ASSESSMENT

775 SERRAMONTE AVENUE
COLMA, CALIFORNIA

EIS, Inc. PROJECT #1913-1

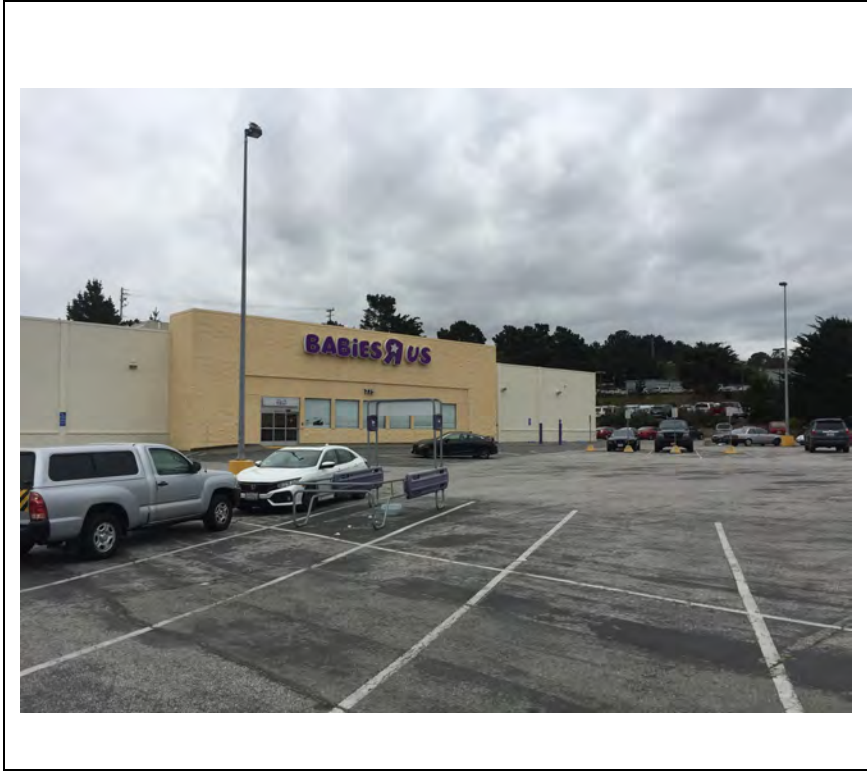
Project No. 1913-1	Description	View of subject property parking lot and retail warehouse.	1
	Name	775 Serramonte Boulevard, Colma, California	Photo Date February 12, 2019

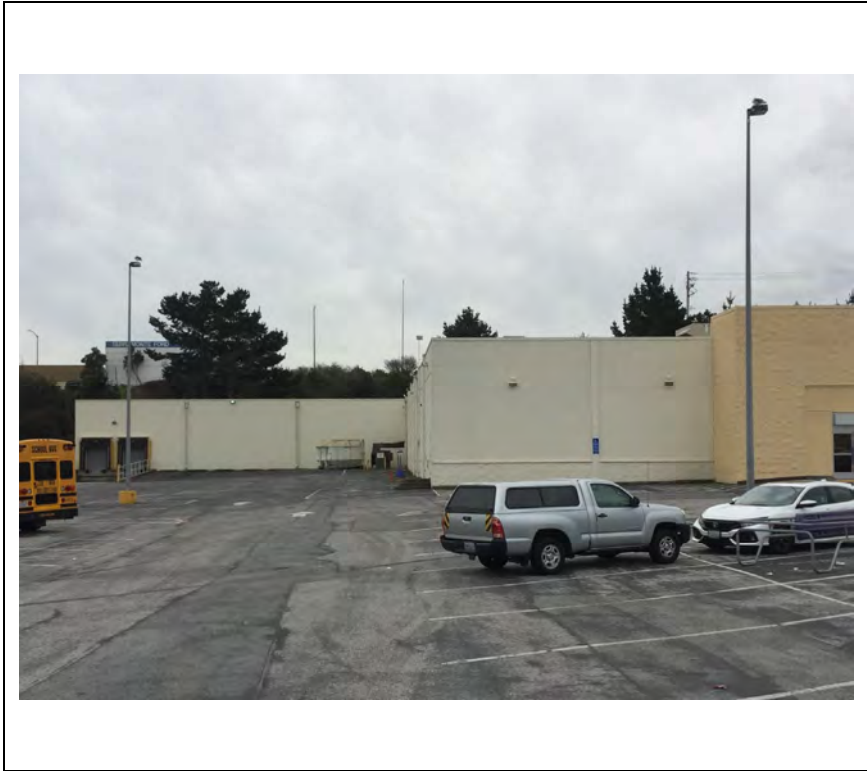
Project No. 1913-1	Description	View of subject property parking area and eastern exterior of the retail warehouse.	2
	Name	775 Serramonte Boulevard, Colma, California	Photo Date February 12, 2019

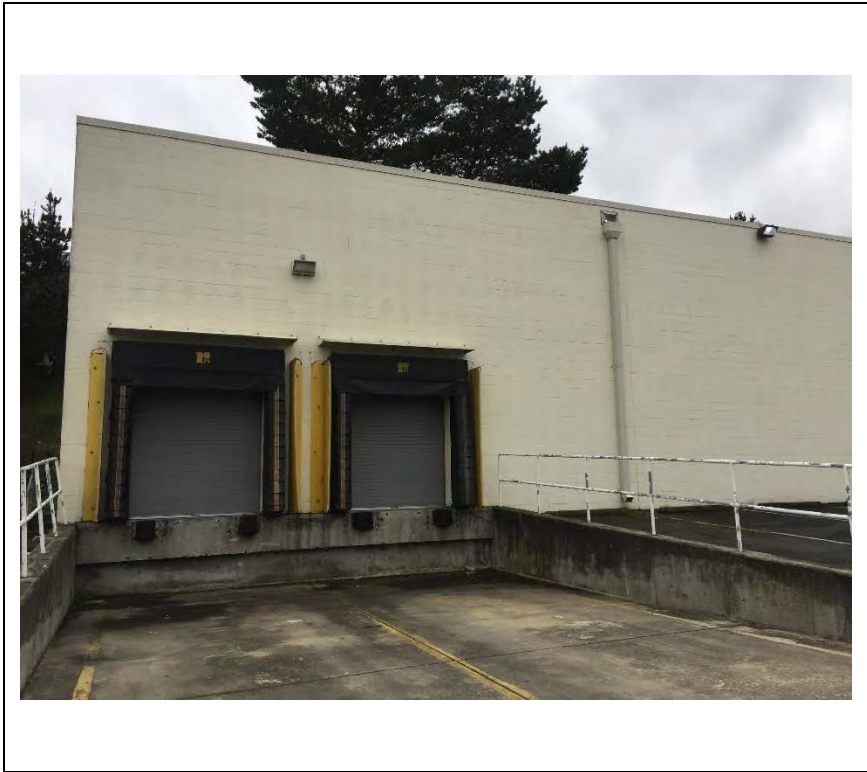
Project No. 1913-1	Description	View of the loading dock located in the eastern exterior of the subject property retail warehouse.	3
	Name	775 Serramonte Boulevard, Colma, California	Photo Date February 12, 2019

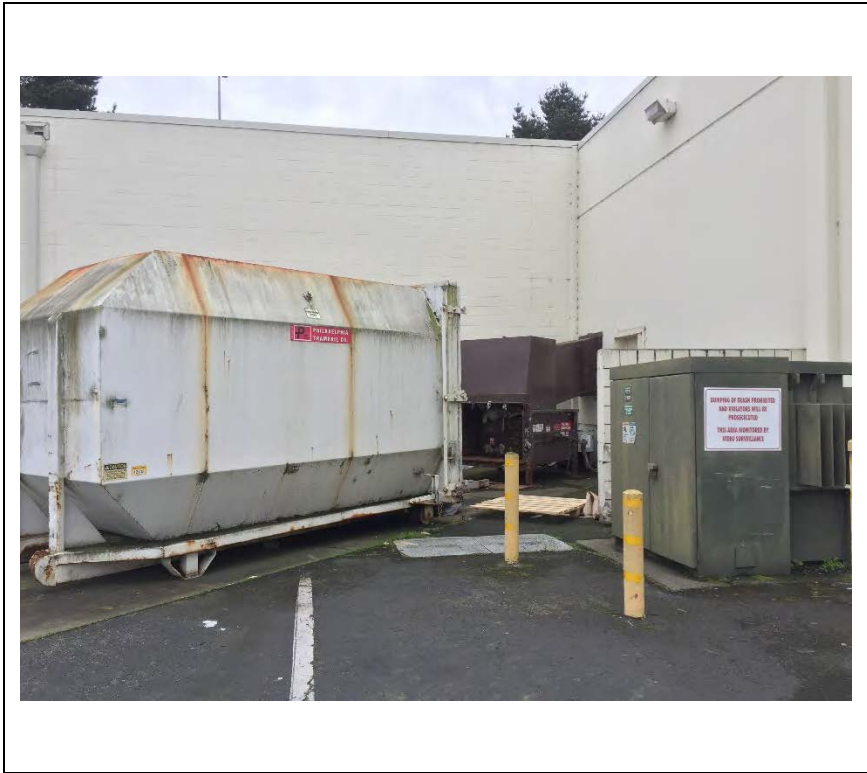
Project No. 1913-1	Description	View of outdoor solid waste storage located outside the eastern portion of the subject property retail warehouse, with dumpster (full), garbage compactor, and pad-mounted transformer visible.	4
	Name	775 Serramonte Boulevard, Colma, California	Photo Date February 12, 2019

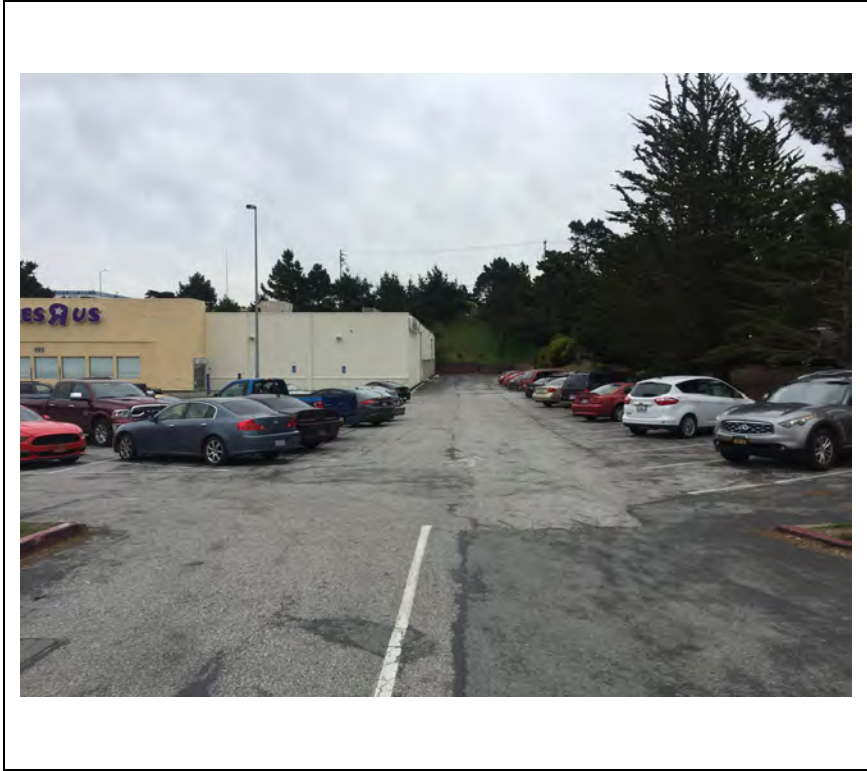
Project No. 1913-1	Description	View of subject property parking area and western exterior of the retail warehouse.	5
	Name	775 Serramonte Boulevard, Colma, California	Photo Date February 12, 2019

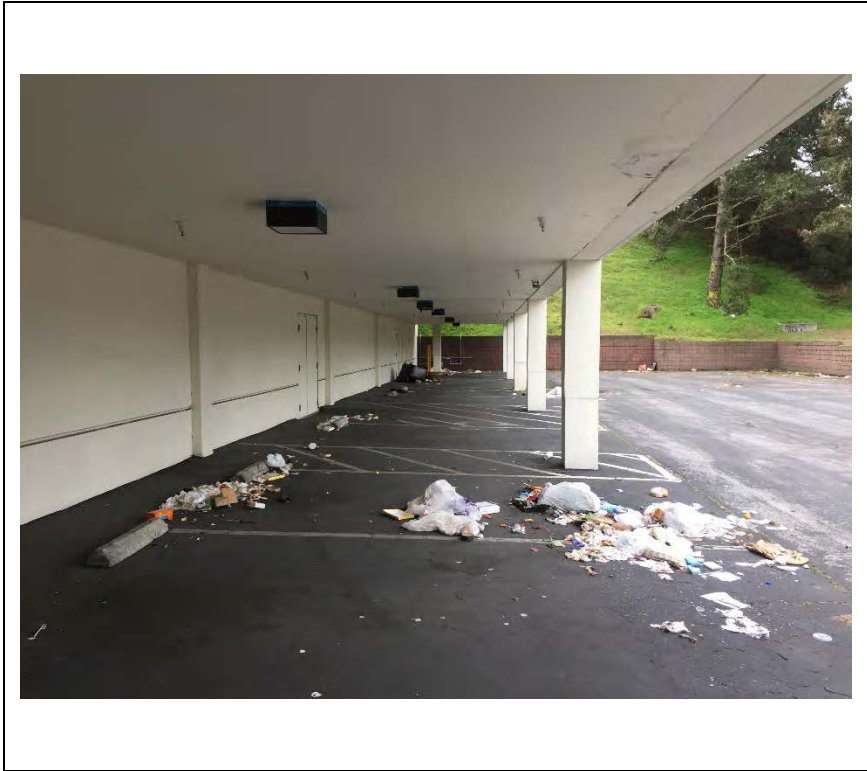
Project No. 1913-1	Description	View of subject property covered parking along the western exterior of the retail warehouse.	6
	Name	775 Serramonte Boulevard, Colma, California	Photo Date February 12, 2019

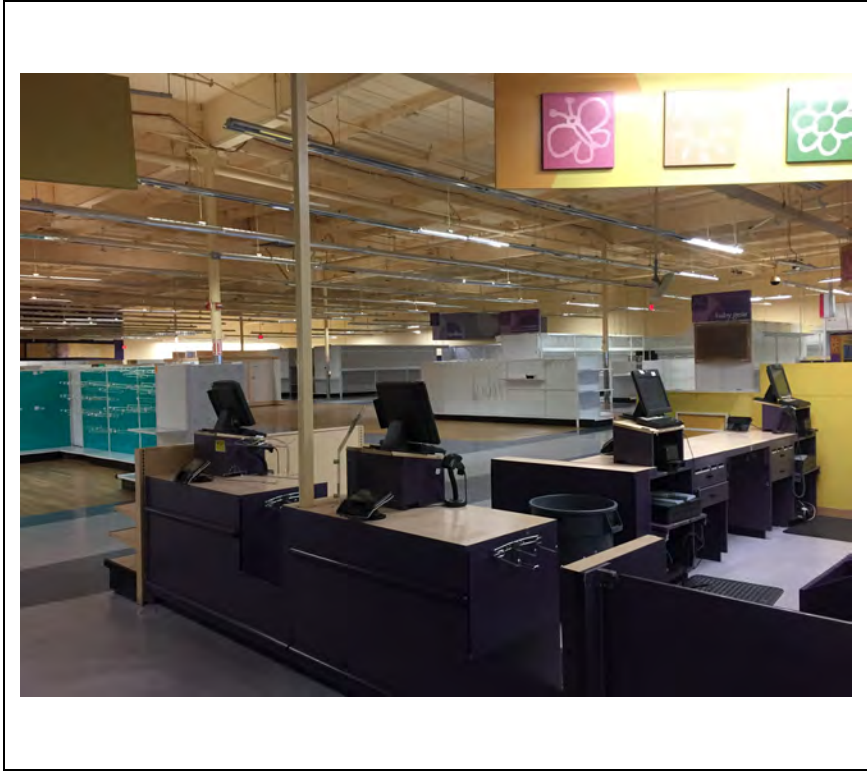
Project No. 1913-1	Description	View of ground level checkout area and sales floor.	7
	Name	775 Serramonte Boulevard, Colma, California	Photo Date February 12, 2019

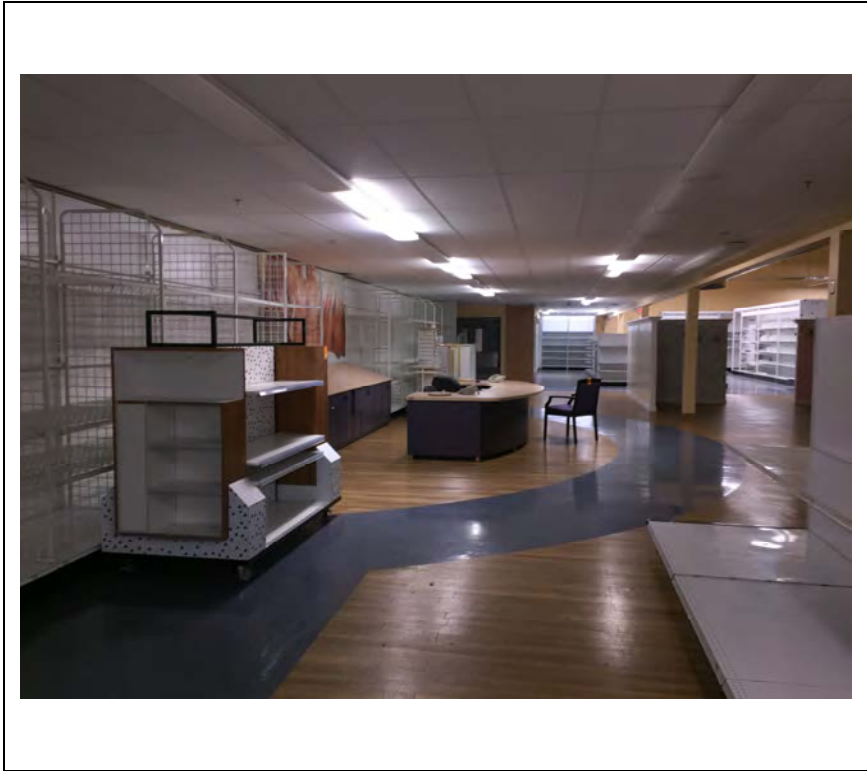
Project No. 1913-1	Description	View of ground level sales floor.	8
	Name	775 Serramonte Boulevard, Colma, California	Photo Date February 12, 2019

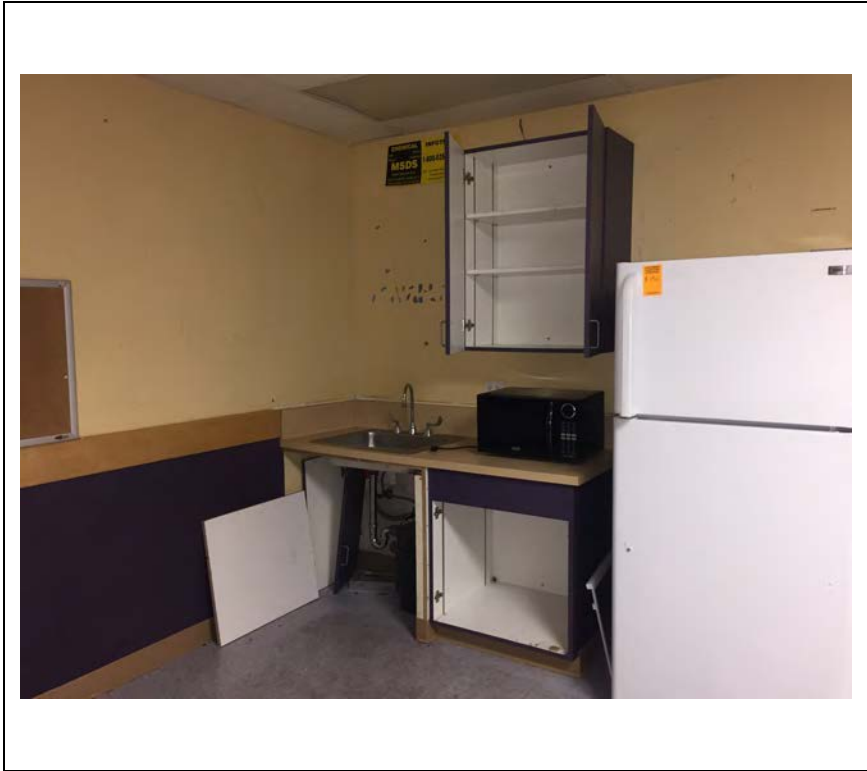
Project No. 1913-1	Description	View of employee breakroom located on the ground level in the western interior of the retail warehouse.	10
	Name	775 Serramonte Boulevard, Colma, California	Photo Date February 12, 2019

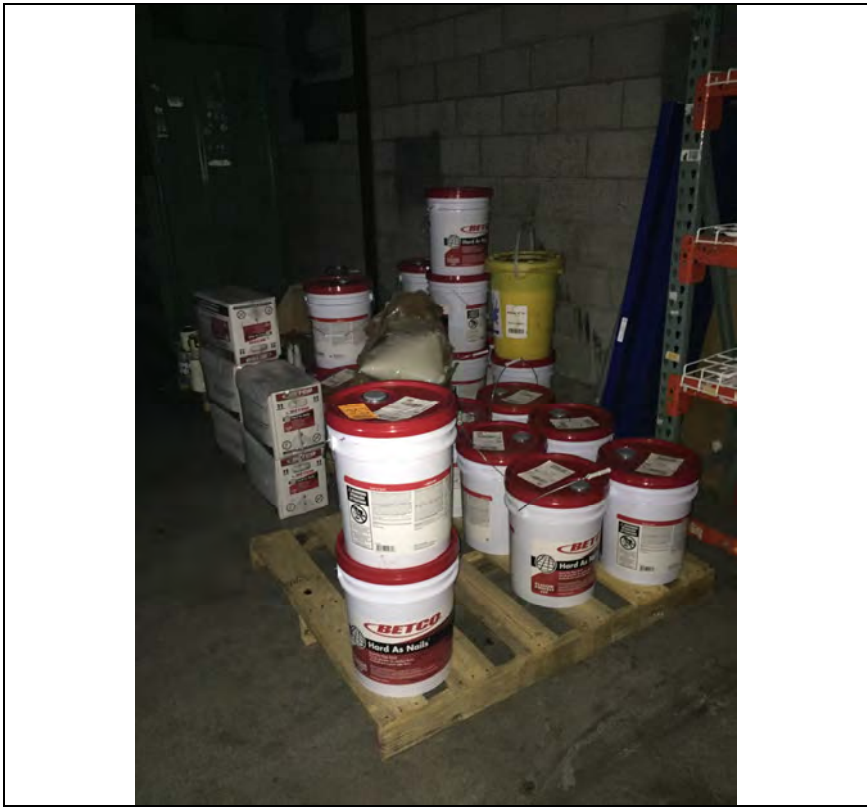
Project No. 1913-1	Description	View of floor finish, paint, and miscellaneous janitorial supply storage located in the interior loading dock area on the ground level.	12
	Name	775 Serramonte Boulevard, Colma, California	Photo Date February 12, 2019

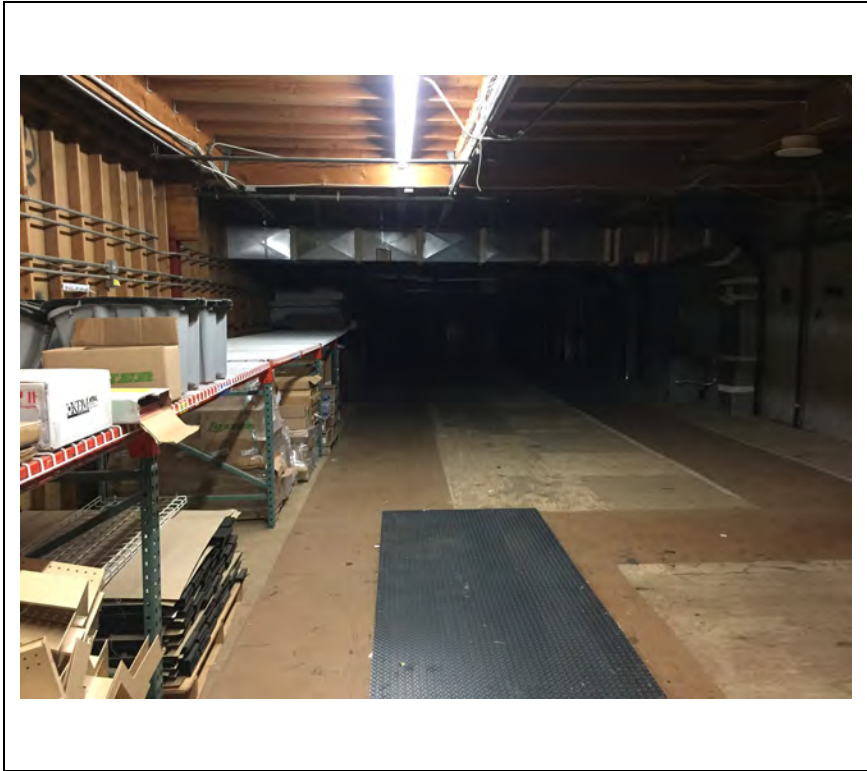
Project No. 1913-1	Description	View of upstairs stock room storage area.	13
	Name	775 Serramonte Boulevard, Colma, California	Photo Date February 12, 2019

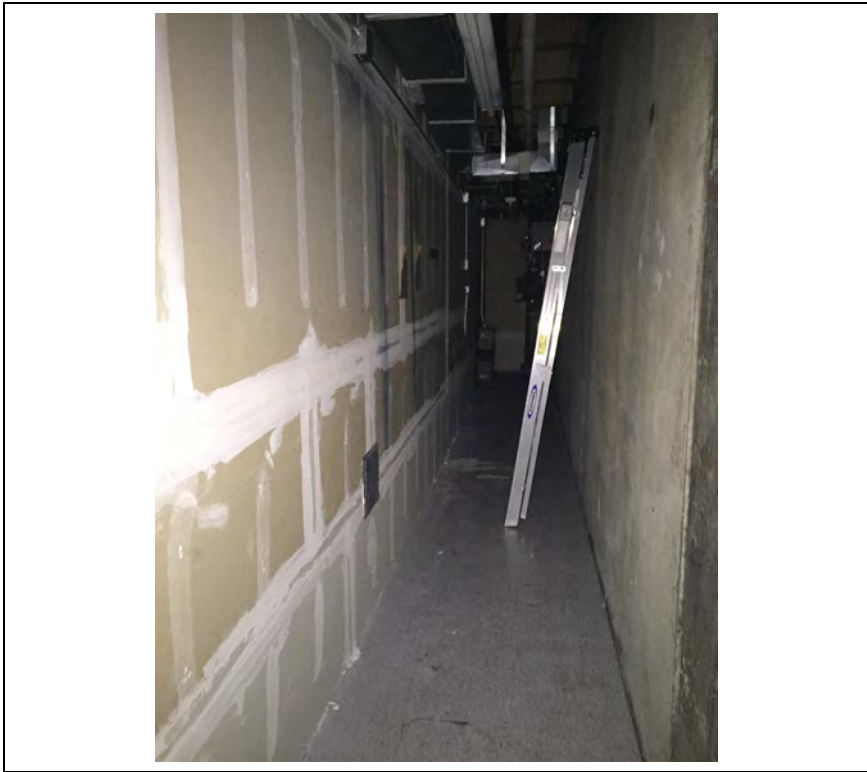
Project No. 1913-1	Description	View of ground level backroom with water riser visible in the background.	14
	Name	775 Serramonte Boulevard, Colma, California	Photo Date February 12, 2019

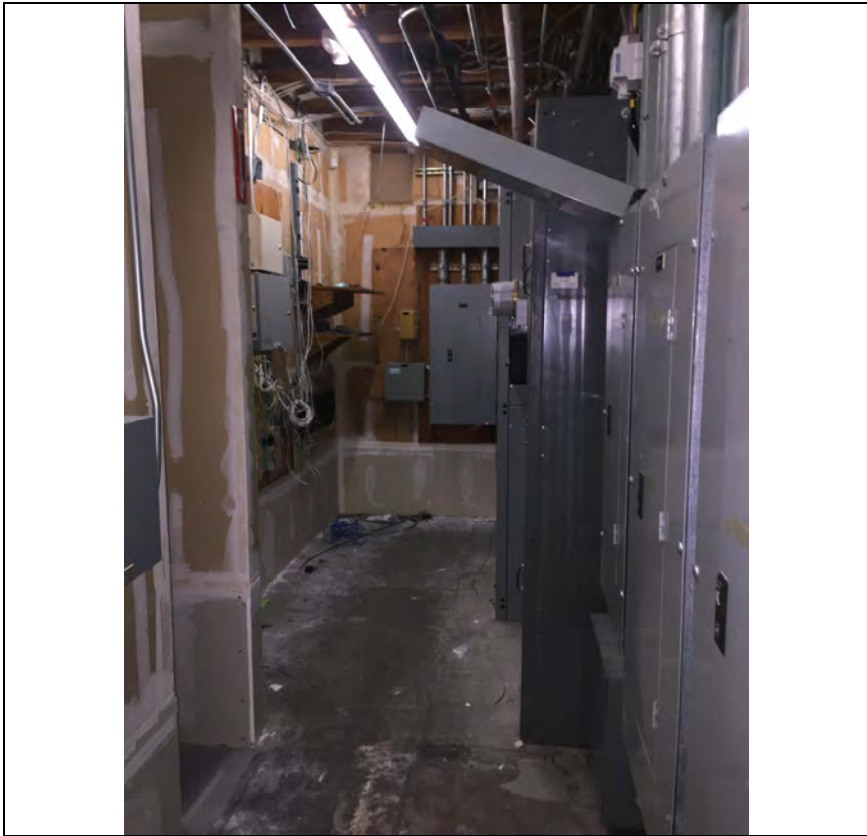
Project No. 1913-1	Description	View of the ground level electrical room.	16
	Name	775 Serramonte Boulevard, Colma, California	Photo Date February 12, 2019

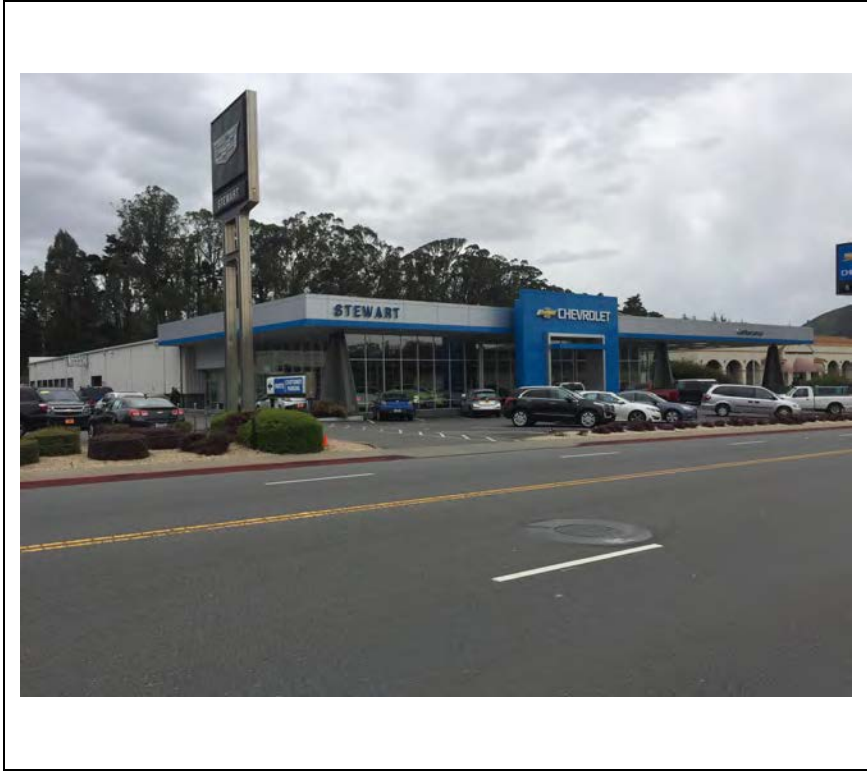
Project No. 1913-1	Description	View from the subject property of the nearby northwestern property.	17
	Name	775 Serramonte Boulevard, Colma, California	Photo Date February 12, 2019

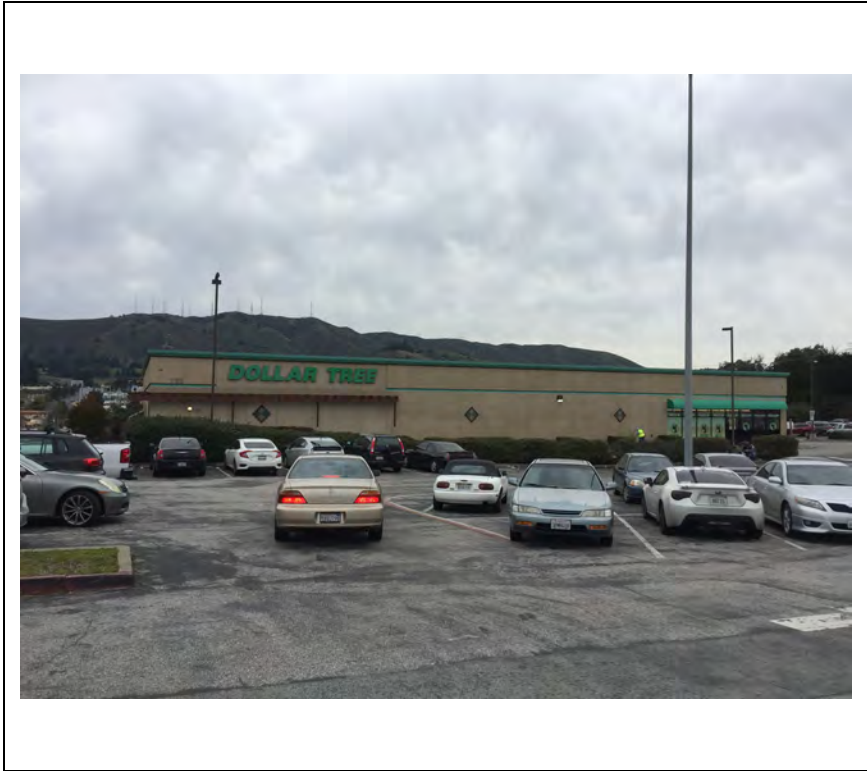
Project No. 1913-1	Description	View from the subject property of the northeastern adjoining property.	18
	Name	775 Serramonte Boulevard, Colma, California	Photo Date February 12, 2019
