# HOOK POND WATER QUALITY IMPROVEMENT STUDY

## DIAGNOSIS, PROBLEM IDENTIFICATION & MANAGEMENT PLAN – APRIL 2015

## Hook Pond Water Quality Improvement Project

# Watershed Definition, Compilation of Existing Water Quality Data & Its Analysis

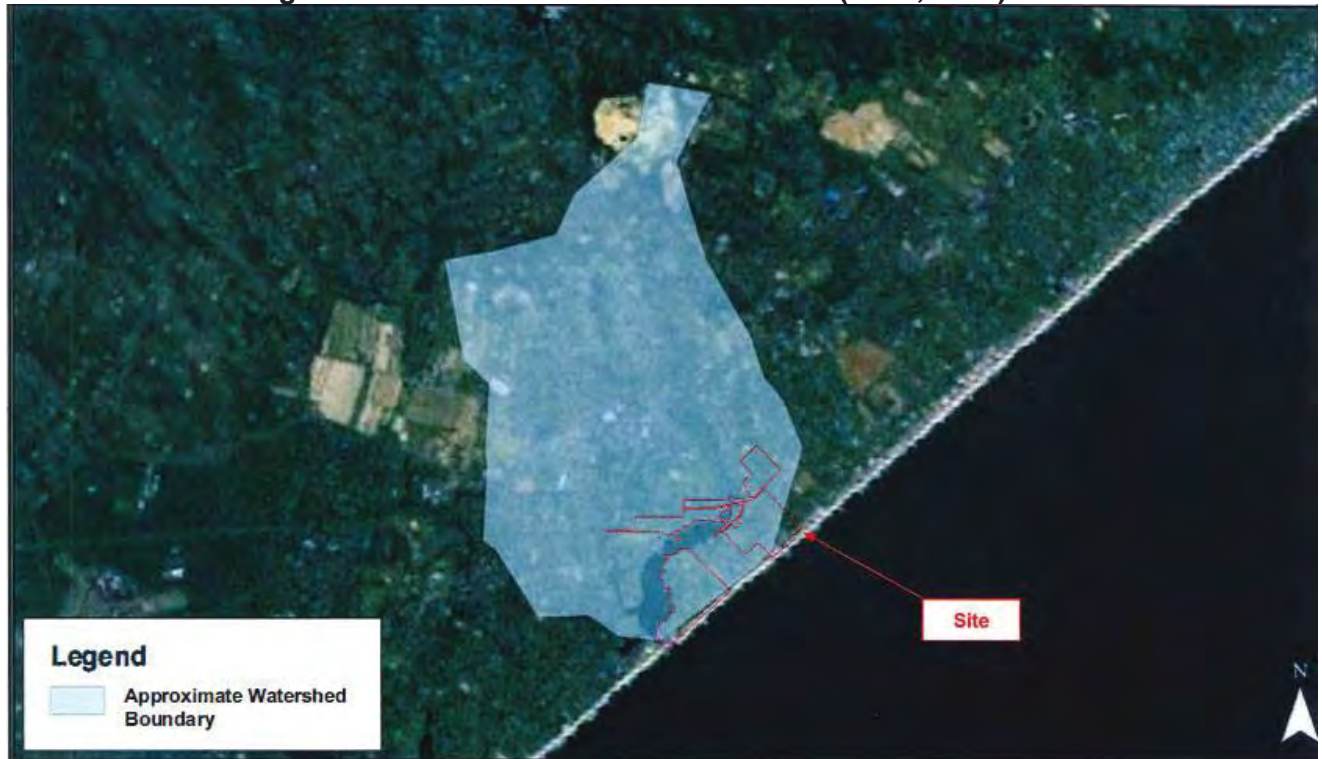
Figure 3-3 Hook Pond Surface Watershed (DEIS, 2013)

FIGURE 10 – HOOK POND WATERSHED

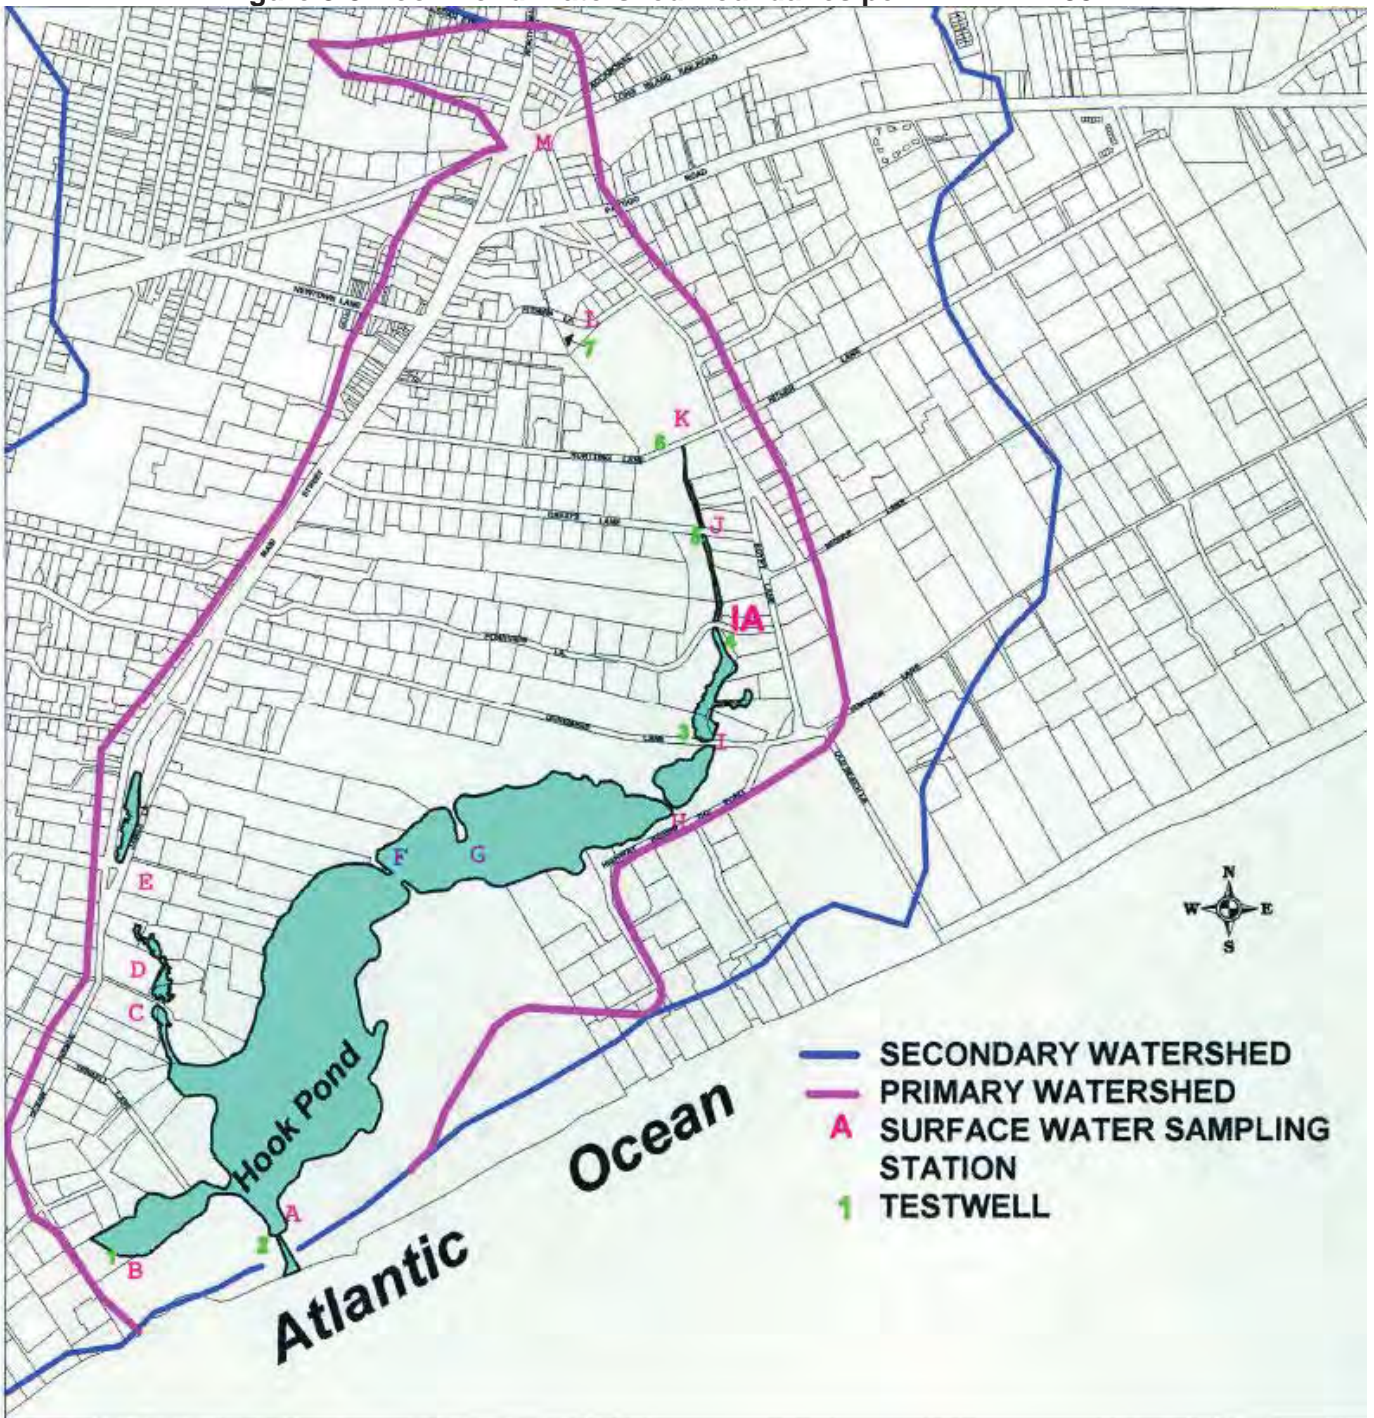
Figure 3-9 Hook Pond Watershed Soils by Suitability for Onsite Systems

Figures 3.6, 3.7, 3.8 and 3.9 present the DEC Wetlands, FEMA Floodplains, Sea, Lake and Overland Surges from Hurricanes (SLOSH) areas of Hook Pond and watershed Soils Map, respectively. Figure 3-9 presents the USDA soils types grouped by suitability for onsite wastewater disposal systems. The soils within the Village area of the Hook Pond watershed largely fall in the category of having a low hydraulic loading rate (HLR). Soils with low HLRs

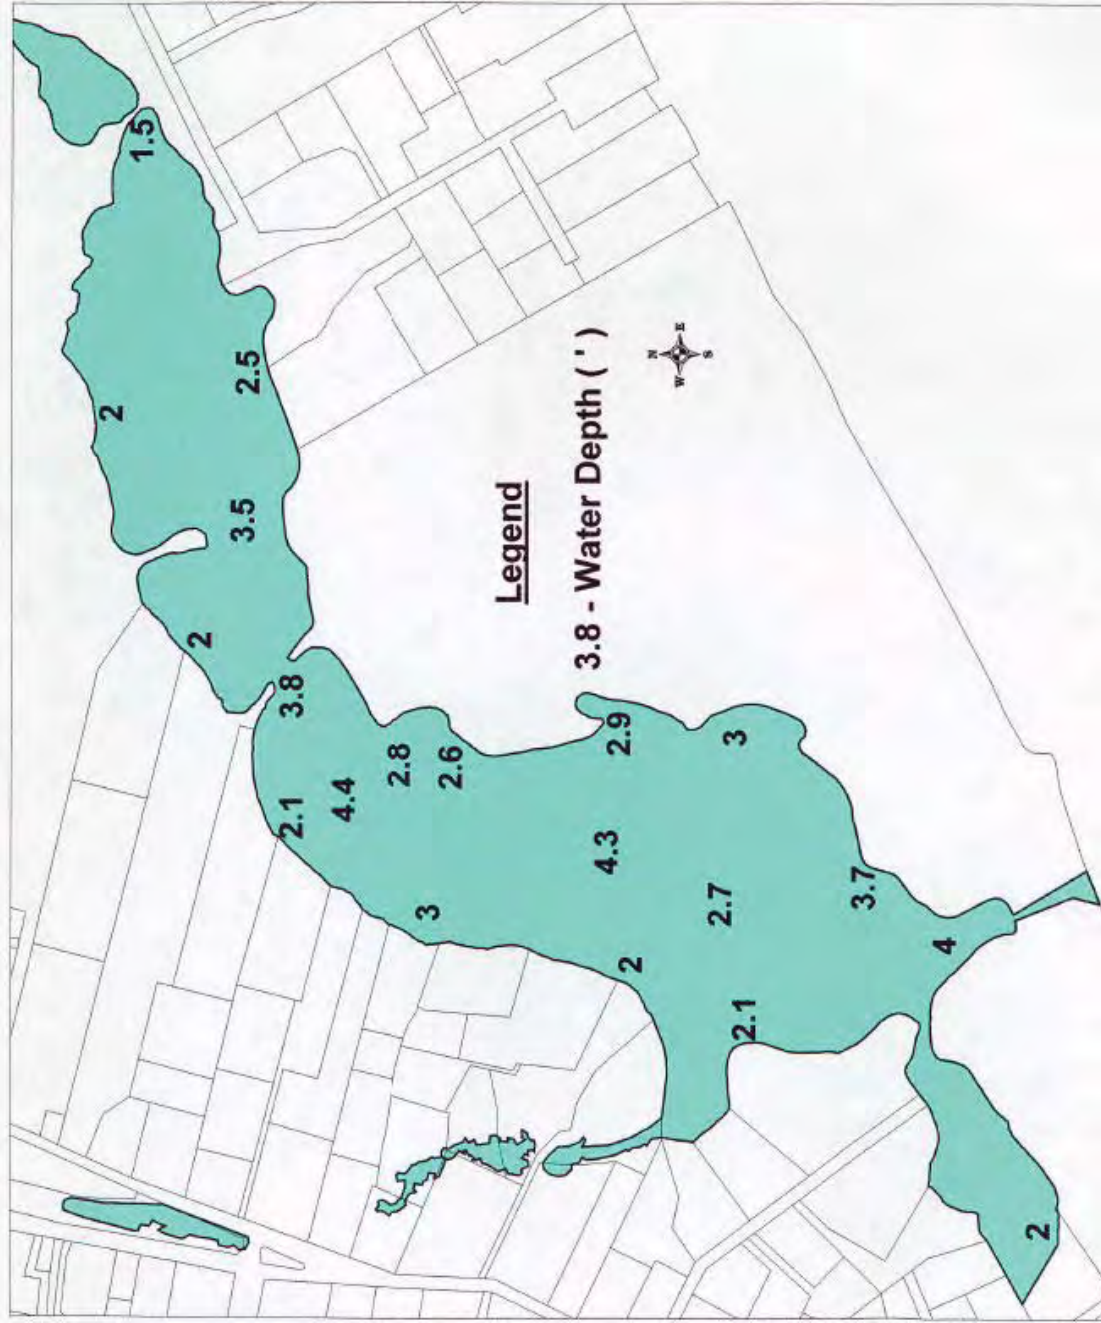
Figure 3-11 Hook Pond Water Depth (feet) - 1997

The bathymetry (water depth) of Hook Pond was determined in the 1981 limnological study as presented on Figure 3-10 and the EHDNR as presented on Figure 3-11. Unfortunately the Pond elevation above the outfall invert was not measured. An annual average water budget for Hook Pond is presented on Table 3-1 with a summertime – 90 day budget presented on Table 3-2 and 3-3 for current and future projected consumptive water uses. Using an average precipitation of 45-inches / year for Suffolk County (USGS, 1998) and 50% rainfall groundwater recharge for pervious areas and 95% for impervious areas, a preliminary annual water budget for Hook Pond, Table 3-1, was calculated using the groundwater watershed area as the source of groundwater discharging to the Pond.

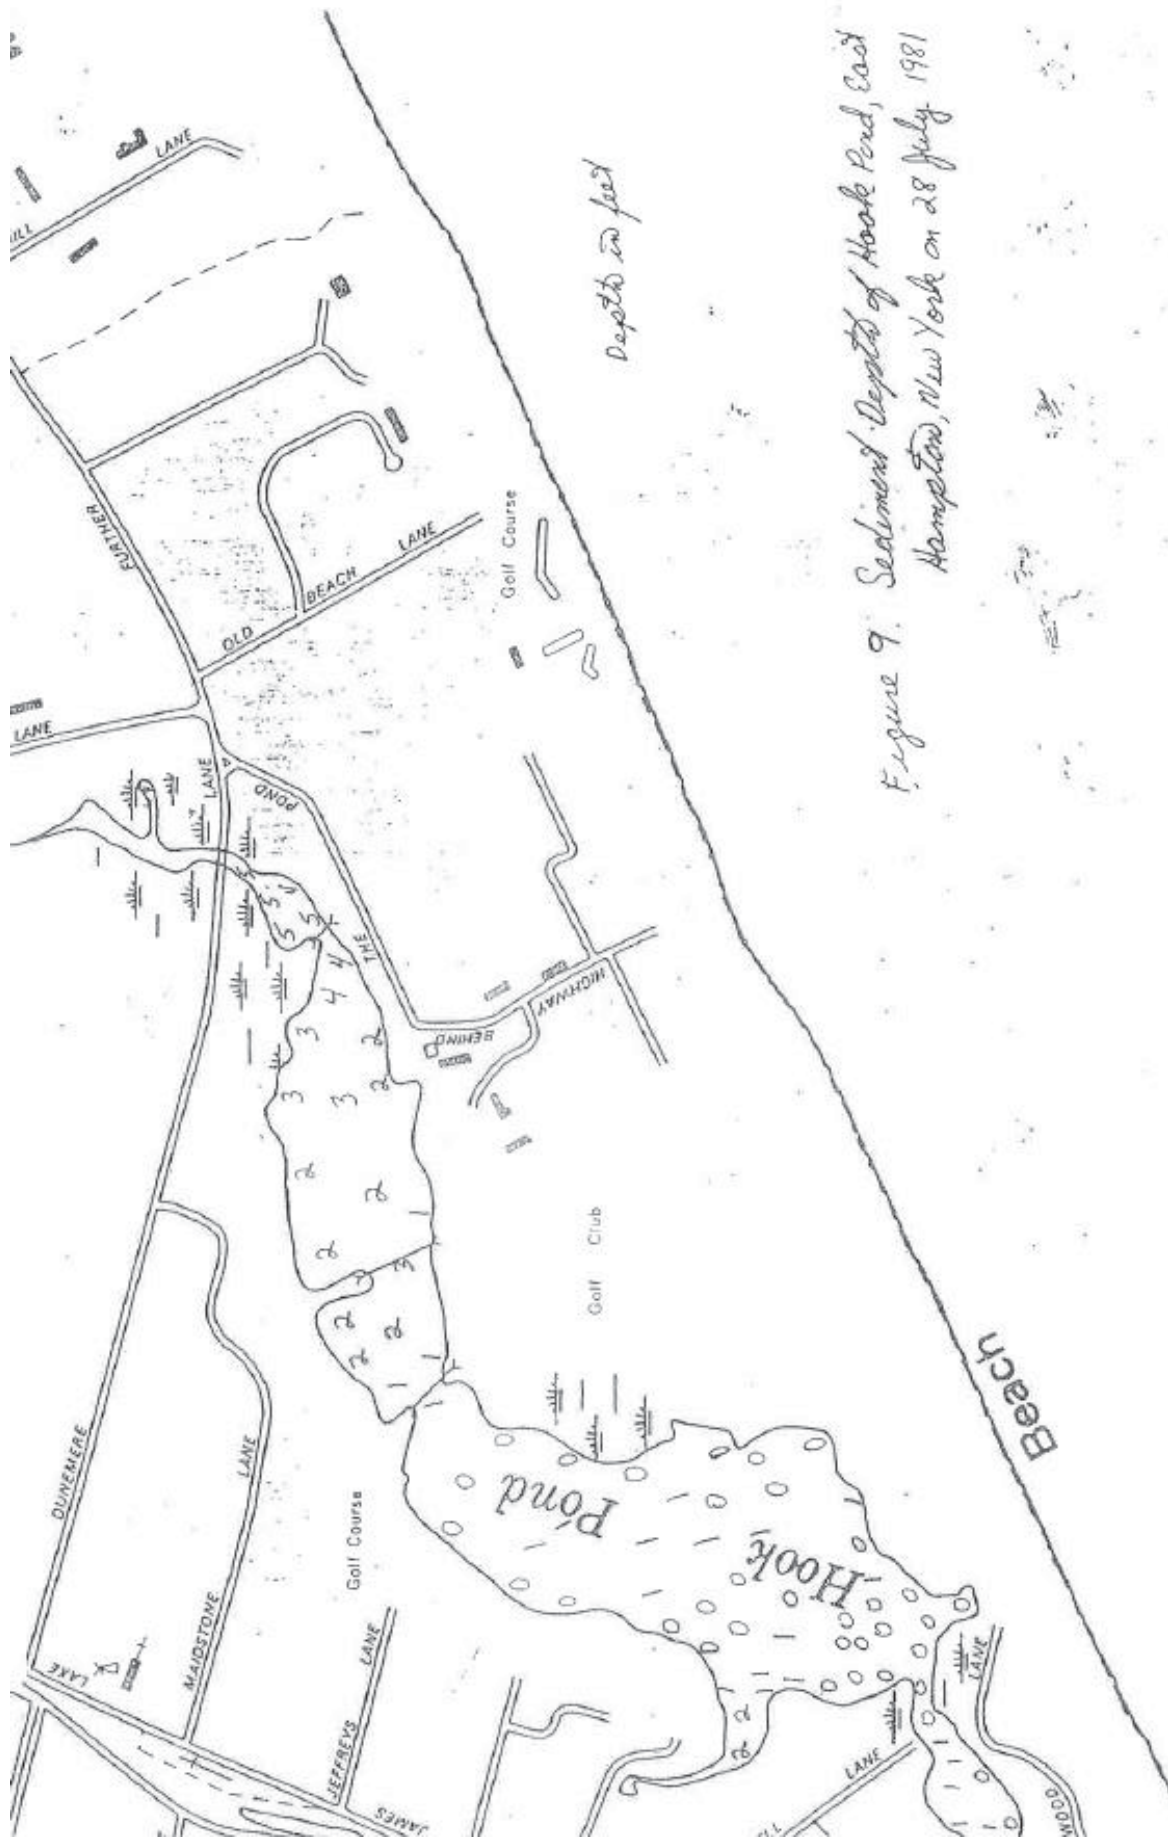
Figure 3-13 Hook Pond Sediment Depth – 1981

Pond sediment depth and quality was determined in the 1981 limnological study with the data presented on Figure 3-13 and Table 3-5 respectively. As noted below, the 1981 sediment data needs to be carefully interpreted for the following reasons:

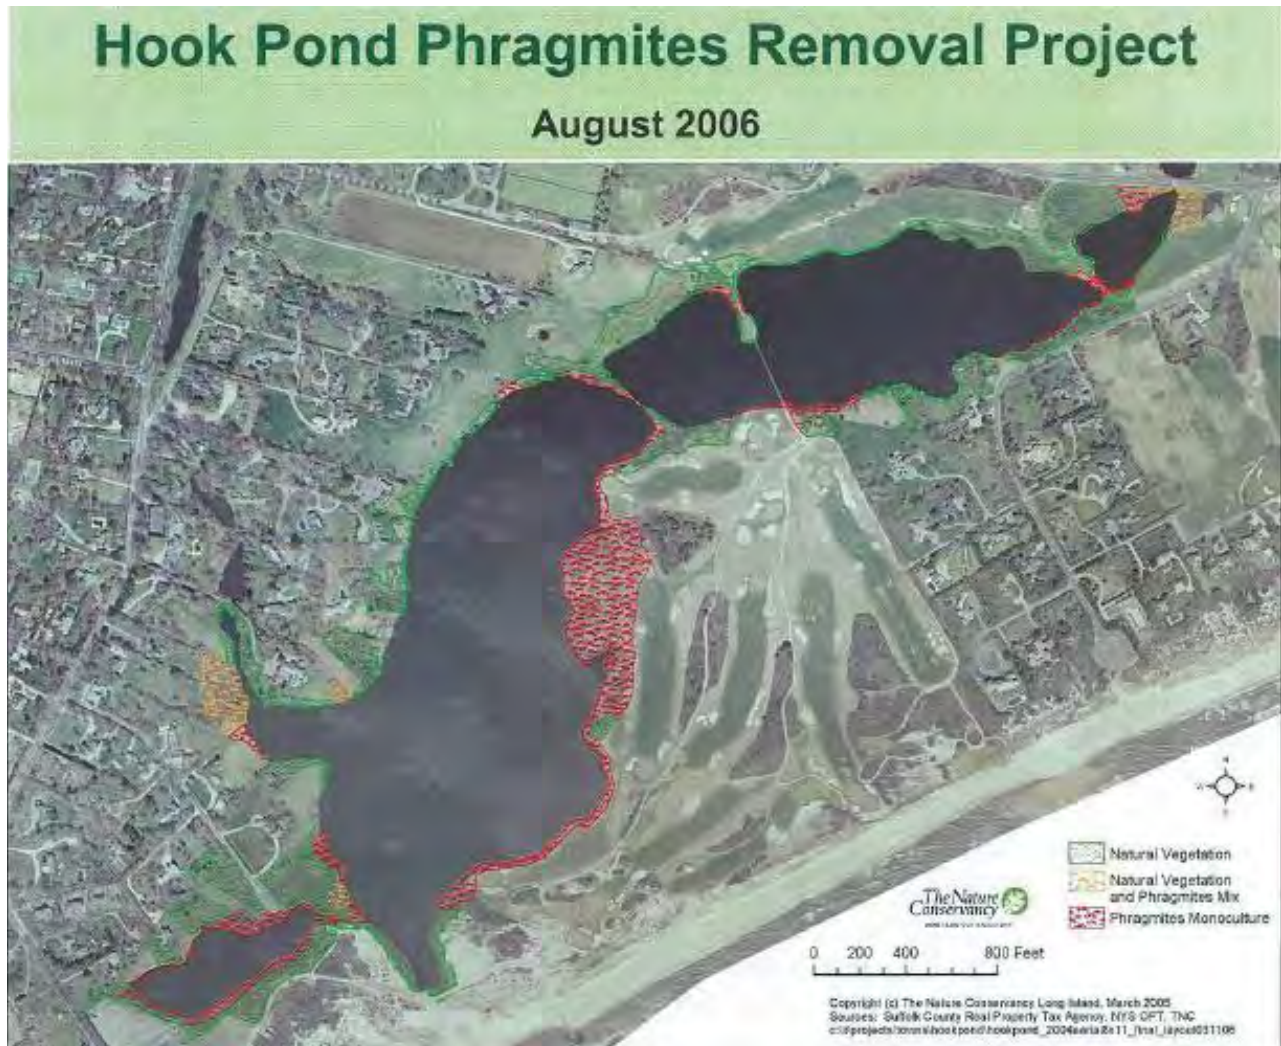
Figure 3-21 Hook Pond Area of Phragmites Removal Areas

- Phragmites are cut 3-4 times per year on the Club's side of the property – see Figure 3-21. NYSDEC periodically inspects the cutting.
- Pond elevations – The Pond elevation is managed by the Village and Maidstone Club, with the Club actually controlling the outfall structure. According to Maidstone, the preferred Pond elevation is 18" above the outlet invert, which would be approximately elevation 2.7 feet. The discharge valve (see Figure 3-19) is opened when the Pond gets above 2.7 feet, in anticipation of large rain events and in preparation for phragmites cutting

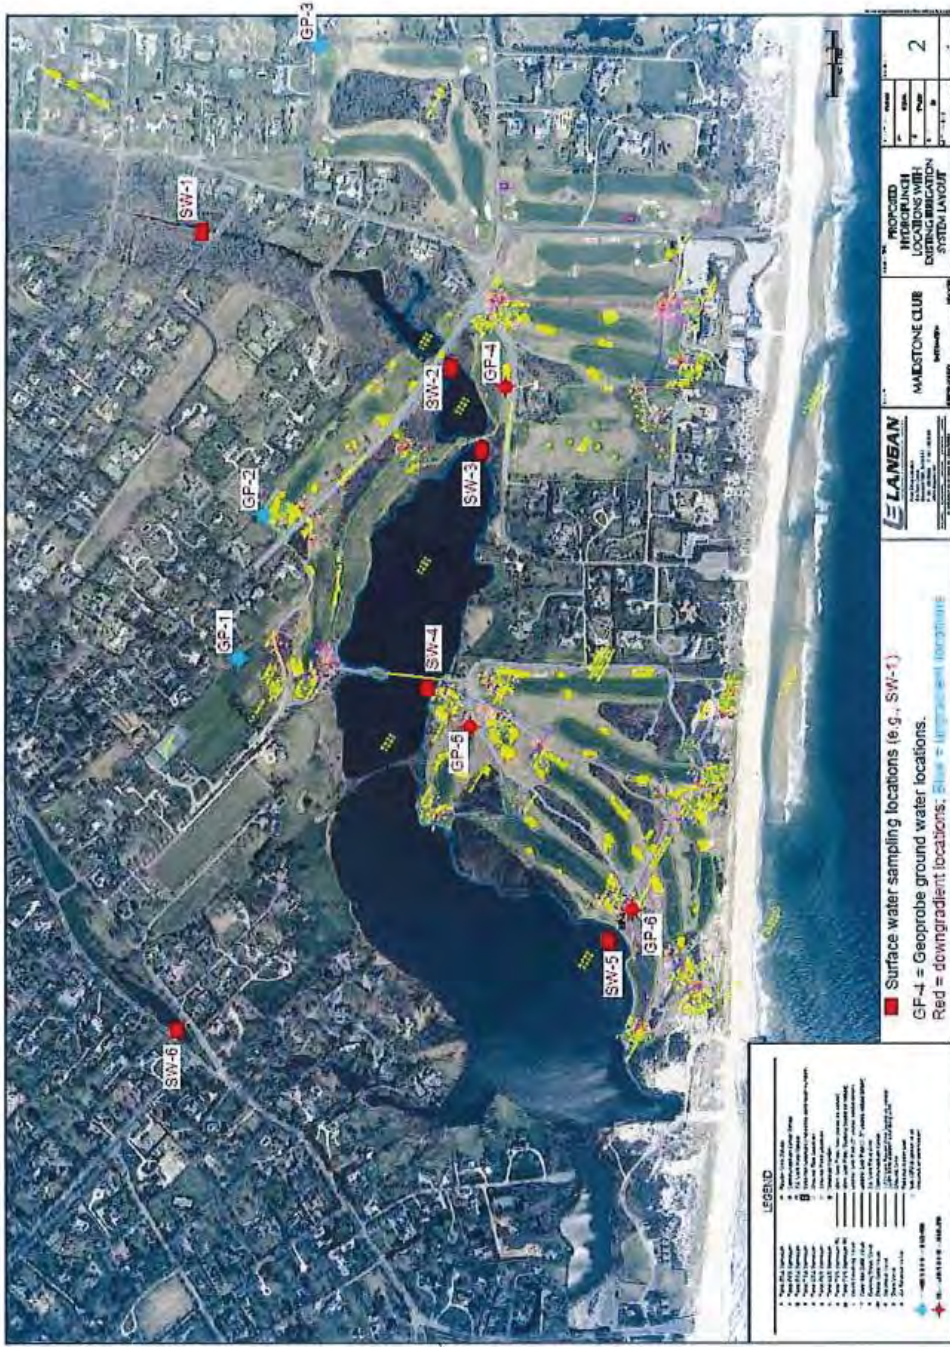
Figure 4-4 Maidstone DEIS Water Quality Sampling Locations

FIGURE 11 – 2013 SURFACE WATER AND GROUNDWATER SAMPLING LOCATIONS

for the locations illustrated on Figure 4-4. The surface water sampling results are presented on Table 4-6 and the groundwater sampling results on Table 4-7.

Sample locations SW-3 (Maidstone short bridge), SW-2 (Dunemere Lane) and SW-1 (Davids Lane bridge) (See Figure 4-4), were sampled on January 30, 2013 and total phosphorus was measured at below the reporting limit of 0.050 mg/L.

Sample locations SW-4 (Maidstone long bridge) and SW-5 (near outlet near eastern shore) (See Figure 4-4), were sampled on January 30, 2013 and total phosphorus was measured at below the reporting limit of 0.050 mg/L.

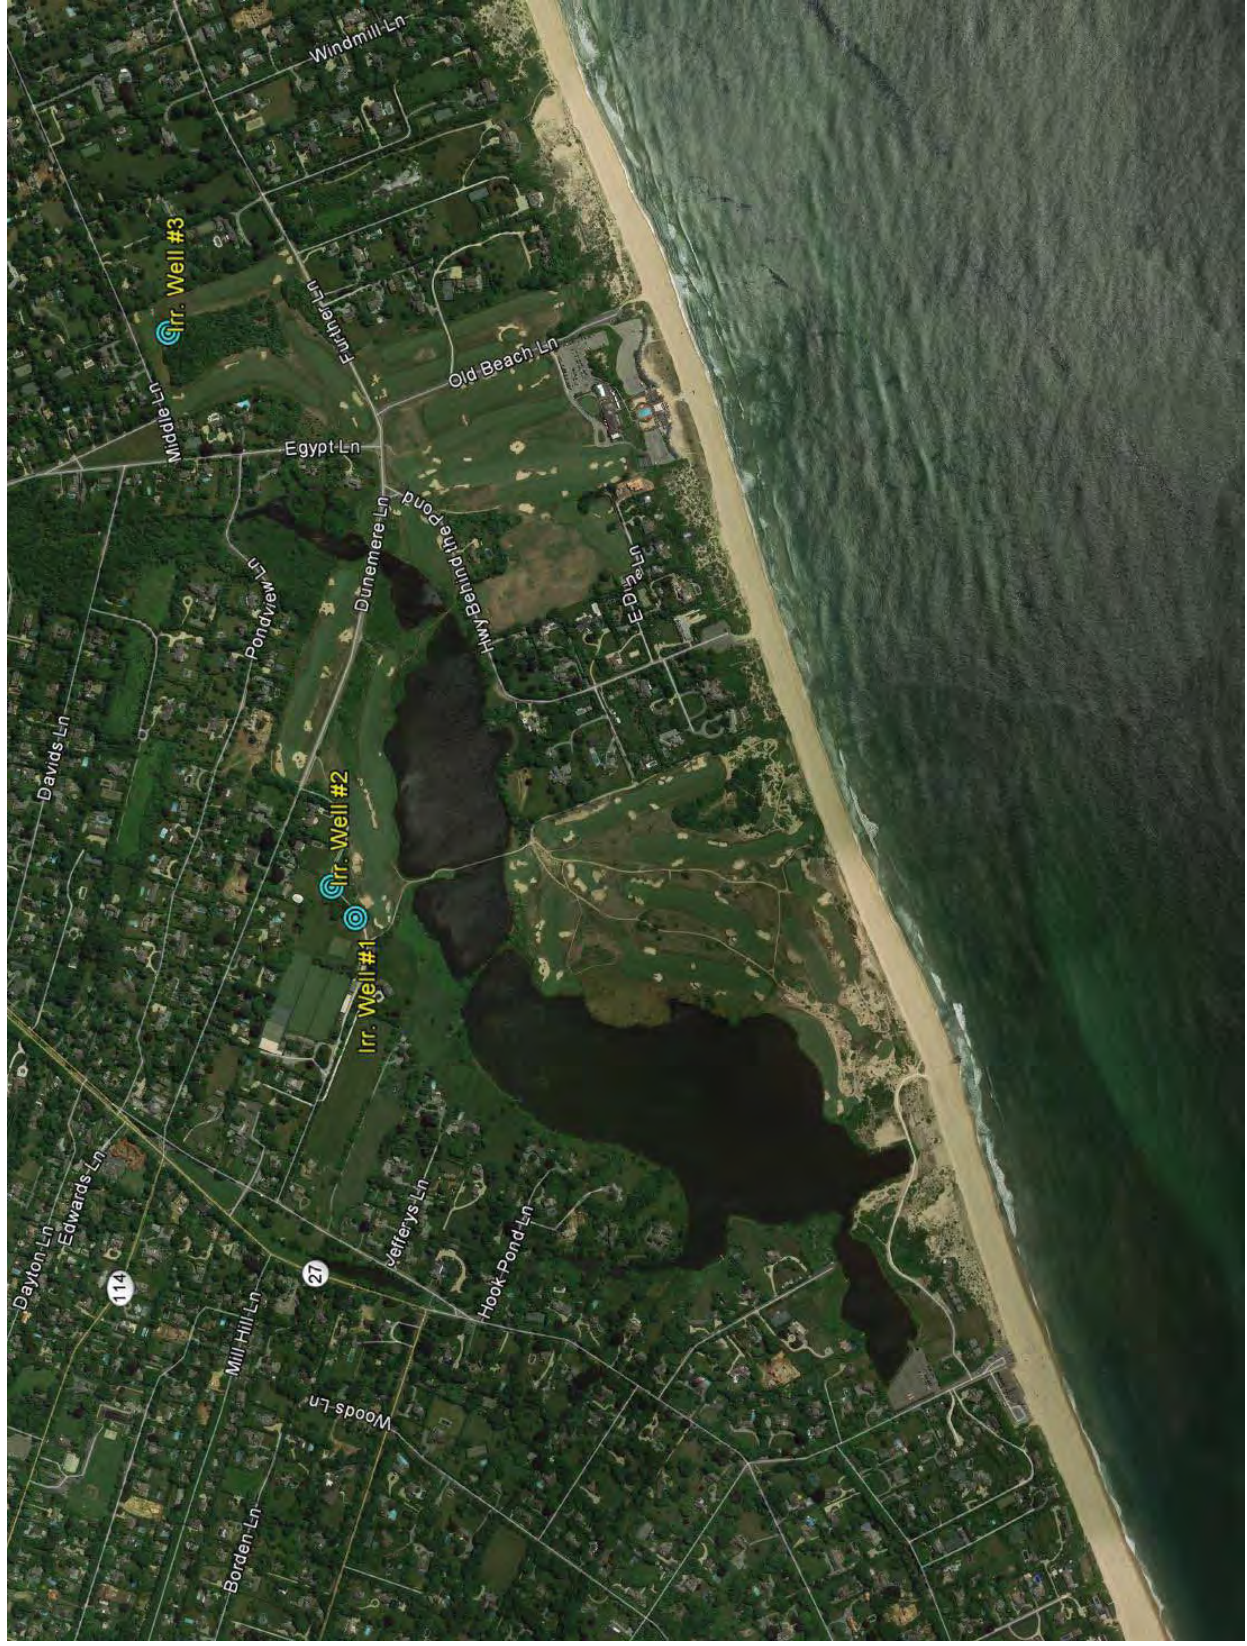
Figure 4-5 Maidstone Irrigation Well Locations (#1 & #2 existing, #3 proposed)

The locations of the existing Maidstone irrigation wells # 1 & # 2 and the proposed new well # 3 are illustrated on Figure 4-5.

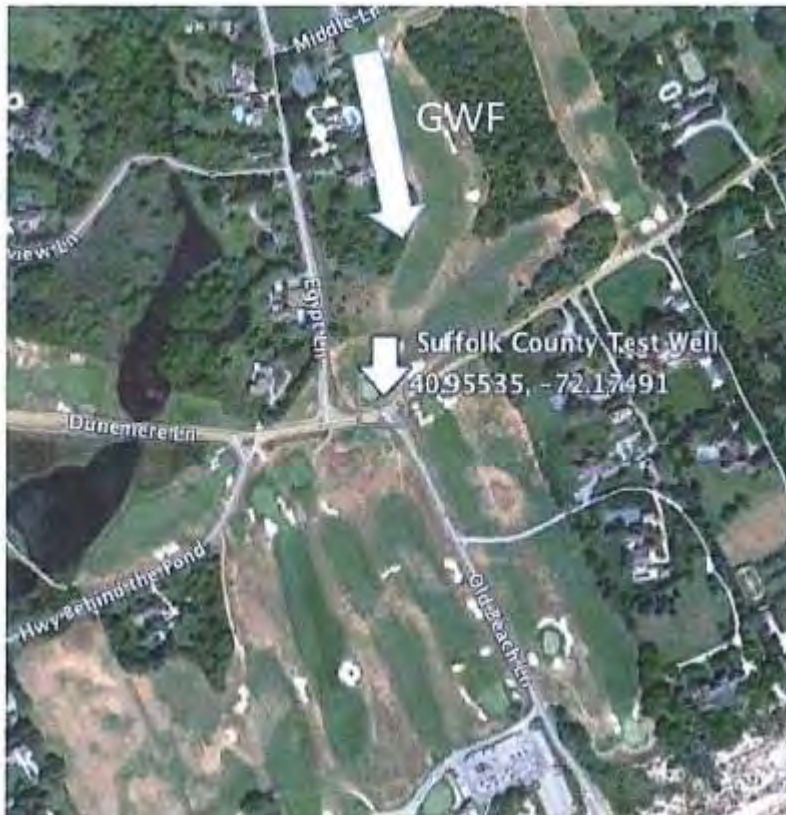
Figure 12 - SCDHS Monitoring Well Location

- Maidstone Club, East Hampton Well Number S-115135 (depth of 50 – 60 feet below grade), since 1999, annual sampling of inorganics (not including phosphorus), metals, volatile organic compounds, semi-volatile compounds and herbicides

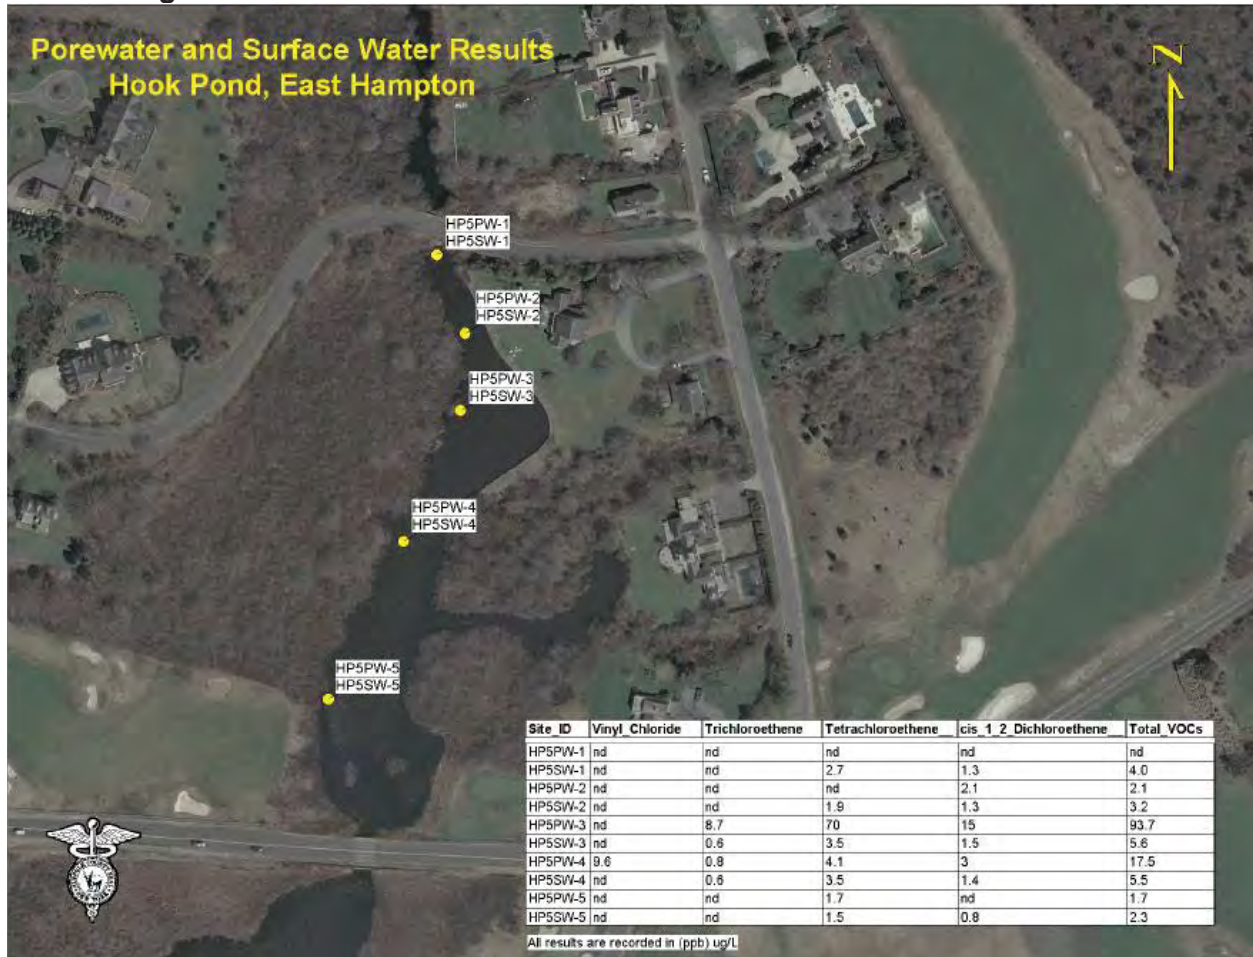
**Figure 4-7 SCDHS VOC Porewater & Surface Water Locations & Results**

- 26 wells were each sampled in 2009 – 2010 on one occasion at various depths for temperature, dissolved oxygen, pH, conductivity, 6 metals, inorganic nitrogen and volatile organic compounds.
- The contaminant plume has been monitored at the locations presented on Figure 4-6. In Pond monitoring by SCDHS is presented on Figure 4-7.

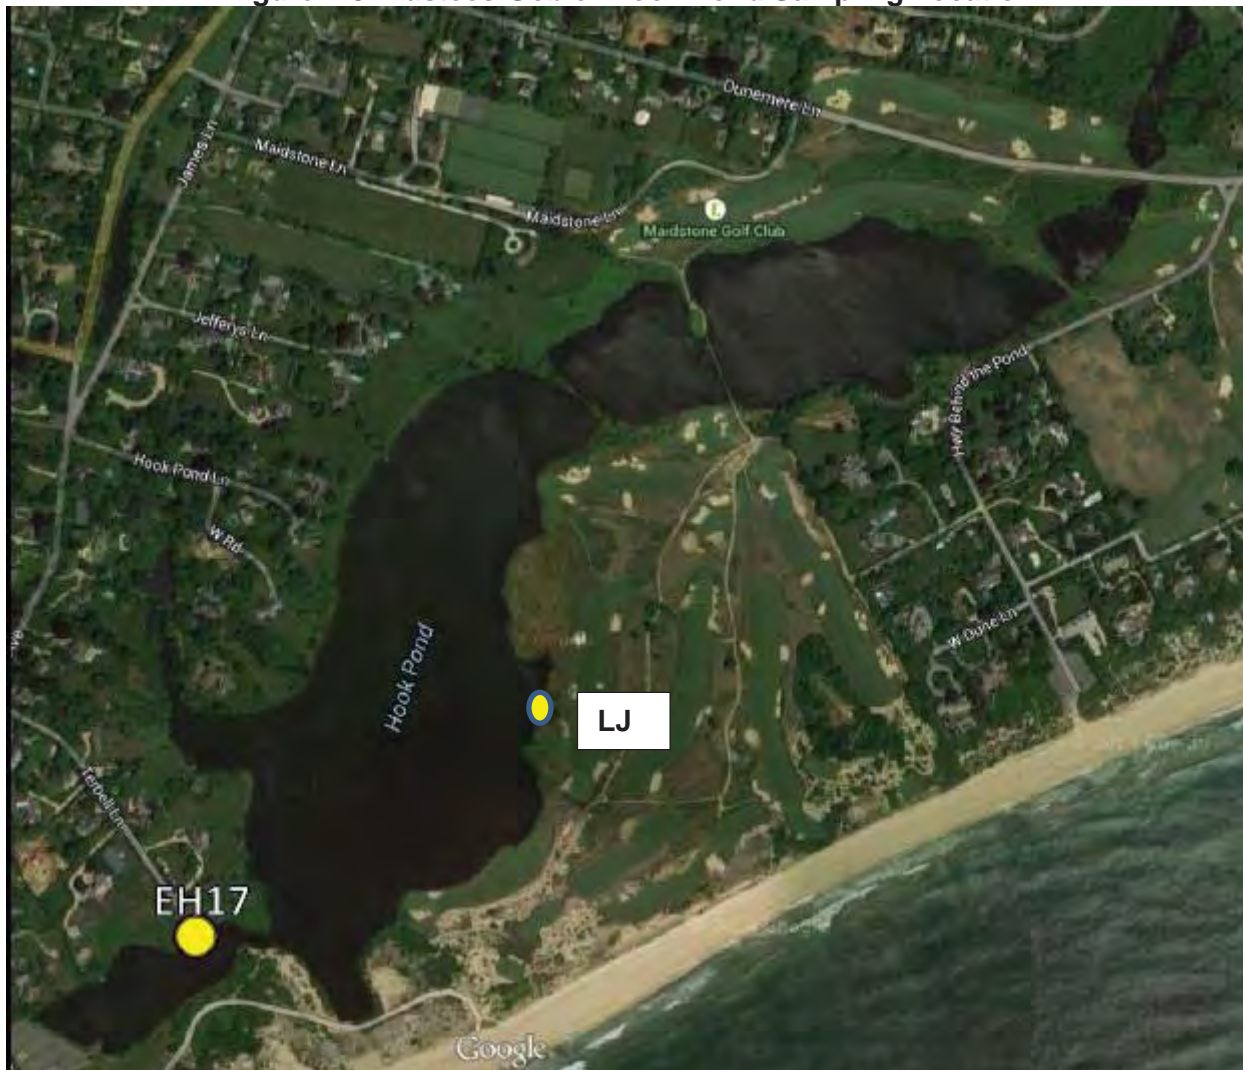
**Figure 4-8 Trustees-Gobler Hook Pond Sampling Location**

dissolved oxygen were made using a handheld YSI 556 sonde. Chlorophyll a, a pigment produced by all algae, was measured as an analog for algal biomass. It was collected onto glass fiber filters, extracted with acetone, and measured with a Turner Designs Trilogy fluorometer. Blue green algal fluorescence was measured from whole water samples using a BBE Fluoroprobe. This same device provided fluorescence of green algae, cryptophytes, and diatoms. In 2013, whole water samples were also collected and preserved in Lugol's iodine solution for cell identification and counting. Cell counts were performed using a Sedgewick rafter slide, and a microscope. Phycocyanin is yet another fluorescent-pigment-analog for cyanobacterial biomass, and was measured with whole water samples in a Turner Designs TD-700 fluorometer during the 2013 sampling season.

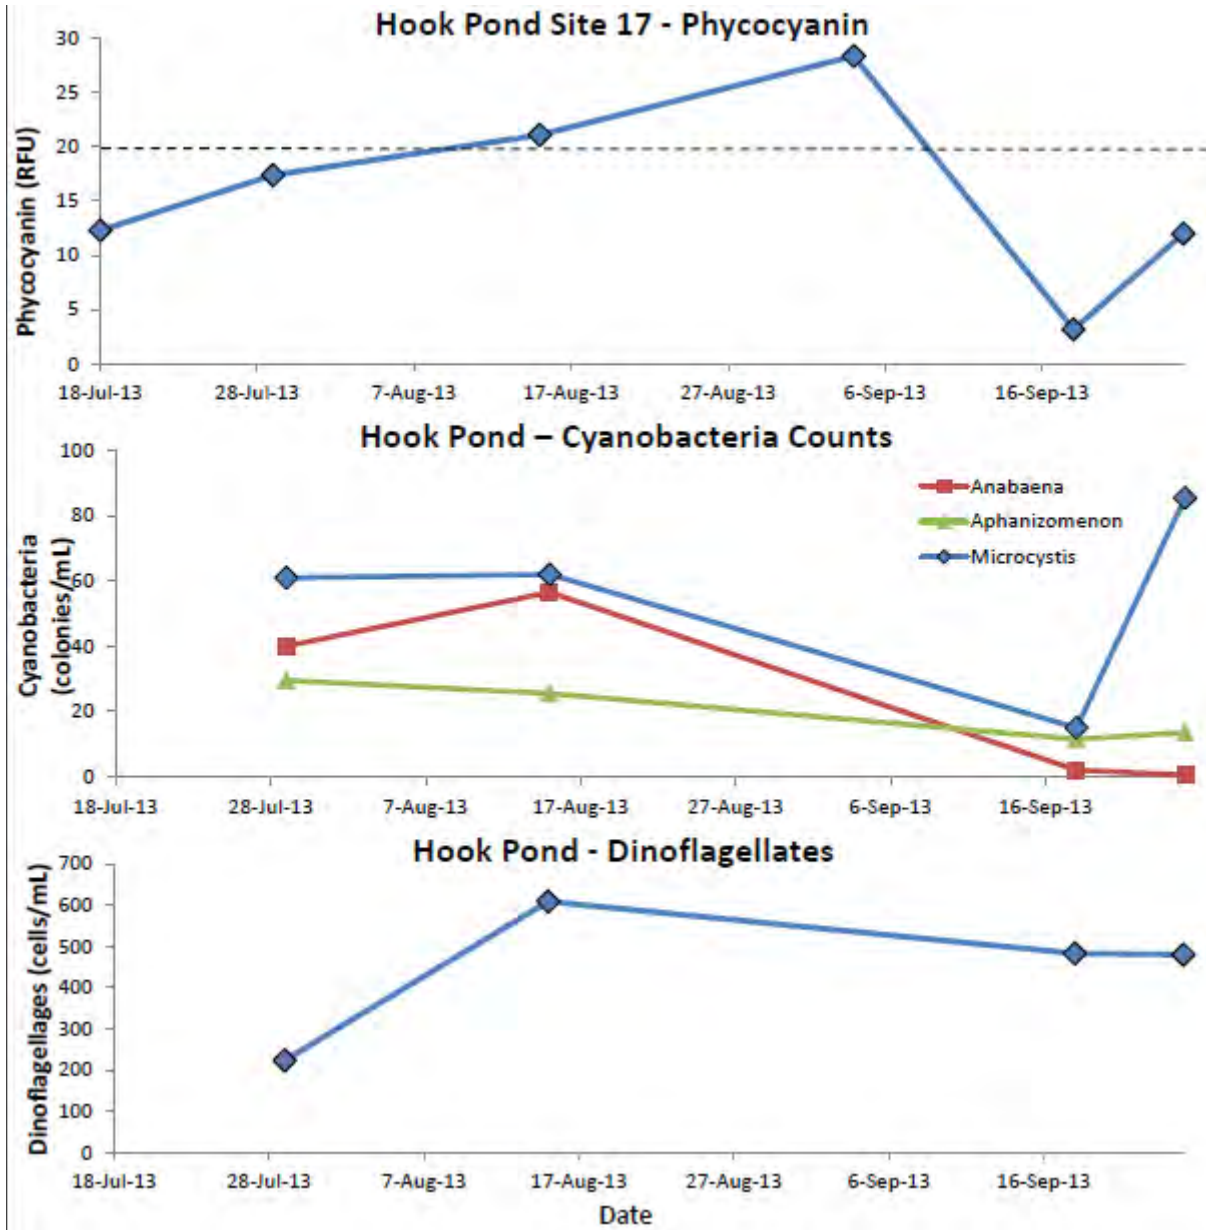
Figure 4-13 Gobler Hook Pond Sampling Location – Bluegreen Fluorescence 2013-2014

of multiple groups of phytoplankton were quantified. Hook Pond had low-to-moderate densities of cyanobacteria genera that are known to cause toxic blue green algae blooms including *Microcystis* and *Anabaena* (Figure 4-13). In addition, densities of dinoflagellates reached levels that can be problematic in some ecosystems (i.e. >500 cells/ml) (Gobler et al, 2012).

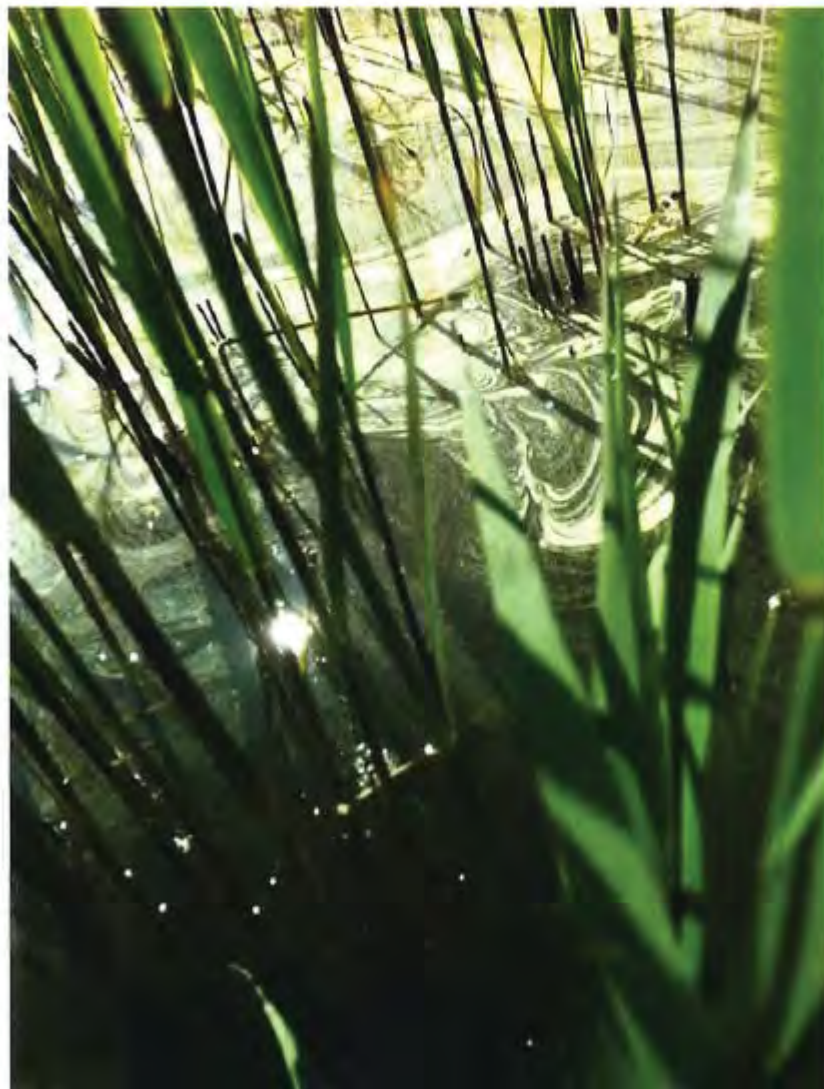
Pond photos taken on May 27, 2013 by Linda James are presented on Figures 4-16. The location is on the east side of Hook Pond near the discharge outlet – see LJ noted location on Figure 4-6. The materials in the photographs were not laboratory identified. Material could be cyanobacteria and/or pollen.

Walking this AM on the MC Golf course I saw this yellow slick on the shoreline between the 6th and 7th hole. The photos were taken from my kyack. I found a second slick in the reeds just north of the first one. Fortunately the slick that is on my paddle has not affected any birds.

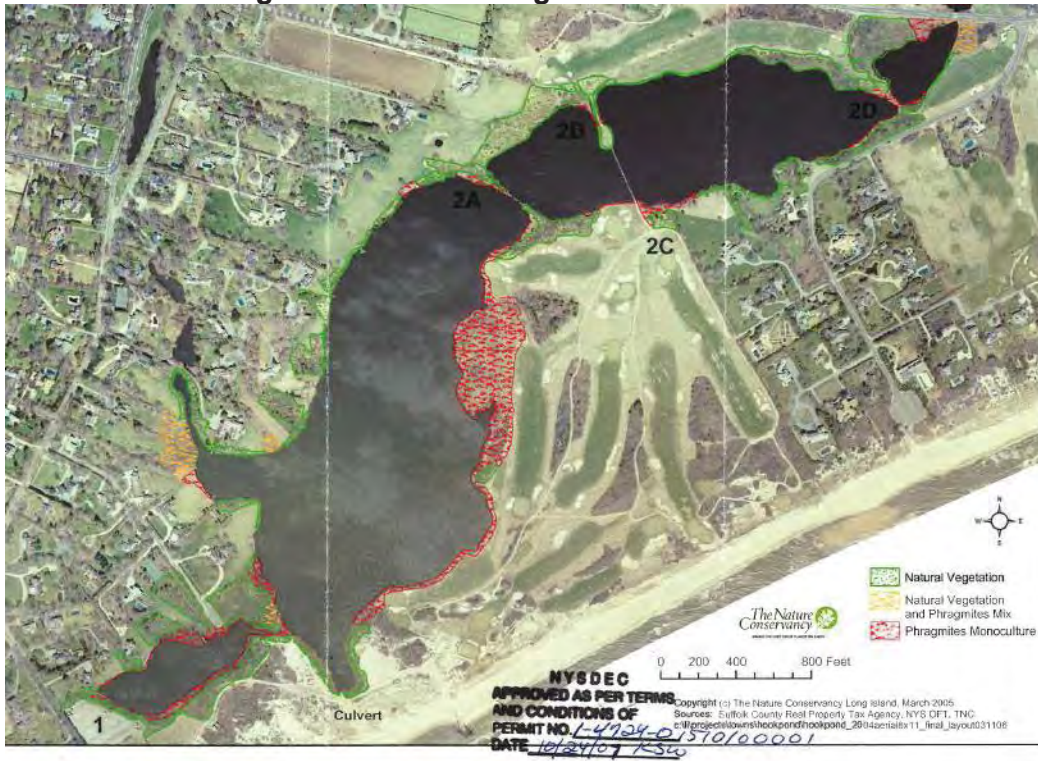
Figure 4-17 2007 Phragmites Removal Area

Phragmites removal project was performed in 2006 – 2007 as is described in Appendix G, and illustrated on Figures 4-17 and 4-18. NYSDEC has permitted the phragmites removal through September 2016 for the Village and June 2015 for the Maidstone Club.

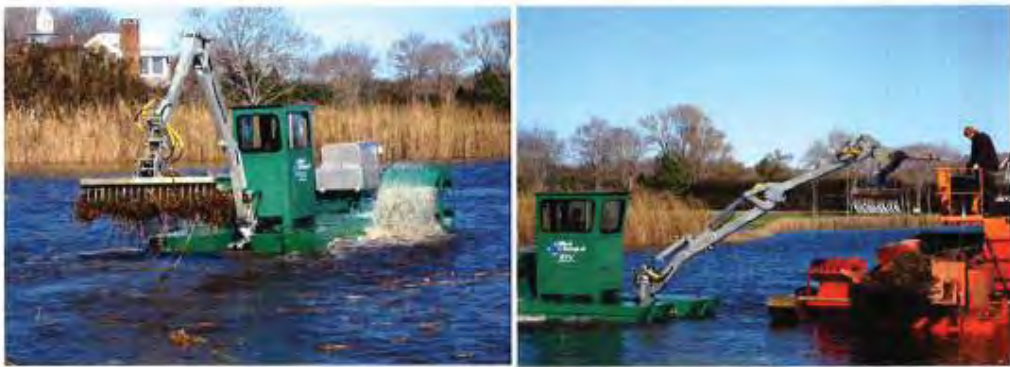
Figure 4-18 2007 Phragmites Removal Area

LITTLE HOOK POND - HYDRO-RAKE WITH FULL LOAD OF PHRAGMITES ROOTS AND RHIZOMES (LEFT); AND THEN TRANSFERRING DUG MATERIAL TO TRANSPORTER (RIGHT). 12/2006

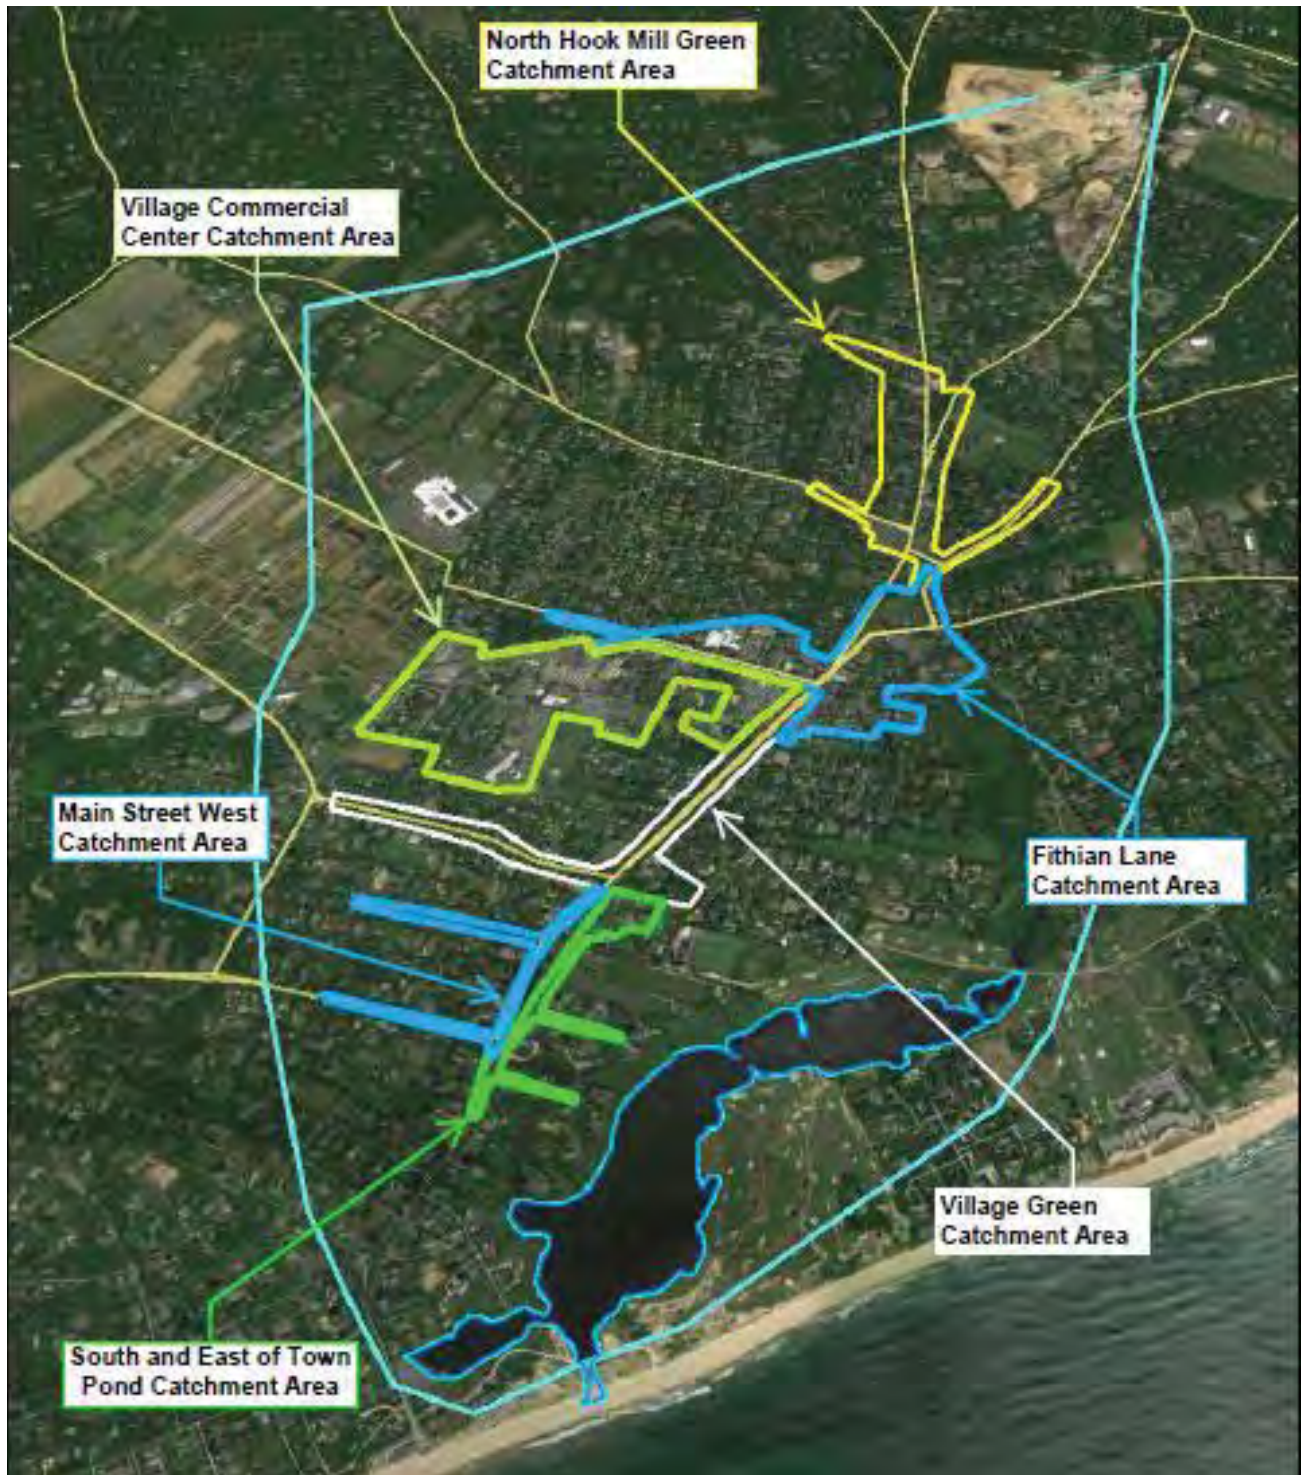
Figure 3-1 North Hook Mill Green and Village Green Stormwater Catchment Areas

The stormwater collection system that discharge directly to Hook Pond via Town Pond and Hook Pond Stream consists of the catchment areas as described on Table 3-1 and illustrated on Figure 3-1. Please note that uncertainty exists on contributing areas to the two Hook Pond tributaries.
