# HOOK POND WATER QUALITY IMPROVEMENT STUDY

## DIAGNOSIS, PROBLEM IDENTIFICATION & MANAGEMENT PLAN – APRIL 2015

## Hook Pond Water Quality Improvement Project

# Watershed Definition, Compilation of Existing Water Quality Data & Its Analysis

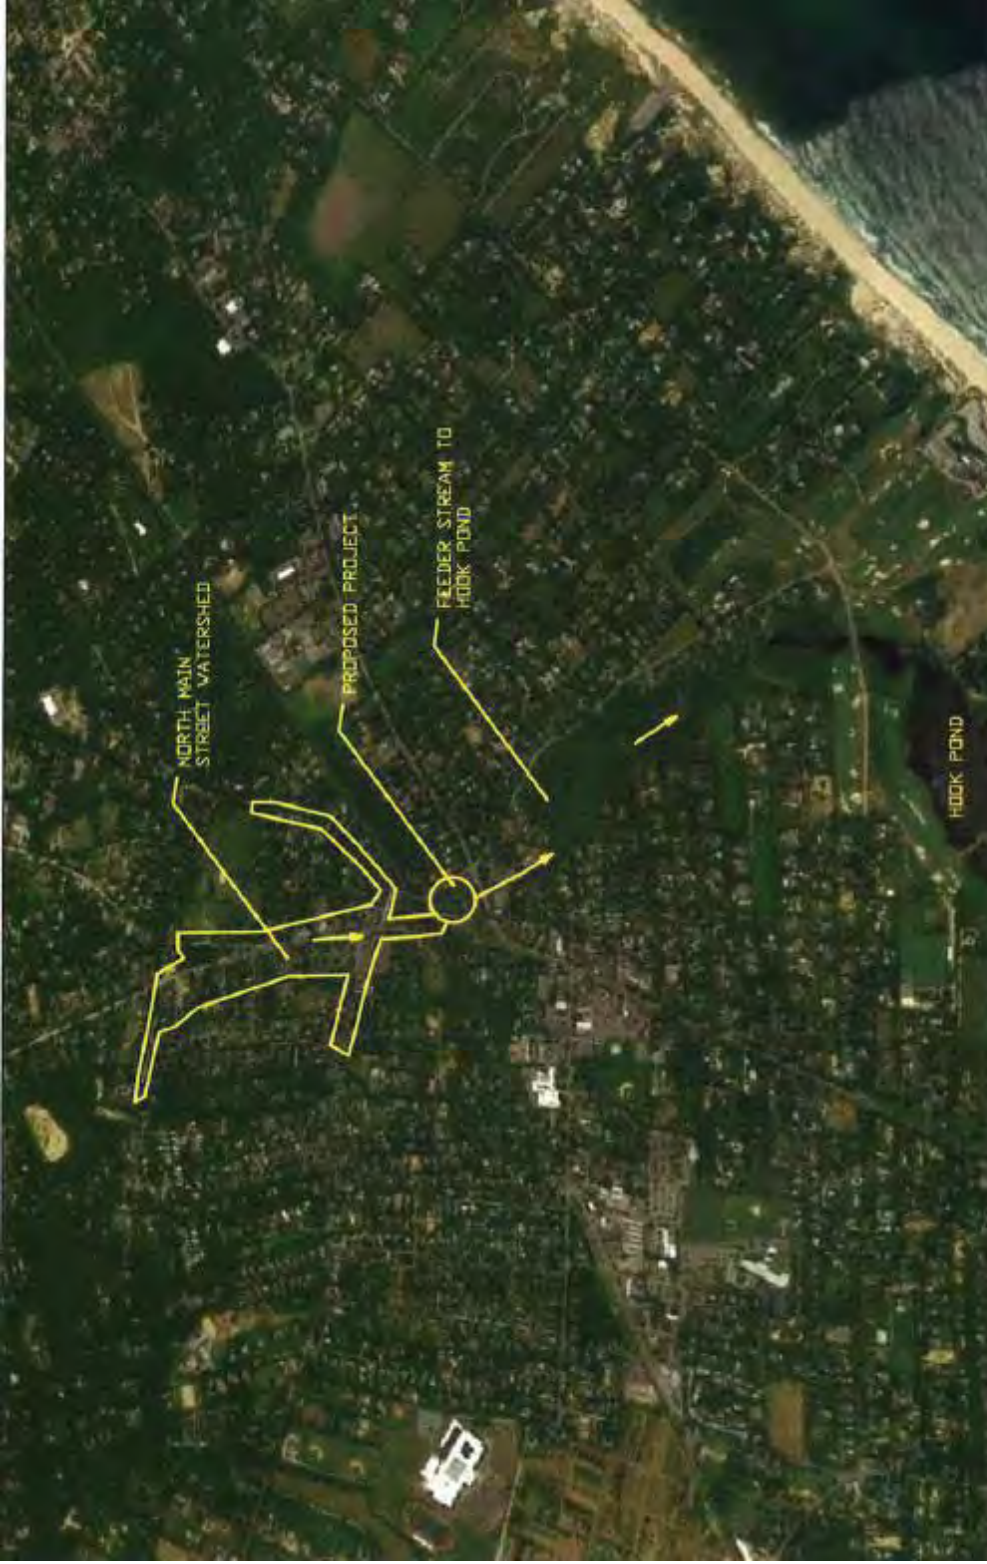
Figure B-2 North Hook Mill Green Stormwater Drainage Area

SHEET	3	WATERSHED	SCALE	AS NOTED	DATE	02.17.16	NORTH HOOK MILL GREEN - BIOSWALE/SALLOW WETLAND HOOK POND WATER QUALITY IMPROVEMENT PROJECT #1 INC. VILLAGE OF EAST HAMPTON, NEW YORK	D.B. Bennett, P.E., P.C.   Consulting Engineer 3 Railroad Avenue, P.O. Box 1442 East Hampton, NY 11937 631-967-0023 (T) 631-329-0324 (F)
-------	---	-----------	-------	----------	------	----------	--	---

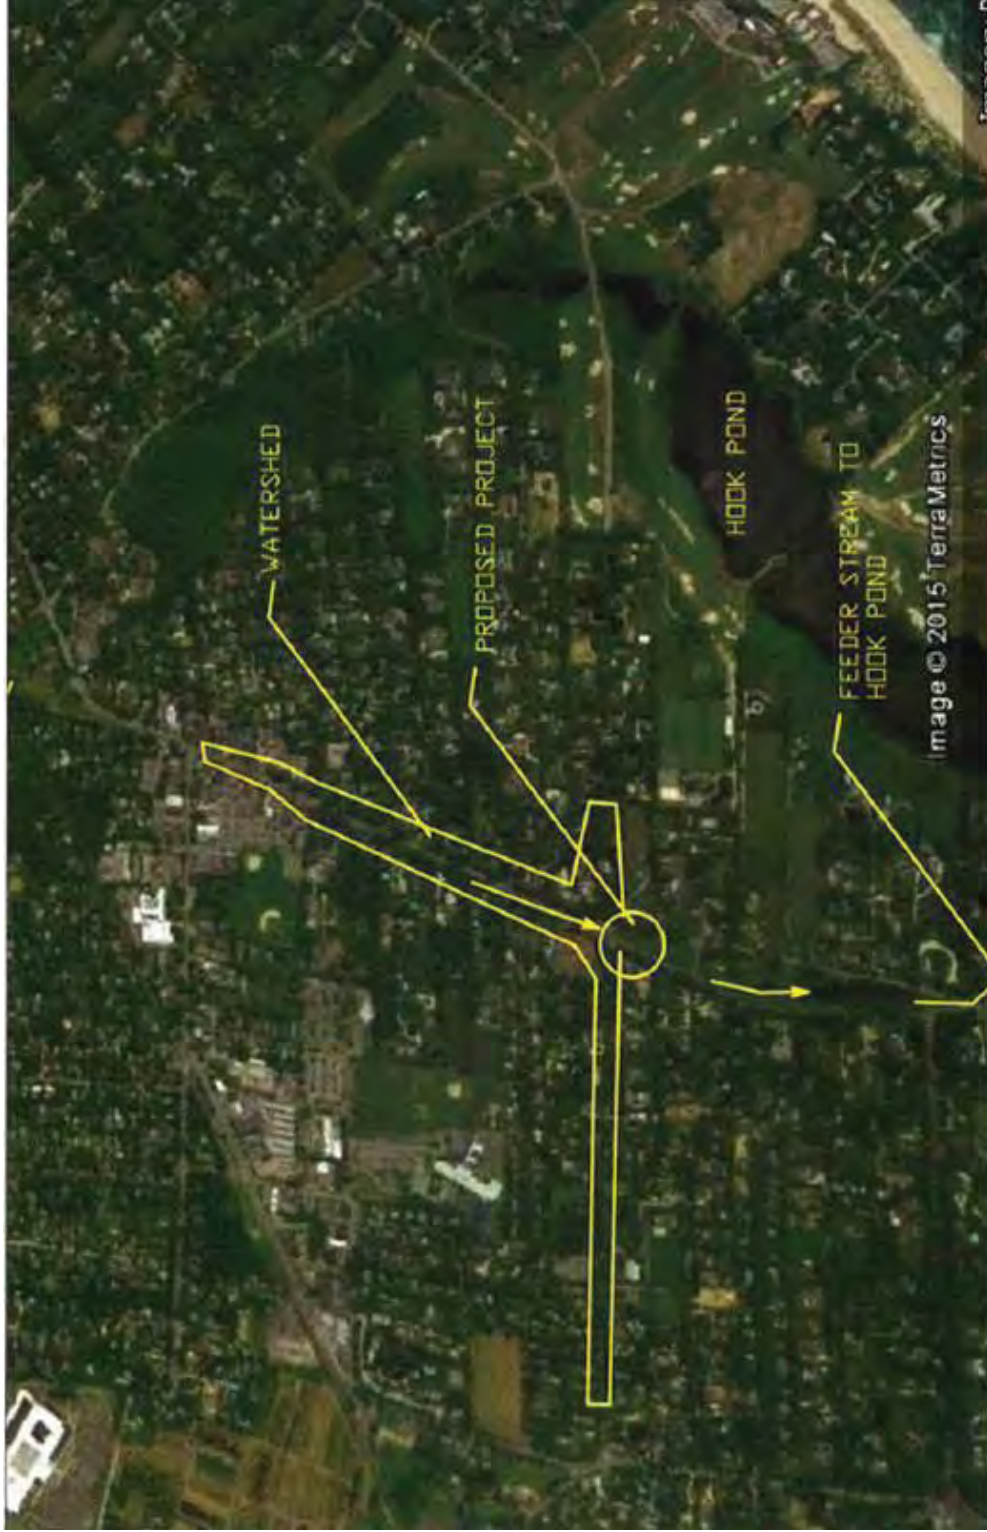
Figure B-5 Village Green – Town Pond Stormwater Drainage Area

SHEET	SCALE	DATE	<b>VILLAGE GREEN - MICROPOOL/SWALES</b>	
<b>2</b>	AS NOTED	02.17.15	HOOK POND WATER QUALITY IMPROVEMENT PROJECT #2 INC. VILLAGE OF EAST HAMPTON, NEW YORK	
			<b>D.B. Bennett, P.E., P.C.   Consulting Engineer</b> 3 Railroad Avenue, P.O. Box 1442 East Hampton, NY 11937 631-967-0023(X) 631-329-0324(F)

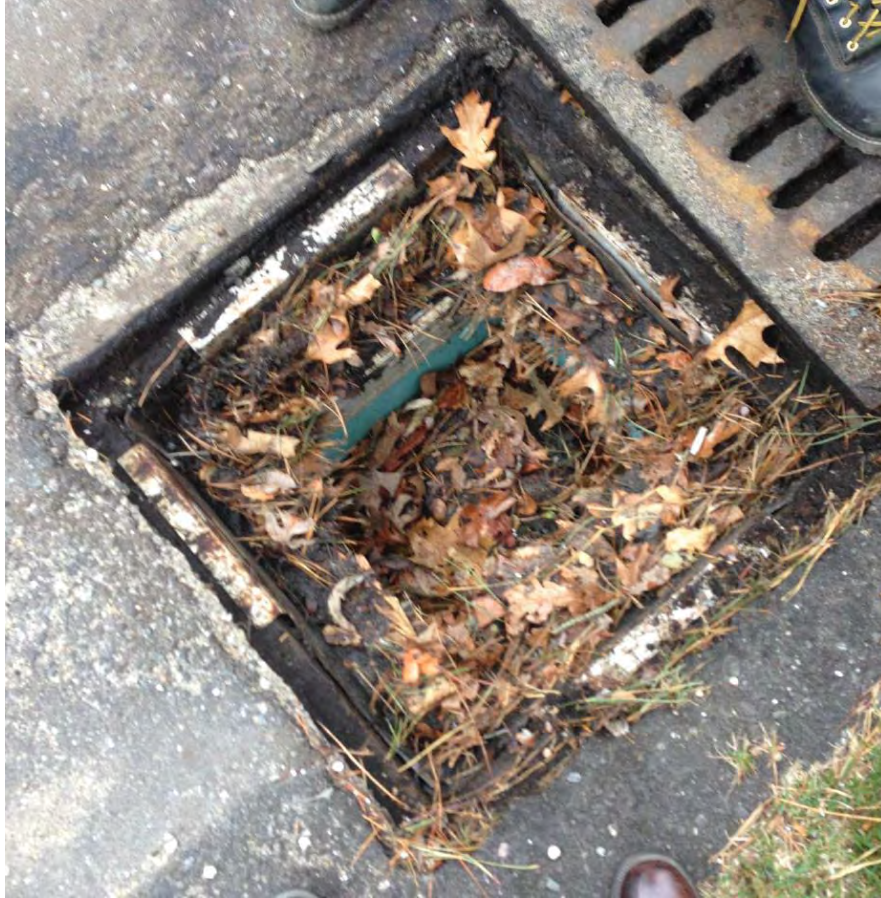
The cartridges can be equipped with sample tubes that separate raw stormwater from water treated by the cartridges. This allows for the systems to be evaluated for nutrient removal efficiency.

The models specified in the grant proposal are the 9730 and 9731 models, which have a filtered flow capacity of 230-gpm, a bypass flow rate of 1,975 – 2,110-gpm, and a debris capacity of 4.0 – 5.0 ft<sup>3</sup> respectively. The cartridges proposed are do not have the FabPhos cartridge for nutrient removal.

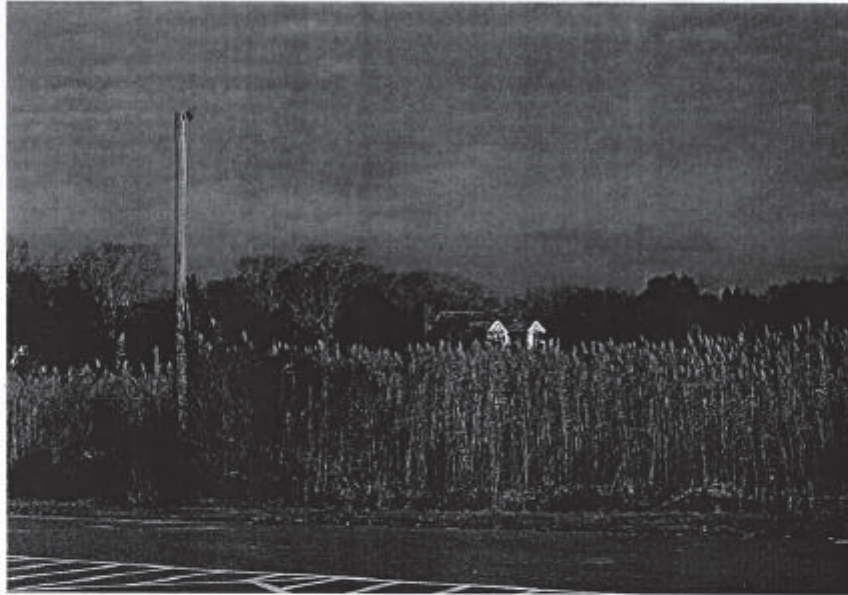
**LITTLE HOOK POND SHORELINE BEFORE START OF PROJECT—11/2006**

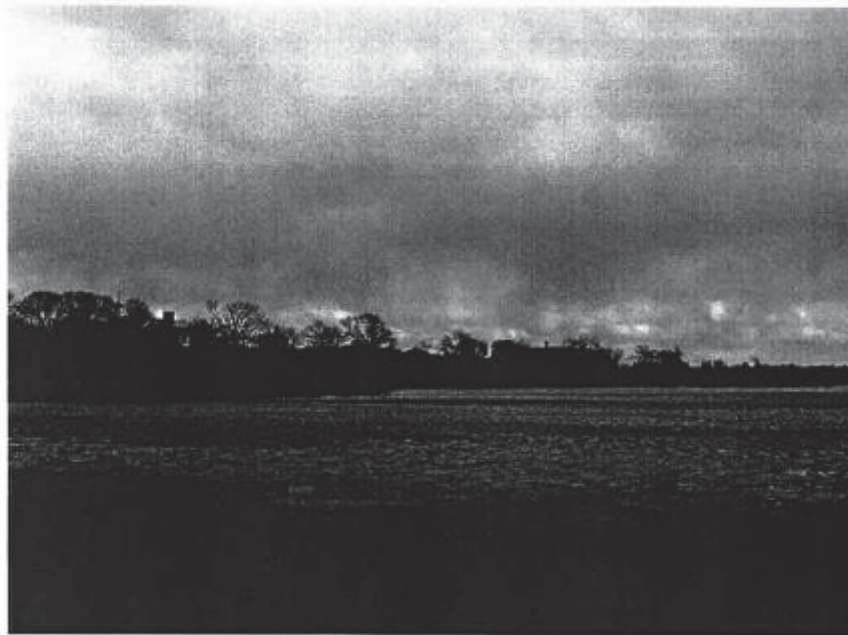
**LITTLE HOOK POND SHORELINE AFTER CUTTING AND DIGGING  
PHRAGMITES-12/2006**

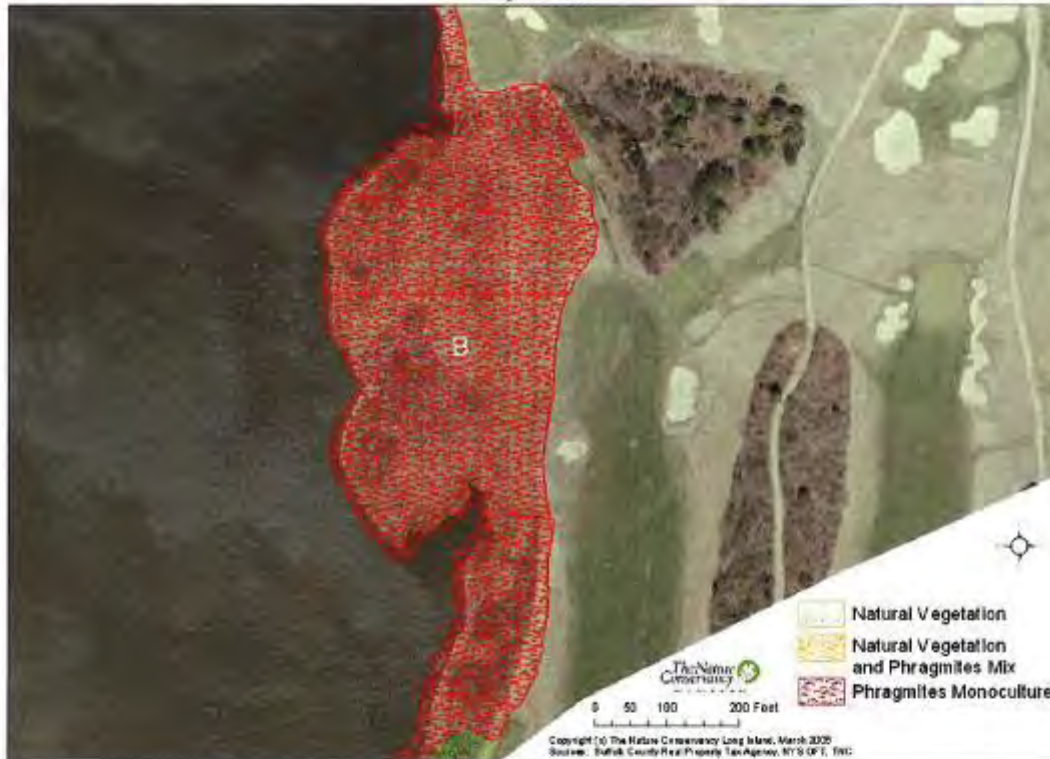
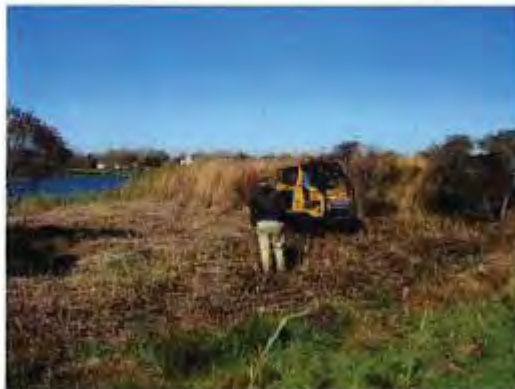
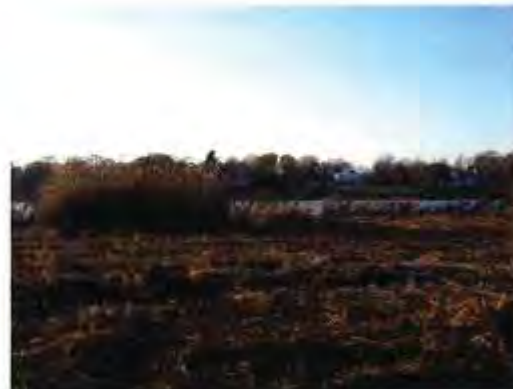
At Maidstone Club hole 6 (see Figure 2b below), the low-impact cutter cut 3.7 acres of the approximate 5.1 acres of dense phragmites. As at Little Hook Pond, the remaining phragmites could not be cut mechanically because they are interspersed with native vegetation.

LOW-IMPACT CUTTER AT MAIDSTONE CLUB HOLE 6, BEFORE (LEFT) AND AFTER (RIGHT). 11/2006

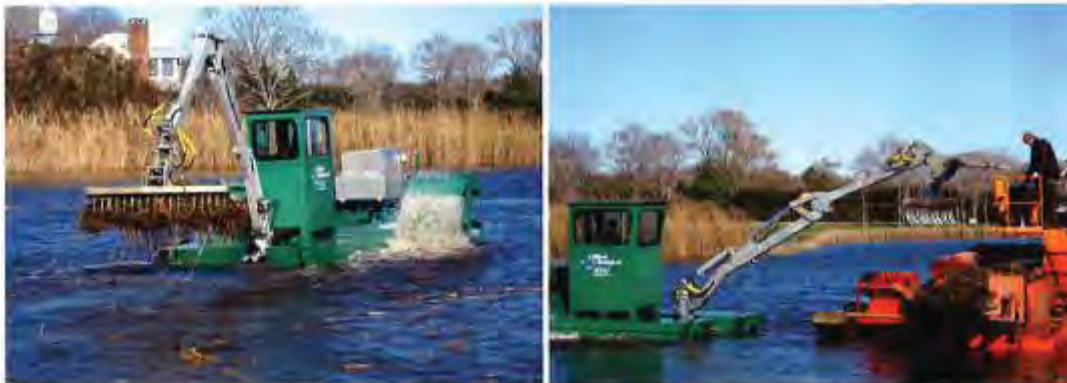
LITTLE HOOK POND - HYDRO-RAKE WITH FULL LOAD OF PHRAGMITES ROOTS AND RHIZOMES (LEFT); AND THEN TRANSFERRING DUG MATERIAL TO TRANSPORTER (RIGHT). 12/2006

The machines returned on November 20 when rains had raised the water level enough to launch the machines (the water level has to be approximately 22 inches or higher). Between November 20 and December 20, the hydro-rake and transporter operated a little over 100 hours, digging phragmites and transporting it to shore, where it was offloaded for the East Hampton Village pay-loader to collect and remove.

The hydro-rake seemed to work well overall in Little Hook Pond, removing phragmites from much of the 2,546 foot shoreline. In some cases, the machine was able to remove a significant amount of phragmites roots and rhizomes; in other cases, it had trouble digging into the ground. In particular, it had trouble working in the shallow sections (<10 inches deep), because of limited access. As we explain below, we won't know how much phragmites was successfully removed until next growing season during late April or early May.

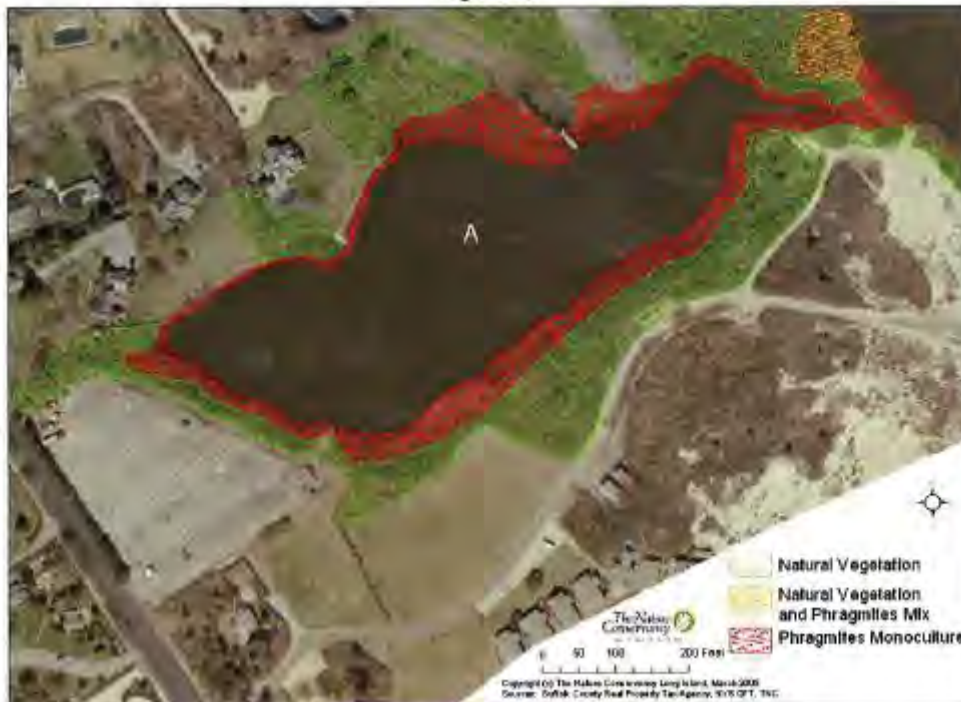
At Little Hook Pond (see Figure 2a below), the low-impact cutter cut 1.3 acres of the approximate 1.67 acres of dense phragmites. Remaining stands of phragmites could not be cut mechanically because they are interspersed with native vegetation.
