**Johnson City  
Community Park Playground  
Safety Inspection Report**

**November 15, 2021**

**Prepared by  
Rene' Hudspeth,  
CPSI #49126-0823**

**Johnson City Community Park**  
**620 N Nugent Avenue**  
**Johnson City, TX**

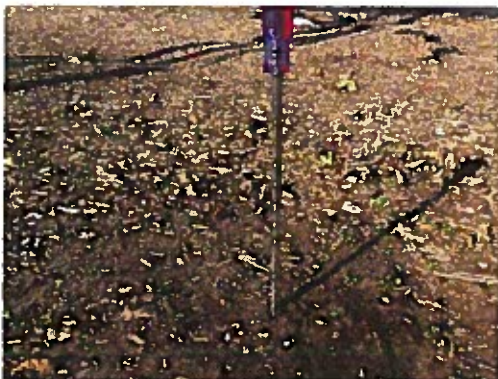
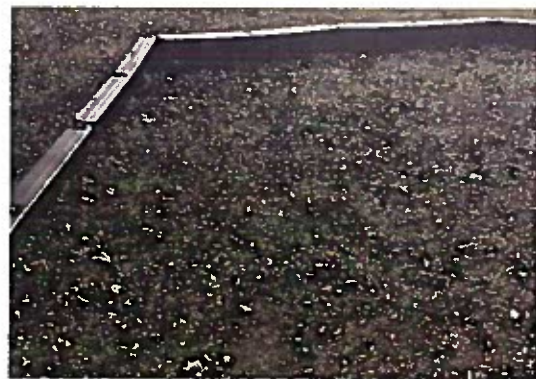
The previous photos were taken of the surfacing within the swing pit. It was noted at time of onsite inspection there was no safety surfacing present within this pit.

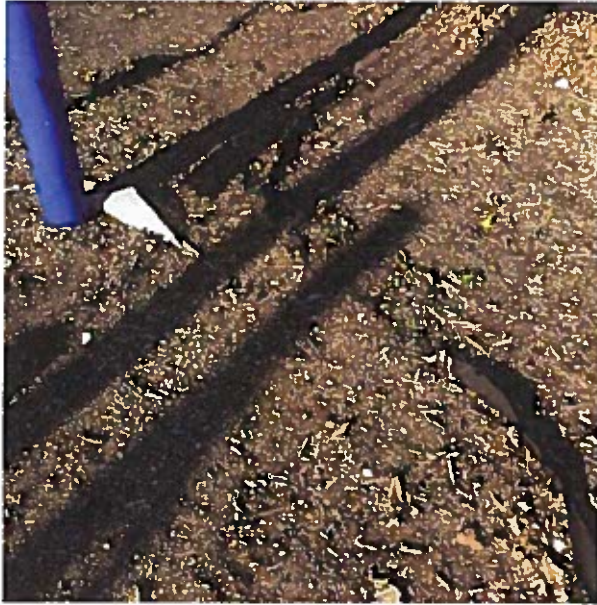
There was exposed filter fabric, which in my opinion, presents a serious tripping hazard as indicated in the photo.

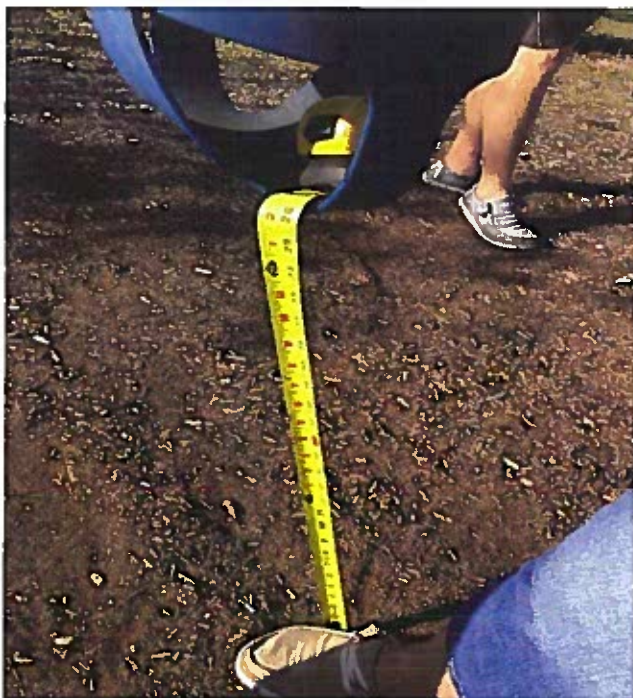
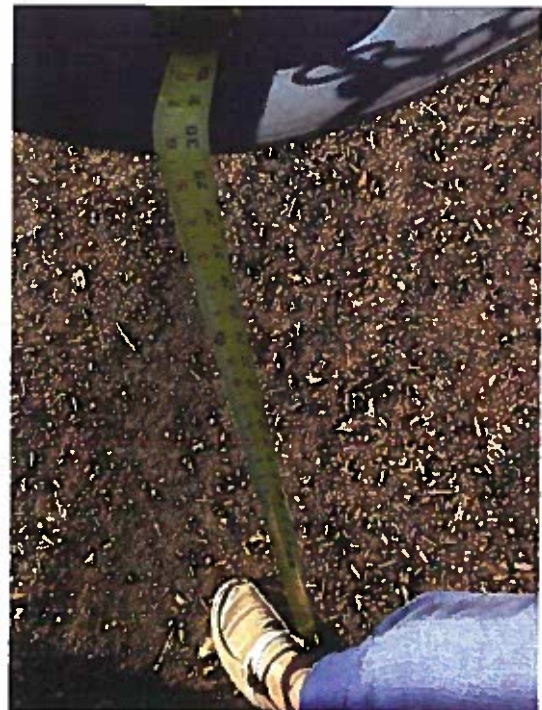
Additionally in the absence of adequate safety surfacing the distance between the bottom of the swings and the top of the safety surfacing becomes an issue. I have attached figure 23 from the CPSC Handbook to further illustrate this lack of compliance to suggested guidelines.

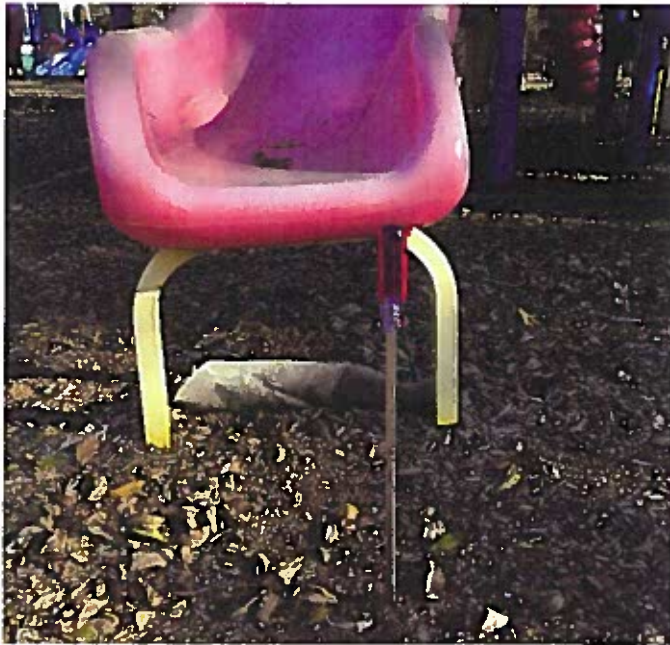
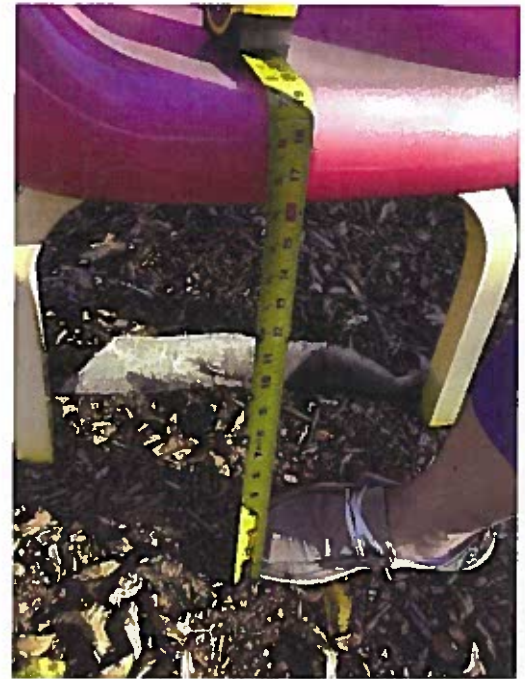
It was also noted at the time of the onsite visit the ewf within the composite unit pit was less than 1 inch in depth and again exposed filter fabric is evident throughout pit and presents a tripping hazard.

As indicated in the above photos adequate safety surfacing would aid in resolving several guideline issues. According to the CPSC (CPSC 5.3.6.4) the slide exit should be at least 7" but no more than 15" above the protective surfacing if the slide is over 4' high.

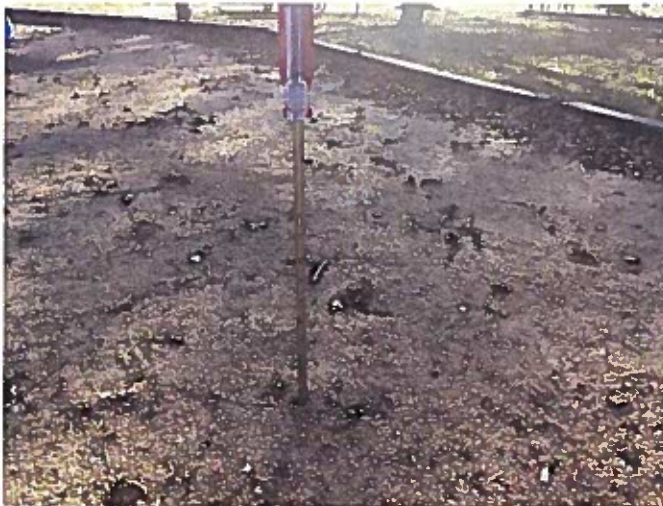
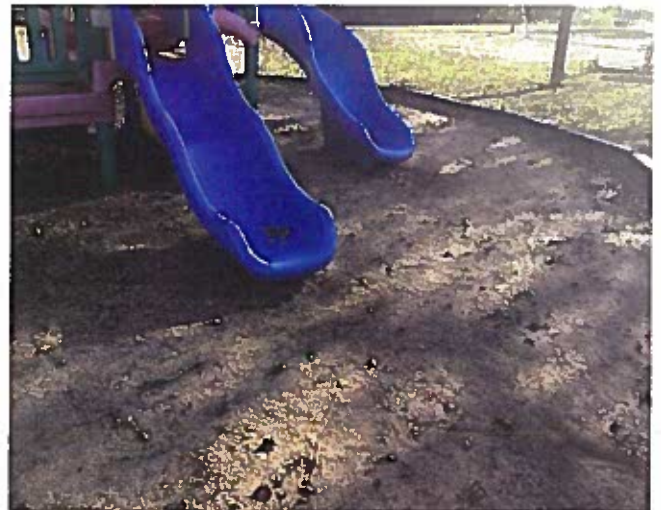
The above photos were taken of the toddler pit. I would reiterate my concern and consider this a top priority as in my opinion there is no acceptable safety surfacing present within the borders of this pit.

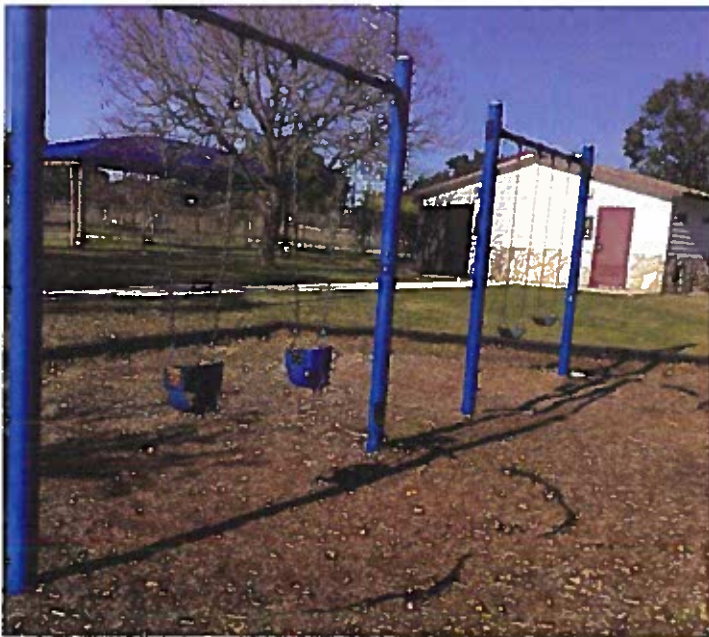
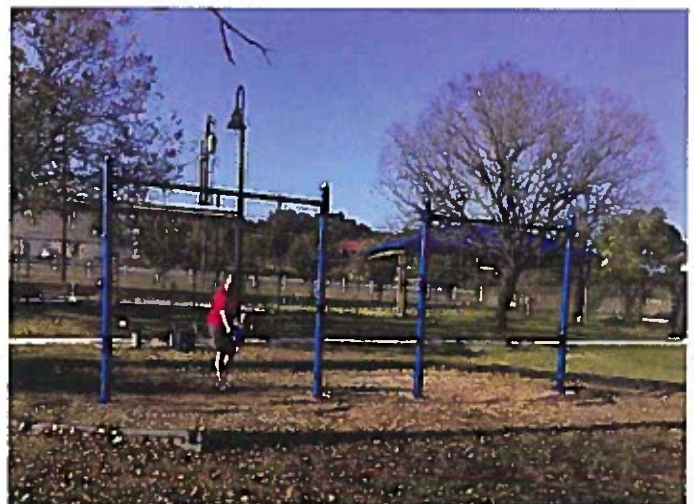
The swing pit consist of two swing units comprised of one bay containing 2 swings per bay. One unit consist of two belt swings and one unit consist of two bucket swings. These swing units had no open "S" hooks. The use zone measured to be adequate surrounding the unit. The belt seats were in good condition presenting no noted protrusion hazard. (CPSC 5.3.8.5) Minimum clearance dimensions for swings were observed. (CPSC Table 7) except as previously noted under "Surfacing". As the swing units are the only features within this pit circulation routes as suggested by both CPSC and ASTM guidelines are evident. (ASTM F1487-17, 9.8.2, CPSC 2.2.3)

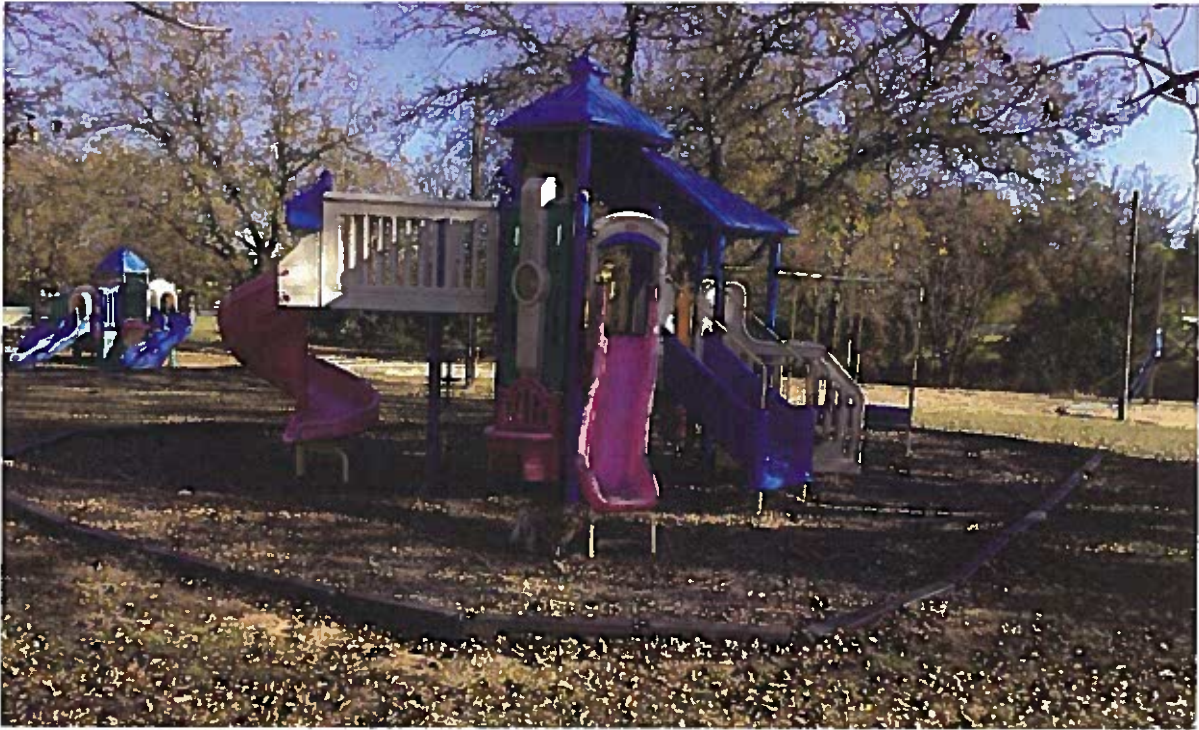
The "center" pit contains a composite unit consisting of a circular slide, a straight slide, balance pods, a fireman's pole, step climber, blue "rock" climber, step climber with chain, upper and lower activity panels. Signage noted on the equipment indicated age appropriate for ages 5-12.

It was noted at the time of the onsite visit the coating on the platforms and stairs of this unit are very degraded and should be repaired/replaced immediately. This wear creates not only a tripping hazard but, in many cases, presents a laceration hazard.

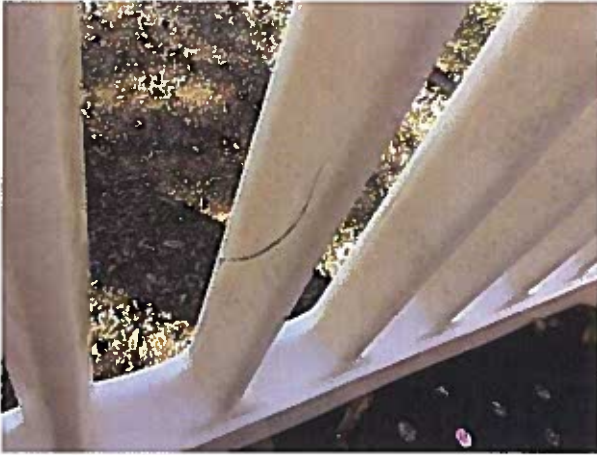
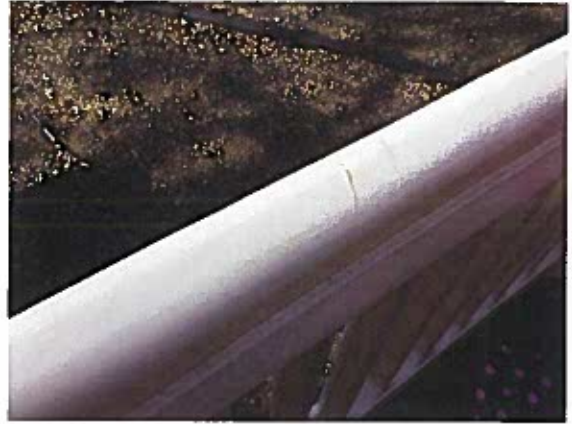
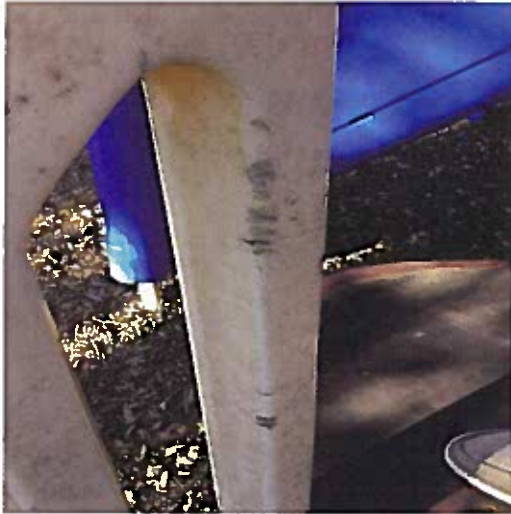
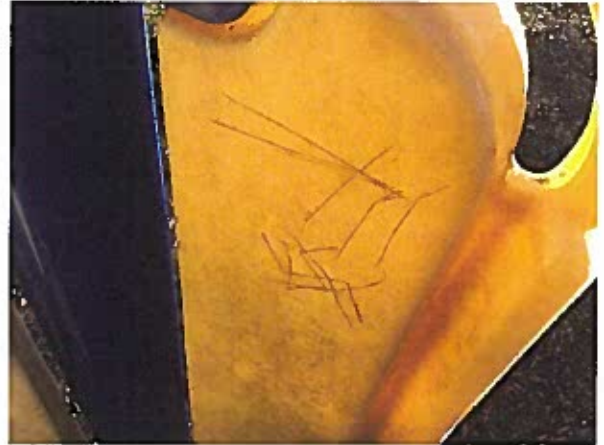
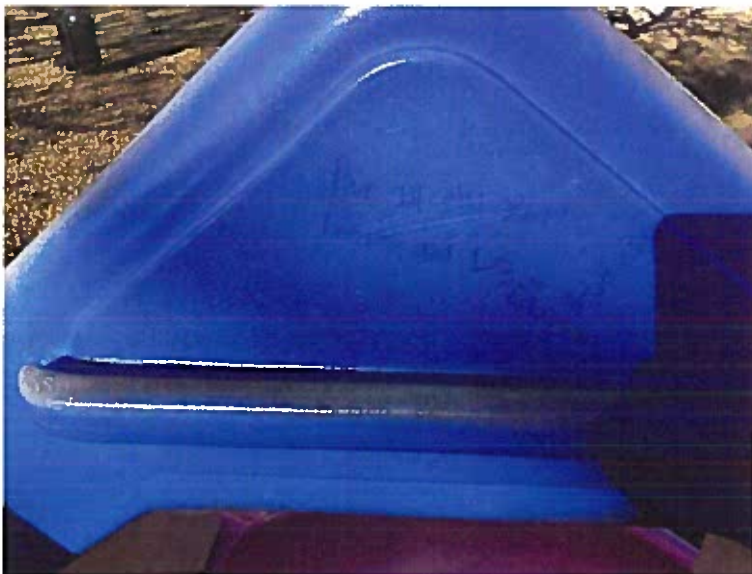
There are many "cuts" in the plastic throughout this unit and in rubbing my hands across them it was evident that laceration hazards were present because of these cuts.

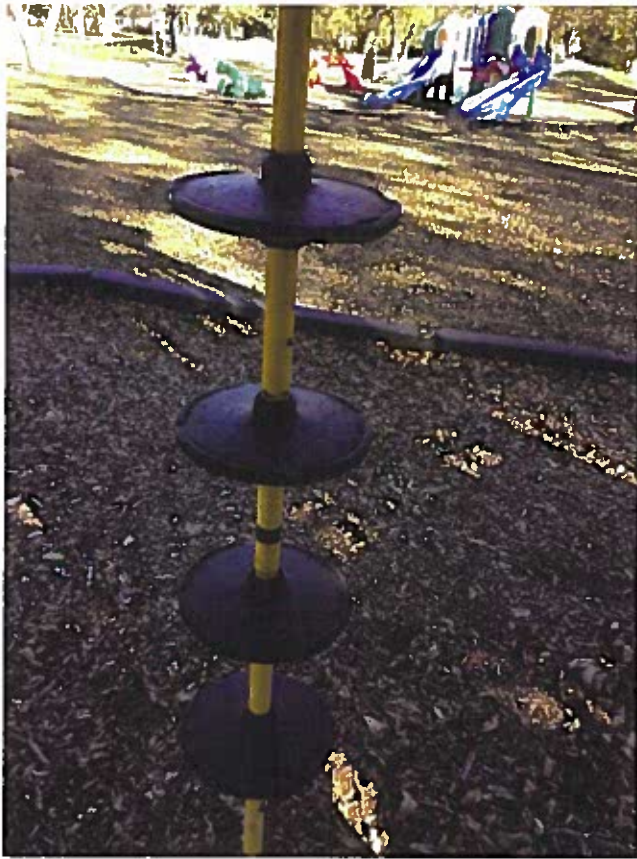
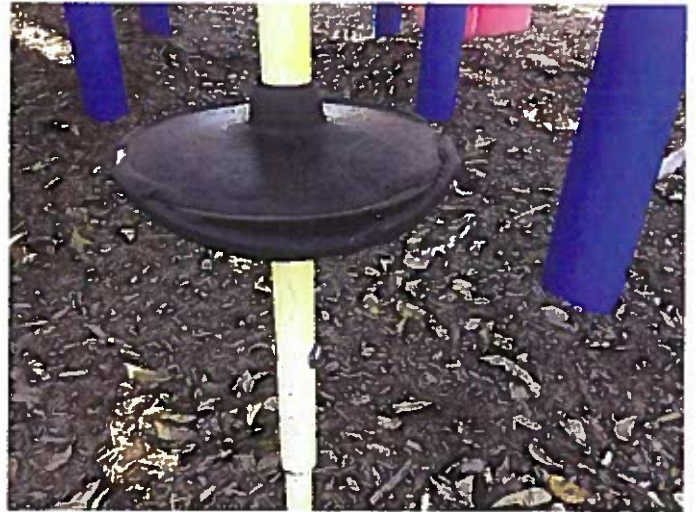
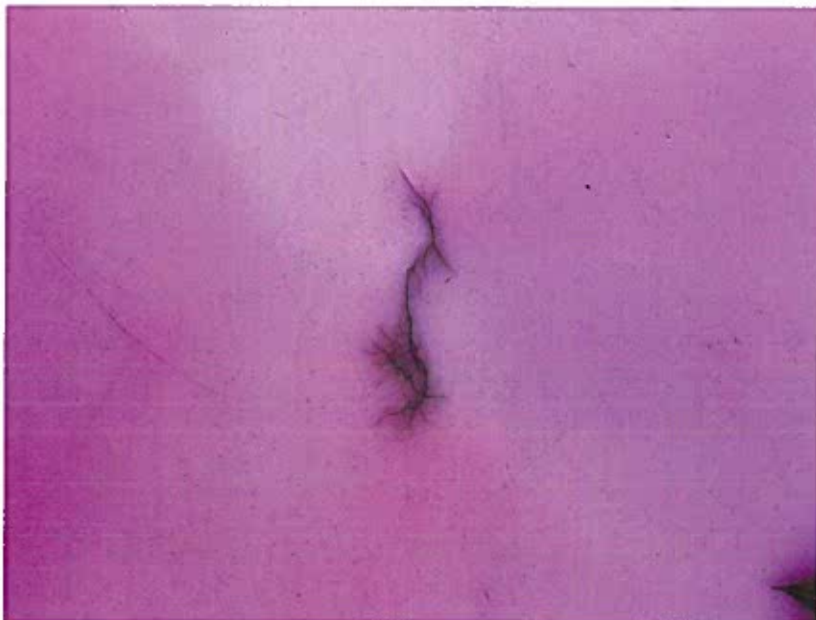
In my opinion the steps of the step climber should be repaired or replaced immediately. They are extremely worn and create laceration and fall hazards.

I believe should the crack in the slide not be addressed soon, it will present a laceration hazard and possibly an entanglement issue.

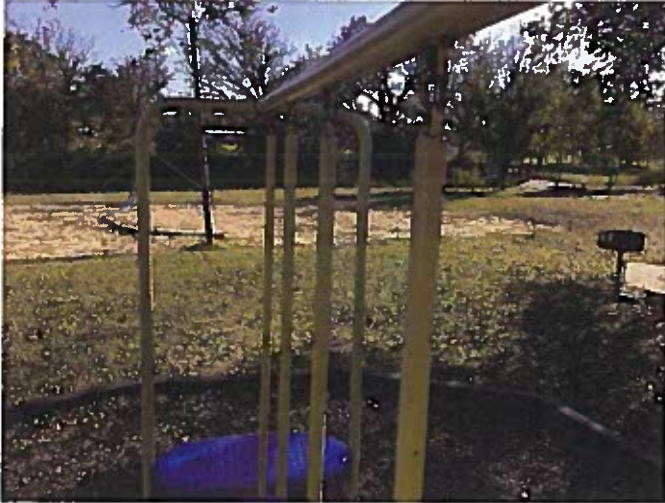
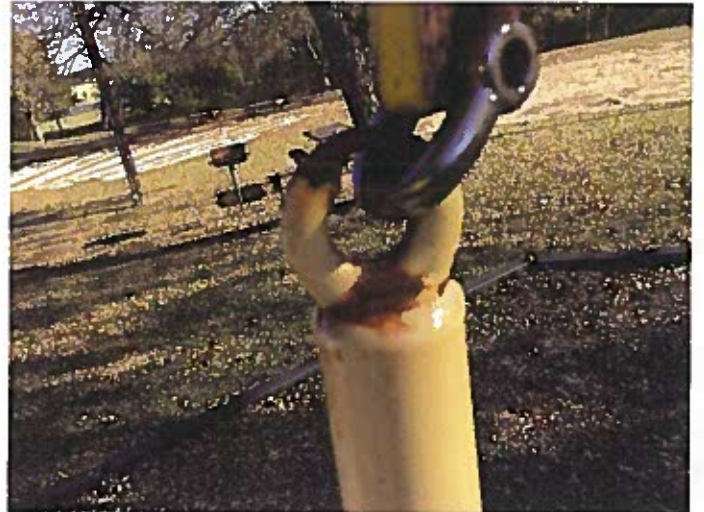
In walking across the balance pods the wear and tear at the pivot point was noted at each of the pods. In my opinion this could present a severe injury hazard should it completely break while a child is crossing.

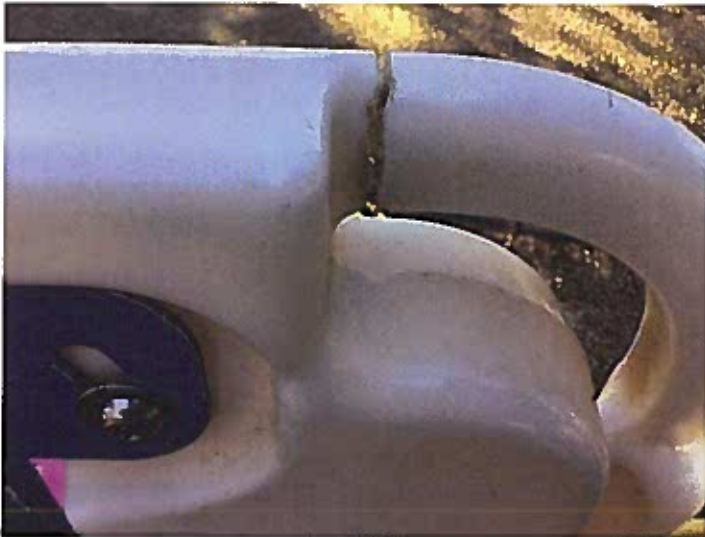
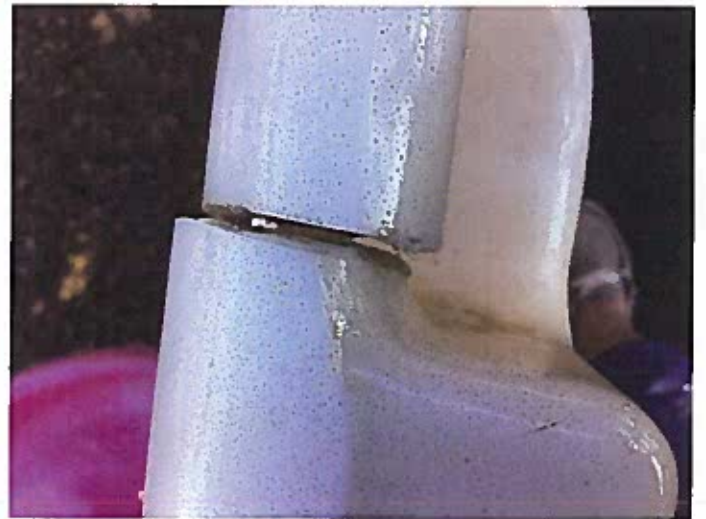
Additionally, there is a complete break in the railing located at the circular slide and the step climber. In my opinion this presents a number of safety issues not the least of which is a fall hazard.

In reviewing this unit, I have noted many, in what are my opinion, safety concerns. I would also note the amount of "mold" and what I would term as normal wear and tear on this unit. Issues such as the broken handrail, worn pivots, and lack of protective surfacing would suggest to me priority one safety concerns and should be addressed immediately. In my opinion if they cannot be addressed in a timely manner closure of the unit should be considered.

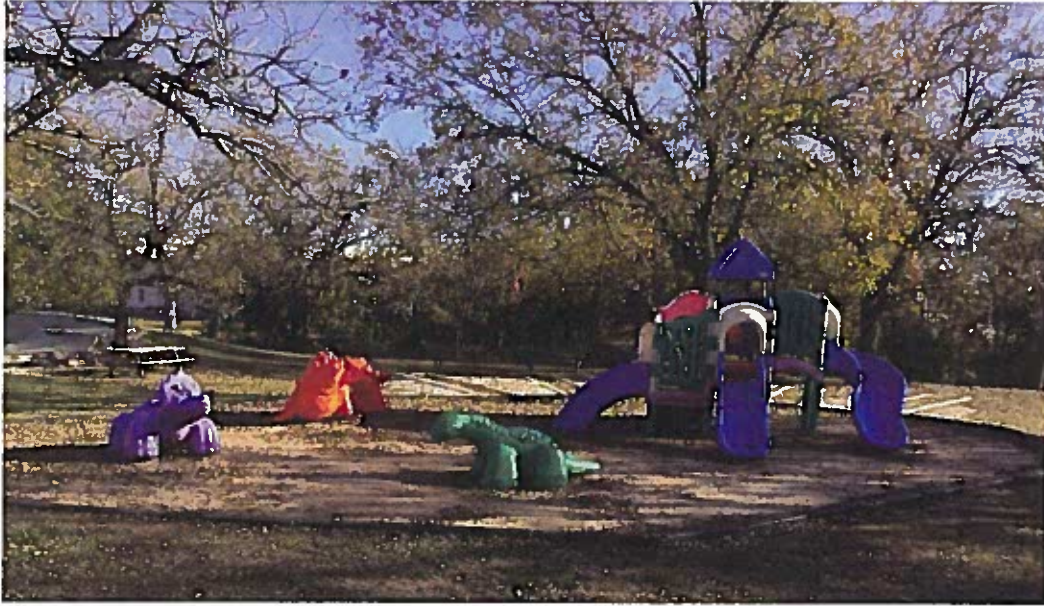
As was mentioned in the Safety Surfacing section, lack of appropriate safety surfacing is a priority one concern of this pit. There is exposed concrete and attachment devices at the dinosaur features.

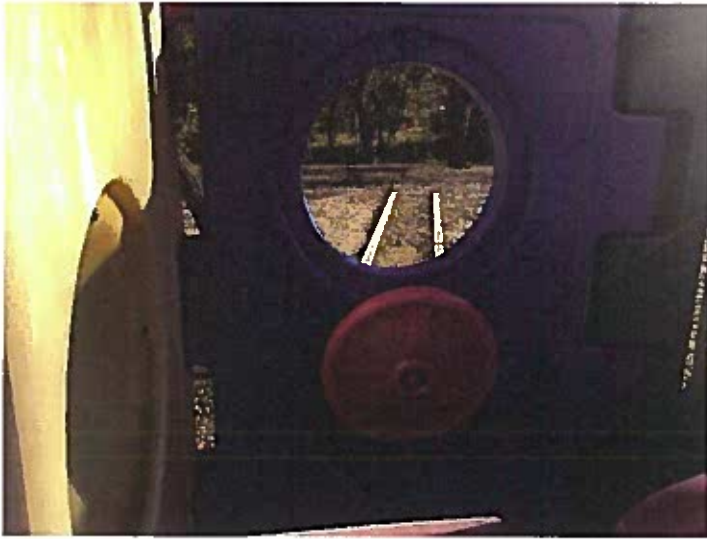
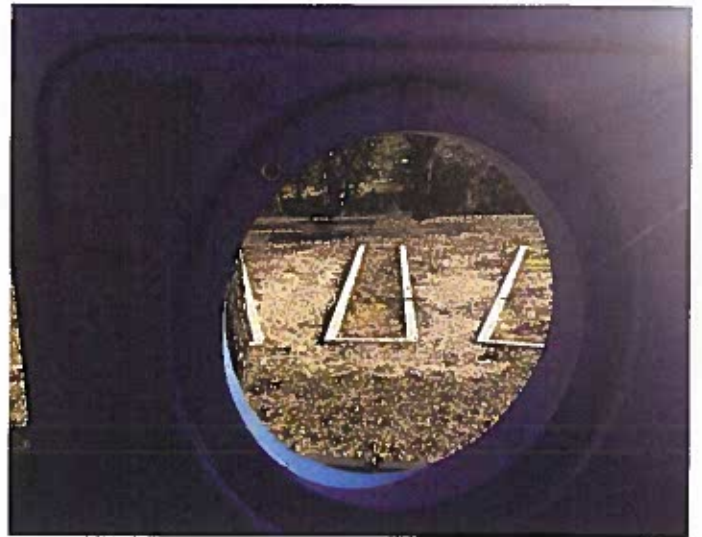
This pit contains three dinosaur features and a composite unit consisting of arched stairs, curved slide, wave straight slide, upper and lower activity panels. Although not certain I believe there is a part missing in one of the upper activity panels as indicated in the following photographs

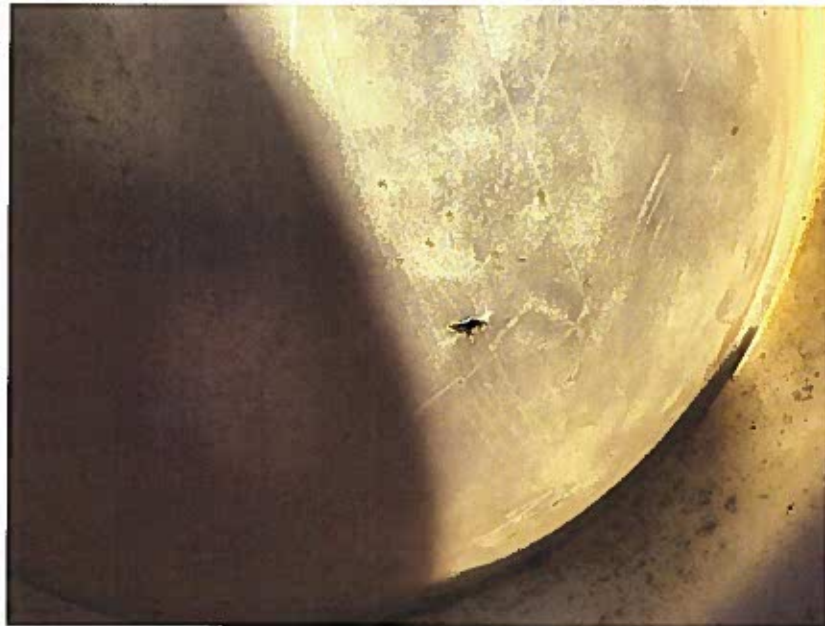
The dome panel to the side has a small crack which I believe could cause injury to a small child.

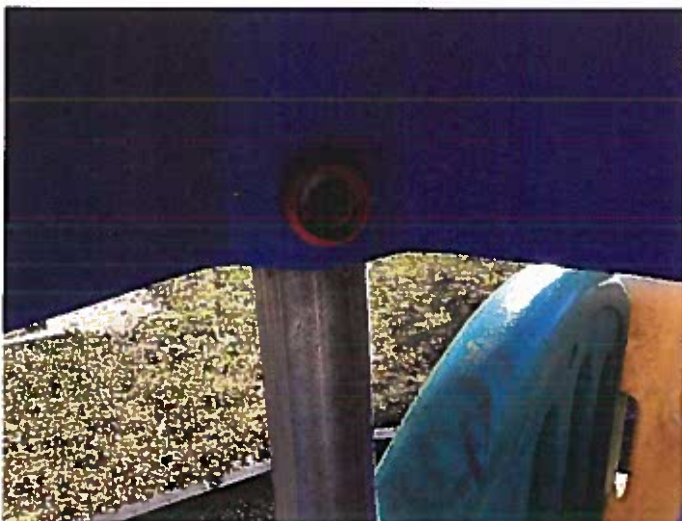
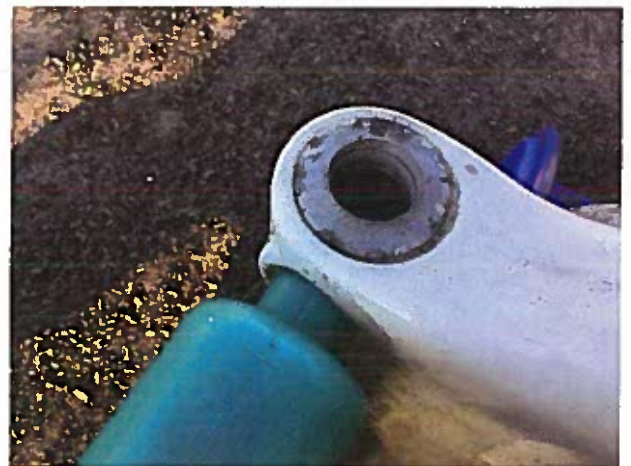
I would also note there are several missing bolt covers throughout this unit, none were noted to be entanglement issues, but are evidence of the wear and tear of this unit.

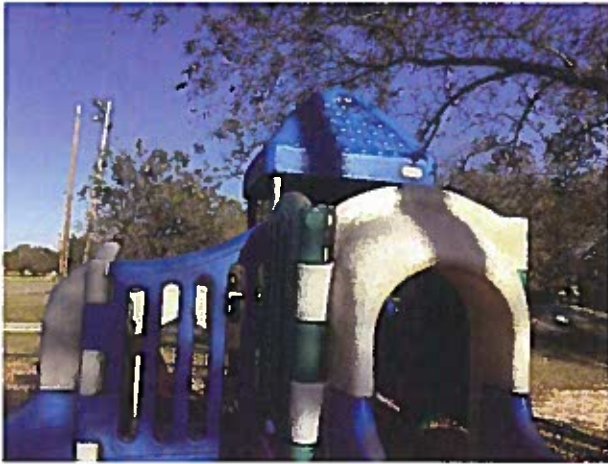
According to the American Academy of Dermatology, research indicates that one in five Americans will develop some form of skin cancer during their lifetime. Utilizing existing shade (e.g., trees) is a potential way to help protect children's skin from the sun. However, when trees are present additional maintenance issues arise such as cleaning up debris and trimming limbs. (CPSC 2.1.1) Overhead obstructions within the use zones of playground equipment that are not part of the play structure (example tree limbs) shall not be within 84" of each designated play surface (ASTM F1487-21 9.8.4.1) You will note in the photos below the proximity of the tree limbs to the play surface of the composite unit.

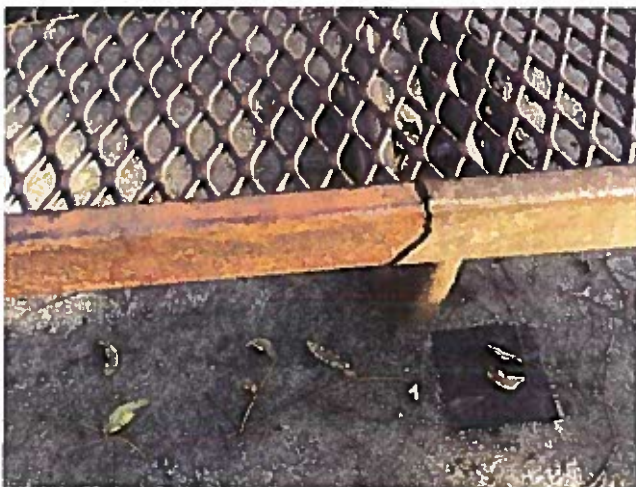
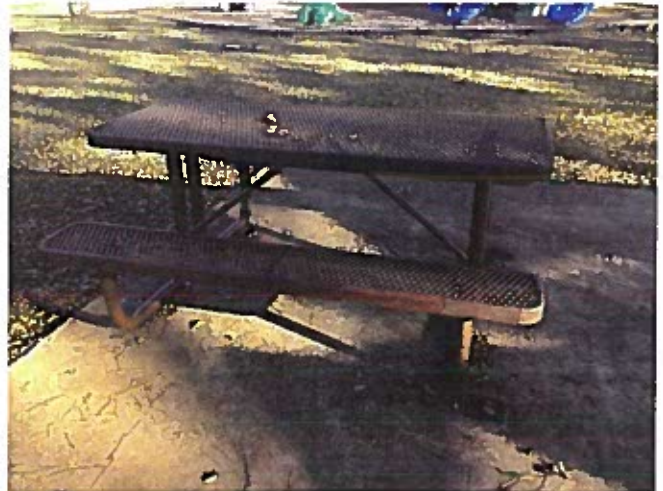
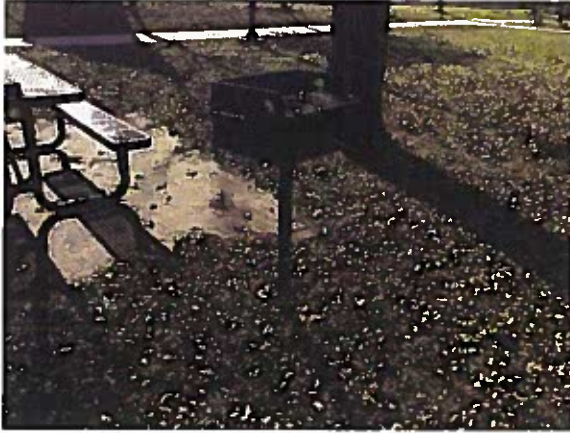
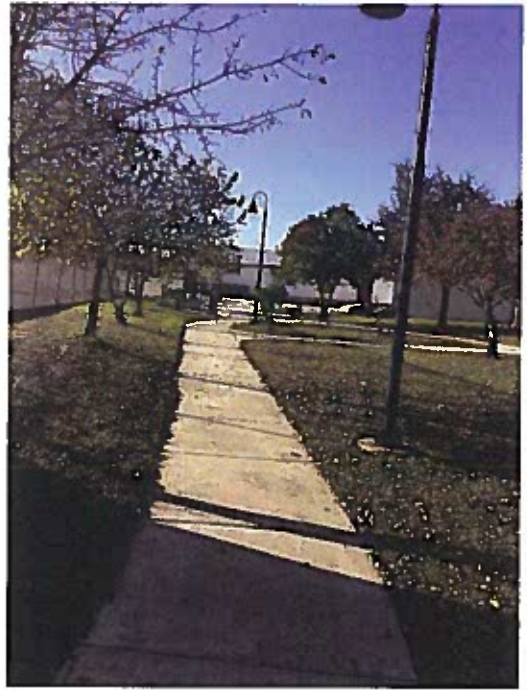
A joining shaded pavilion is provided within the outdoor play environment. (CPSC 2.1, 2.1.1) Seating (benches, tables) are provided. As mentioned in relation to the coating on the play equipment the coating on some of the tables and benches is also in need of repair. Trash receptacles are provided and located outside of the play area use zone as well as cooking grills. The playground is accessed safely by a sidewalk that is free of standing water, pea gravel, and low branches. (NOTE\* Accessibility Audit is recommended)

I believe I would be remiss if I did not mention the hazard of the damaged volleyball net in the sandy area next to the playground pits. I noted several tripping hazards from the anchoring devices, and I believe a child could easily become entangled in the net. I would recommend removal of the net as soon as possible. Although I was not present at this location after dark this appears to be a well-lit facility.
