# Appendix C Biological Resources Reports and Arborist Report

# Biological Resources Report

**DRAFT**  
**BIOLOGICAL RESOURCES REPORT**  
**COSTCO WHOLESALE PROJECT**  
**TOWN OF LOOMIS, PLACER COUNTY, CALIFORNIA**

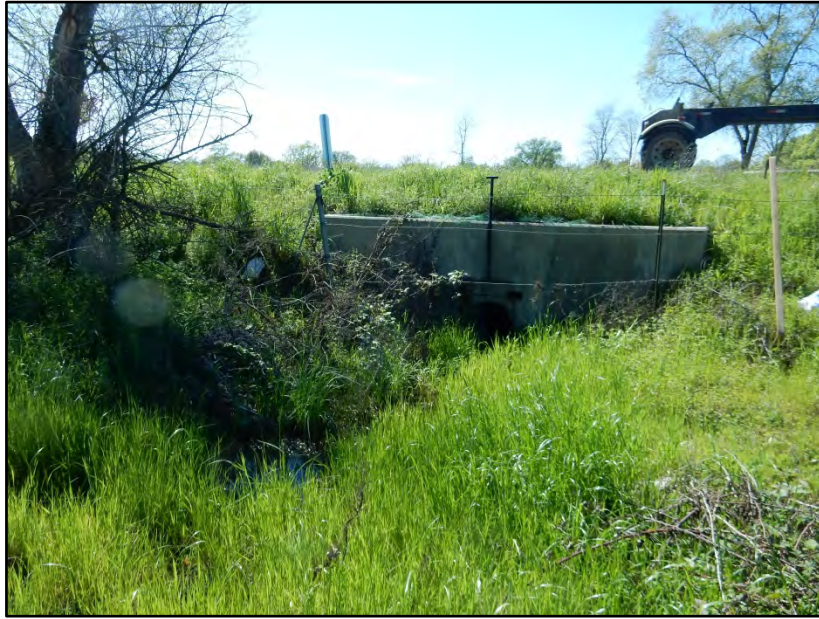
1. Culvert carrying flows to the west from WS-1 under Sierra College Boulevard. *Photo date: 3-25-16*

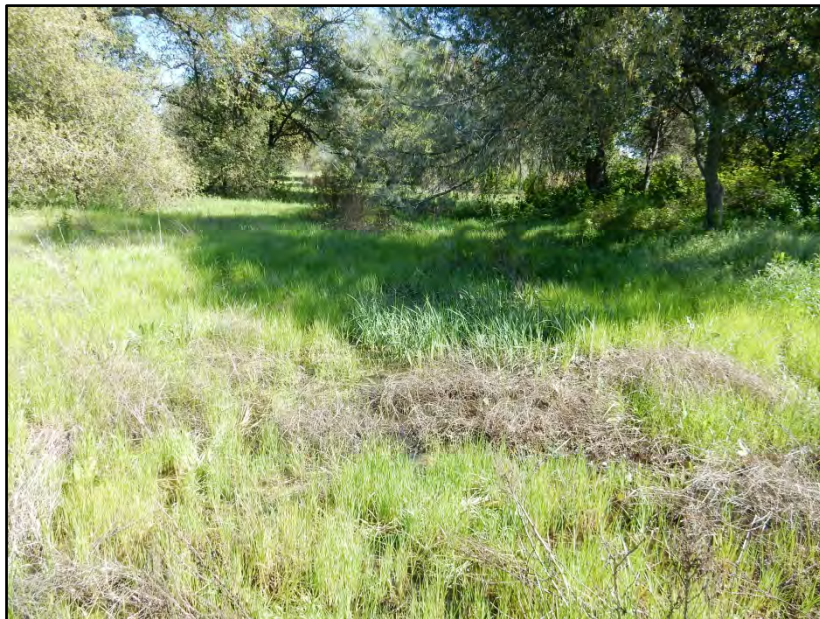
2. Looking upslope along WS-1. *Photo date: 3-25-16*

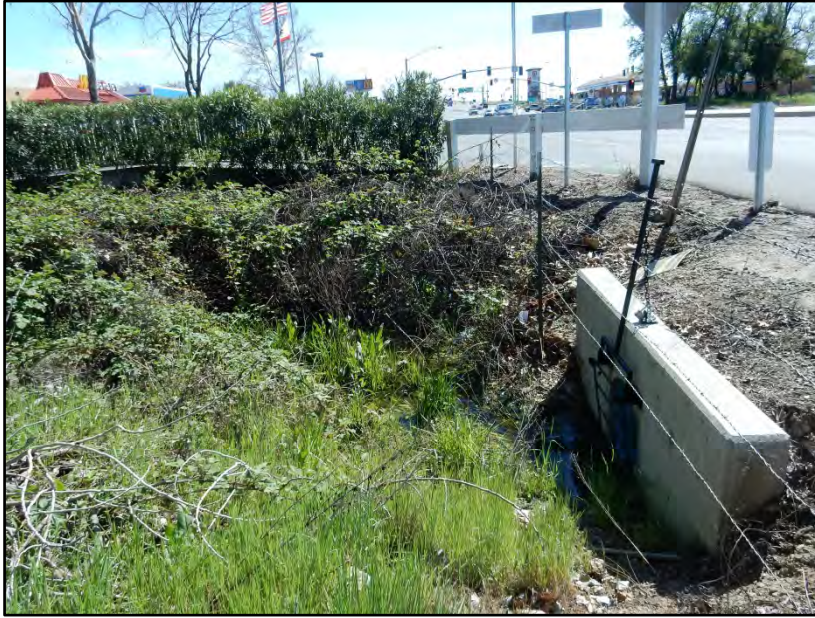
1. Looking at southwest corner of property at culvert carrying flows of WS-3 to the west under Sierra College Blvd. *Photo date: 3-25-16*

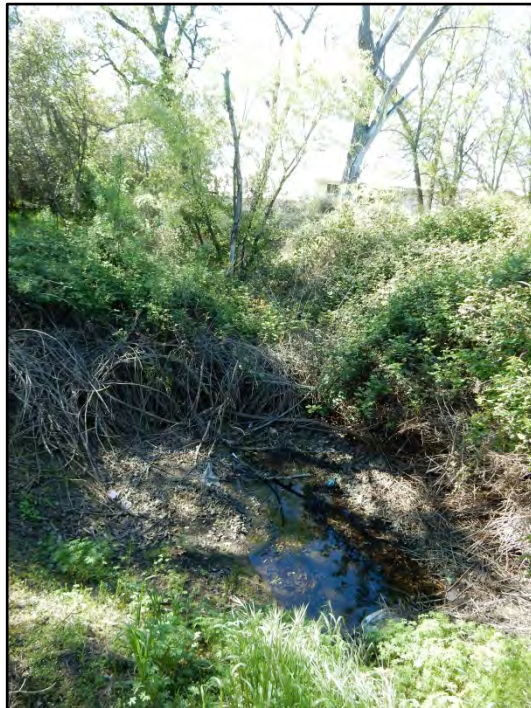
2. Looking west over outfall of WS-2. *Photo date: 3-25-16*

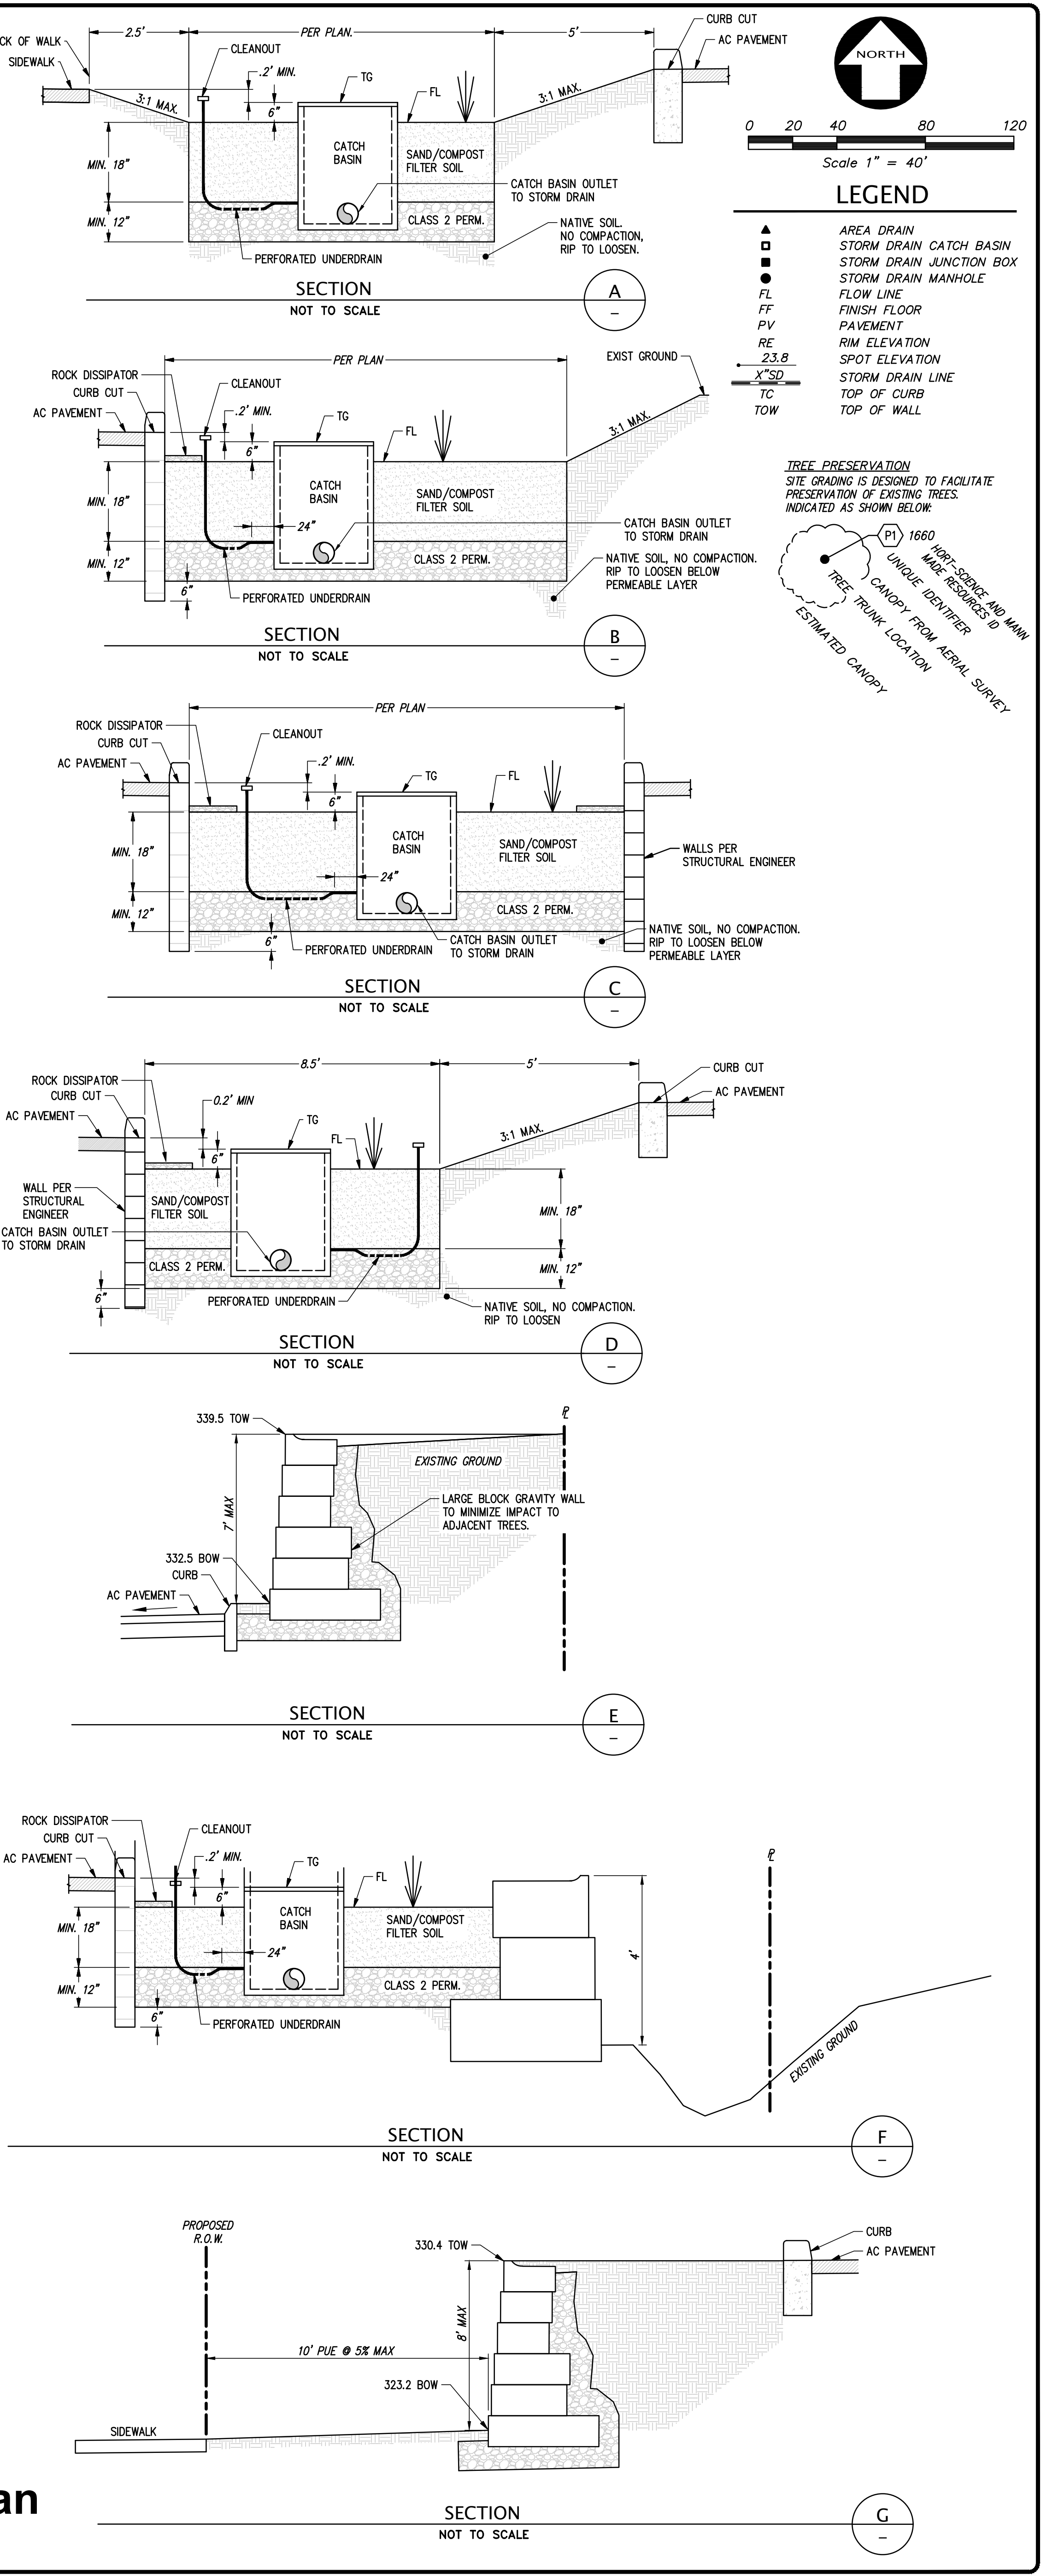
**Figure 5. Preliminary Grading and Drainage Plan**  
 Costco Wholesale Project, Town of Loomis, Placer County, California

**TREE PRESERVATION**  
 SITE GRADING IS DESIGNED TO FACILITATE PRESERVATION OF EXISTING TREES. INDICATED AS SHOWN BELOW:

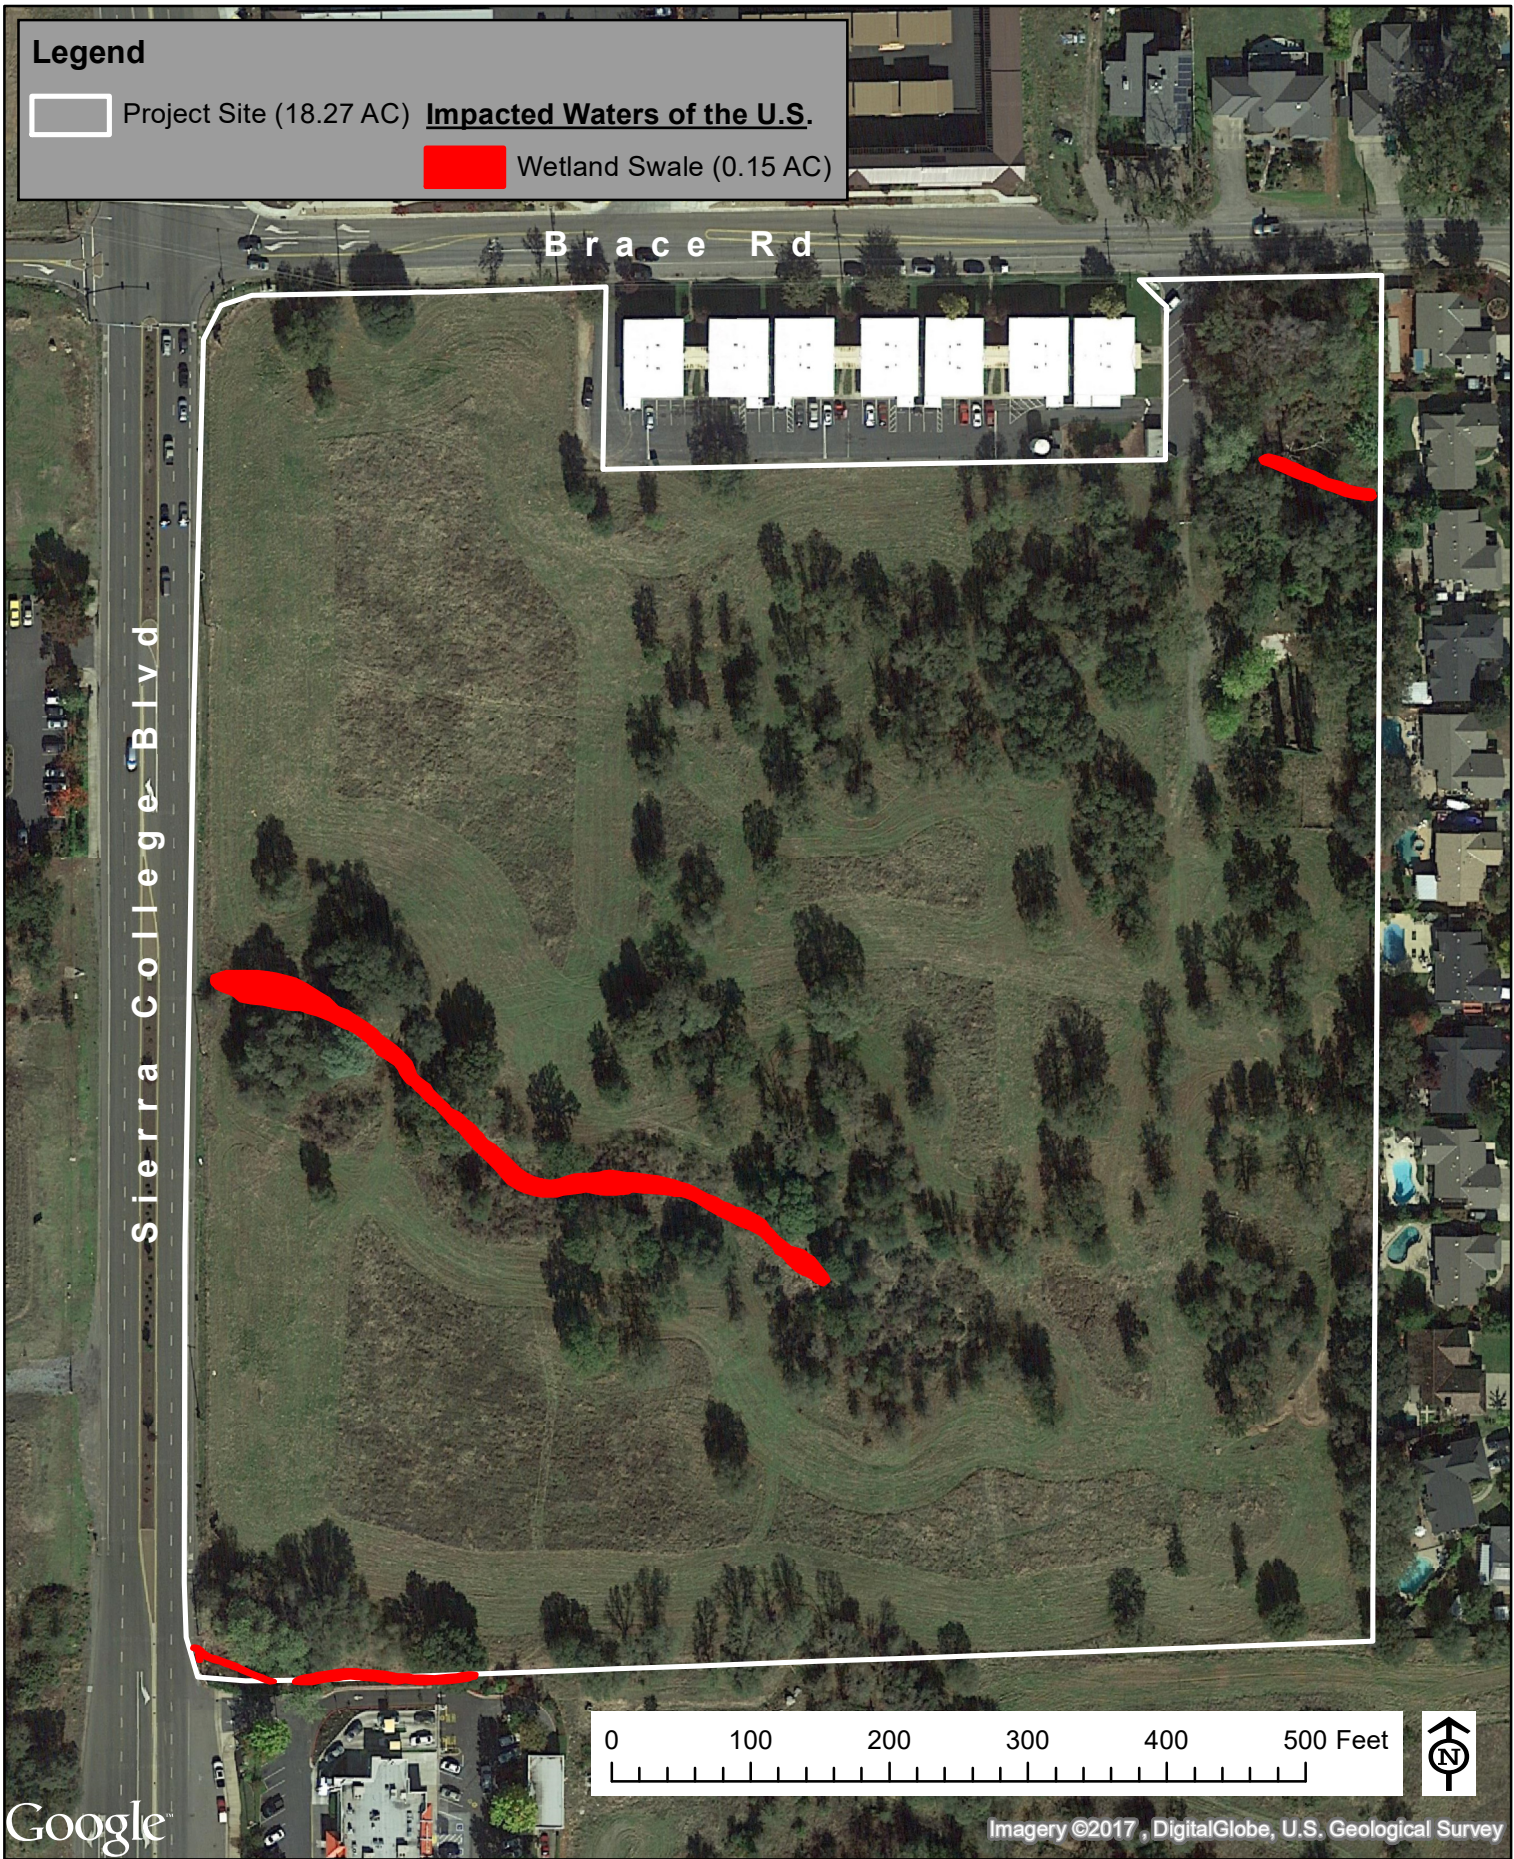
- Project Site (18.27 AC) **Impacted Waters of the U.S.**
- Wetland Swale (0.15 AC)

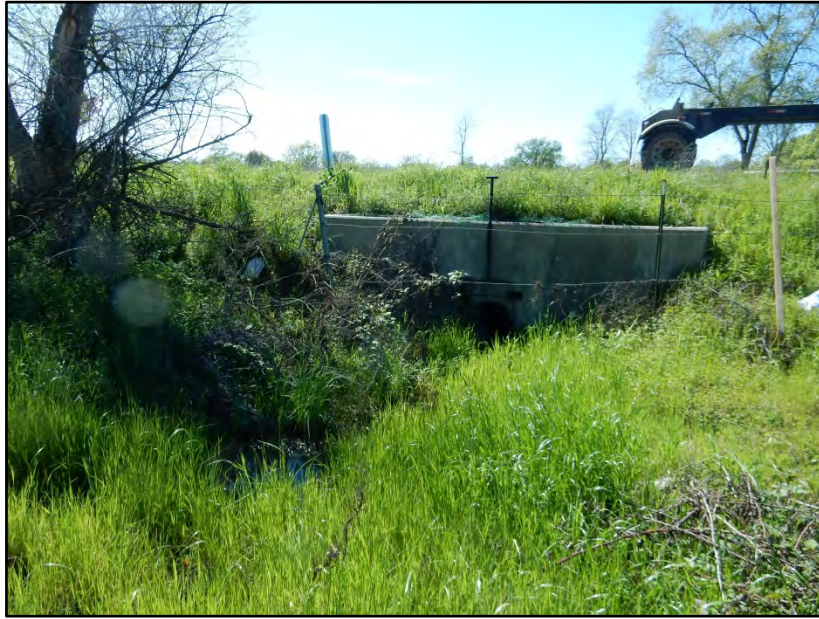
1. Culvert carrying flows to the west from WS-1 under Sierra College Boulevard. *Photo date: 3-25-16*

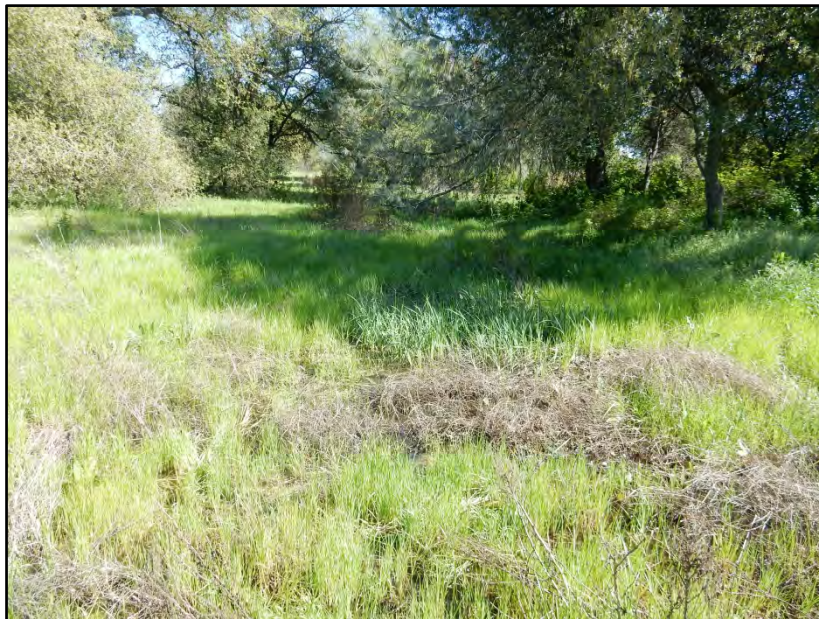
2. Looking upslope along WS-1. *Photo date: 3-25-16*

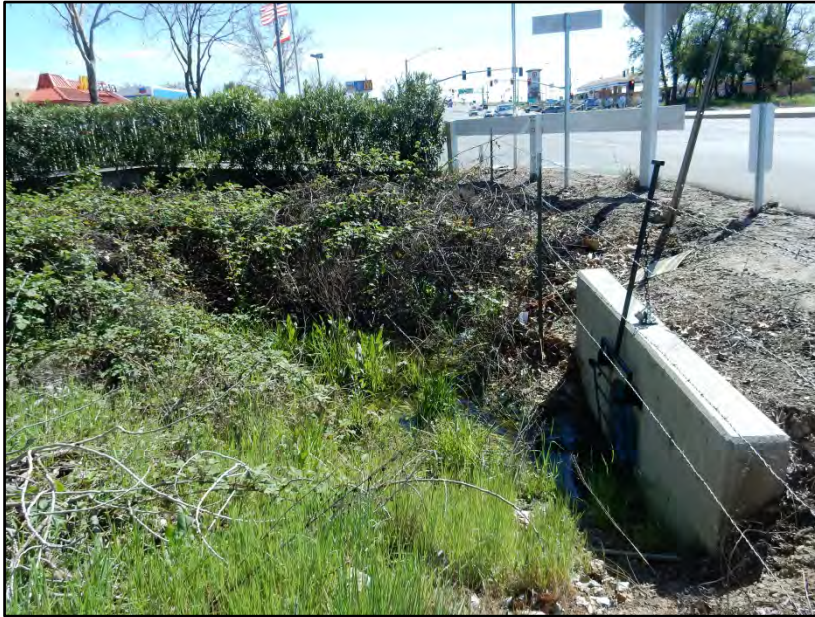
1. Looking at southwest corner of property at culvert carrying flows of WS-3 to the west under Sierra College Blvd. *Photo date: 3-25-16*

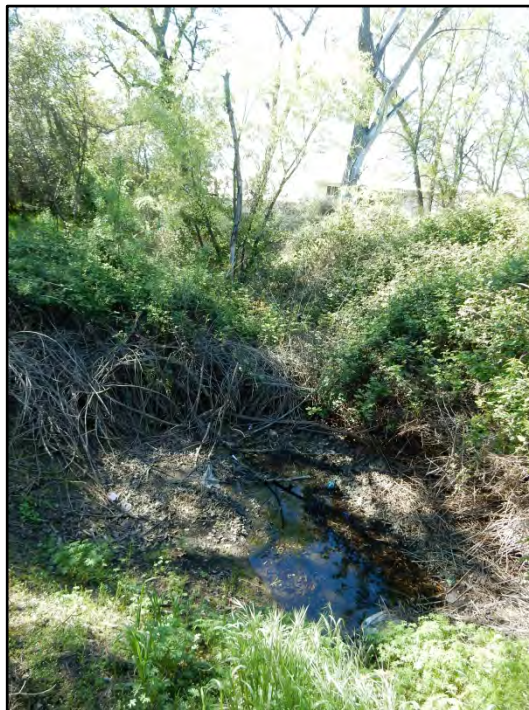
2. Looking west over outfall of WS-2. *Photo date: 3-25-16*
