Aquatic Resources Delineation Report

Green Business Park Loomis

Loomis, Placer County, California
November 2018

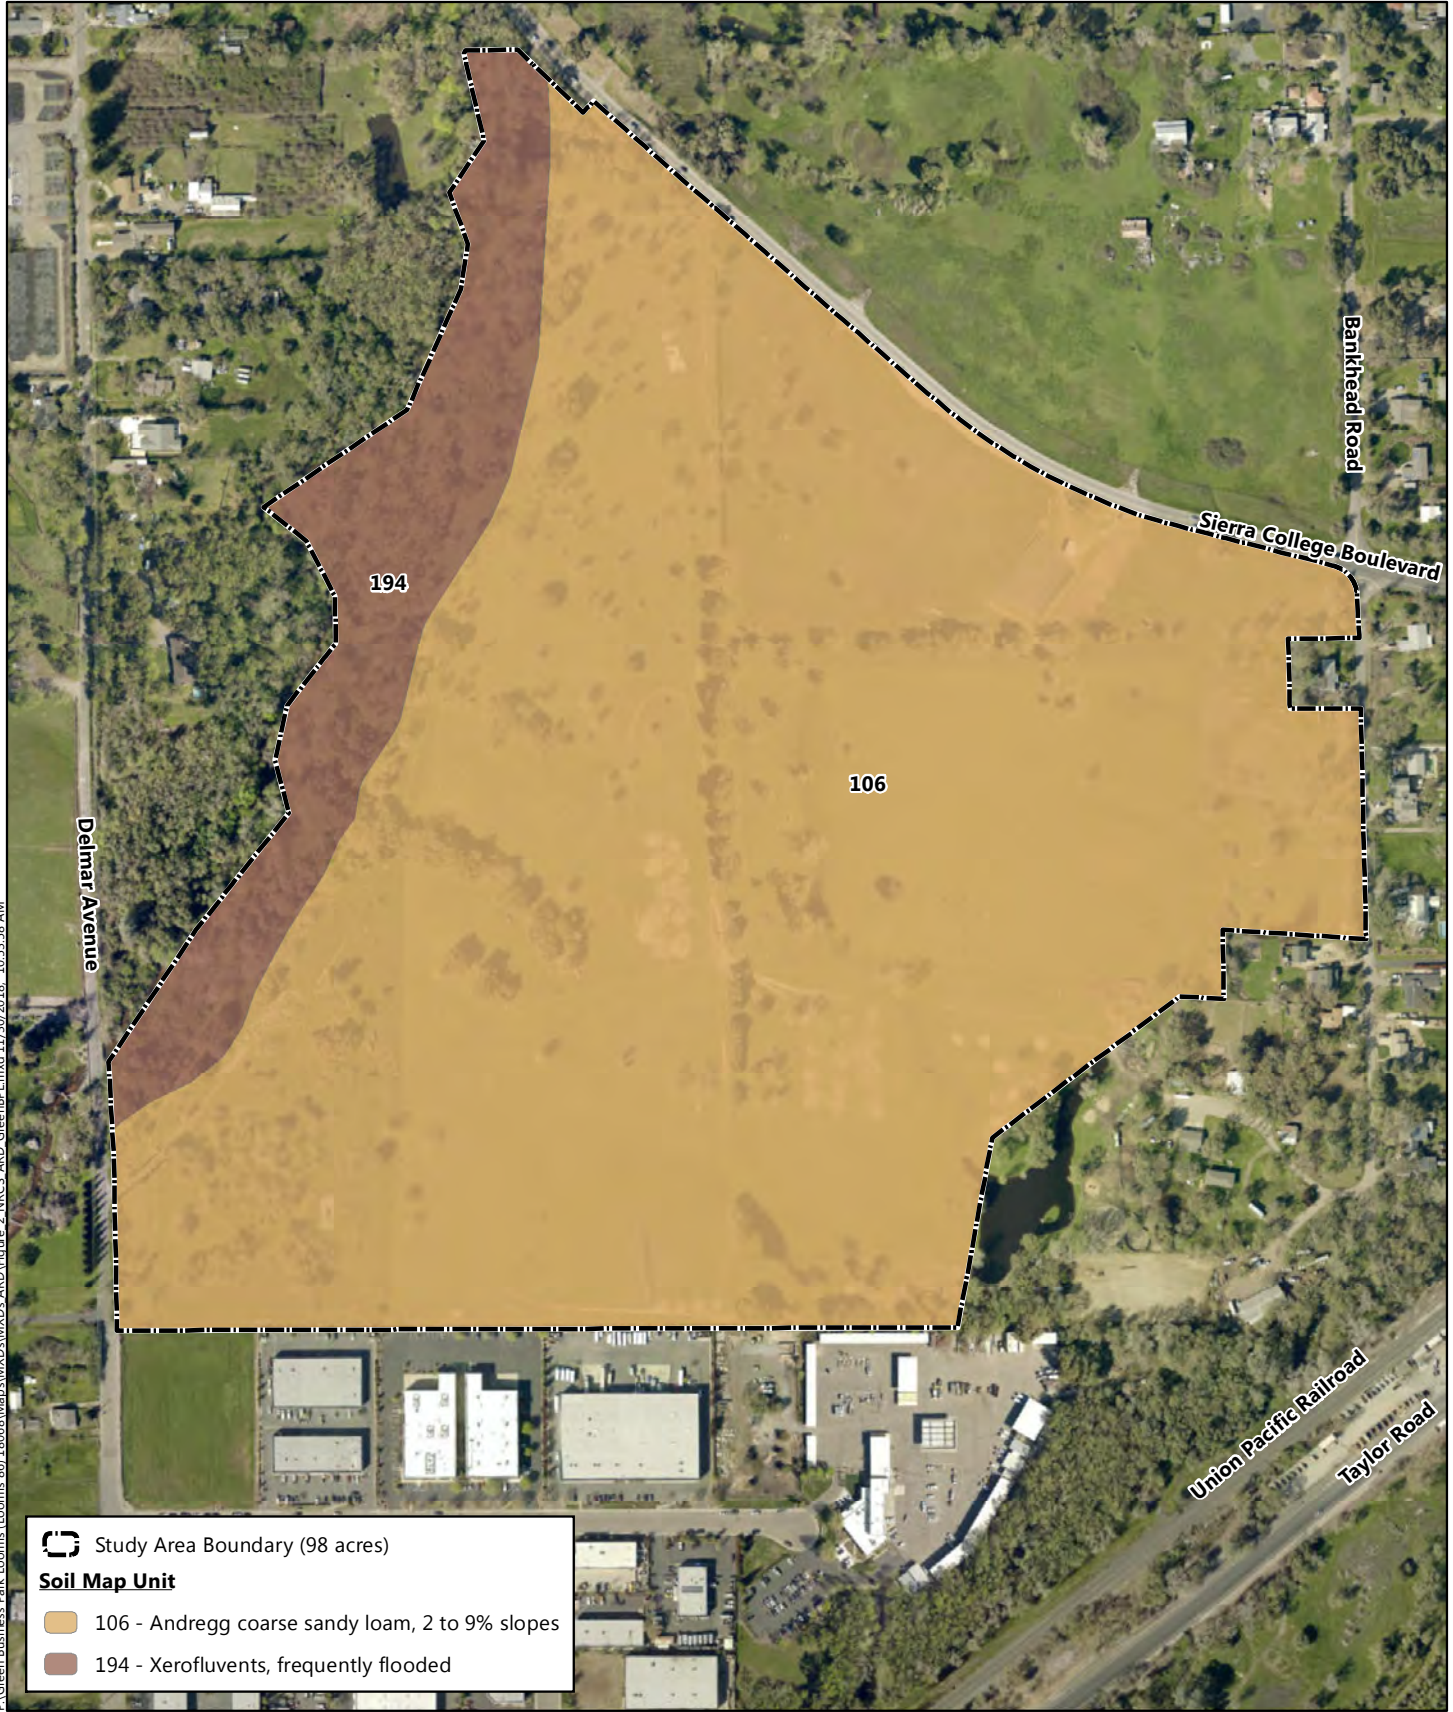
Figure 2
Natural Resources Conservation
Service Soils

According to the Natural Resources Conservation Service (NRCS) Soil Survey Database (NRCS 2018), two soil mapping units occur within the Study Area (**Figure 2**). One of these soil units (194) consists of hydric components, and the other unit (106) contains hydric inclusions (NRCS 2018). The soils within the Study Area fall within the hydrological soil group B, which generally have a moderate infiltration rate when thoroughly wet and a moderate rate of water transmission. Soils found within the Study Area are summarized in **Table 1**.

Soil Unit Name	Map Unit Symbol	Hydric Rating
Andregg coarse sandy loam, 2 to 9 percent slopes	106	No
Xerofluvents, frequently flooded	194	Yes

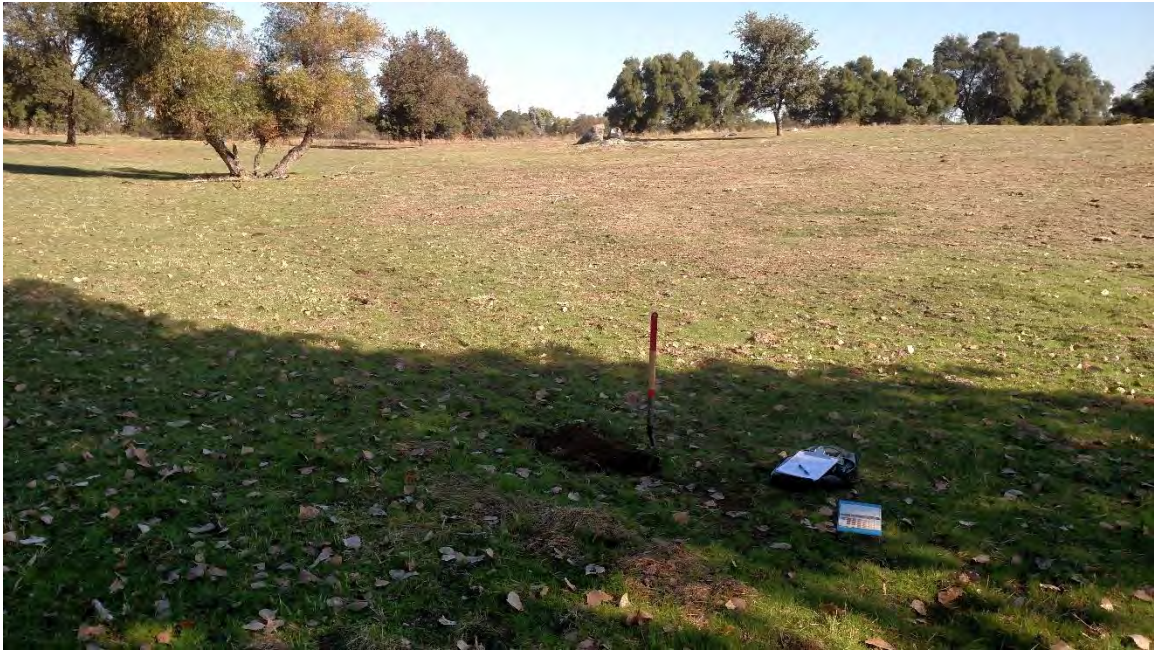
Data Point DP-3 (within SWS-1) – 17 October 2018

Depth (inches)	Matrix		Redox Features				Texture	Remarks
	Color (moist)	%	Color (moist)	%	Type ¹	Loc ²		
0-3	7.5YR 3/2	95	7.5YR 3/4	5	C	PL, M	loam	
3-7	10YR 3/2	98	7.5 YR 3/4	2	C	M	sandy loam	
7-10	7.5YR 3/2	95	7.5YR 3/4	5	C	M	sandy loam

<input checked="" type="checkbox"/> Drift Deposits (B3) (Nonriverine)	<input type="checkbox"/> Presence of Reduced Iron (C4)	<input type="checkbox"/> Crayfish Burrows (C8)
<input type="checkbox"/> Surface Soil Cracks (B6)	<input type="checkbox"/> Recent Iron Reduction in Tilled Soils (C6)	<input checked="" type="checkbox"/> Saturation Visible on Aerial Imagery (C9)
<input type="checkbox"/> Inundation Visible on Aerial Imagery (B7)	<input type="checkbox"/> Thin Muck Surface (C7)	<input type="checkbox"/> Shallow Aquitard (D3)
<input type="checkbox"/> Water-Stained Leaves (B9)	<input type="checkbox"/> Other (Explain in Remarks)	<input type="checkbox"/> FAC-Neutral Test (D5)
Field Observations:		
Surface Water Present? Yes <input type="checkbox"/> No <input checked="" type="checkbox"/>	Depth (inches): _____	Wetland Hydrology Present? Yes <input checked="" type="checkbox"/> No <input type="checkbox"/>

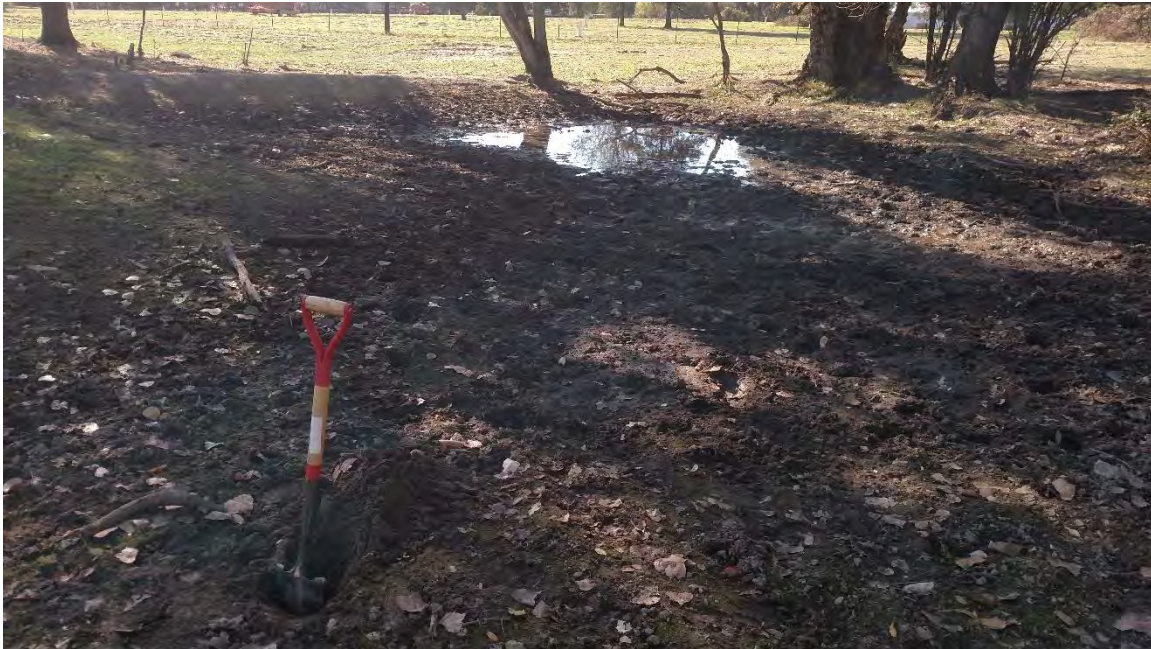
Data point DP-5 (within P-2) – 17 October 2018

Depth (inches)	Matrix		Redox Features				Texture	Remarks
	Color (moist)	%	Color (moist)	%	Type ¹	Loc ²		
0-1	2.5Y 2.5/1	100					silt loam	mucky
1-9	10YR 3/2	70	7.5YR 3/4	25	C	M	sandy loam	
			10R 3/4	5	C	M		
9-12	10YR 3/2	95	2.5YR 2.5/2	5	C	M	sandy loam

Hydric Soil Indicators: (Applicable to all LRRs, unless otherwise noted.)		Indicators for Problematic Hydric Soils³:	
<input type="checkbox"/> Histosol (A1)	<input type="checkbox"/> Sandy Redox (S5)	<input checked="" type="checkbox"/> 1 cm Muck (A9) (LRR C)	
<input type="checkbox"/> Histic Epipedon (A2)	<input type="checkbox"/> Stripped Matrix (S6)	<input type="checkbox"/> 2 cm Muck (A10) (LRR B)	
<input type="checkbox"/> Black Histic (A3)	<input type="checkbox"/> Loamy Mucky Mineral (F1)	<input type="checkbox"/> Reduced Vertic (F18)	
<input type="checkbox"/> Hydrogen Sulfide (A4)	<input type="checkbox"/> Loamy Gleyed Matrix (F2)	<input type="checkbox"/> Red Parent Material (TF2)	
<input type="checkbox"/> Stratified Layers (A5) (LRR C)	<input type="checkbox"/> Depleted Matrix (F3)	<input type="checkbox"/> Other (Explain in Remarks)	
<input type="checkbox"/> 1 cm Muck (A9) (LRR D)	<input checked="" type="checkbox"/> Redox Dark Surface (F6)

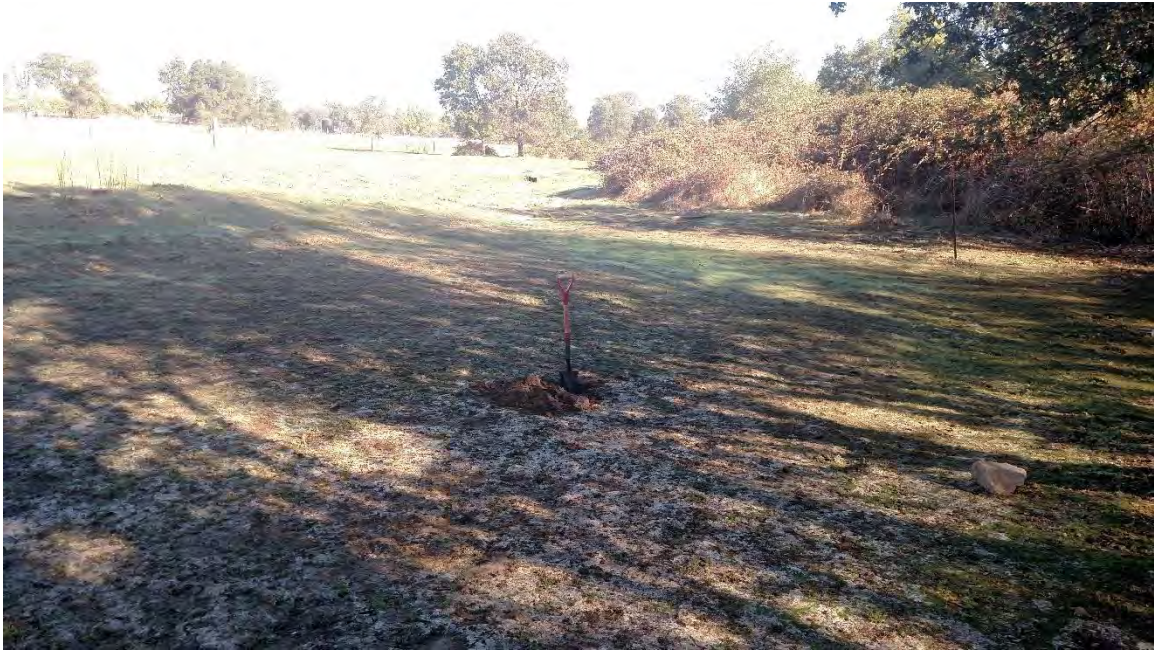
Data point DP-7 (within SWS-5) – 18 October 2018

Depth (inches)	Matrix		Redox Features				Texture	Remarks
	Color (moist)	%	Color (moist)	%	Type ¹	Loc ²		
0-3	10YR 3/2	100					silty clay loam	
3-10	10YR 3/2	95	5YR 3/4	5	C	C	loam

<input type="checkbox"/> Drift Deposits (B3) (Nonriverine)	<input type="checkbox"/> Presence of Reduced Iron (C4)	<input type="checkbox"/> Crayfish Burrows (C8)
<input checked="" type="checkbox"/> Surface Soil Cracks (B6)	<input type="checkbox"/> Recent Iron Reduction in Tilled Soils (C6)	<input type="checkbox"/> Saturation Visible on Aerial Imagery (C9)
<input checked="" type="checkbox"/> Inundation Visible on Aerial Imagery (B7)	<input type="checkbox"/> Thin Muck Surface (C7)	<input type="checkbox"/> Shallow Aquitard (D3)
<input checked="" type="checkbox"/> Water-Stained Leaves (B9)	<input type="checkbox"/> Other (Explain in Remarks)	<input type="checkbox"/> FAC-Neutral Test (D5)

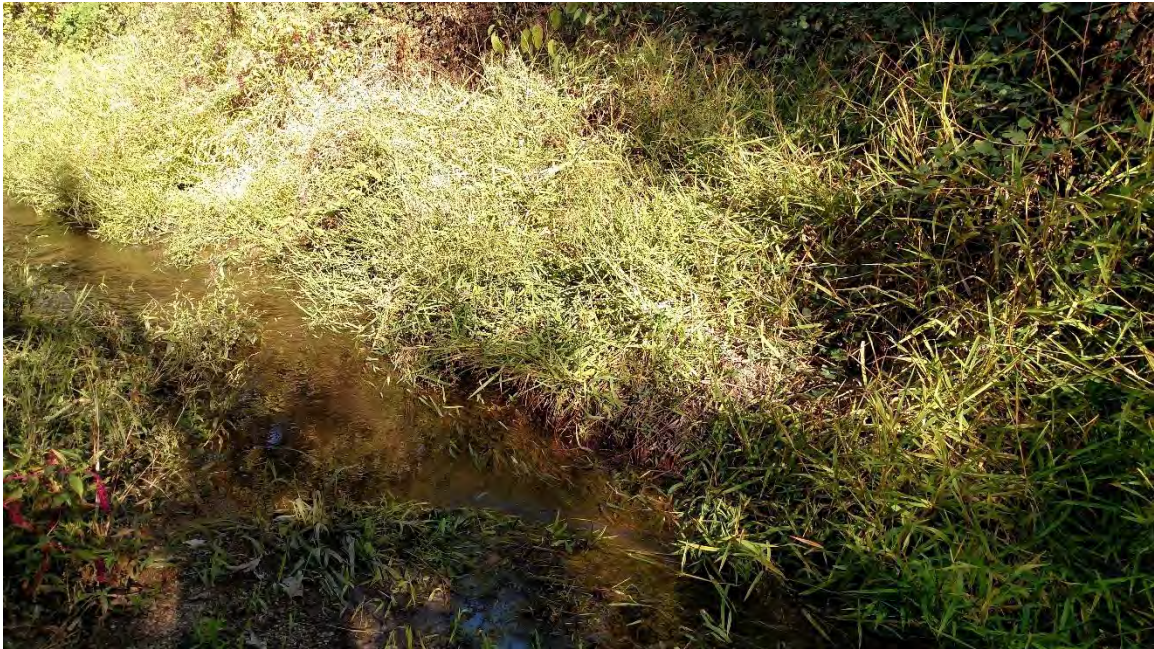
Data point DP-9 (within Creek-11) – 18 October 2018

<p>Wetland Hydrology Indicators:</p> <p>Primary Indicators (minimum of one required; check all that apply)</p> <p><input checked="" type="checkbox"/> Surface Water (A1)</p> <p><input checked="" type="checkbox"/> High Water Table (A2)</p> <p><input checked="" type="checkbox"/> Saturation (A3)</p> <p><input type="checkbox"/> Water Marks (B1) (Nonriverine)</p> <p><input type="checkbox"/> Sediment Deposits (B2) (Nonriverine)</p> <p><input type="checkbox"/> Drift Deposits (B3) (Nonriverine)</p> <p><input type="checkbox"/> Surface Soil Cracks (B6)</p> <p><input checked="" type="checkbox"/> Inundation Visible on Aerial Imagery (B7)</p> <p><input checked="" type="checkbox"/> Water-Stained Leaves (B9)</p>		<p>Secondary Indicators (2 or more required)</p> <p><input type="checkbox"/> Salt Crust (B11)</p> <p><input type="checkbox"/> Biotic Crust (B12)</p> <p><input checked="" type="checkbox"/> Aquatic Invertebrates (B13)</p> <p><input type="checkbox"/> Hydrogen Sulfide Odor (C1)</p> <p><input type="checkbox"/> Oxidized Rhizospheres along Living Roots (C3)</p> <p><input type="checkbox"/> Presence of Reduced Iron (C4)</p> <p><input type="checkbox"/> Recent Iron Reduction in Tilled Soils (C6)</p> <p><input type="checkbox"/> Thin Muck Surface (C7)</p> <p><input type="checkbox"/> Other (Explain in Remarks)</p>	<p><input type="checkbox"/> Water Marks (B1) (Riverine)</p> <p><input checked="" type="checkbox"/> Sediment Deposits (B2) (Riverine)</p> <p><input checked="" type="checkbox"/> Drift Deposits (B3) (Riverine)</p> <p><input checked="" type="checkbox"/> Drainage Patterns (B10)</p> <p><input type="checkbox"/> Dry-Season Water Table (C2)</p> <p><input type="checkbox"/> Crayfish Burrows (C8)</p> <p><input type="checkbox"/> Saturation Visible on Aerial Imagery (C9)</p> <p><input type="checkbox"/> Shallow Aquitard (D3)</p> <p><input type="checkbox"/> FAC-Neutral Test (D5)</p>

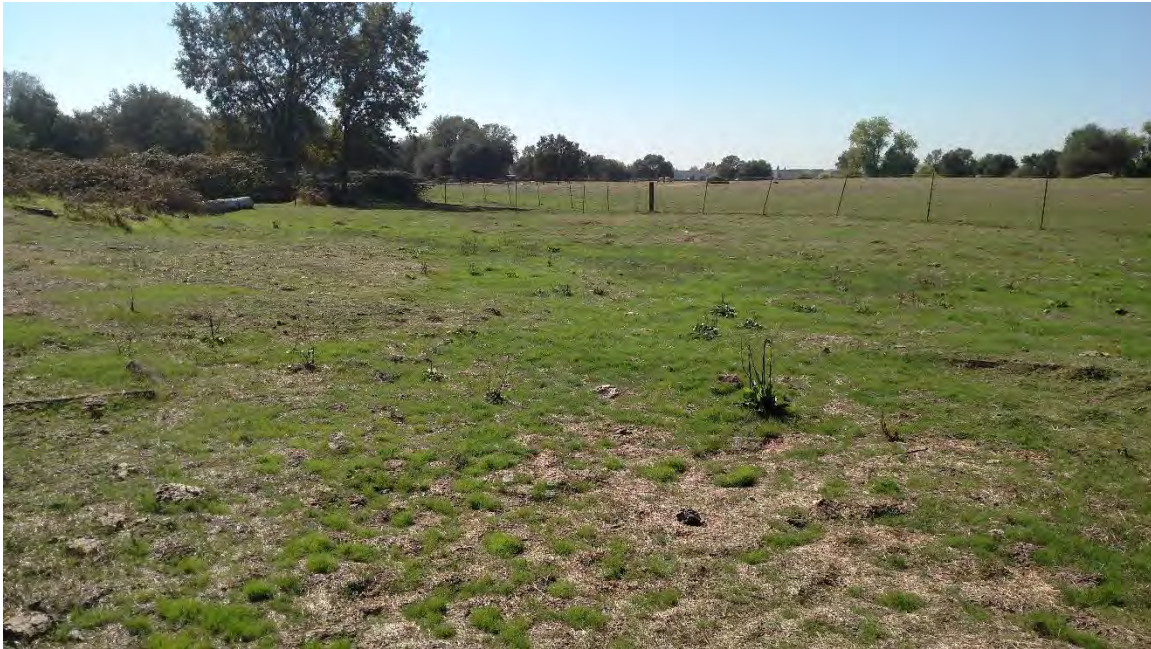
Seasonal wetland swale (SWS-6), facing southwest – 17 October 2018

Seasonal wetland swales are sloping, linear seasonal wetlands that convey storm water runoff, and may detain it for short periods of time. Six seasonal wetland swale segments are located in pastures within the central and southeast portion of the Study Area. SWS-1 drains into a small pond in the center of the site (P-2), while two swale segments (SWS-2, SWS-3) drain via culvert from P-2 into a large pond (P-3) in the southeast corner of the Study Area. Another swale (SWS-5, SWS-6) also flows into P-3 via a system of culverts. P-3 is drained via culvert by SWS-4, which flows off-site at the southern end of the Study Area. Approximately 0.288 acre of seasonal wetland swales are located on-site. At the time of the survey, vegetation within the swales was heavily grazed, and some species were unidentifiable. Identifiable plant species within the swales on-site include curly dock (*Rumex crispus*), Carter's buttercup (*Ranunculus bonariensis*), rabbitsfoot grass (*Polypogon monspeliensis*), pennyroyal (*Mentha pulegium*), common purslane (*Portulaca oleracea*), hyssop loosestrife (*Lythrum hyssopifolia*), tall flatsedge (*Cyperus eragrostis*), swamp grass (*Crypsis schoenoides*), Bermuda grass (*Cynodon dactylon*), and prostrate knotweed (*Polygonum aviculare*). Hydrology within the swales is driven predominantly by storm water runoff within the pasture areas, along with draining water from ponds P-2 and P-3. The swales generally flow south, and eventually

all drain into an off-site culvert which flows into Sucker Ravine. As previously described, Sucker Ravine is a tributary to the navigable Sacramento River; thus, the swales on-site are likely to be jurisdictional waters of the U.S. Data Points DP-3 and DP-7 were collected within seasonal wetland swales and contained hydrophytic vegetation, soils, and wetland hydrology. The swales were mapped at the Ordinary High Water Mark (OHWM), which was identified based on drift deposits, water marks, topographic breaks, and aerial imagery.

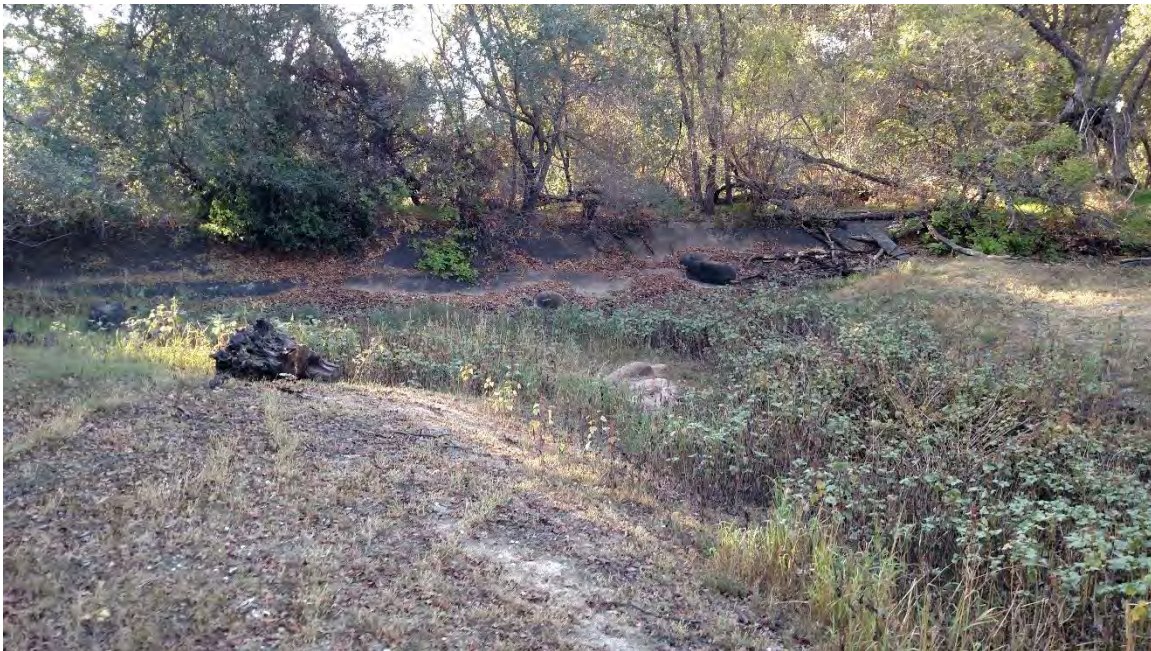
Pond (P-4), facing west – 18 October 2018

Four man-made ponds reside within the Study Area (0.404 acre); three ponds (P-1, P-2, P-3) are located in the central and southeast portion of the site, and one pond (P-4) is located in the northwest corner. As previously described, P-2 and P-3 are connected via a seasonal wetland swale system. P-1 and P-2 appear to have been created as stock ponds and exhibit evidence of cattle use, such as extensive hoof prints in the muddy margins of the ponds. At the time of the survey P-1 was dry and P-2 was almost empty (although the pond features a small berm along the southern edge to help store water). P-3 also has a low water level; it appears to have been created to store water for irrigation purposes, and has much steeper, less mucky margins than P-1 and P-2. All three ponds are mostly unvegetated with scattered species occurring along the margins, such as common purslane, prostrate knotweed, and Bermuda grass. P-4 was constructed at some point after 1966 (Historic Aerials), and is much older than the other ponds on site. It features steep stone walls, and appears to have been created from a historic swale. The pond is no longer in active use, and was dry during the October survey. A man-made spillway on the west side of the pond may drain overflow water into Antelope Creek. Vegetation is abundant within and along the margins of

the pond, and includes bull thistle, tall flatsedge, Oregon ash, prostrate knotweed, Himalayan blackberry, curly dock, sandbar willow, rough cocklebur, and manyflower tobacco (*Nicotiana acuminata*). P-2 and P-3 are connected to Sucker Ravine, and P-4 appears to drain into Antelope Creek. As previously described, both Sucker Ravine and Antelope Creek are tributaries to the navigable Sacramento River, and thus these ponds are likely to be jurisdictional waters of the U.S. It is uncertain whether or not P-1 drains or otherwise connects with other waters; the jurisdictional status of this pond is unclear. Data point DP-5 was collected within P-2, and contained hydrophytic vegetation, soils, and wetland hydrology. The ponds were mapped at the OHWM, which was identified based on water marks, vegetation, topographic breaks, and aerial imagery.

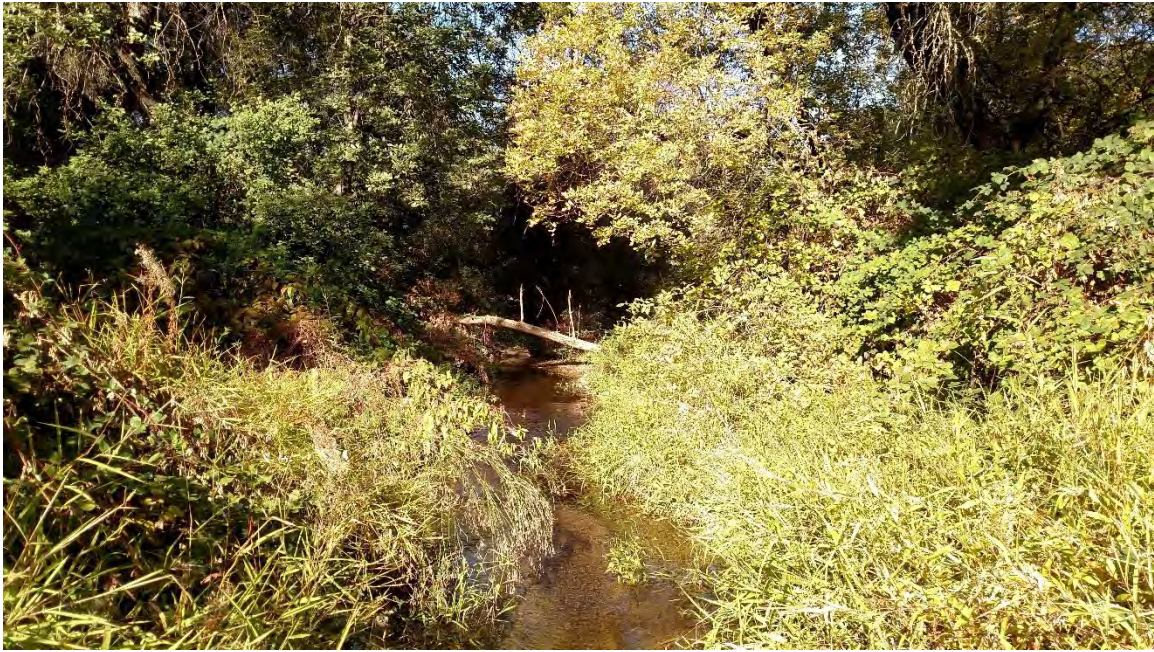
Antelope Creek (Creek-11), facing northeast – 18 October 2018

Antelope Creek (Creek-1 through Creek-11), a perennial creek, travels from north to south along the western margin of the Study Area. Flows within the creek are perennial in nature, with steady-flowing water observed during the site visits. The creek passes in and out of the Study Area, and 11 segments (0.156 acre) fall within the site boundary. Vegetation within and along the banks of the creek is robust and includes tall flatsedge, curly dock, floating primrose willow (*Ludwigia peploides*), paniced willowherb (*Epilobium brachycarpum*), fringed willowherb (*Epilobium ciliatum*), common knotweed (*Persicaria lapathifolia*), common plantain (*Plantago major*), Johnsongrass (*Sorghum halepense*), cattail (*Typha sp.*), and rough cocklebur (*Xanthium strumarium*). Vegetation within the riparian corridor along Antelope Creek consists almost exclusively of Himalayan blackberry (*Rubus armeniacus*) thickets, with some pokeweed (*Phytolacca americana*). Tree cover includes valley oak, Oregon ash (*Fraxinus latifolia*), western sycamore (*Platanus racemosa*), Fremont cottonwood (*Populus fremontii*), sandbar willow (*Salix exigua*), Goodding's black willow (*Salix gooddingii*), and arroyo willow (*Salix lasiolepis*). In addition, black elderberry (*Sambucus nigra*), the host plant for the federally threatened valley elderberry longhorn beetle, was found within the riparian corridor. The creek is directly connected to the navigable Sacramento River, as previously described, and is therefore likely to be a jurisdictional water of the U.S. Data point DP-9 was collected within the creek; it contained hydrophytic vegetation, wetland hydrology, and was inundated with water. The creek was mapped at the OHWM, which was identified based on sediment deposits, drift deposits, water marks, vegetation, topographic breaks, and aerial imagery.

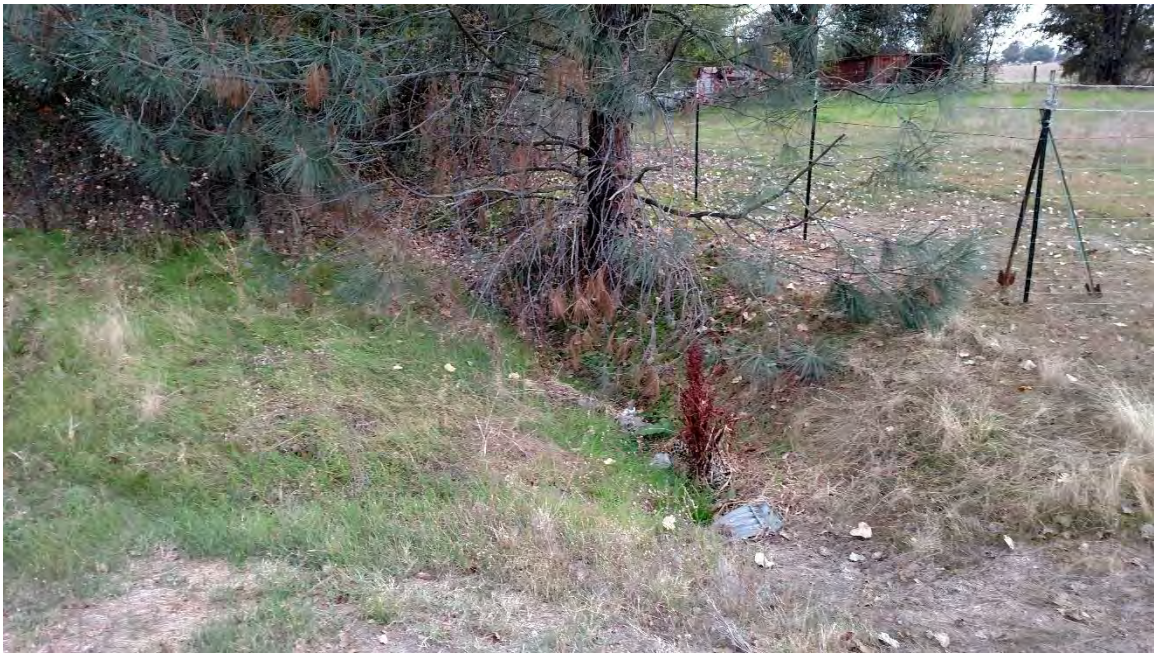
Roadside Ditch (RD-1), facing southwest – 21 November 2018

A single roadside drainage ditch (RD-1, 0.009 acre) is located within the Study Area, along Bankhead Road. The ditch features scattered vegetative ground cover that primarily includes Himalayan blackberry, perennial ryegrass, curly dock, and tall flatsedge. The base of the ditch is mostly unvegetated, and much of the area is covered in leaf litter. Many trees are growing within and along the ditch, including valley oak, interior live oak, grey pine, and Fremont cottonwood. Storm water runoff flows south from a culvert at the northern end of the ditch, and eventually drains off-site onto a single-family home and property. It is uncertain whether or not the ditch drains into other waters; thus, the jurisdictional status of the feature is unknown. The ditch was mapped at the OHWM based on vegetation, water marks, and topographic breaks.
