**PHASE I ENVIRONMENTAL SITE ASSESSMENT
OF THE PROPERTY AT
5397 BRACE ROAD, LOOMIS, CALIFORNIA**

March 5, 2019

Nicholas Bair
Tiny Toes Academy
5735 Stone Road, Loomis, CA 95650

G. O. Graening, PhD, MSE and Kristen Ahrens, M.S.

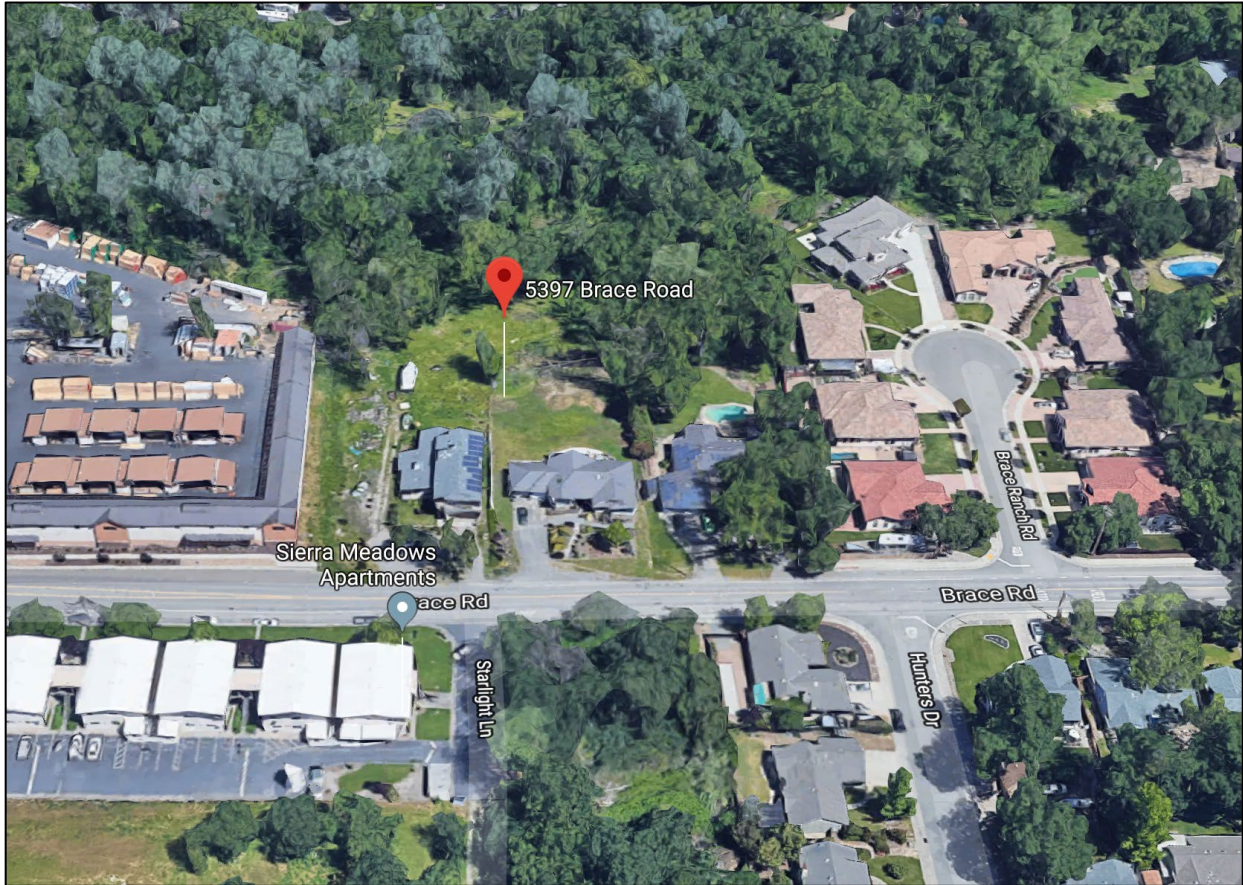
The subject Property consists of a single-family residence comprised of a two-story structure at the southern portion of the parcel. The residence is accessed by a driveway off of Brace Road. The residence is currently unoccupied and being renovated. Utilities are present on the west side of the building. Just north of the residence is a gravel yard and several gravel stockpiles and piles of rubbish. In the center of the yard, a groundwater well is present, though not in use. The northern-most portion of the parcel is

undeveloped land and lies within the floodplain of Secret Ravine which is northerly adjacent. A culvert along Brace Road on the southwestern corner of the parcel directs stormwater to a drainage ditch which follows the western parcel boundary and flows to Secret Ravine.

Figure 2.3.1. Oblique aerial photo, view looking north, of subject property and surrounding properties (Google Maps).
