Project No. S2134-05-01  
April 9, 2021

Subject: PRELIMINARY GEOTECHNICAL EVALUATION  
LOOMIS RESIDENTIAL DEVELOPMNENT  
LOOMIS, CALIFORNIA

In accordance with your request, we have prepared this Preliminary Geotechnical Evaluation for the 60-acre property located north of Interstate 80 and east of Horseshoe Bar Road in the Town of Loomis, California. The approximate location of the project area is shown on the Vicinity Map, Figure 1.

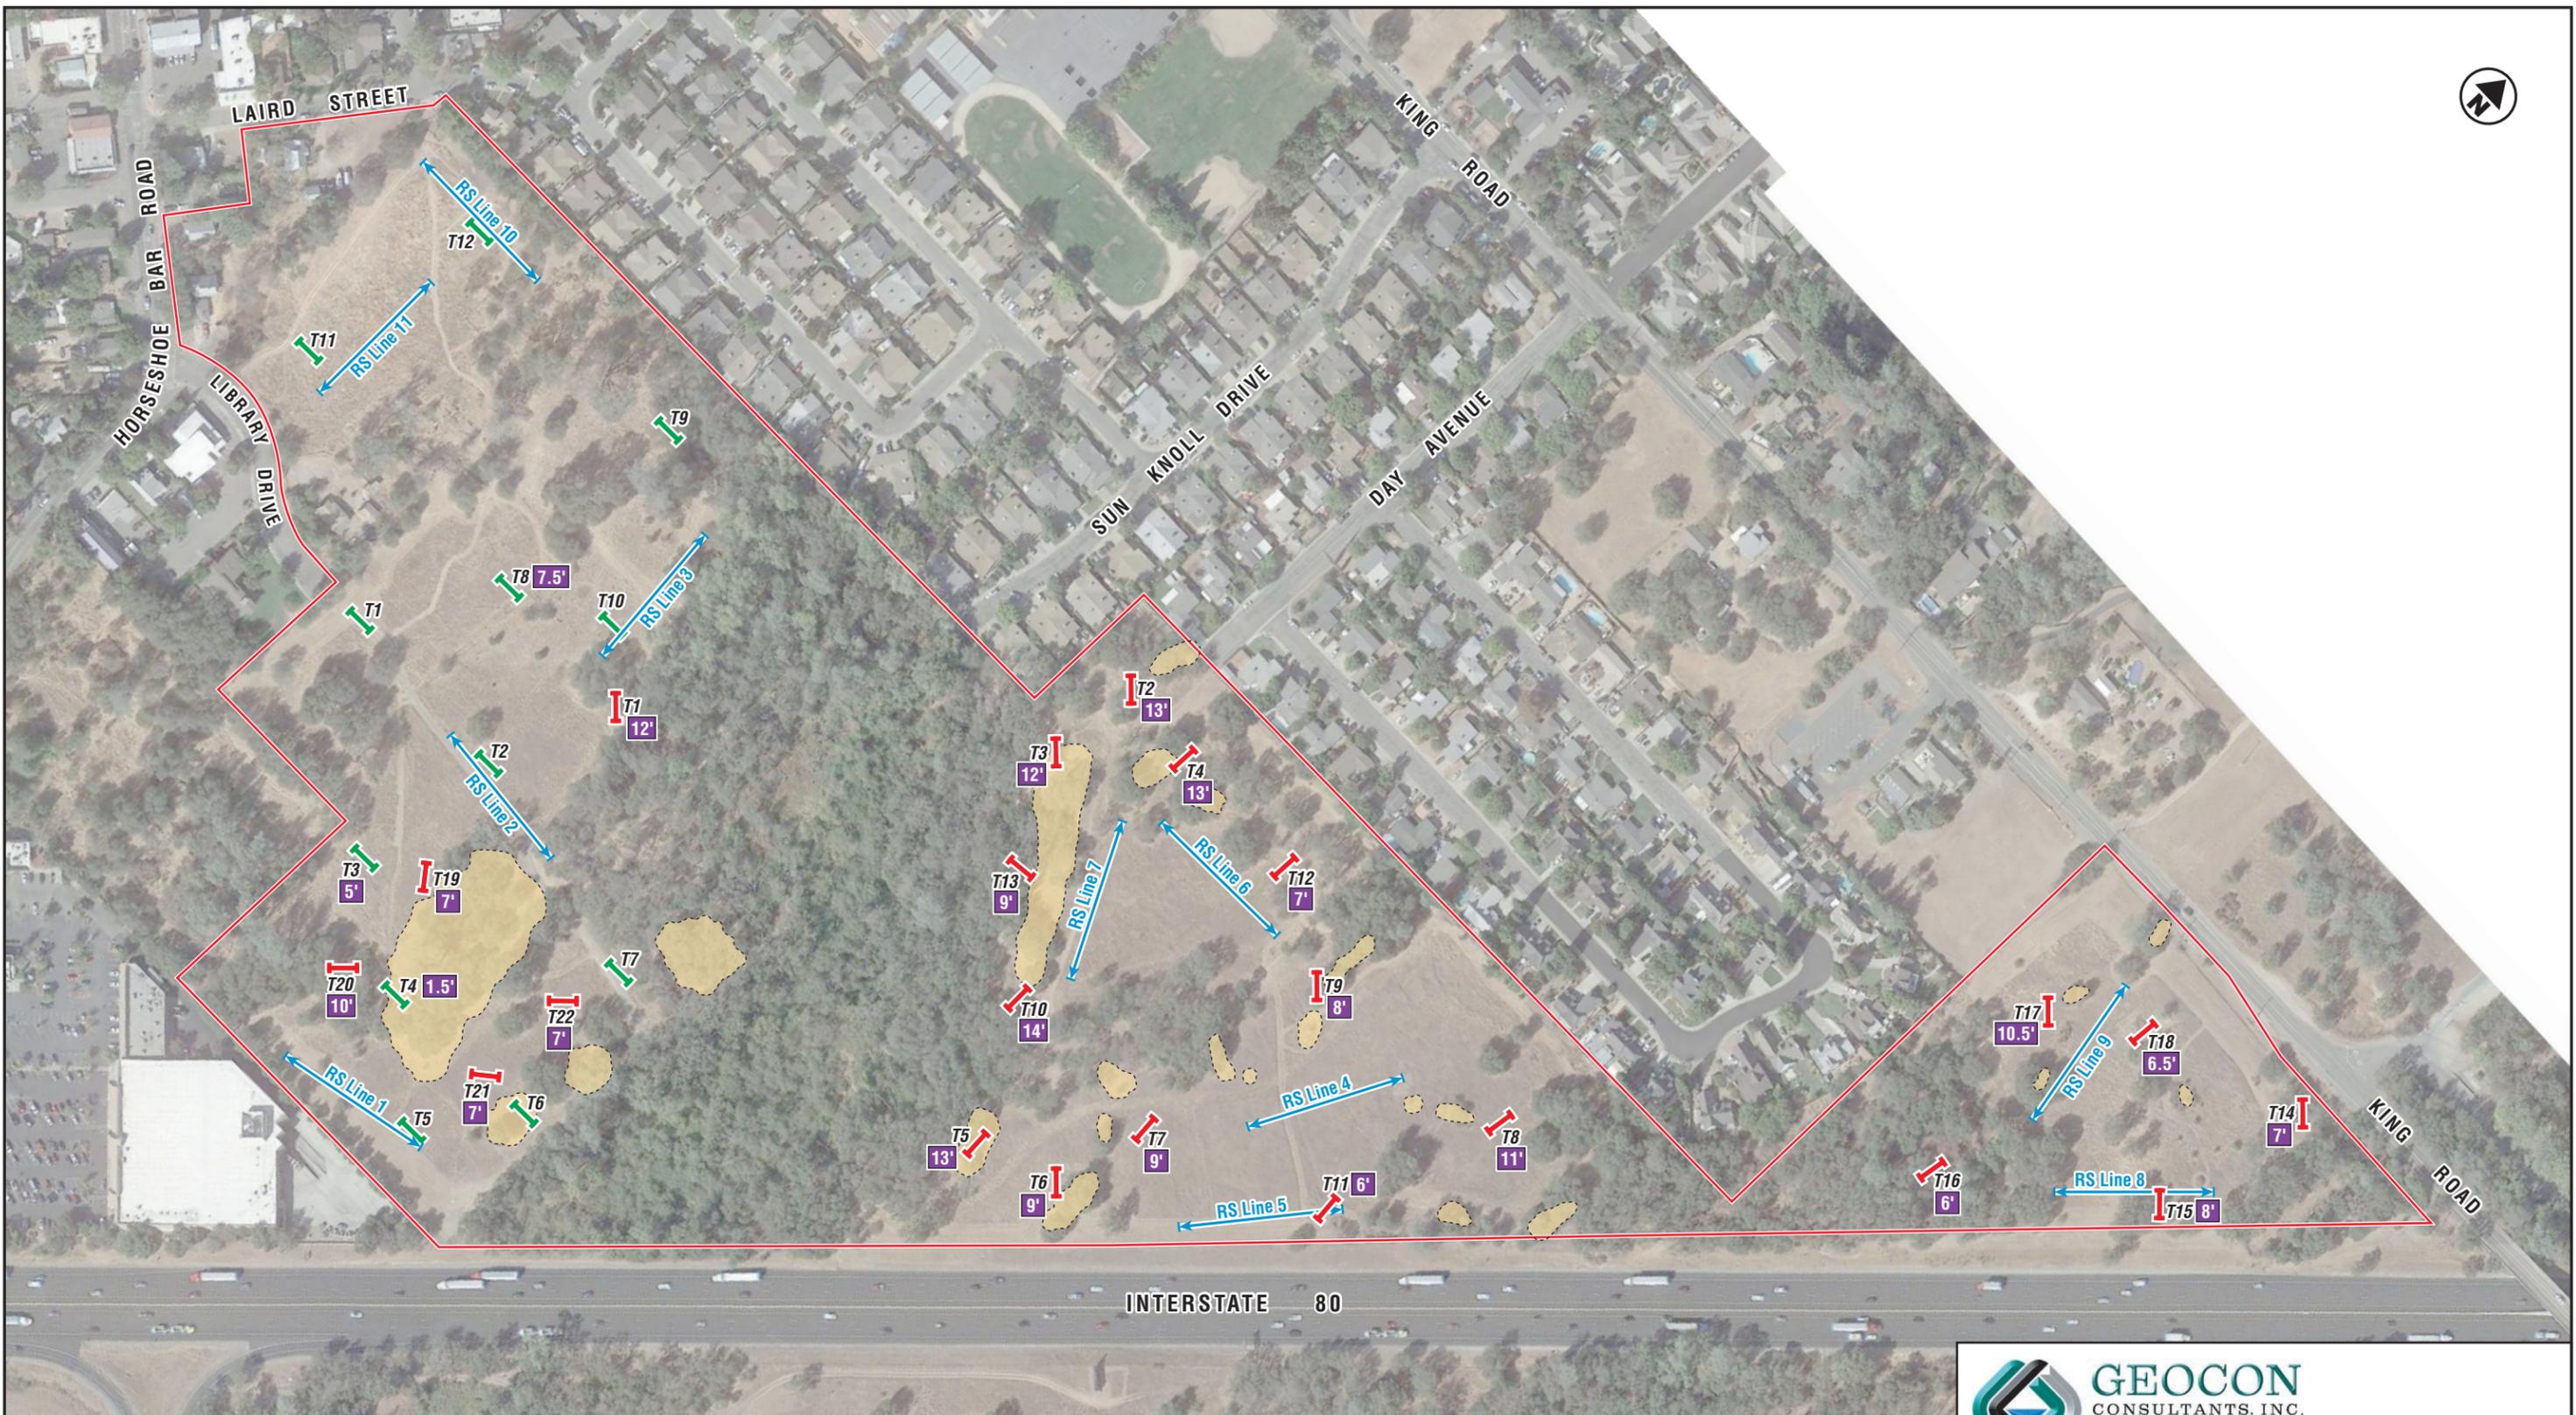
Loomis Development		
Loomis, California		
<b>SITE PLAN</b>		
S2134-05-01	April 2021	Figure 2

We identified geologic and soil conditions by observing and sampling exploratory test pits, reviewing the refraction seismic data, and reviewing available geologic literature for the site vicinity. Soil descriptions below include the USCS symbol where applicable. The site is predominantly underlain by shallow granitic rock (Penryn Pluton) with a relatively thin colluvial soil cover. Based on our explorations, the granitic rock is decomposed near the ground surface throughout the majority of the site and becomes less weathered with increasing depth, however rock outcrops are present in localized areas. Our approximate exploration locations and areas of outcropping rock are shown on the Site Plan, Figure 2.

Our evaluation is based on our review of the referenced preliminary geotechnical report and supplemental field exploration performed between March 23 and April 2, 2021. Our field exploration program included 22 exploratory test pits (T1 through T22) and eleven (11) refraction seismic (RS) survey lines (RS Line 1 through RS Line 11) performed by Gasch Geophysical Services (G<sup>2</sup>S). Approximate exploration locations (including the previous WKA test pits) are shown on the Site Plan,
