Greenwood Beach Restoration Project Reference Beach Study

Data Collection Report

**Greenwood Beach Restoration Project – Reference Beach Study
Data Collection Report**

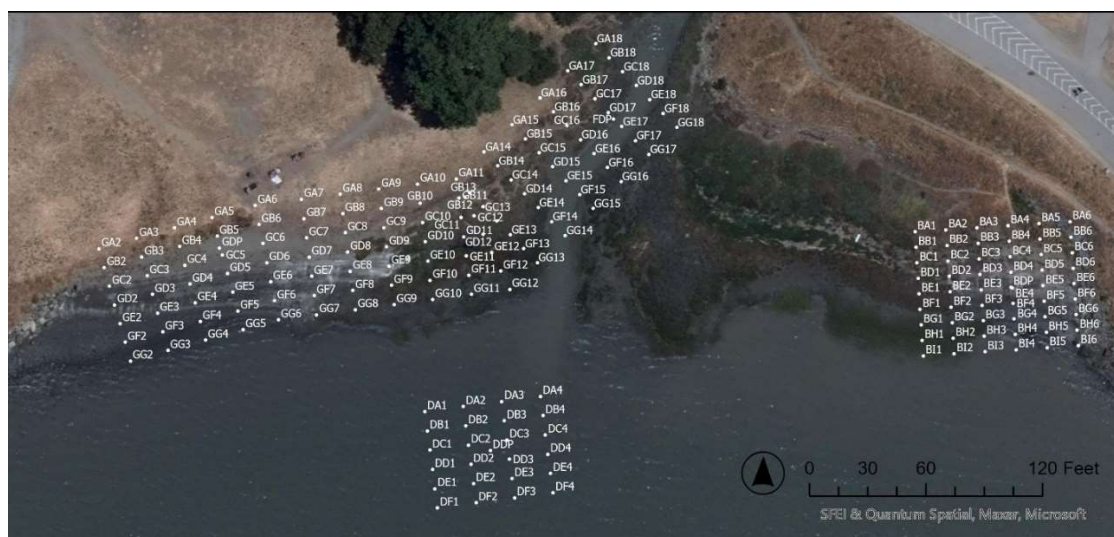
Figure 1. Grid of Survey Points

Based on intended sediment deployment locations (see Figure 2), a grid was established at regularly spaced intervals around each deployment point and labeled individually. A map of these labeled points is shown in Figure 1.

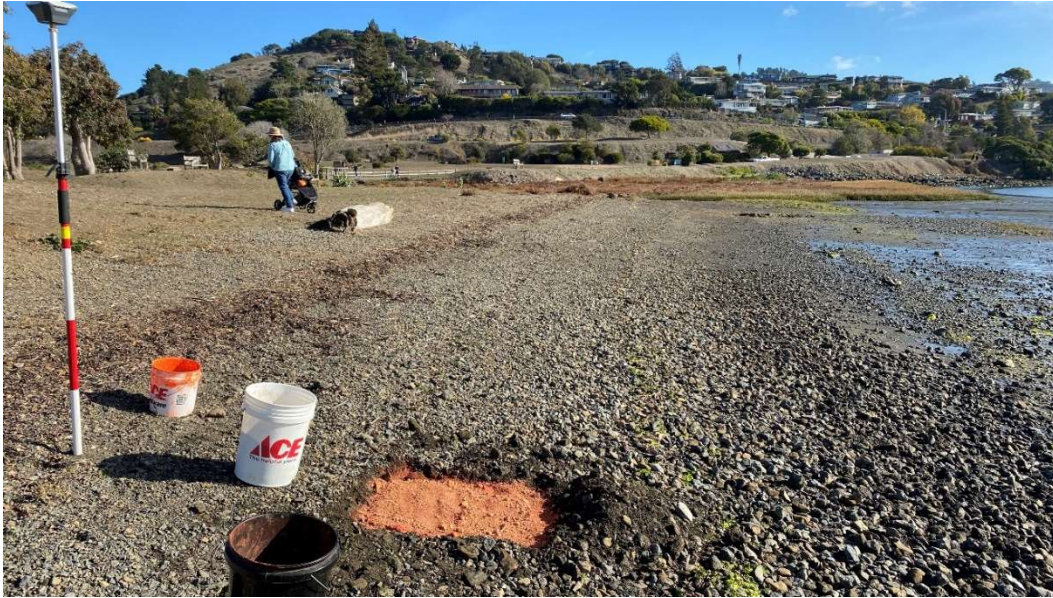
Figure 3. Example Tracer Deployment at Greenwood Beach, 11/30/22.

Sediment was covered with a thin (approx. 1/2 - 2") layer of surrounding sediment. An example of tracer deployment prior to cover at Greenwood Beach is seen in Figure 3.

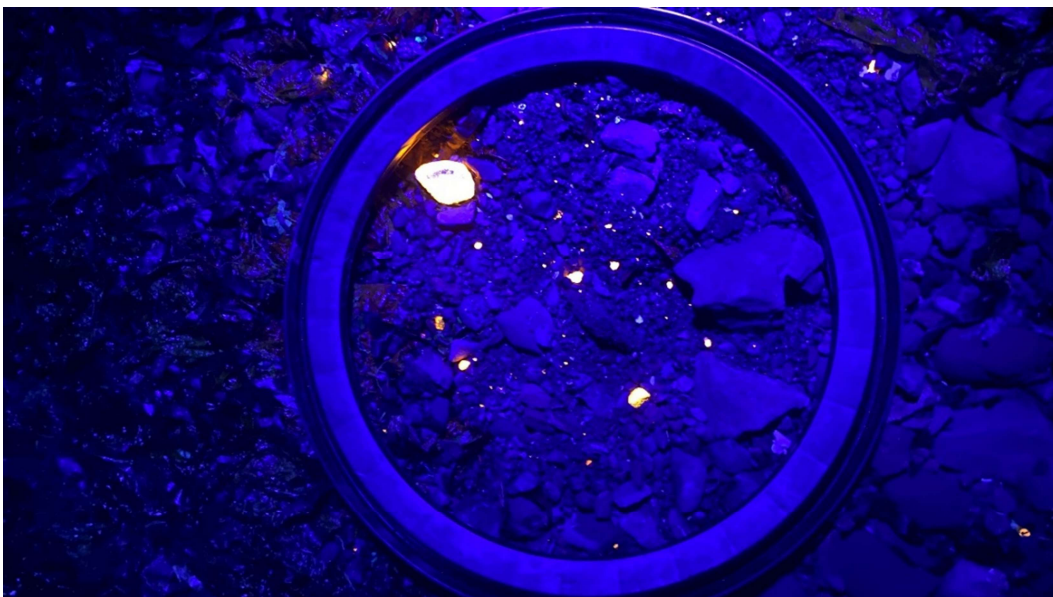
Figure 4. Example Surface Observation, Grid Point GB5 on 12/01/22.

An RTK GPS unit guided me to each pre-established grid point. A circular black frame with a diameter of 9.75" (0.52 sq. ft. area) was placed at each grid point and a UV flashlight illuminated the ground within the frame. Fluorescent grains that were visible within the frame were counted by manual observation. Photos were taken when grain sizes exceeded 0.5 mm and the maximum grain size was recorded (photos of fluorescent grains finer than approximately 0.5mm did not register as visible when photographed). An example photo of this surface measurement is shown in Figure 4.

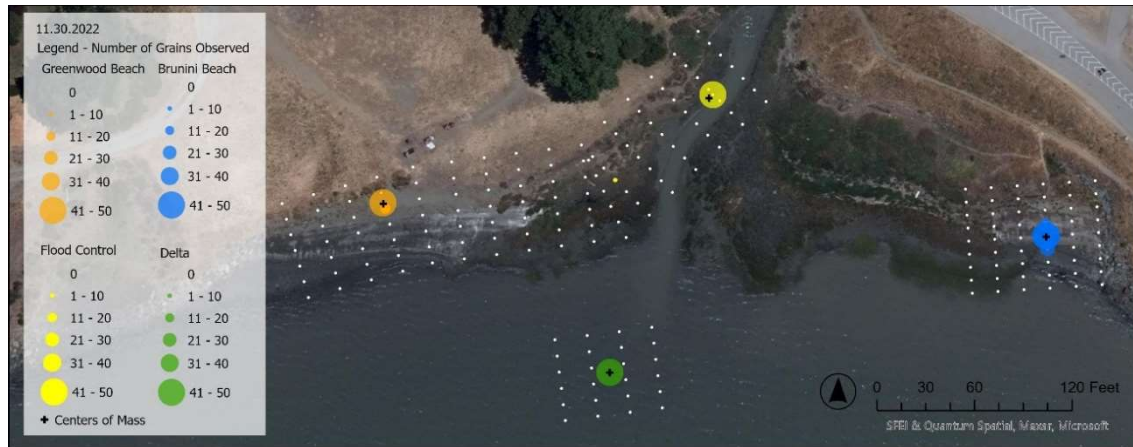
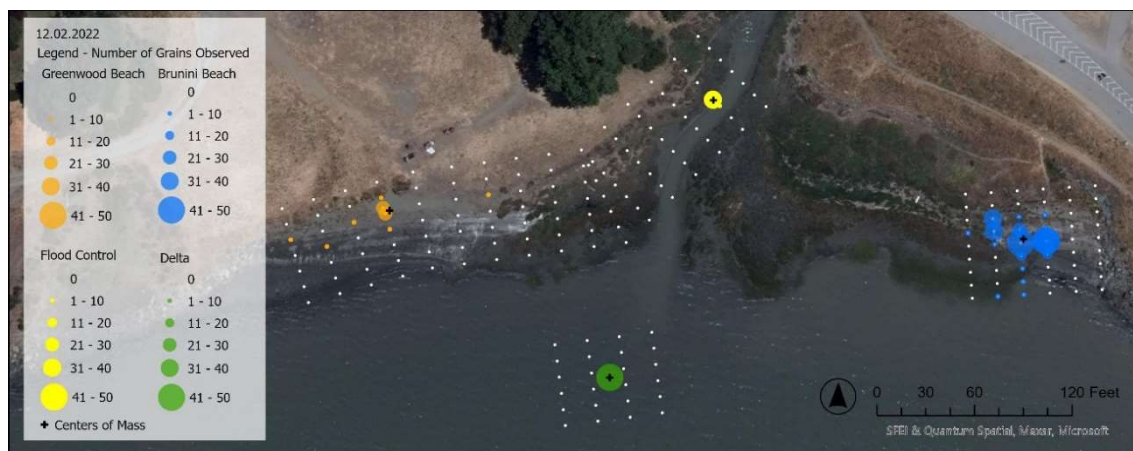
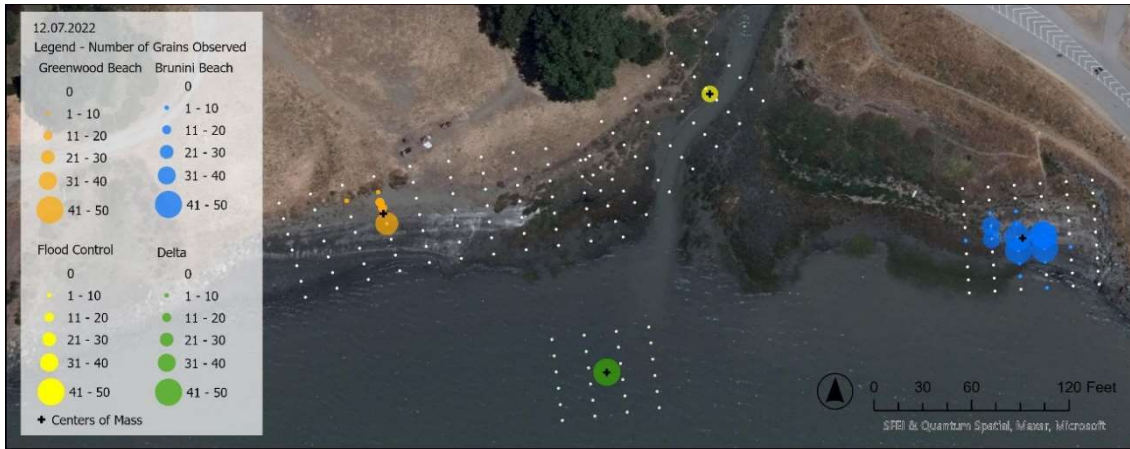
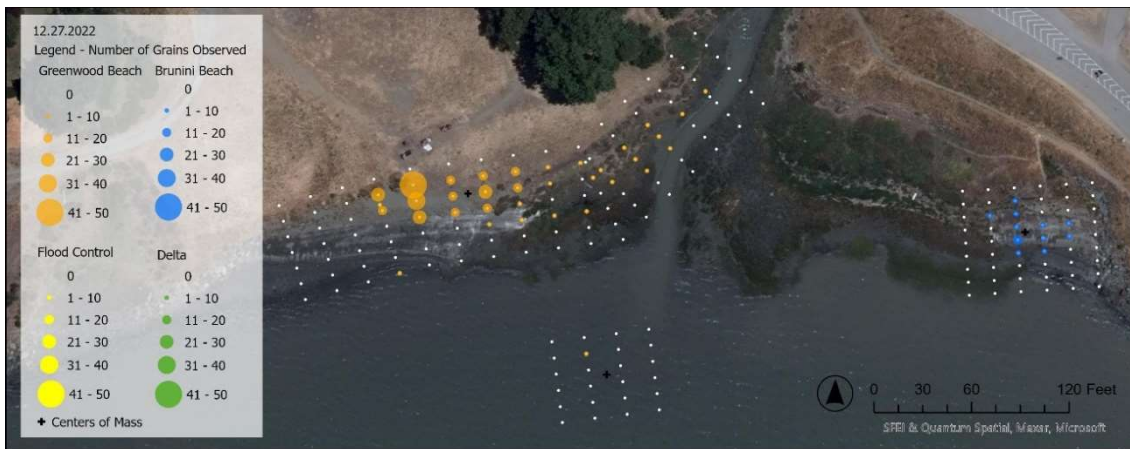
Maps of surface grains observed at each grid point, with symbols sized to reflect the quantity of grains observed, are shown in Figures 7a-f.

Figure 6a. Surface Grains Observed, 11/30/22.

Figure 6b. Surface Grains Observed, 12/01/22.

Figure 6c. Surface Grains Observed, 12/02/22.

Figure 6d. Surface Grains Observed, 12/07/22.

Figure 6e. Surface Grains Observed, 12/12/22.

Figure 6f. Surface Grains Observed, 12/27/22.

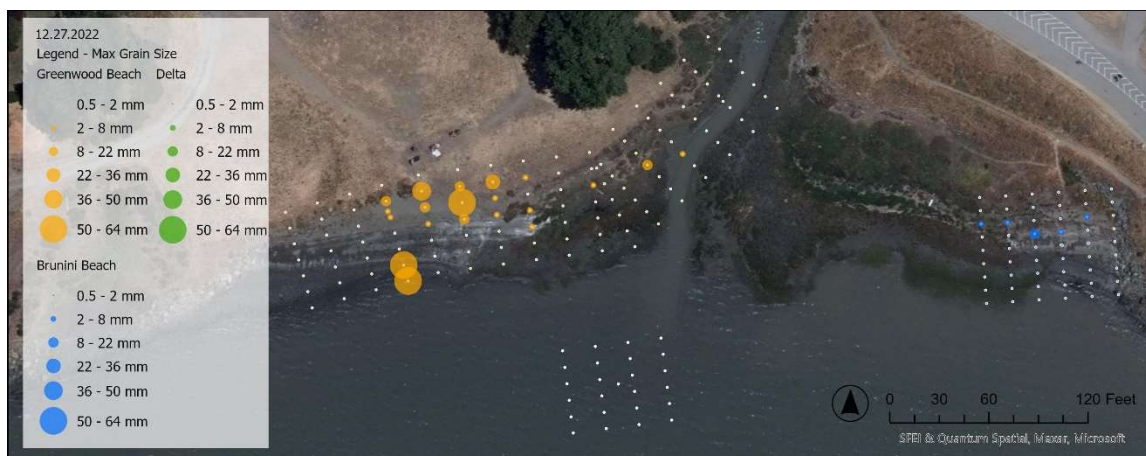
Plots of maximum grain sizes 0.5 mm or larger at each grid point were produced similar to the grain count maps. The complete set of these figures can be found at “...Data – Greenwood – particle tracking – Tracer Study I – Figures.” Most of these figures do not contain many points since the majority of grains observed were medium sand or finer. However, the plot from 12/27/22 shown in Figure 7 illustrates how coarser grains within the Greenwood Beach sample were found both in the mudflat bayward of the deployment site and in the beachface upslope and slightly downdrift of the deployment site.

Figure 7. Maximum Grain Size Observed, 12/27/22.

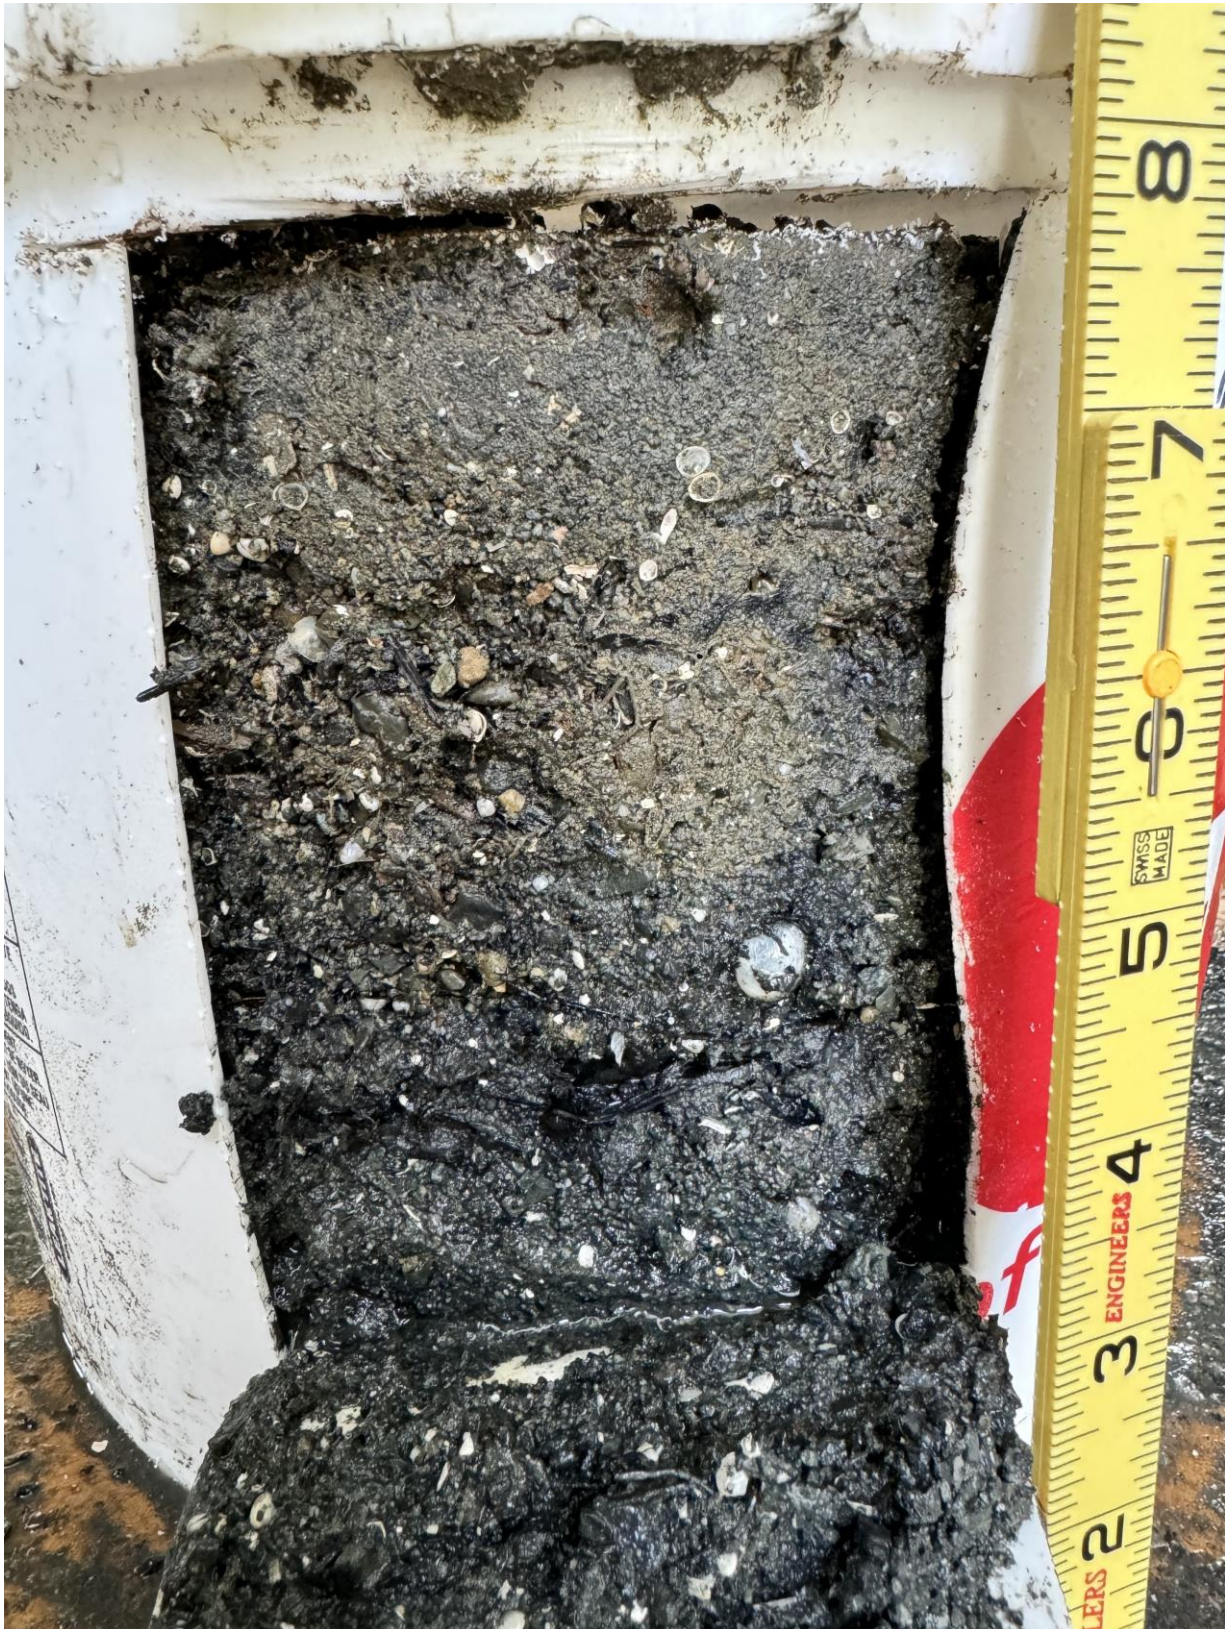
Appendix 1. Bar Pit BP1 bucket contents.

0.25 ↓ 0.24 0 bottom of bucket		Sand, pebbles, small shells. very few smaller gravel no gravel piled up on top Thin layer of leaf debris same as top layer	GW-BP1

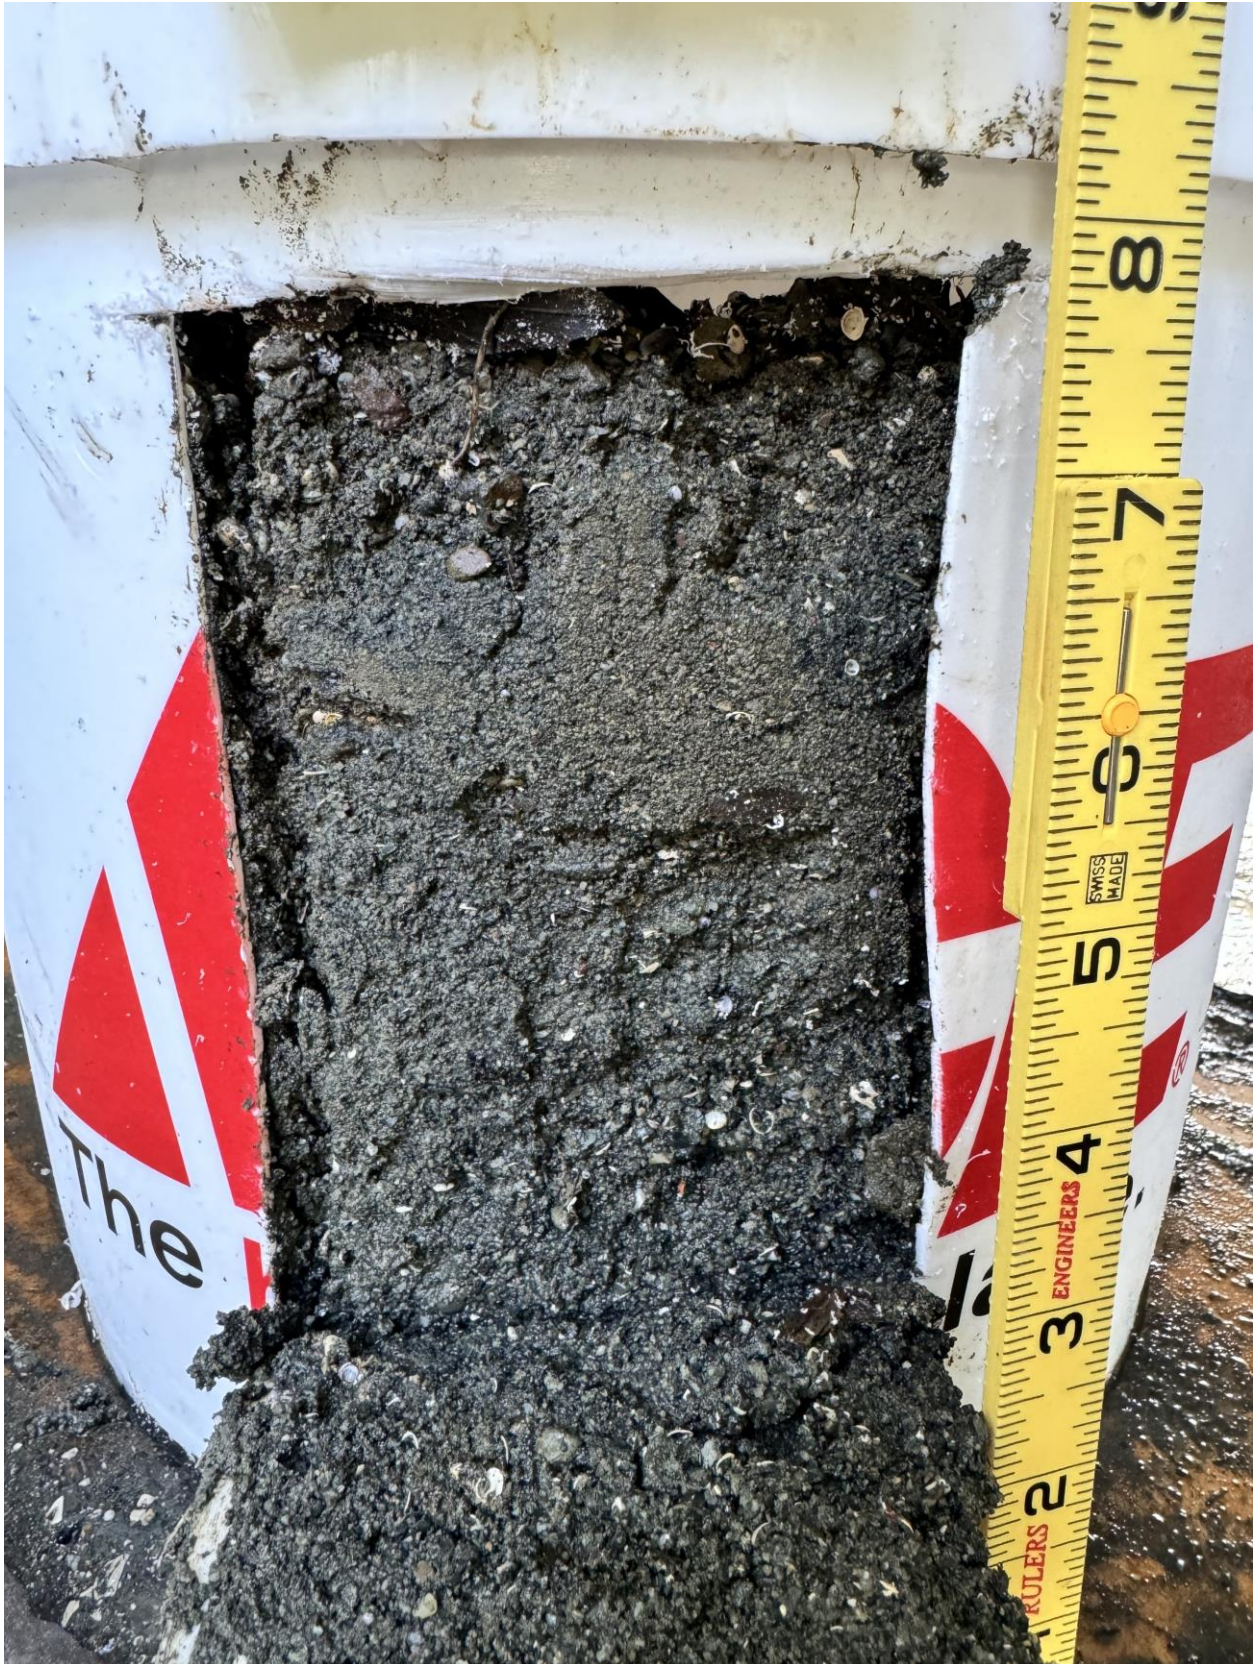
Appendix 3. Bar Pit BP2 bucket contents.

Bottom of Bucket		homogeneous, sand, small shells, pebbles + few gravels. little vegetation, some algae	GW-BP2

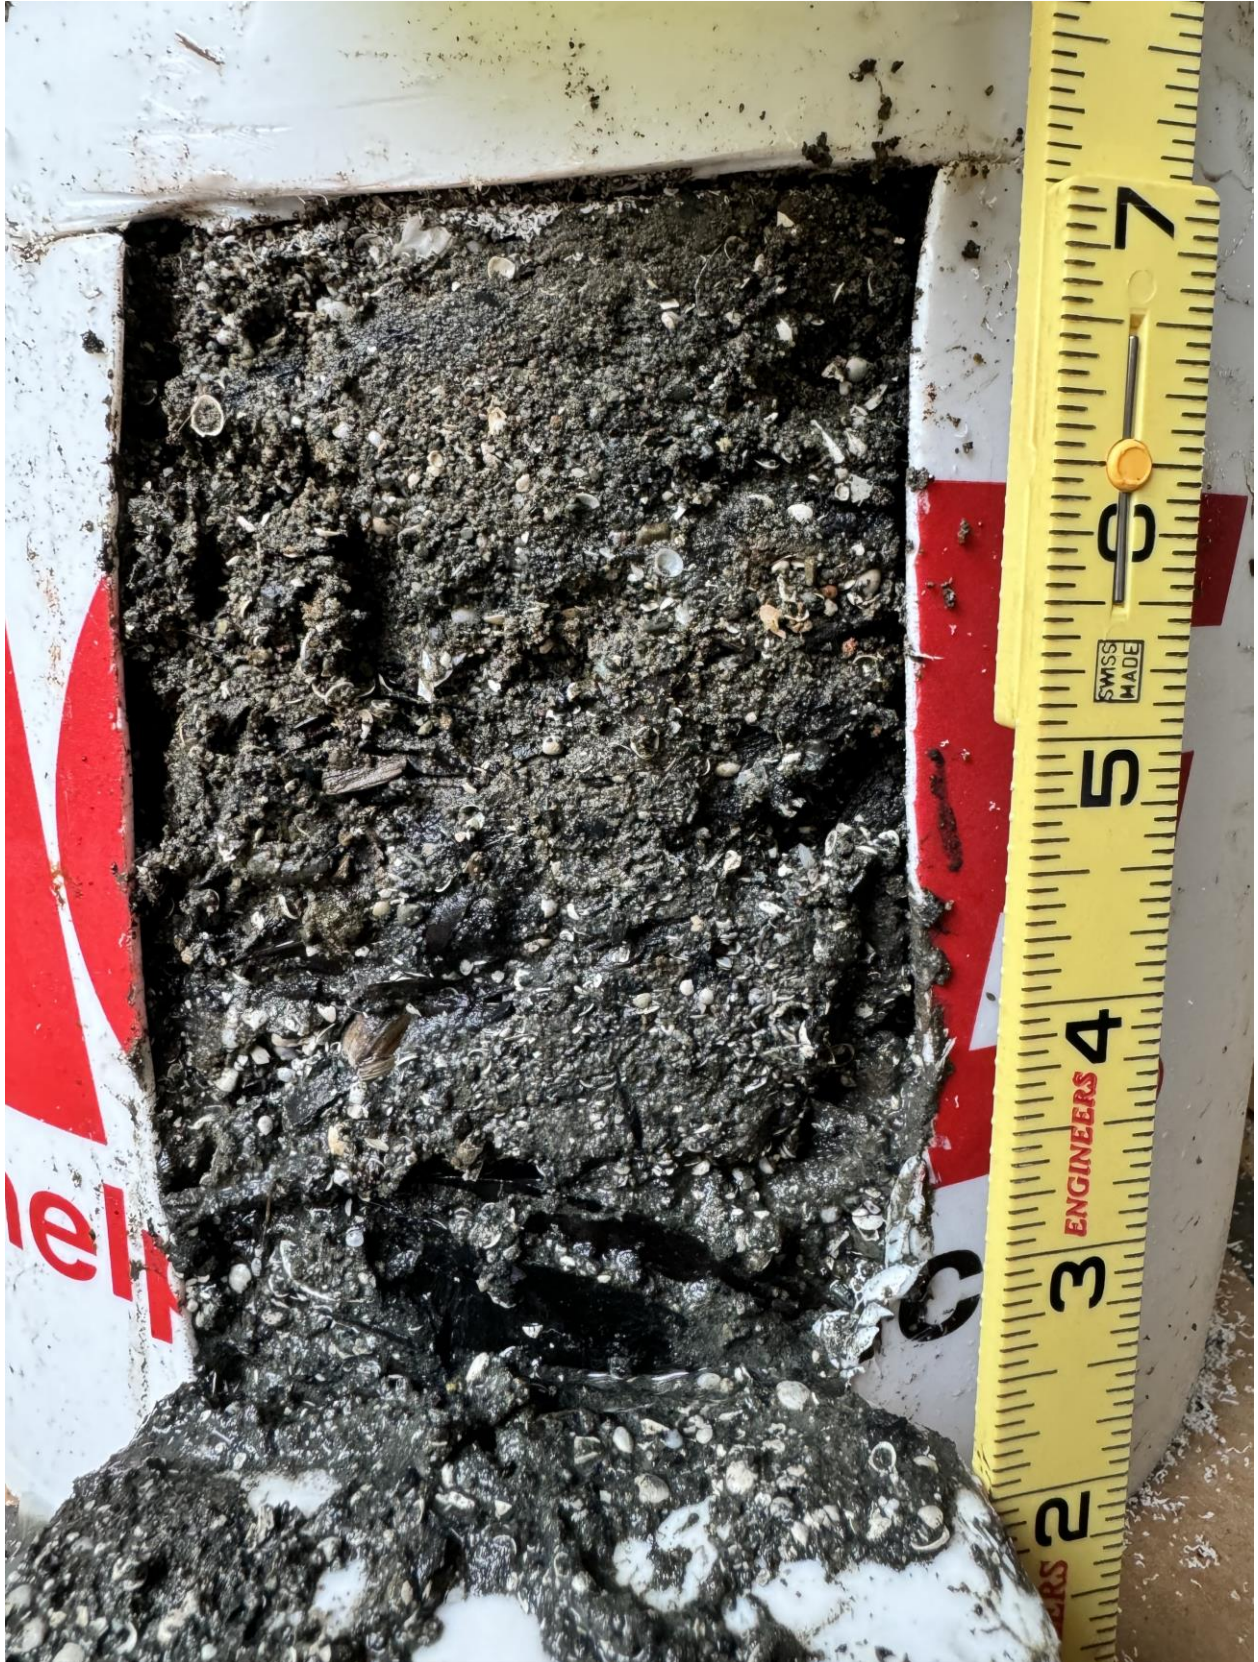
Appendix 5. Channel Pit CP1 bucket contents.

Depth BGS Unit: ft.	Symbol	Description	Sample ID	Analysis
surface 0.8		some gravel deposited on surface.		
↓		fairly homogeneous small shell, sand, small pebbles. Some mud. vegetation debris few gravel.	GW-CP1 GW-CP1	
0.4				
↓		lots of vegetation debris. mud, sand, small.		
↓		few few gravel.		
bottom of Bucket 0

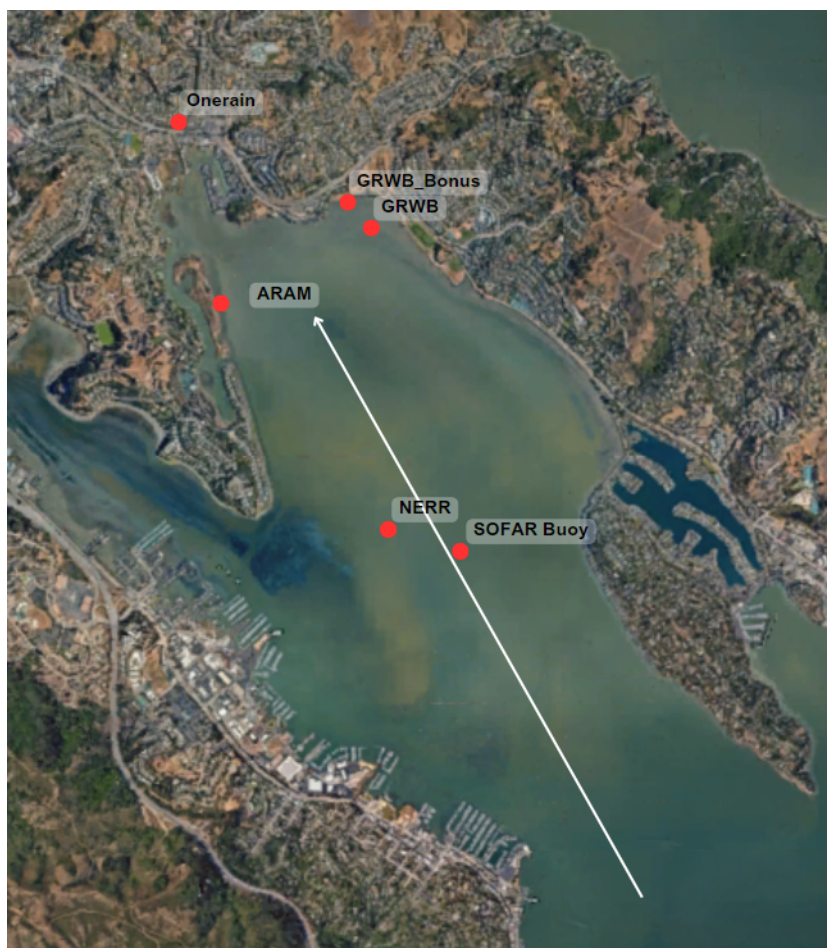
Figure 1: Richardson Bay with Sausalito waterfront in lower left and Tiburon Peninsula in upper right. The white arrow indicates the orientation of winds with longest fetch (157.5°N). The red dots show the locations where sensors were installed (details in text and Table 1): Greenwood Beach (GRWB), Aramburu Beach (ARAM), sensor piling maintained by the National Estuarine Research Reserve (NERR), and Wave buoy (SOFAR Buoy). Also shown is a weather station (Onerain) and a short-term sensor deployed during a winter storm higher on Greenwood Beach (GRWB Bonus).

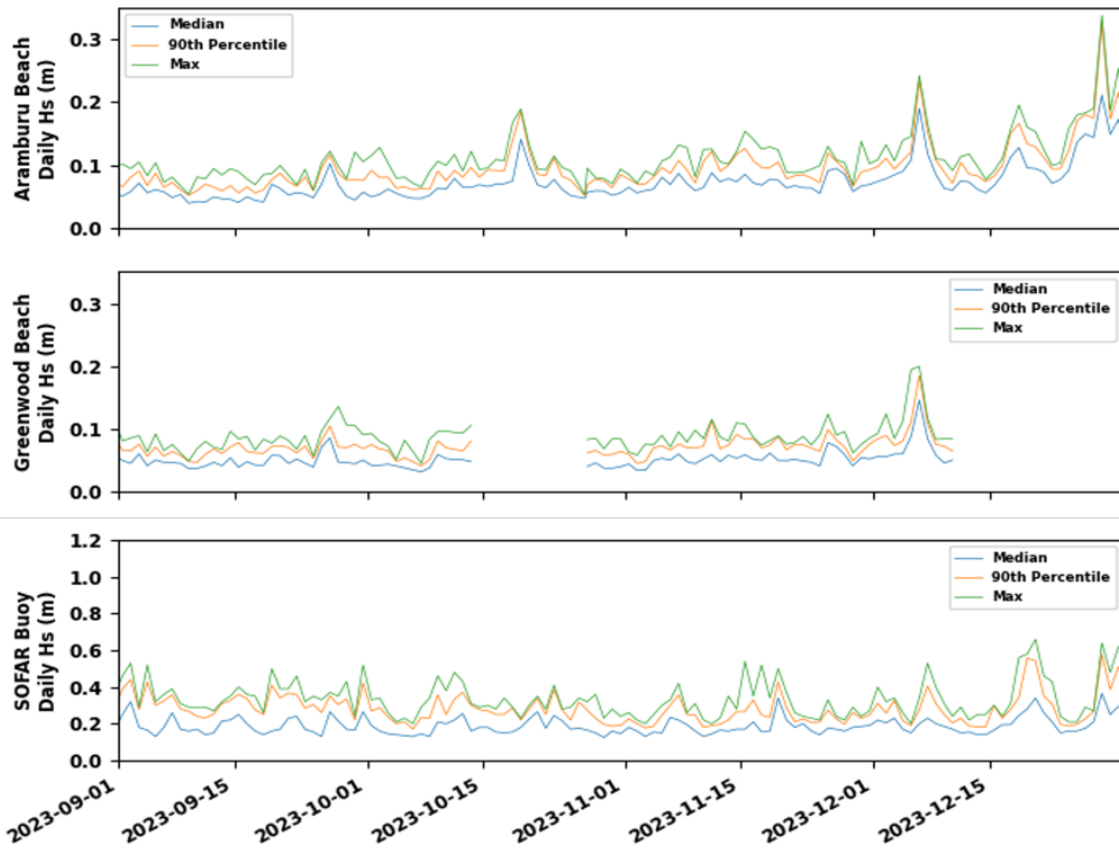
Figure 8: Daily wave statistics for Aramburu Beach (top panel), Greenwood Beach (middle panel), and SOFAR Buoy (bottom panel) from 1 September to 31 December 2023. For each site, the daily maximum wave height is green, daily 90-percentile wave height is orange, and daily median wave height is blue.

While the concurrence of wave events mid-bay and at the beaches is clear (Figure 8), typical values from the SOFAR buoy are larger than from the RBR pressure sensors. Modal wave height at the SOFAR buoy is 0.2 m and maximum wave heights are over 0.5 m – two to three times larger than values from beach sites and from the pressure sensor deployed on the NERR piling.
