Geotechnical Evaluation Report

NOVATO CREEK LEVEE EVALUATION

**Novato Creek Levee Evaluation
Marin County, California**

**Marin County Flood Control and Water
Conservation District**

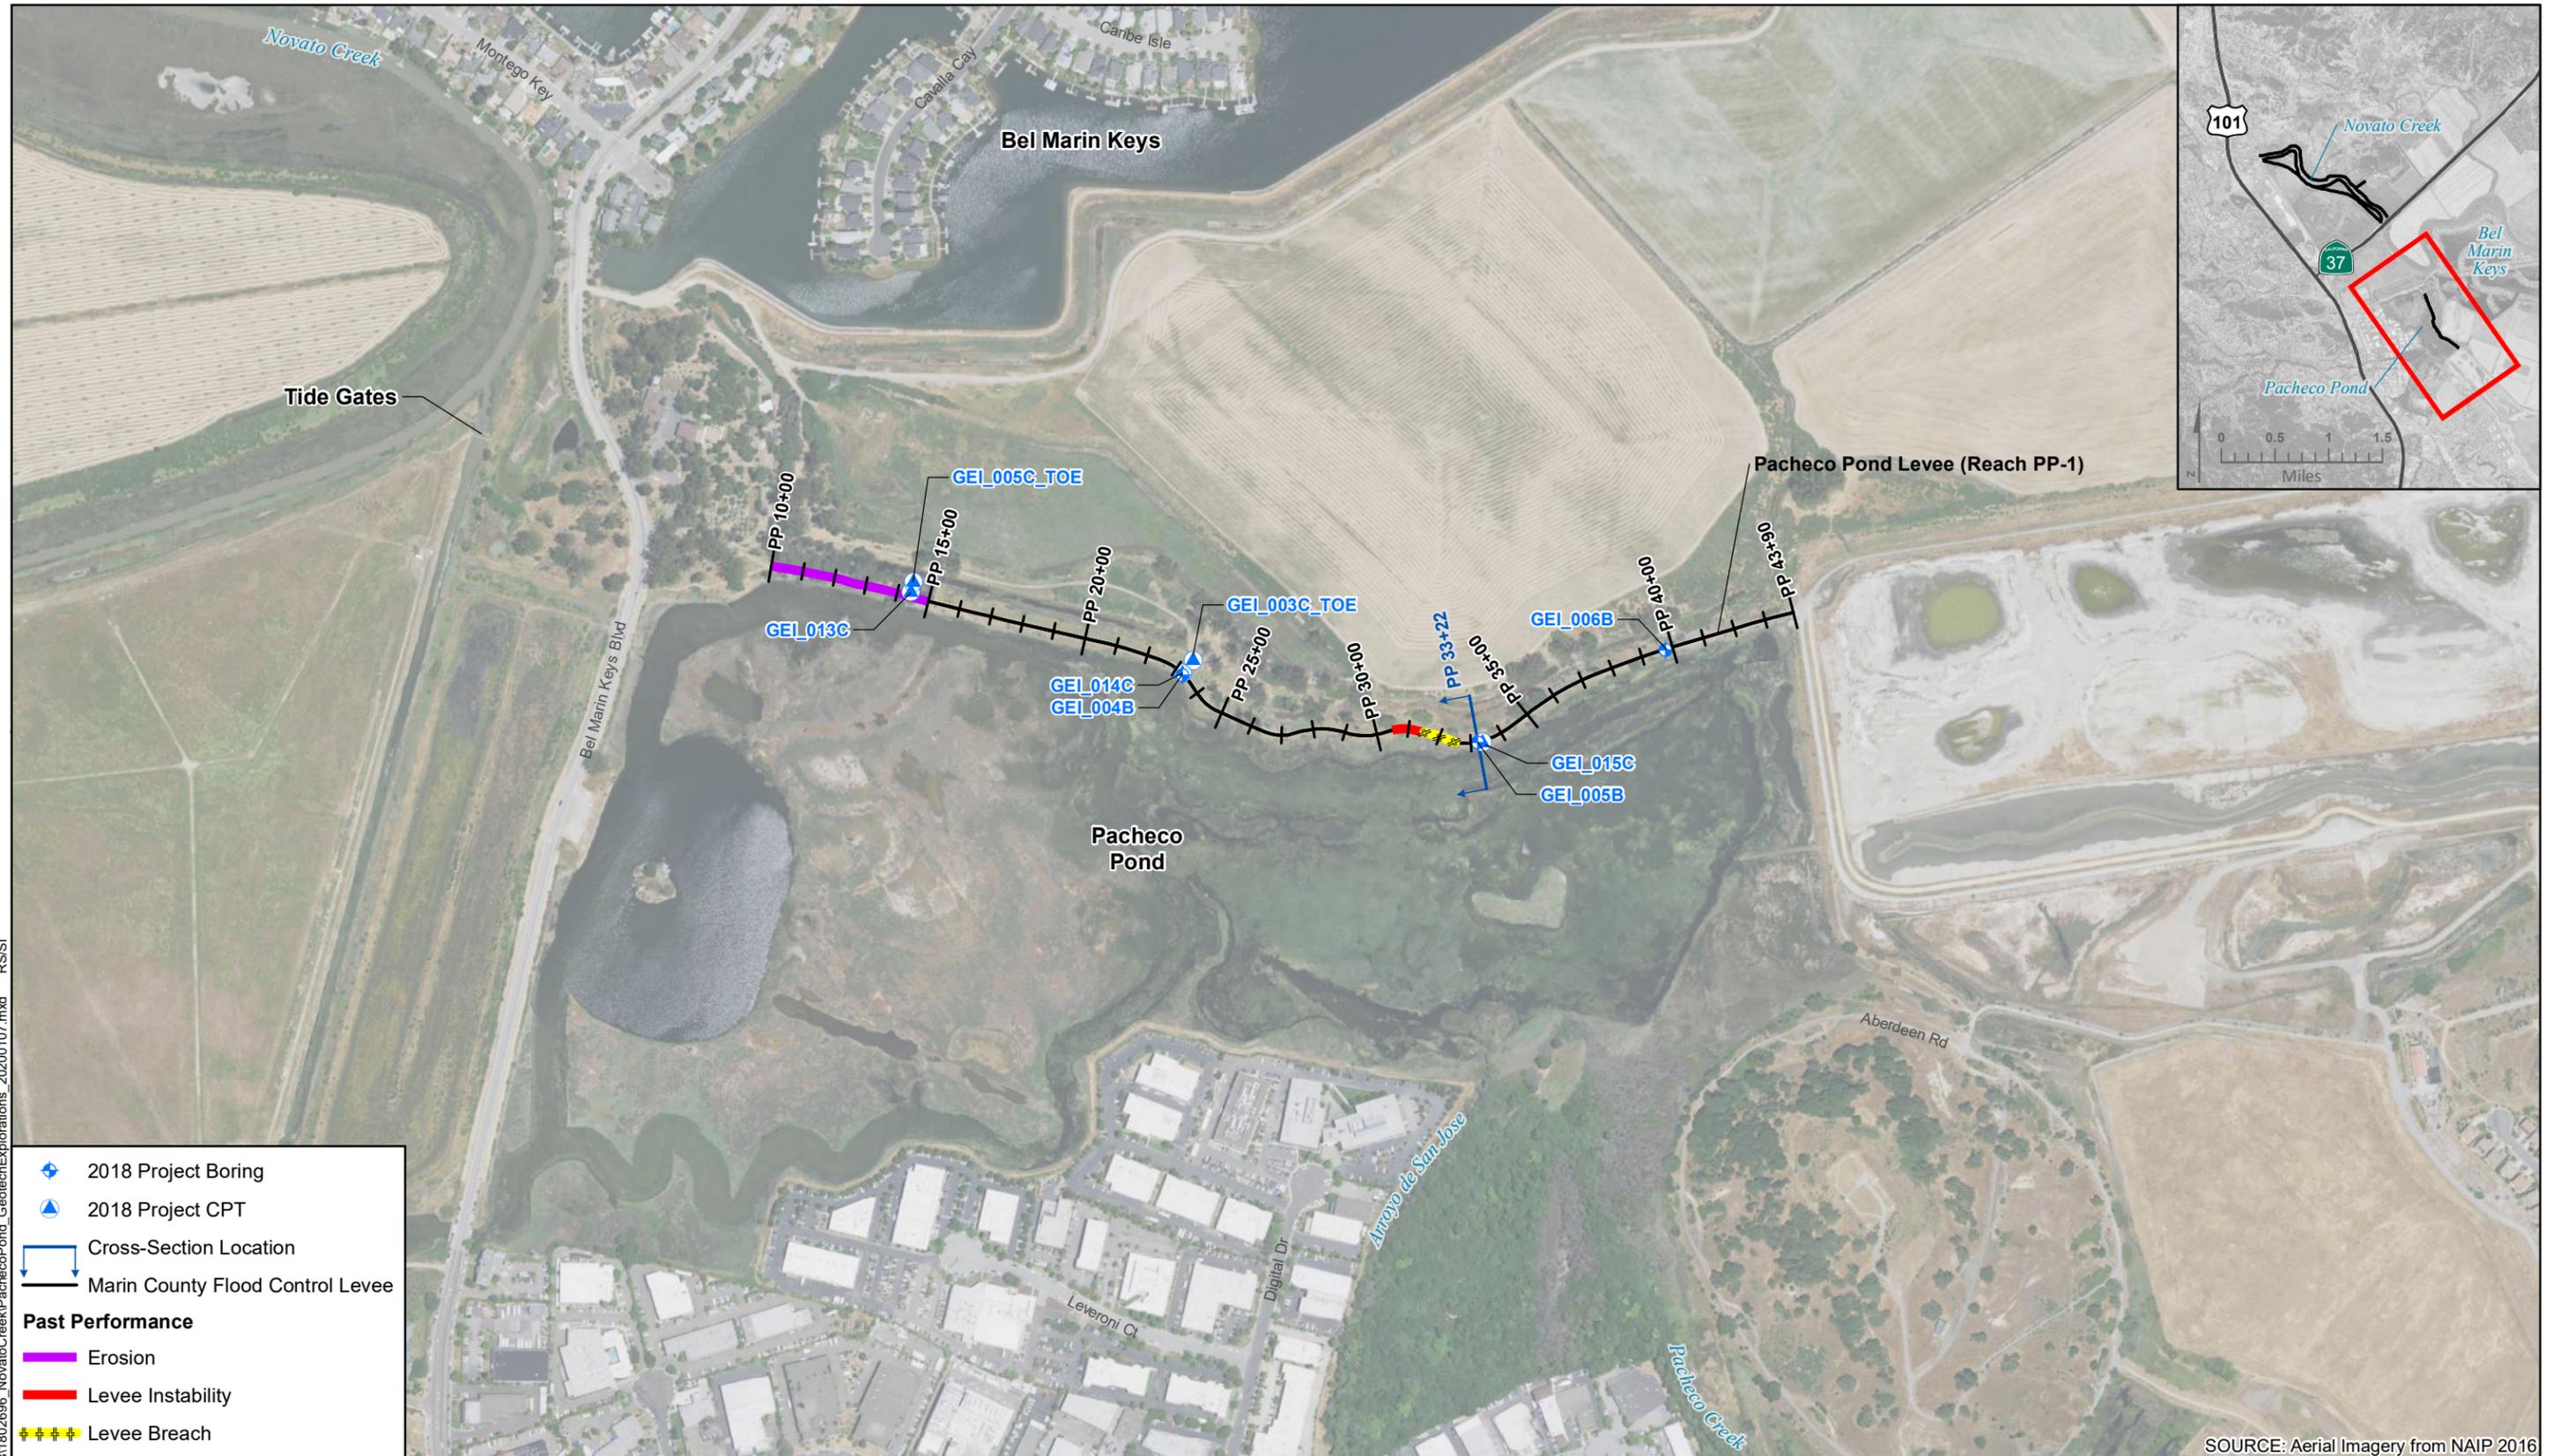
FIGURE 1-2

2018 Project Boring
	2018 Project CPT
	Cross-Section Location
	Marin County Flood Control Levee
Past Performance	
	Erosion
	Levee Instability
	Levee Breach

- Novato Creek left bank¹, which is approximately 8,500 feet long and extends from the Sonoma Marin Area Rail Transit (SMART) trestle to the northwest and ends at the State Route (SR) 37 bridge to the southeast (Figure 1-2).
- Lynwood Levee is approximately 6,800 feet and extends from the SMART trestle to SR-37 (Figure 1-2). It separates the Lynwood stormwater detention basin on the west side from two wildlife preserve ponds to the east (Duckbill and Heron's Beak Ponds). The detention basin was created primarily for wildlife habitat, but also functions to provide stormwater detention as the Lynwood pump station has three pumps discharging directly to Novato Creek and one pump discharging into the Duckbill Pond before and after high water events.
- Pacheco Pond levee is approximately 3,400 feet long and is located south of SR-37 near Bel Marin Keys (Figure 1-3).

The locations of the previous explorations are shown in Figures 1-2 and 1-3 and in the profiles on Plates 10 through 19.

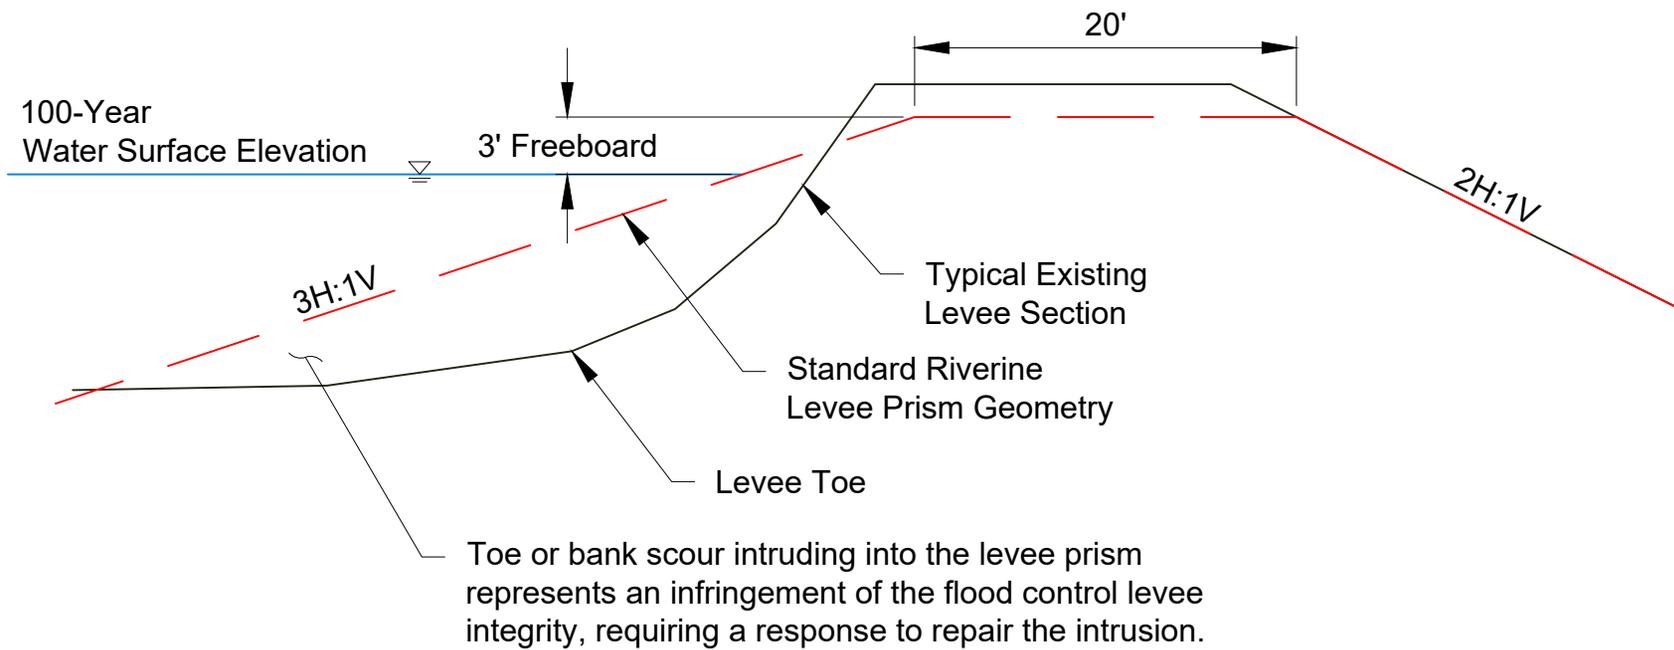
FIGURE 5-1. Standard Levee Prism Geometry within a Riverine Levee Section

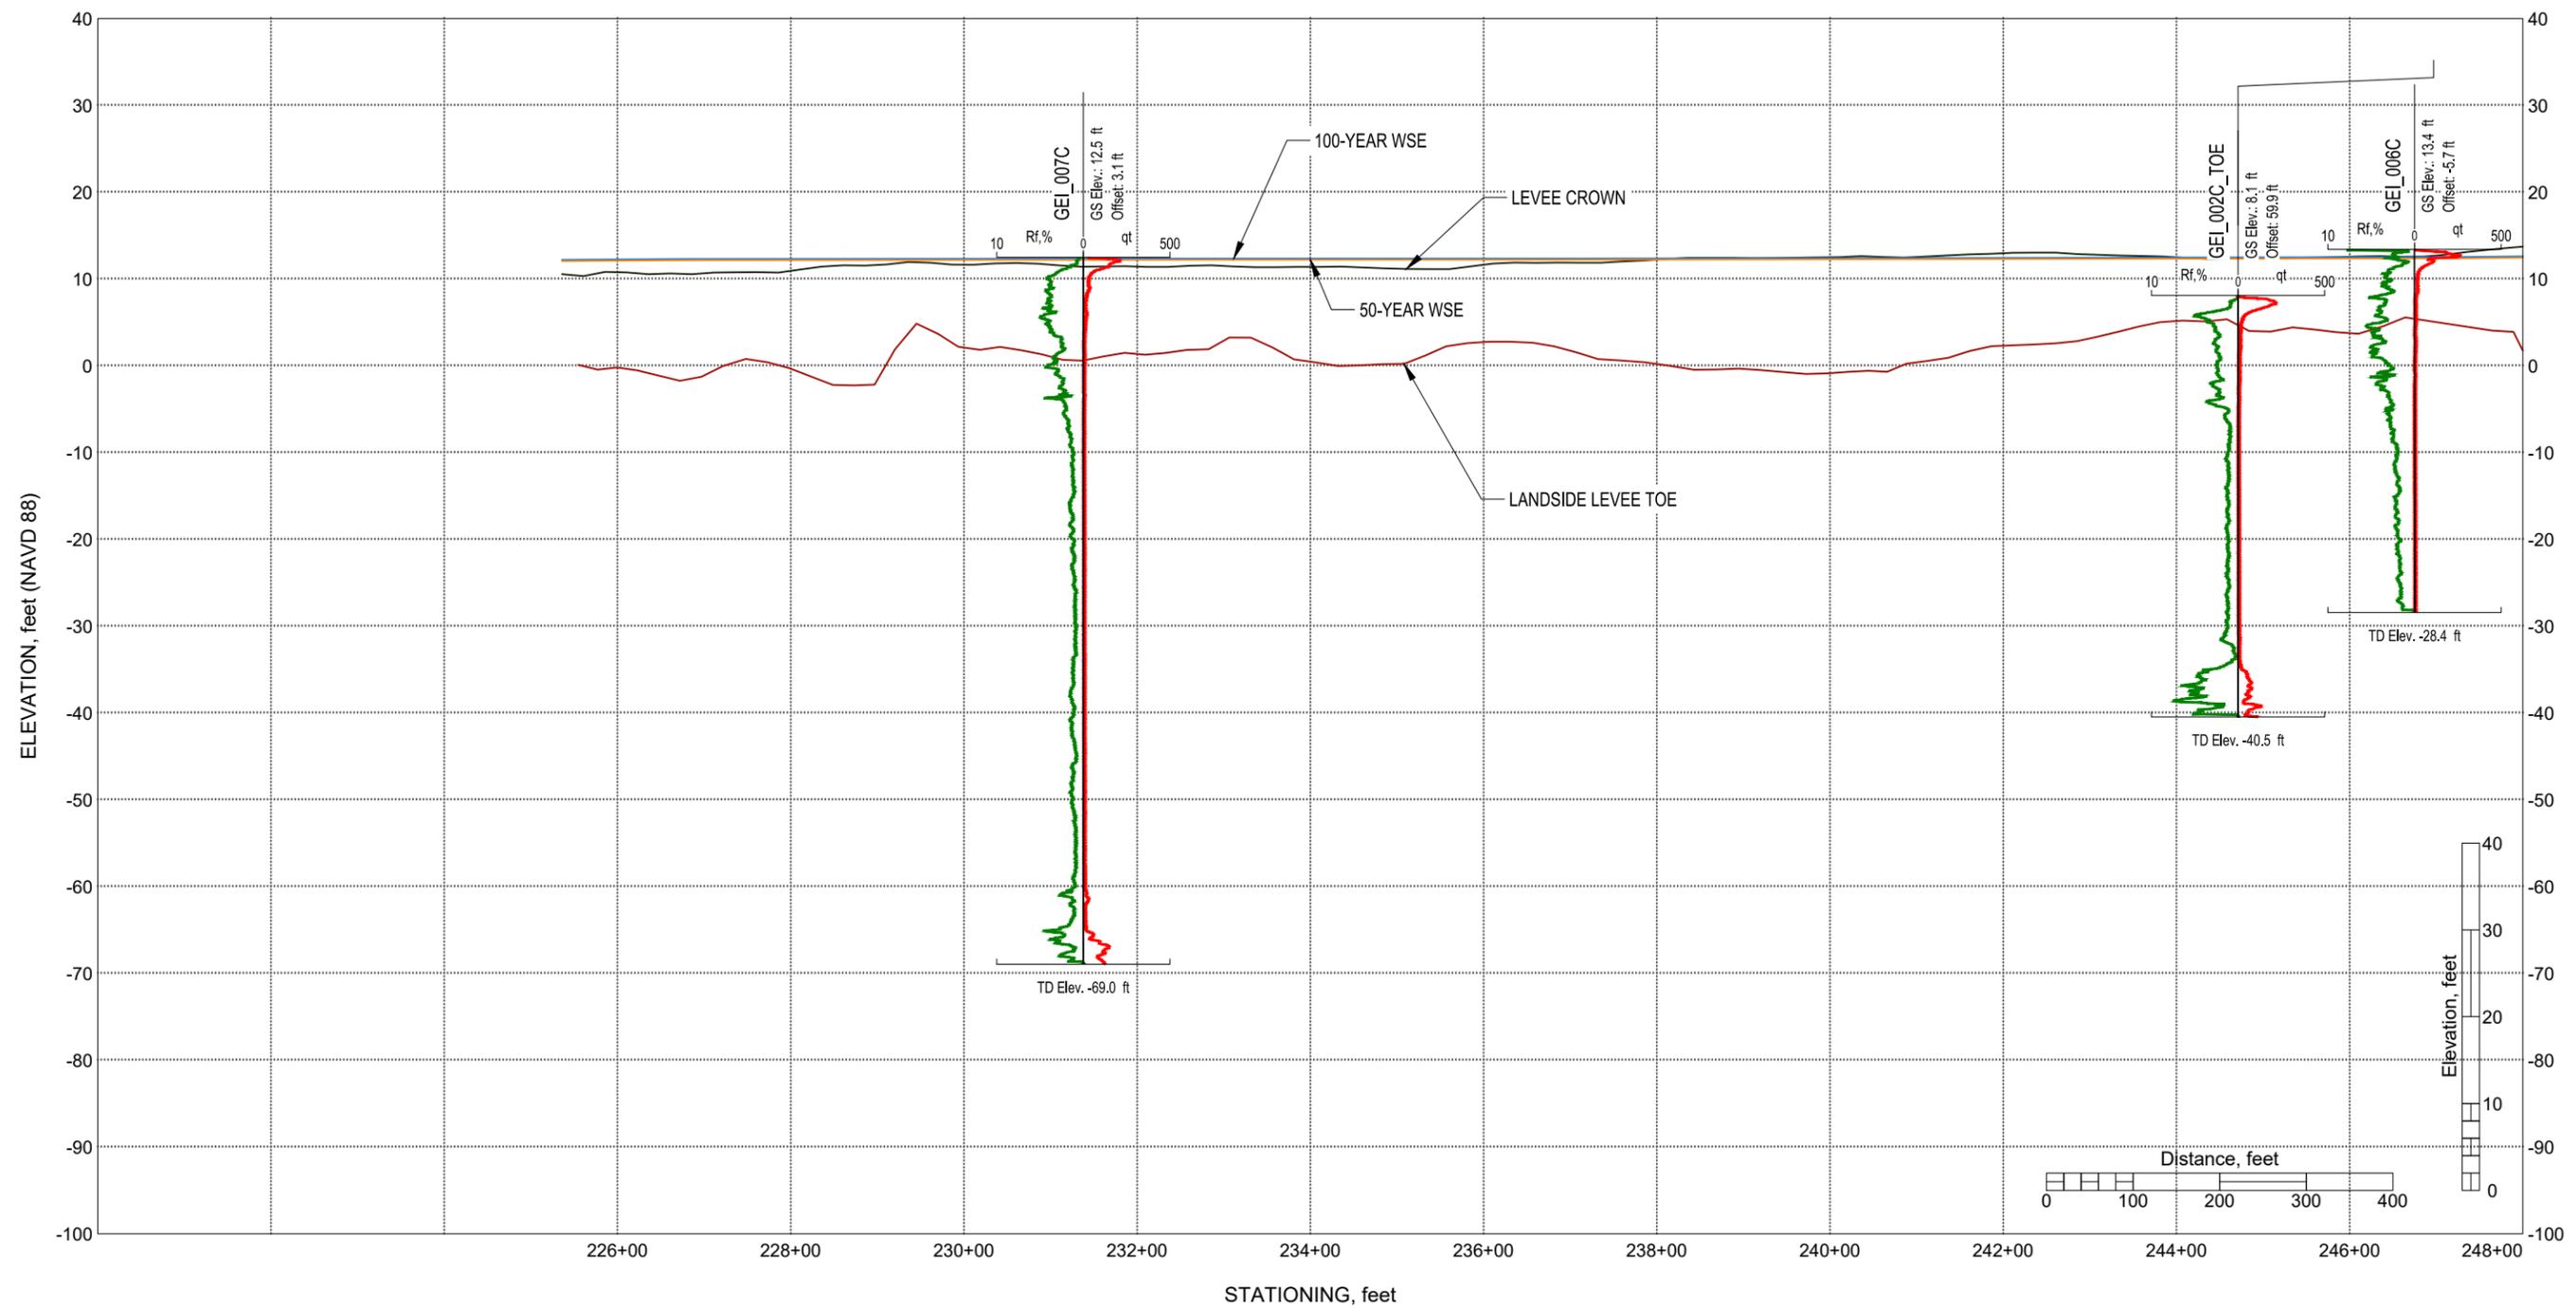
<p>PROFILE ALONG NOVATO CREEK LEVEE STATION NCLB 225+36 TO 248+00</p>
<p>Marin County Flood Control and Water Conservation District</p>	<p>December 2019</p>	<p>Project #1802696 Plate 11</p>

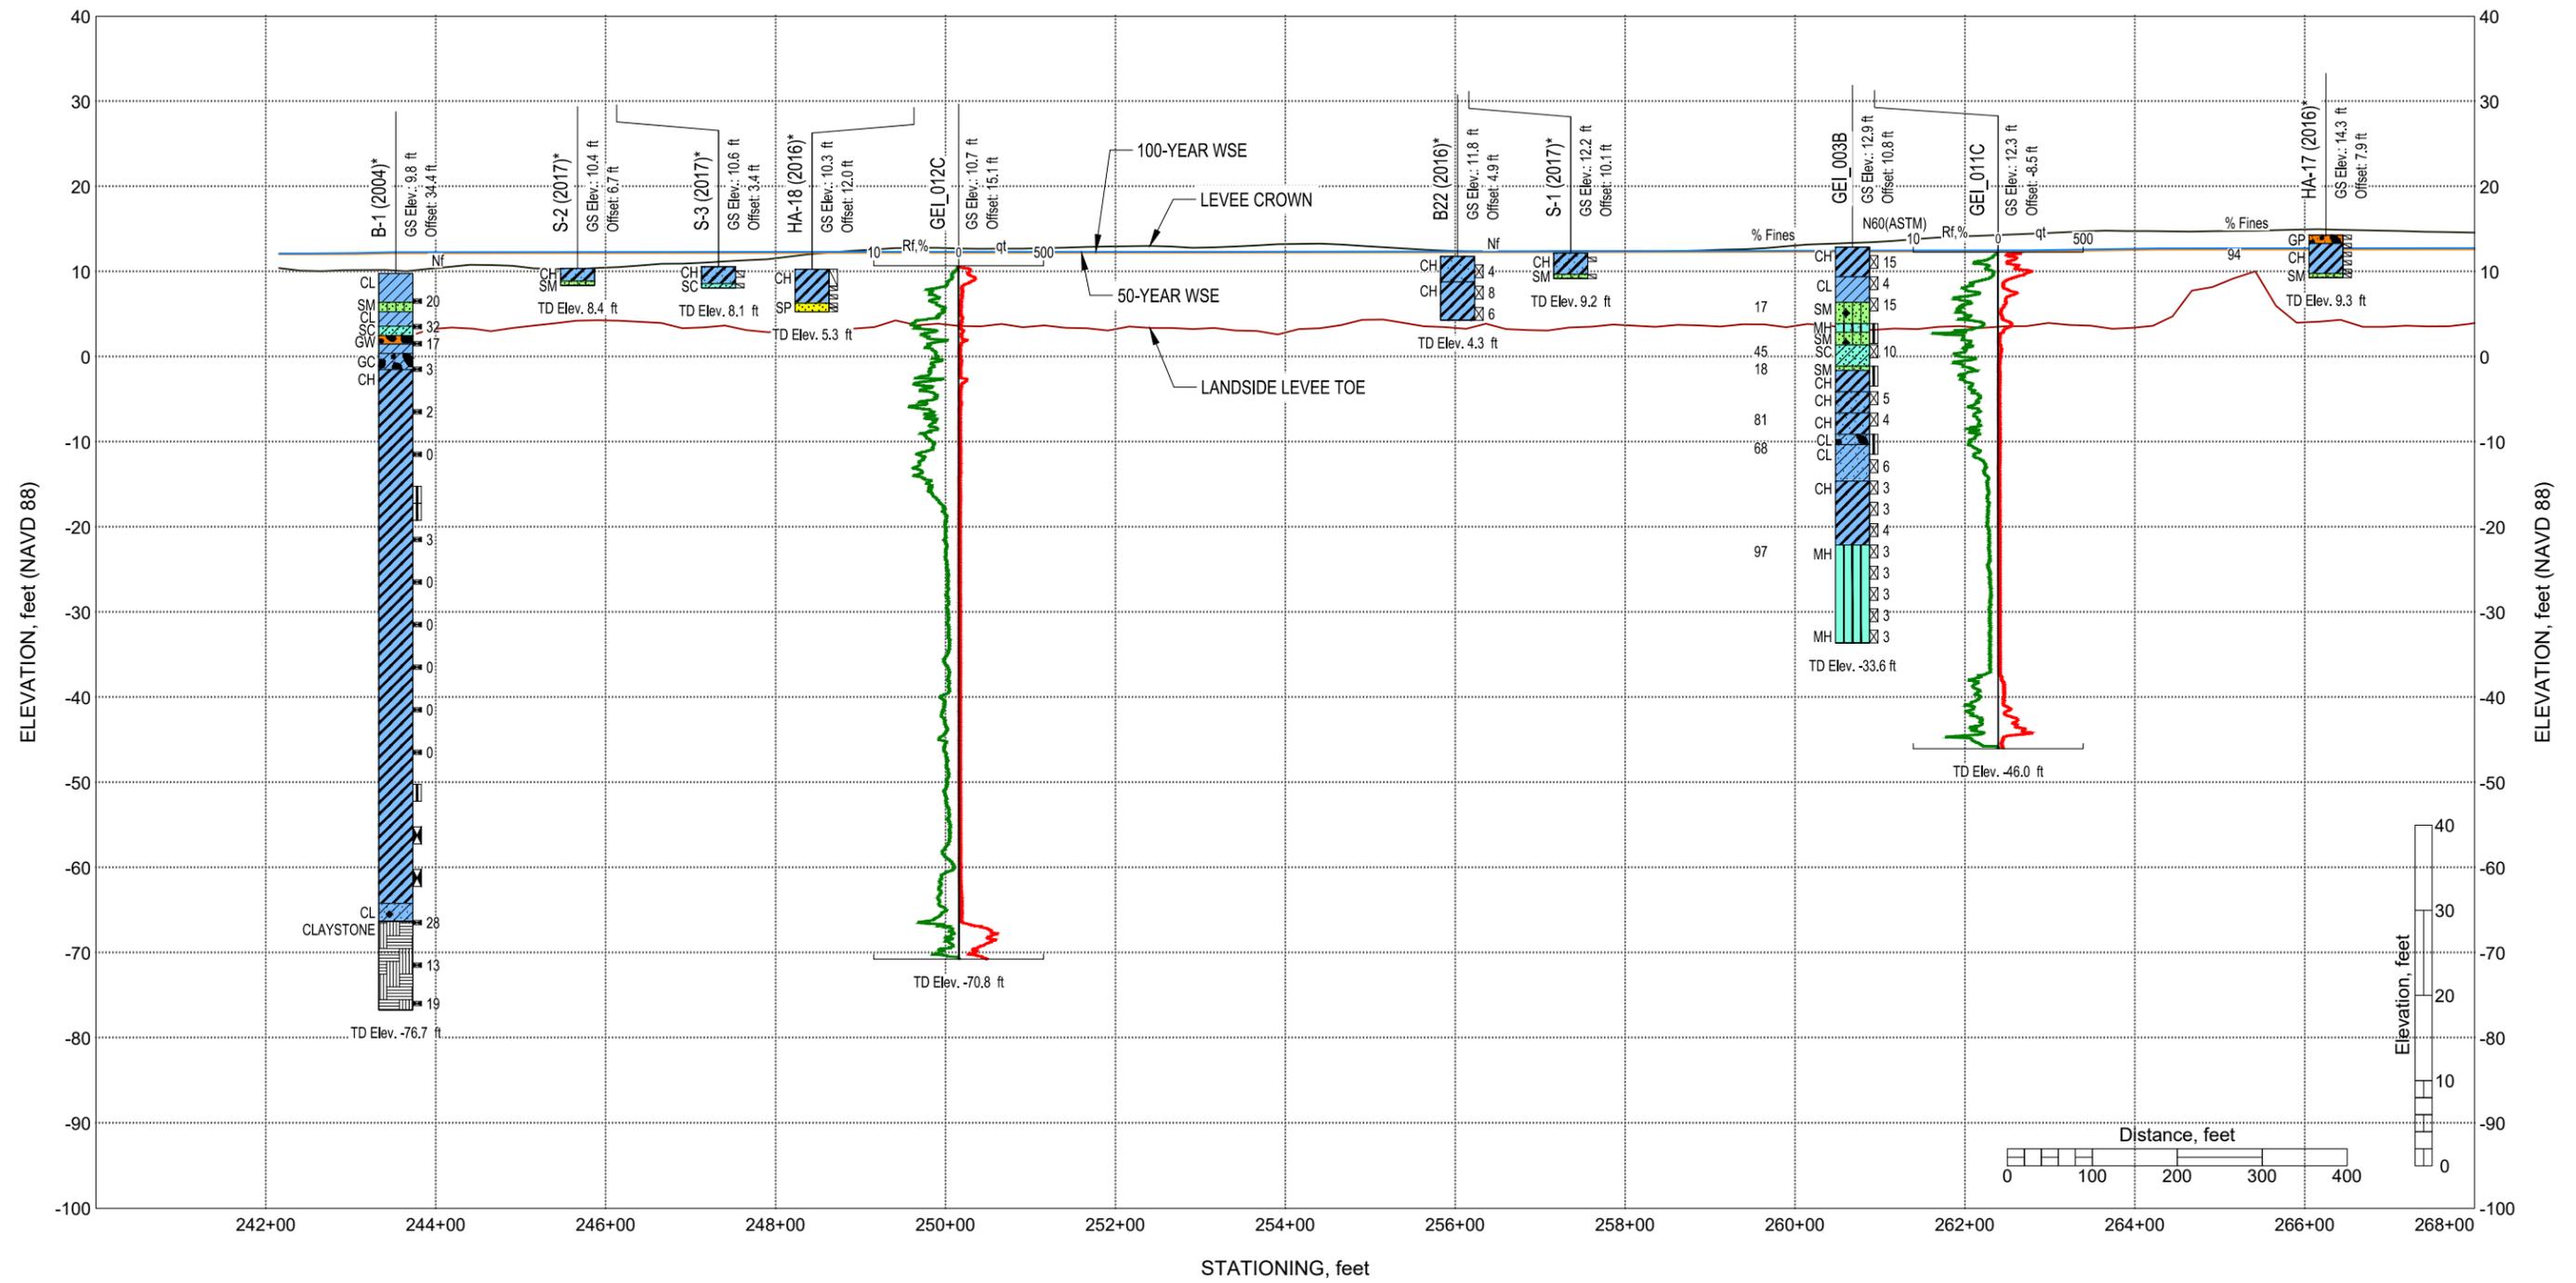
Novato Creek Levee Evaluation Project Novato, CA		PROFILE ALONG LYNWOOD LEVEE STATION 242+16 TO 268+00
Marin County Flood Control and Water Conservation District	December 2019 Project #1802696	Plate 15

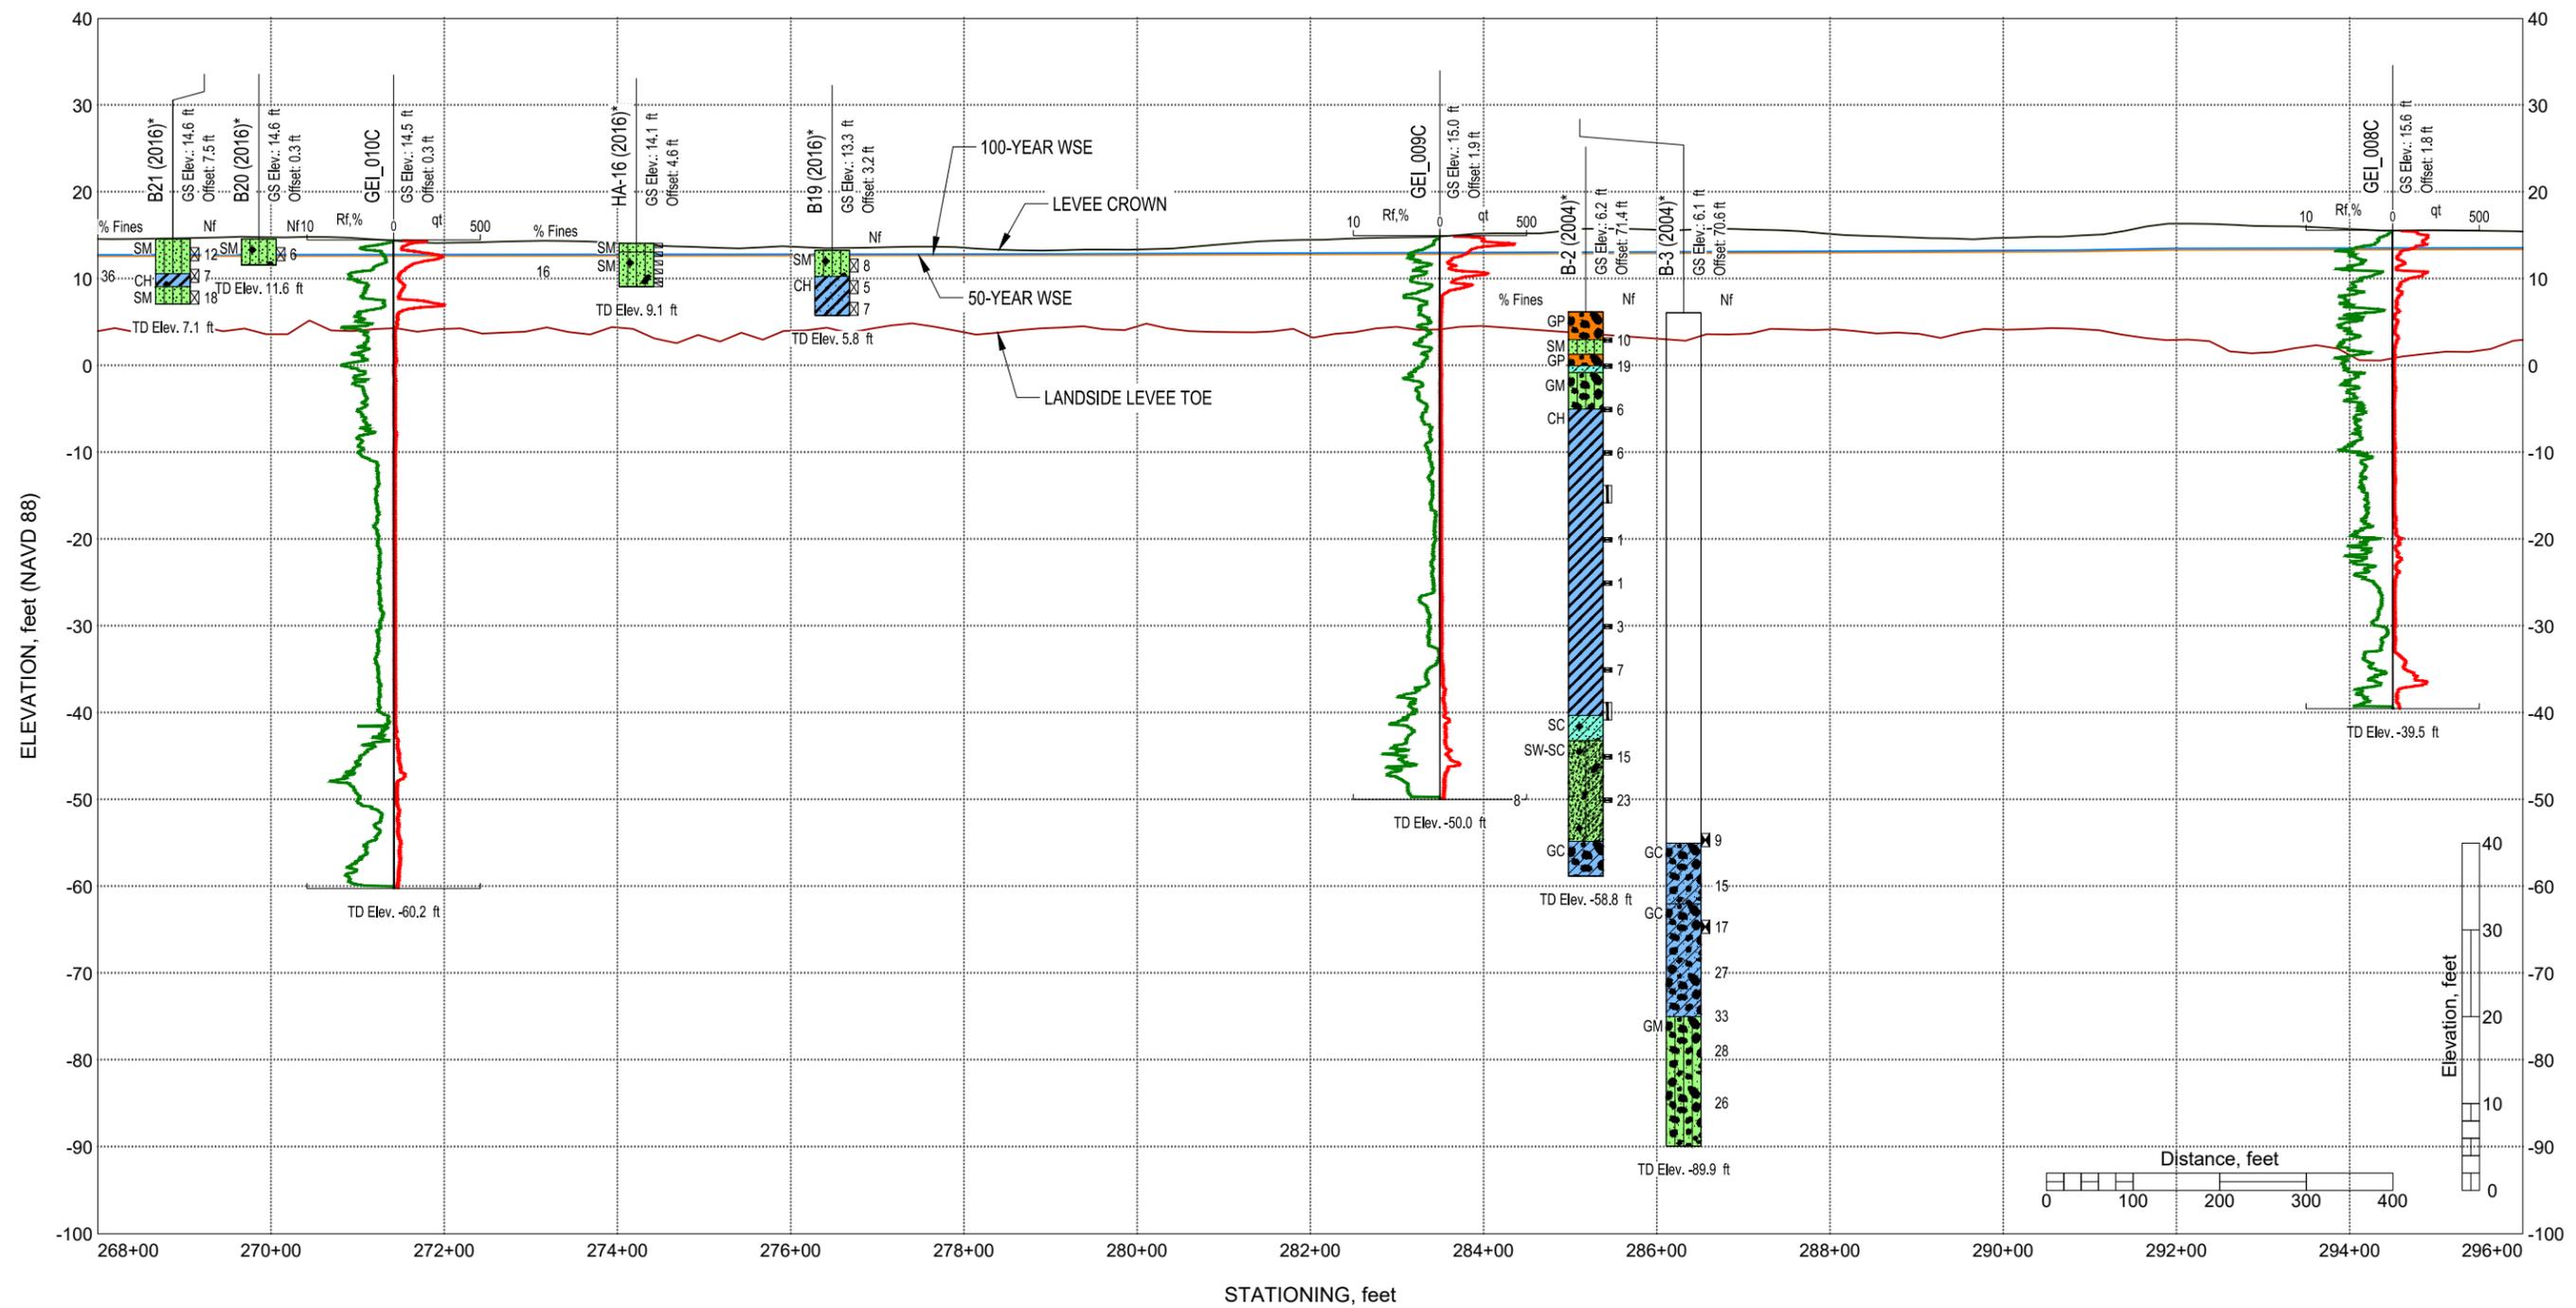
Novato Creek Levee Evaluation Project Novato, CA		PROFILE ALONG LYNWOOD LEVEE STATION 268+00 TO 296+00
Marin County Flood Control and Water Conservation District	December 2019 Project #1802696	Plate 16

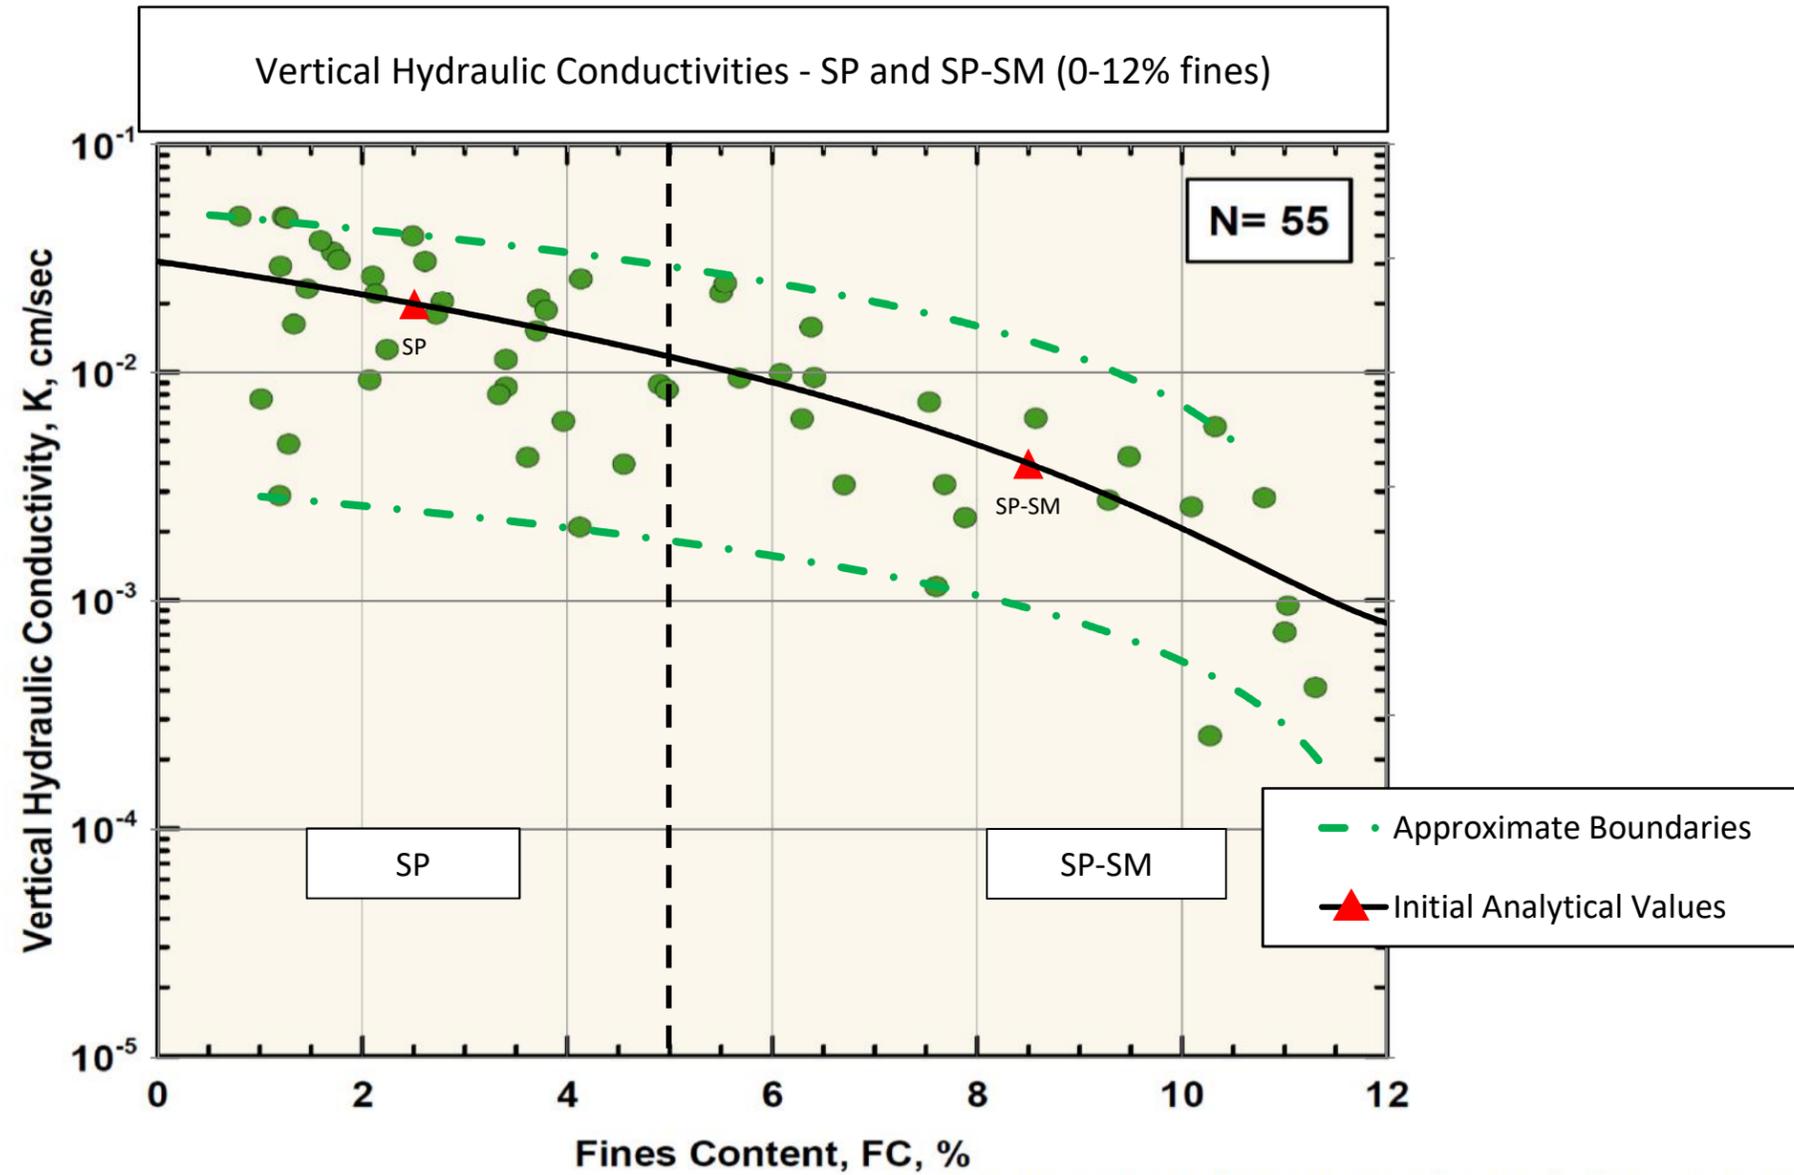
**VARIATION OF HYDRAULIC CONDUCTIVITY WITH FINES CONTENT:
RESULTS OF TESTS ON HOMOGENEOUS,
RELATIVELY CLEAN SANDS (SP, SP-SM): ULE PROGRAM**

Figure A-3. Vertical Hydraulic Conductivities –SM (12 to 49% fines)

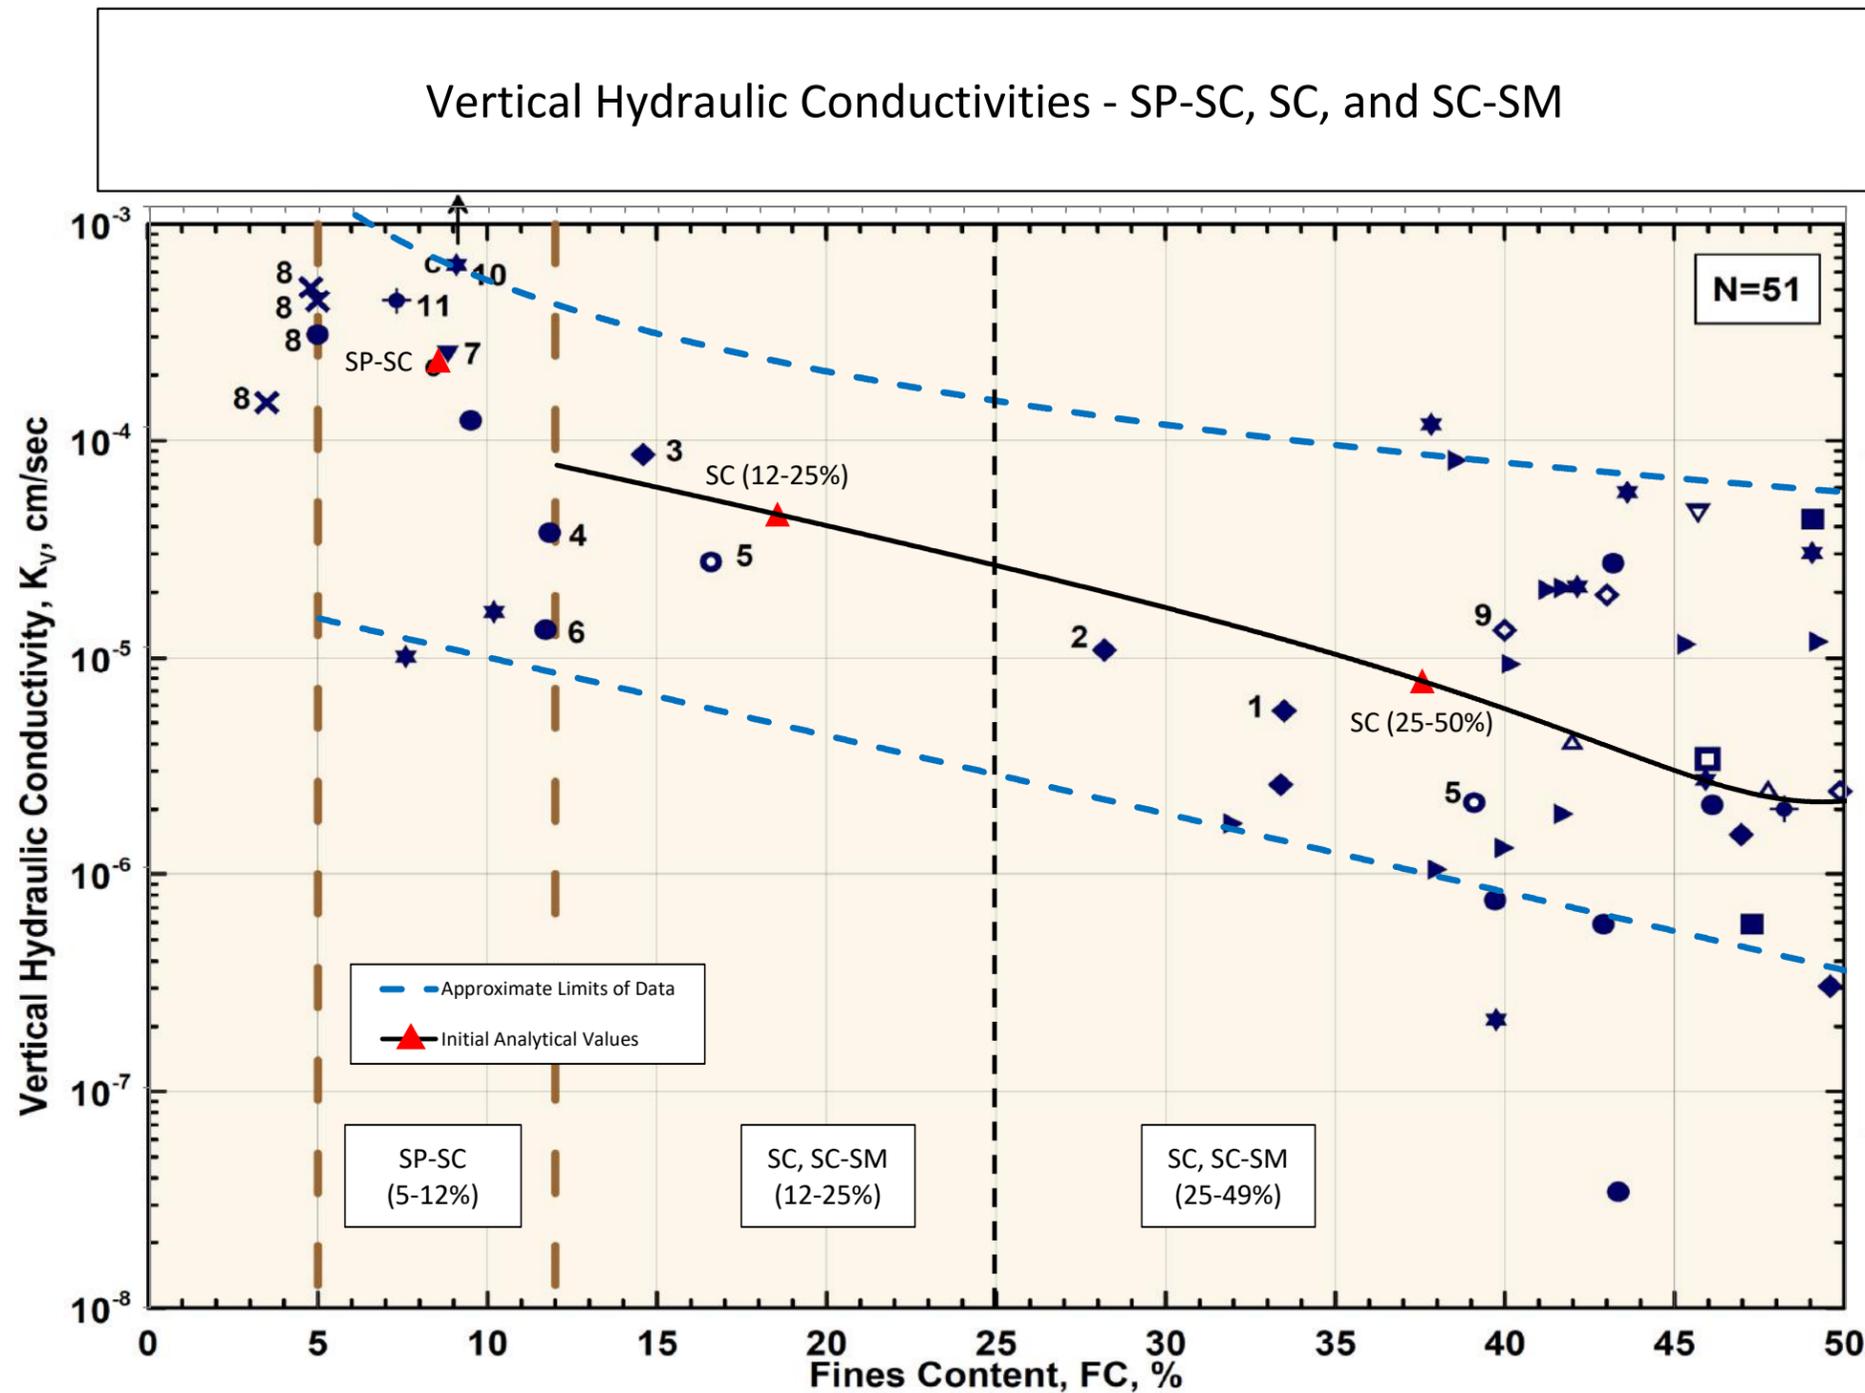
Figure A-4. Vertical Hydraulic Conductivities – SP-SC, SC, and SC-SM
