Geotechnical Evaluation Report

NOVATO CREEK LEVEE EVALUATION

**Novato Creek Levee Evaluation
Marin County, California**

**Marin County Flood Control and Water
Conservation District**

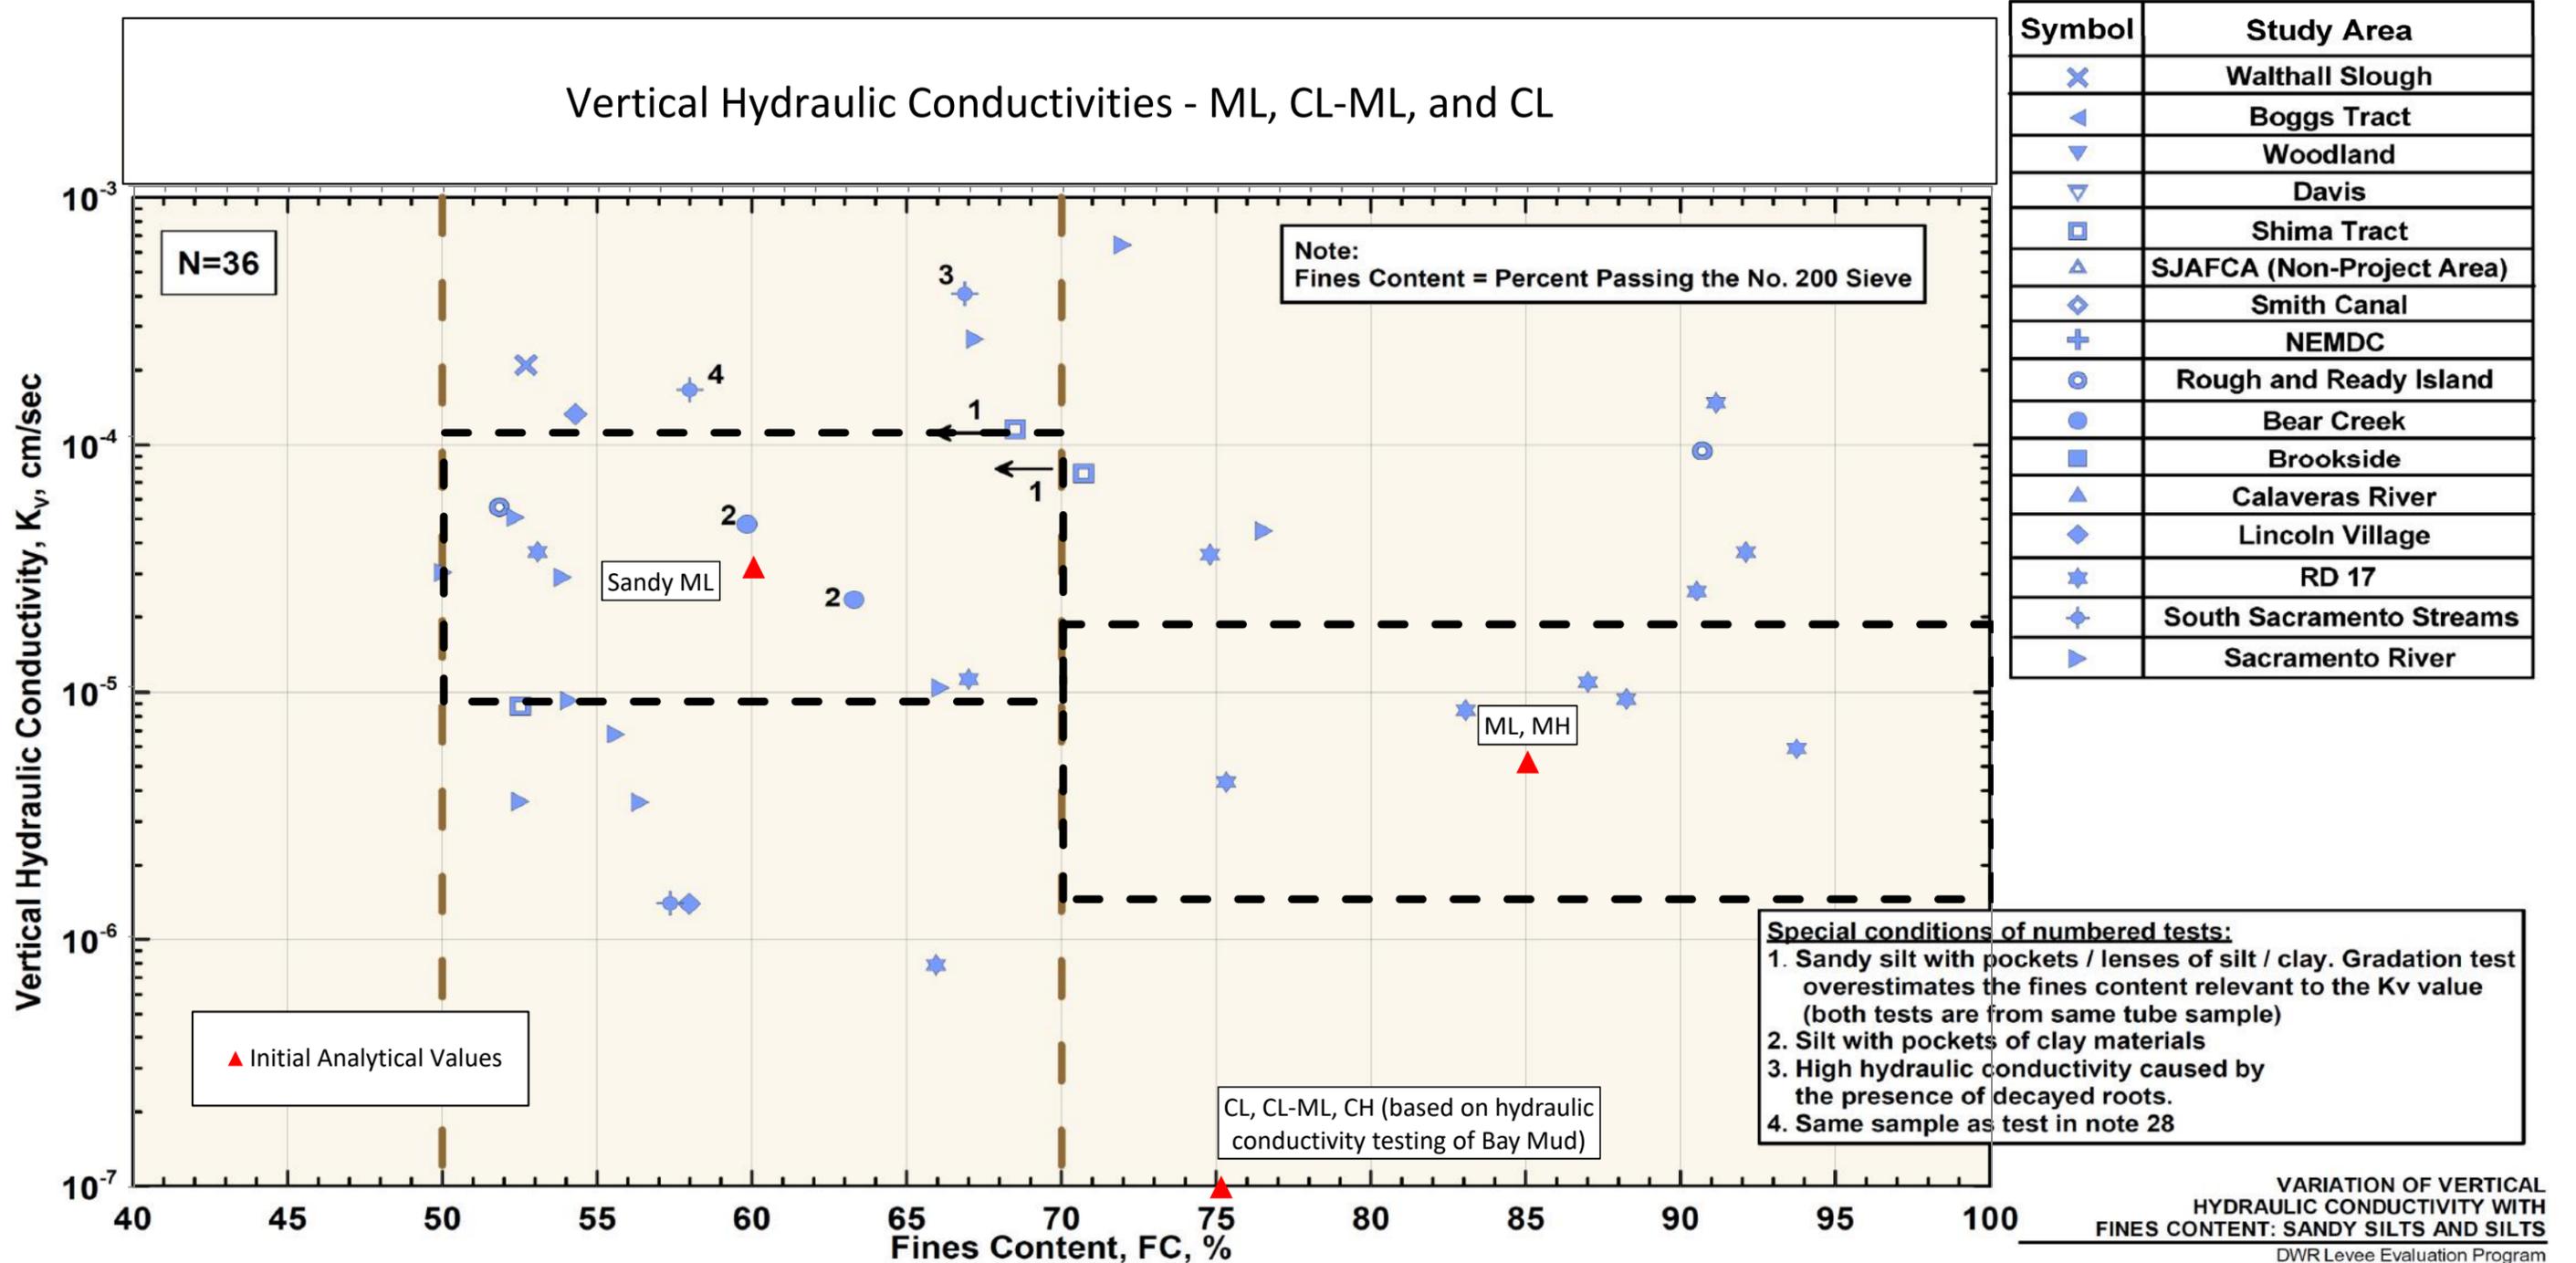
Figure A-5. Vertical Hydraulic Conductivities – ML, CL-ML, and CL

VARIATION OF VERTICAL HYDRAULIC CONDUCTIVITY WITH FINES CONTENT: SANDY SILTS AND SILTS
 DWR Levee Evaluation Program
 ULE Special Testing Program
 DWR Guidance Document
 California Department of Water Resources
 Sacramento, CA
 November 2013

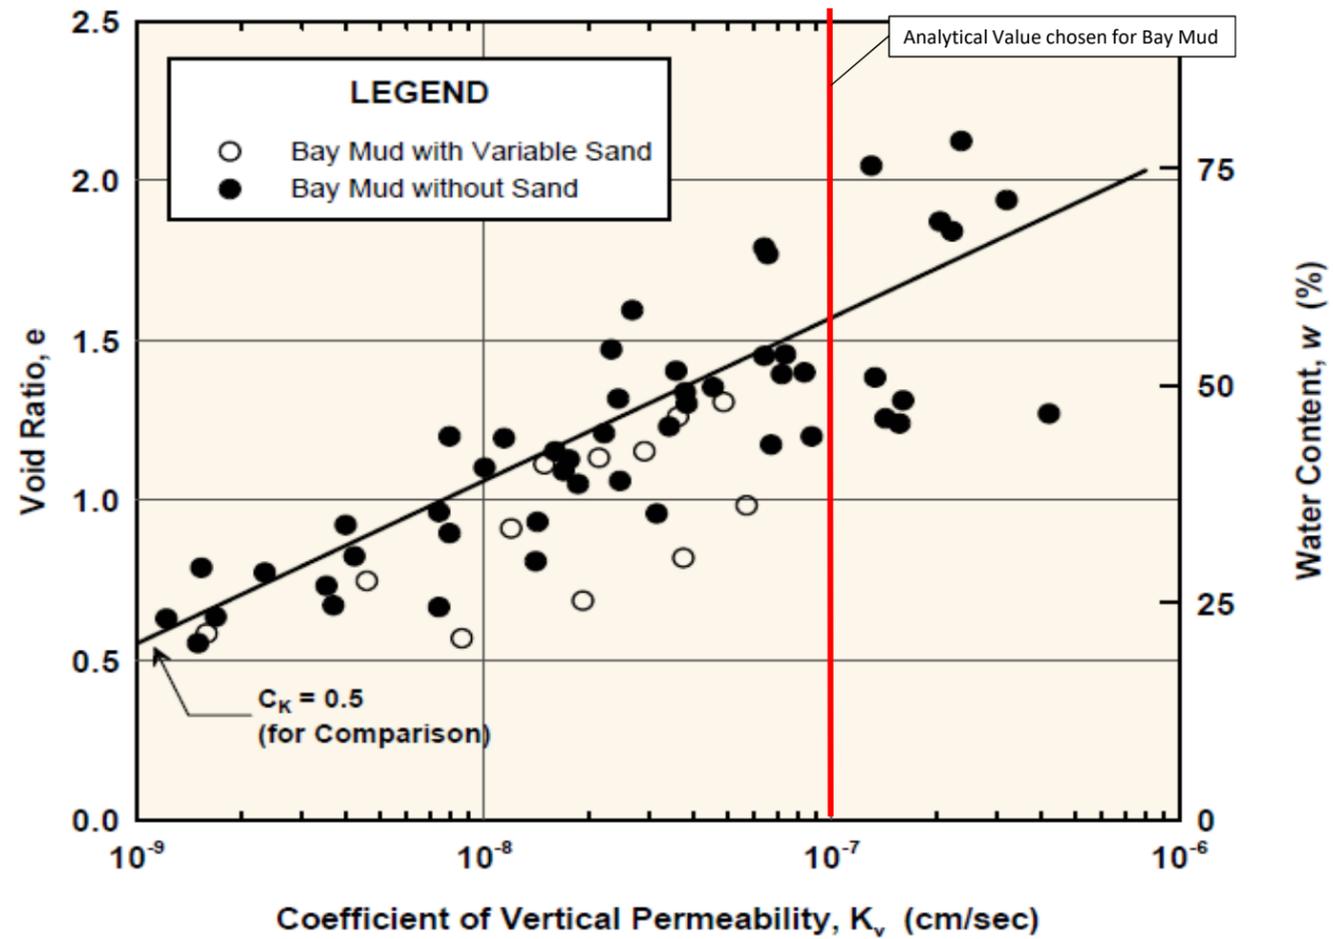
Figure A-6. Vertical Hydraulic Conductivities – San Francisco Bay Mud

HYDRAULIC CONDUCTIVITY OF BAY MUD ESTIMATED FROM INCREMENTAL LOADING CONSOLIDATION TESTS

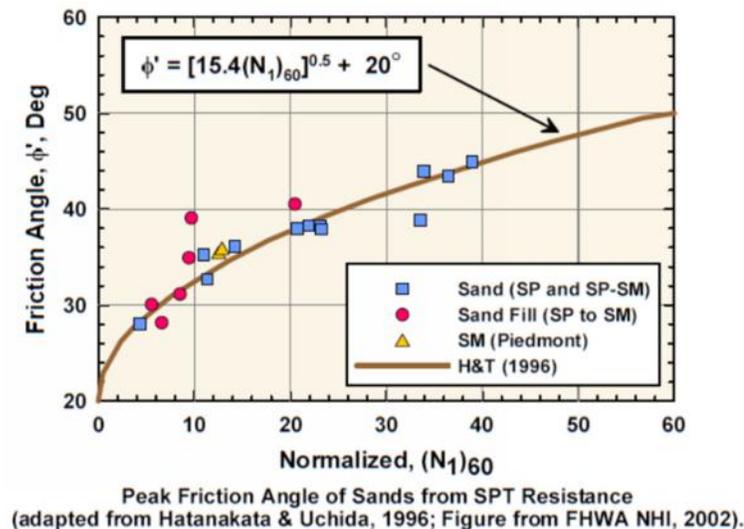
For SPT N-Value data, from FHWA (2002), adapted from Hatanaka & Uchida (1996):

As part of a previous project we contacted Prof. Paul Mayne, the author of the NHI publication, to confirm which corrections were incorporated into the correlation. Dr. Mayne indicated that only the N_{60} energy correction and the N_1 overburden correction were included. Other corrections, such as those for rod length, borehole diameter, and sampler type were not included.

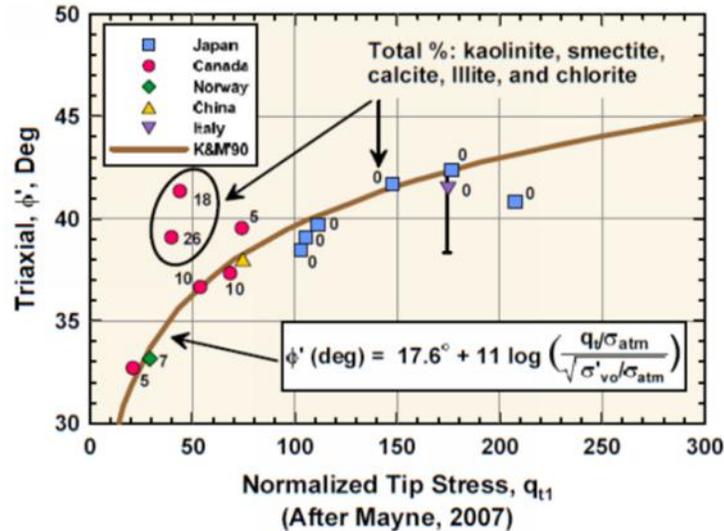
For CPT normalized tip stress, from Kulhawy & Mayne (1990), published in Mayne (2007):

We selected representative drained shear strengths for each coarse-grained soil layer by estimating the typical drained friction angles estimated with the above SPT and CPT correlations.
