FLOOD CONTROL ZONE 5 ADVISORY BOARD

JUNE 26, 2018

Item 2. Easkoot Creek Maintenance Update

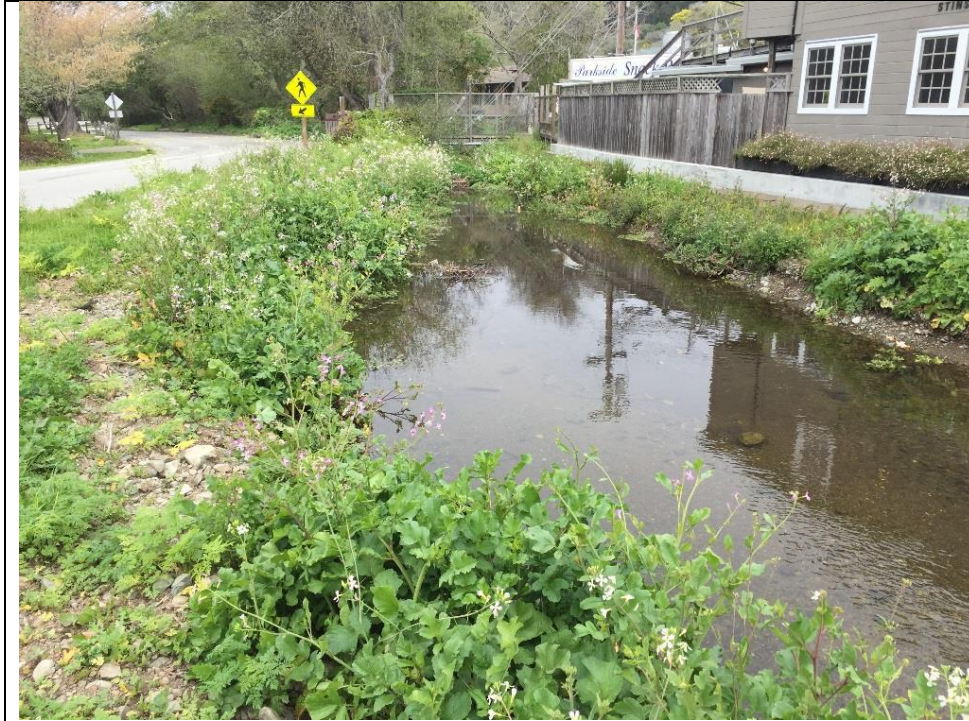
Date: April 3, 2018

Sediment trap adjacent to Parkside Café.

Inspection by District Staff before the storm.

Sedimentation in Eastkoot Creek was negligible at that time.

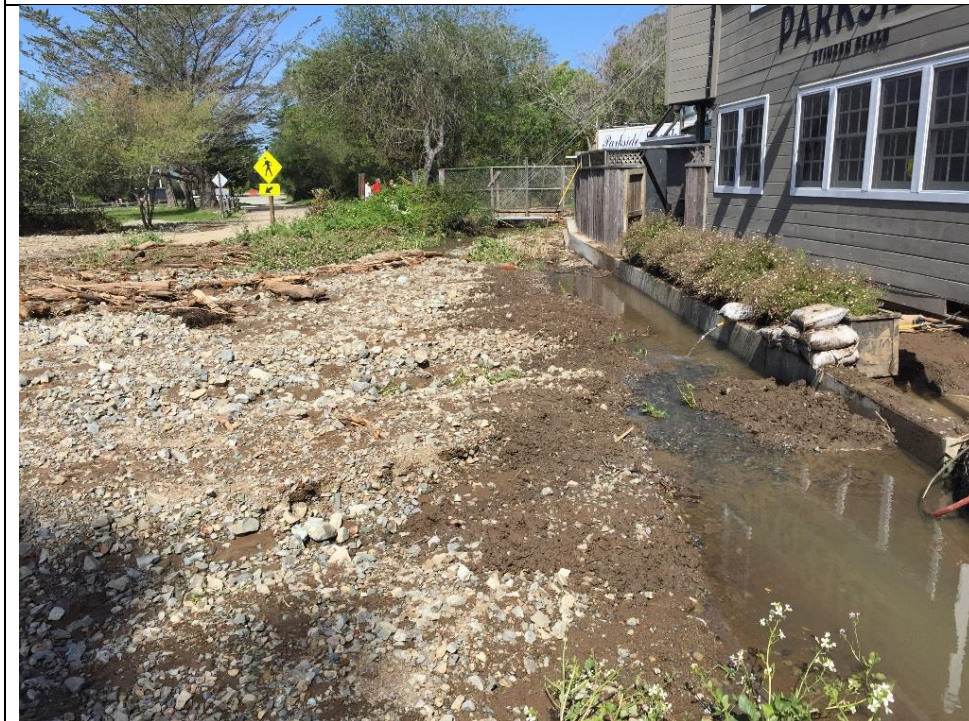
Date: April 9, 2018

Inspection by District Staff after the storm.

District will remove sediment from the channel in September when potential impacts to young vulnerable steelhead are minimized.

Consultation with National Marine Fisheries regarding protecting fish is currently underway.

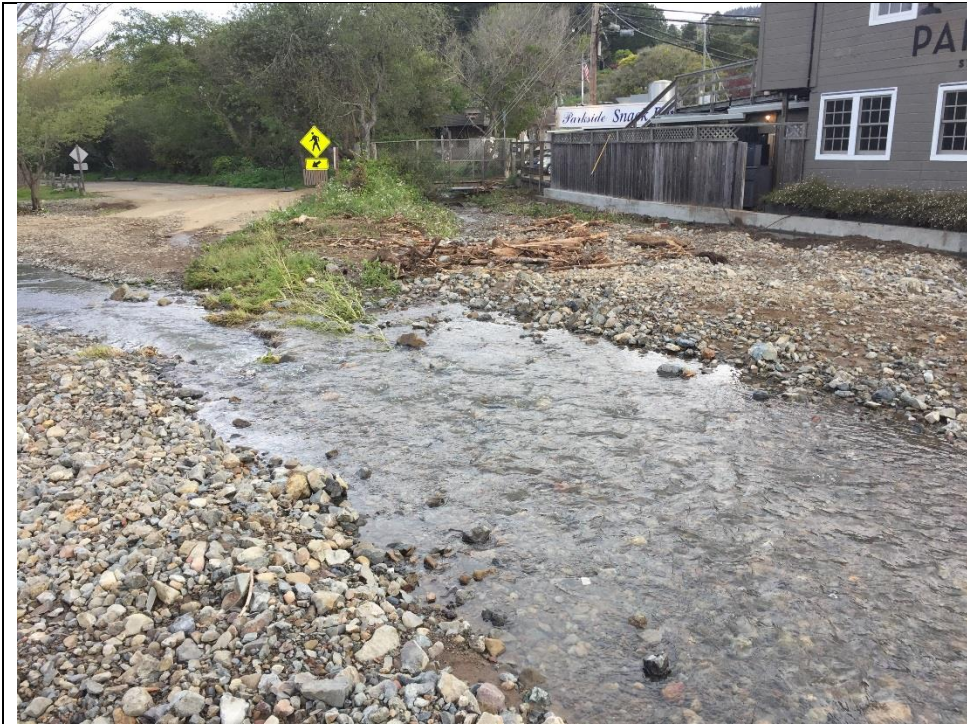
Date: April 9, 2018

Creek was mostly running through the parking lot instead of through its normal course. A small amount of water was running along side the Parkside Café's concrete wall.

There were concerns about potential for a lack of water in the creek to support young steelhead if water wasn't redirected back to the creek.

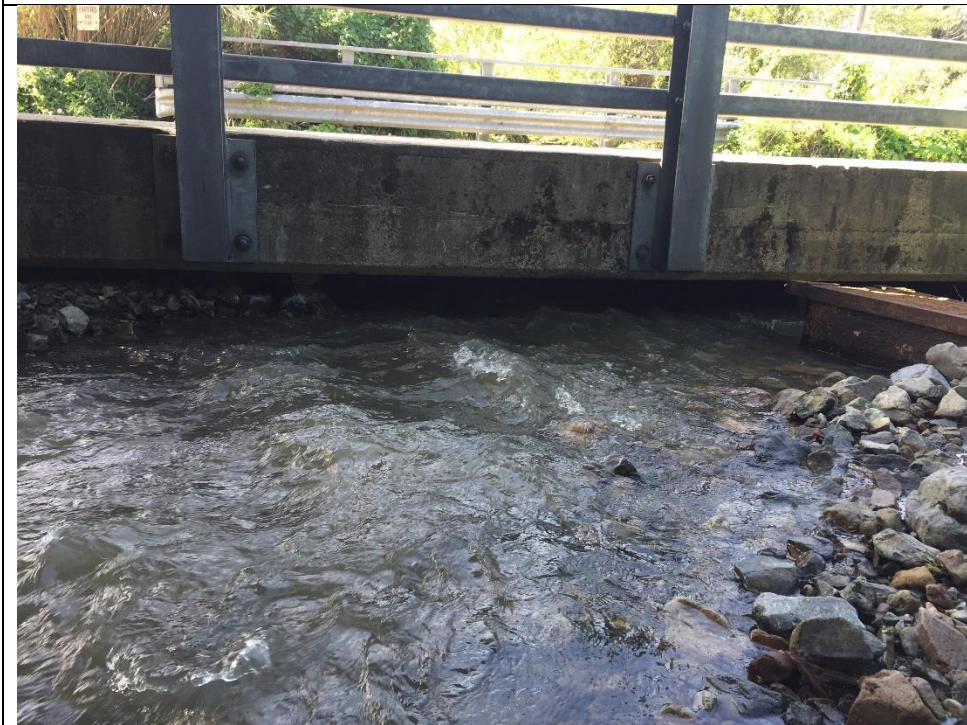
Date: April 9, 2018

Levels of sediment leave very little room for water to flow under Arenal bridge, therefore cleaning out sediment under that bridge is part of the District's sediment removal work scheduled for September.

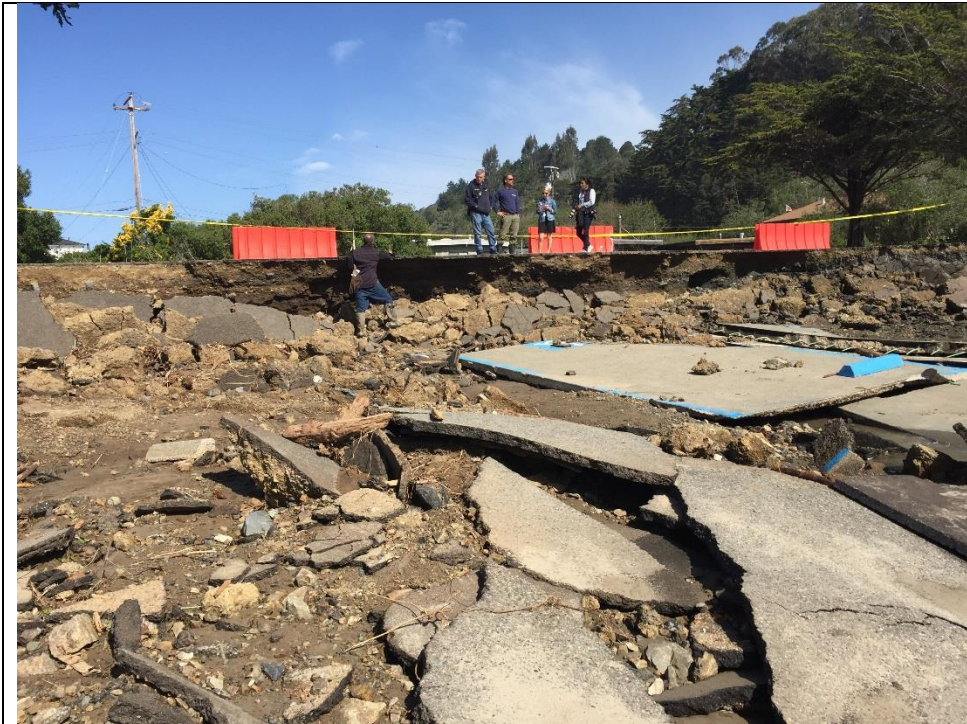
Date: April 9, 2018

Collapse at NPS Stinson Beach parking lot following the April 6 washout.

District staff were invited by NPS to be part of the planning team for repairs and improvements at the parking lot. Staff appreciate the opportunity to engage in this process.

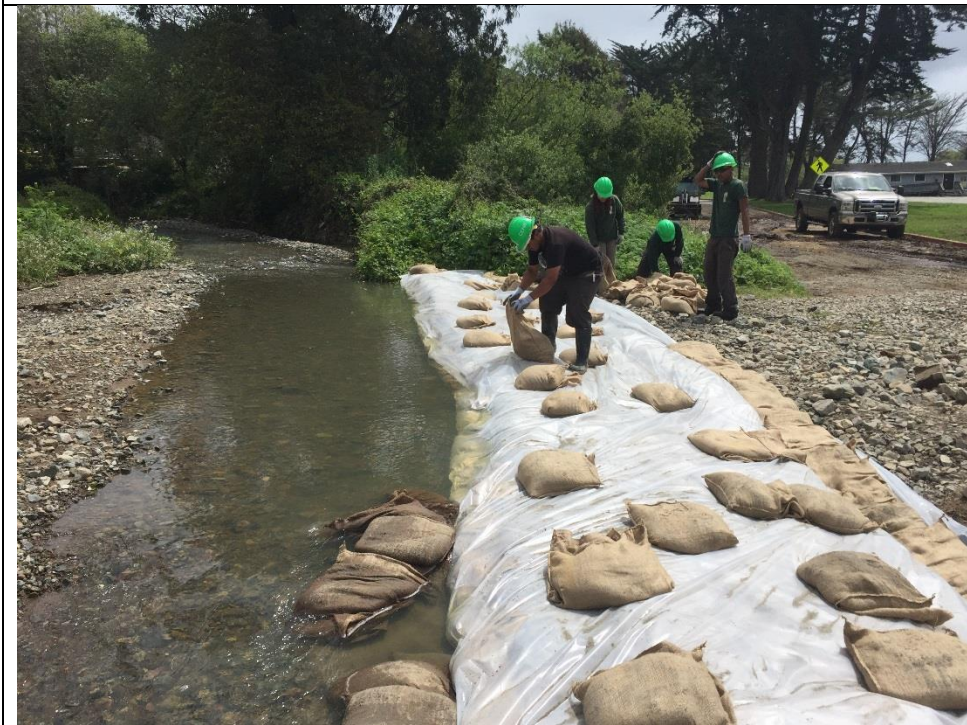
Date: April 11, 2018

Sandbag Berm placed by CCNB to redirect creek flows back to its normal course and off of the NPS parking lot.

Secondary goal was to coax deep flows away from the Parkside Café concrete wall and more towards the middle of the creek.

The berm held up well during two small subsequent storms.
