FLOOD CONTROL ZONE 5 ADVISORY BOARD
NOVEMBER 26, 2018

Item 1. Easkoot Creek Maintenance Update

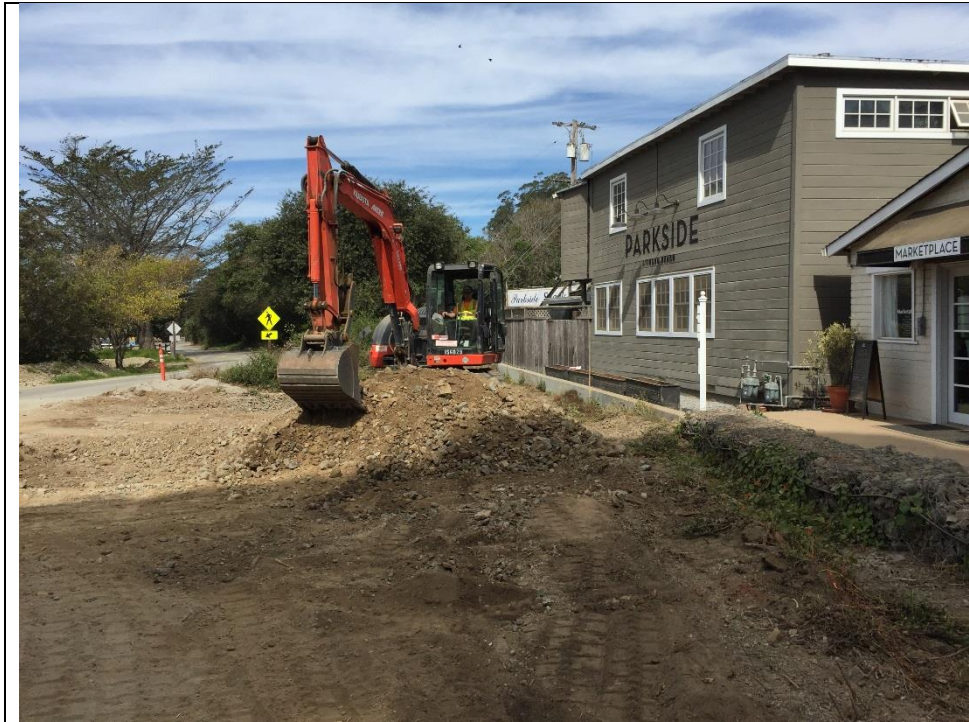
Sept 12, 2018

Sediment removal adjacent to Parkside Café.

Excavators and a skid steer were used to load cut material into a dump truck.

In September, the District hired a contractor, AMA Diversified, to remove sediment from Easkoot Creek behind the Parkside Café and up to Arenal Avenue. The contract with AMA was for \$25,908. The next lowest bid received was for \$78,800. Using excavators and a dump truck, AMA completed the work in four days without any incidents or change orders. The Park Service agreed to accept the spoils of the excavation in the North parking lot, where the erosion from the April storm occurred. The Park Service prepared the site by installing concrete blocks along the face of the eroded head-cut. Our contractor dumped the spoils into the pit, and NPS compacted and graded the hole as it was filled in. Approximately 500 cubic yards of material were relocated from the creek to the North lot.

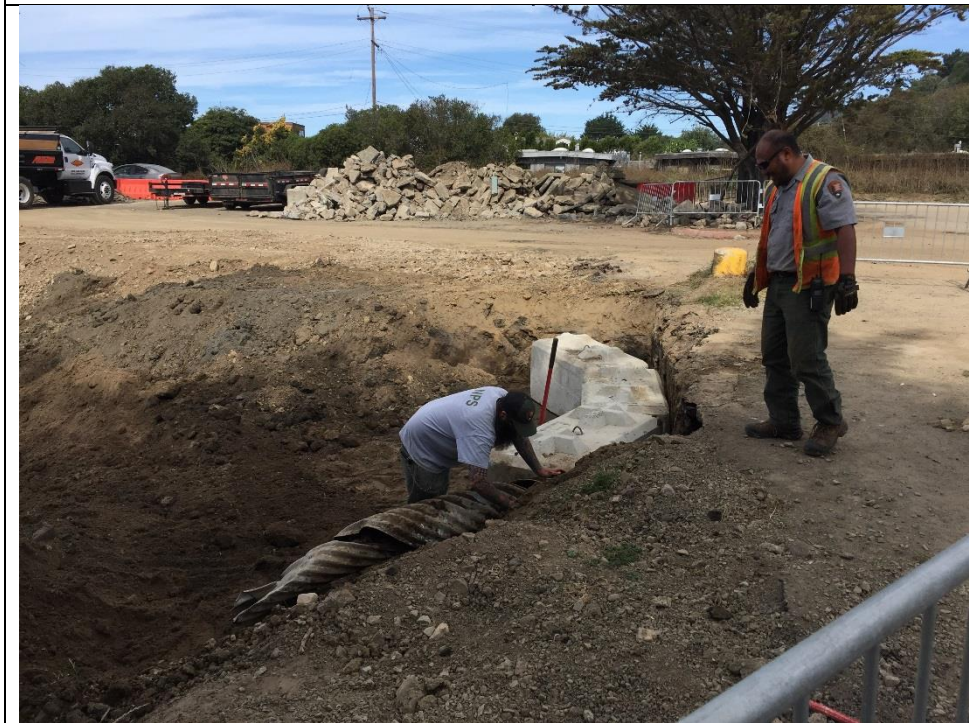
Sept 12, 2018

NPS installing a cut-off wall in the North parking lot hole before it was backfilled with sediment excavated from the creek.

This cut off wall in intended to prevent further erosion of the parking lot should another flooding event occur.

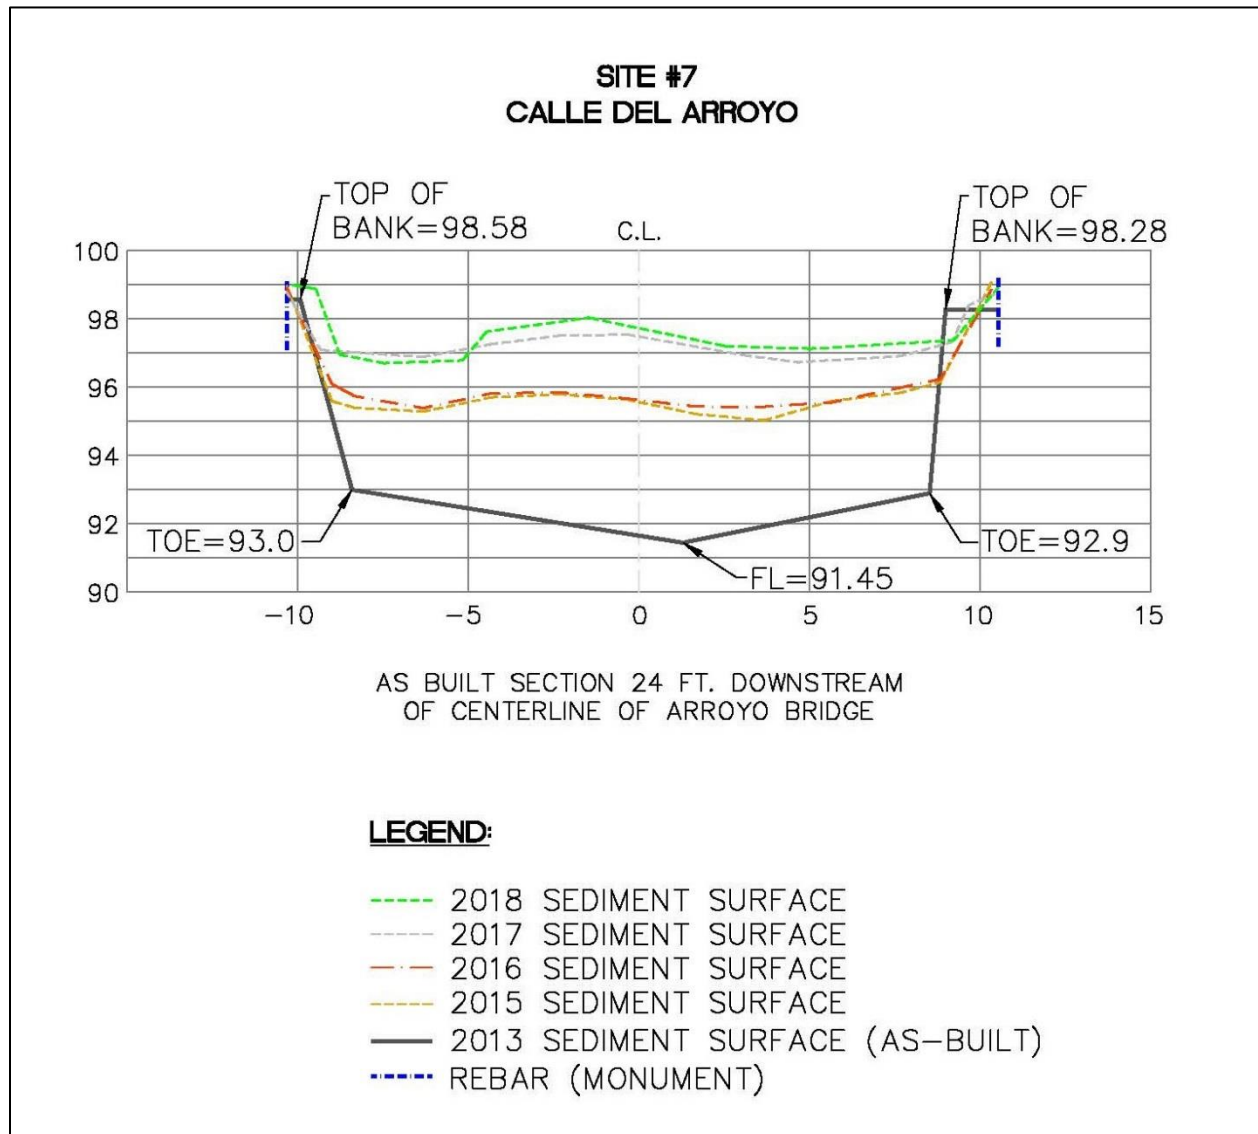
The cross section below is from downstream of Calle Del Arroyo and is characteristic of the other locations. It shows the 2013 channel cross section after sediment excavation in solid black at the bottom. Within two years this area fills in to match the profile of the rest of the stream length. During the wet winter of 2016-2017 almost two feet of sediment were deposited along the bed. Last year a significant change didn't occur because it was so dry and during our one large storm all the sediment spilled over to the NPS parking lot and straight to the ocean.

For the last four years, the Flood Control District has been monitoring the accumulation of sediment in the channel adjacent to bridge crossings in the Calles. This monitoring was initiated in conjunction with construction of the sediment trap within the beach park and concurrent with sediment removal at those bridge crossings. The premise of the monitoring was to test the efficacy of the sediment trap in providing a centralized, accessible, and seasonally dry location for sediment removal and its ability to reduce need for downstream maintenance.

One of the objectives of our permit with the San Francisco Bay Regional Water Quality Control Board is to establish quantitative metrics triggering when we do sediment removal, and continuation of this effort is well suited to inform those decisions. Unfortunately, many of the monitoring pins have been lost, buried or eroded away over the years. Therefore the District is simplifying the monitoring this year by taking measurements straight down from the actual bridges. In time the goal is to establish sediment removal triggers that are tied to hydraulic modeling and a specific recurrence interval, such as the 5 or 10-year storm event. We will plan to look at these monitoring results in more detail at our next advisory board meeting.
