APPENDIX A

Notice of Preparation and Scoping Report

NOTICE OF PREPARATION AND NOTICE OF PUBLIC SCOPING MEETING FOR THE SAN ANSELMO FLOOD RISK REDUCTION PROJECT ENVIRONMENTAL IMPACT REPORT

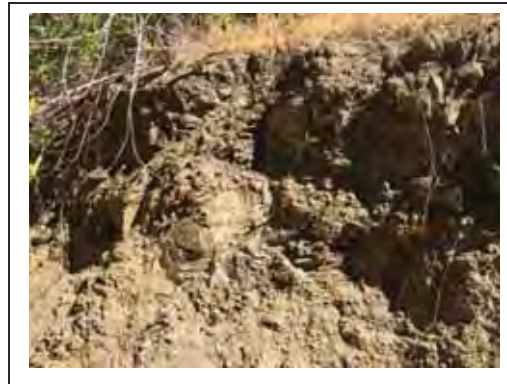
Photo 1. Exposure of weathered Franciscan Complex from northern hillslope adjacent to Former Nursery site.

The project site is situated in the Coast Range province, along an east-west trending valley flanked to the north and south by relatively steep hillsides. According to Blake (2000), the hills are Franciscan Complex, and appear to consist of variably deformed Cretaceous sandstone and shale (see Photo 1) on the lower slope, with *mélange* and Serpentinite on the upper slope, as shown on Figure 2-2. The valley floor is filled with Quaternary alluvial and colluvial sediments of uncertain depths, which underlie the project site. The alluvial sediments thin and pinch out or merge with Quaternary hillside slope deposits at the edges of the valley.
