STATE OF TENNESSEE
DEPARTMENT OF ENVIRONMENT AND CONSERVATION
DIVISION OF WATER RESOURCES

RE: Compliance Evaluation Inspection
 Munford Water System
 NPDES Permit Number TN0081671
 Tipton County

**Compliance Inspection for Filter Backwash and Sedimentation Basin Washout from Water Treatment Plants
General NPDES Permit**

Facility Name: City of Munford Water Plant (WTP)	NPDES Tracking Number: TN0081671
Permit Coverage Effective Date: 1/11/2021	Permit Expiration Date: 8/31/2025
Date and Time of Inspection: 7/14/2021	Inspector Name: Cameron Byrd

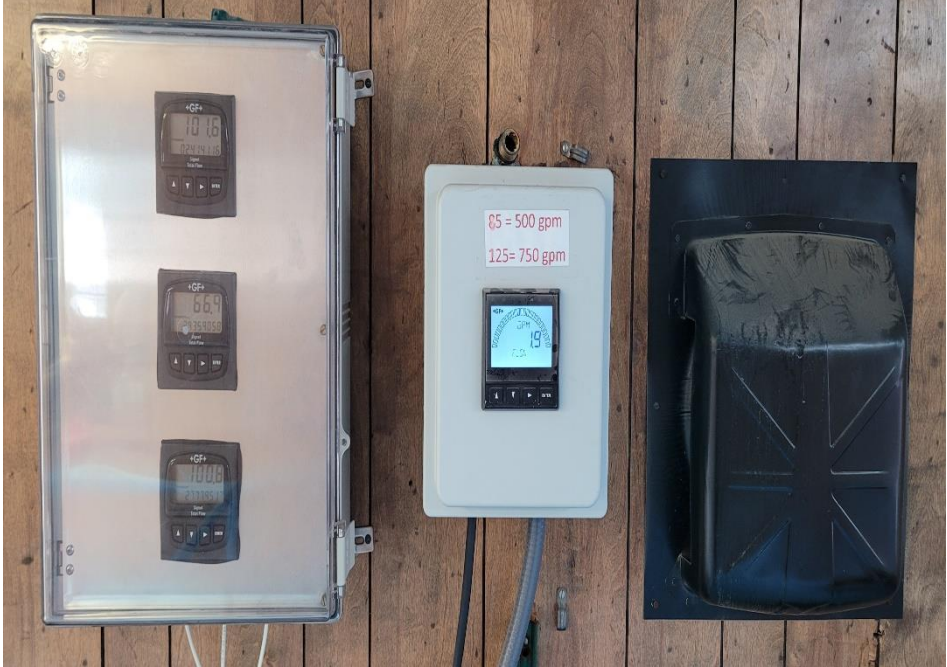
Project: Munford Water Plant		Site Location: Munford, Tipton County	Permit No.: TN0081671
Photo No. 3	Date 7-14-21

A photograph showing three digital flow meters mounted vertically on a wooden wall. To their right is a white control panel with a digital display and two red labels: 'Q5 = 500 gpm' and '125 = 750 gpm'. Further right is a black rectangular panel with a recessed area.	
Description View of flow meter used to measure the amount of water utilized for the backwash process.

A flow meter is used to measure the amount of water utilized in the backwash process (photo 3). The measurement is in gallons per minute, which is then converted to million gallons per day and reported on the DMR.

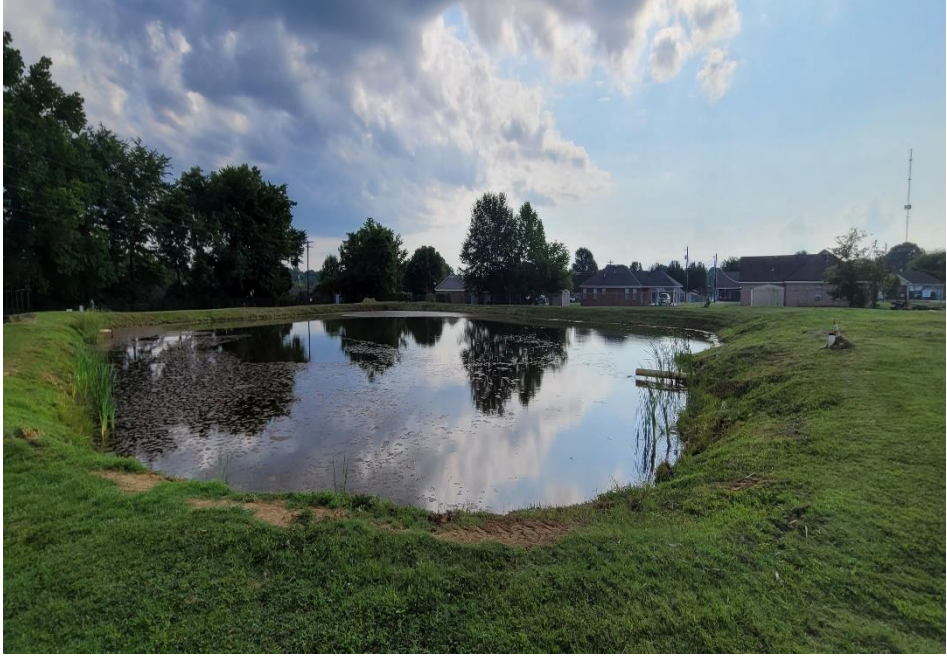
Photo No. 4	Date 7-14-21

A photograph of a lagoon with a grassy bank in the foreground. The water reflects the sky and surrounding trees. In the background, there are residential houses and a utility pole under a cloudy sky.
Description View of lagoon. It was dredged in the fall of 2019.

The lagoon was dredged out during the fall of 2019 and currently has three plus feet of free-board along its perimeter (photo 4). Land adjacent to the town's wastewater lagoon was approved for application of the iron sludge.

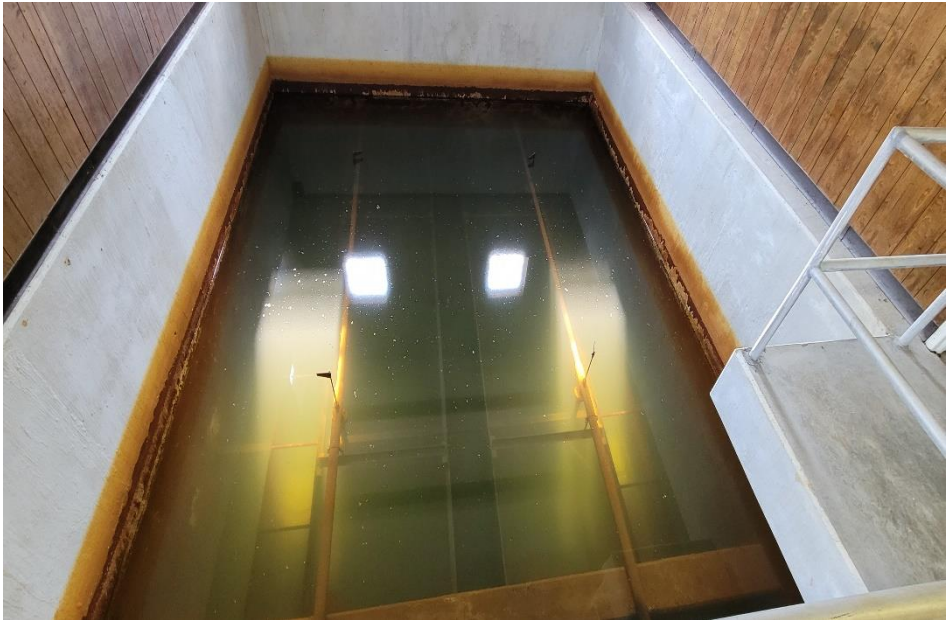
Photo No. 5	Date 7-14-21

Description View of filter backwash basin full of water, during the filter backwash process.

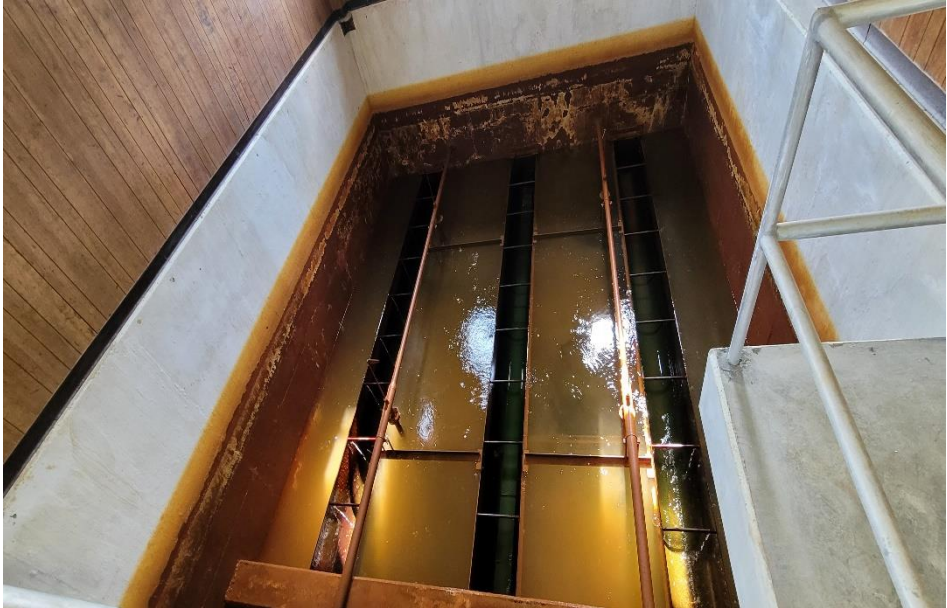
Photo No. 6	Date 7-14-21

Description View of filter backwash basin during the filter backwash process.
