Deer Creek & Walborn Reservoir Watershed Study

Executive Summary

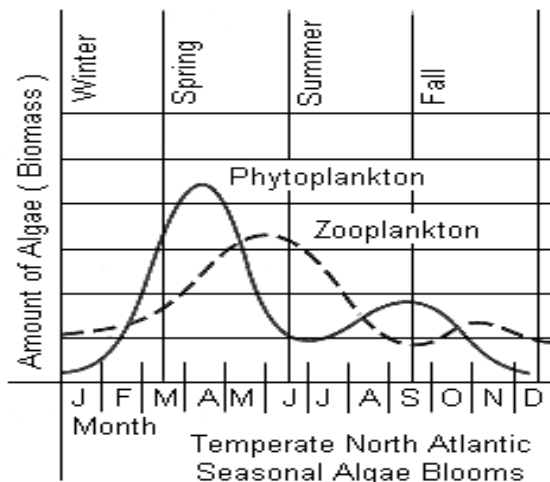
Figure 1: Seasonal cycle of plankton

Algal scums are typically found near the outer edge of slow moving, high nutrient waters. HABs can occur at any time, but are most common during spring, and late summer/early fall when the temperature, amount of sunlight, and nutrient levels are supportive of their growth (Figures 1 & 2).

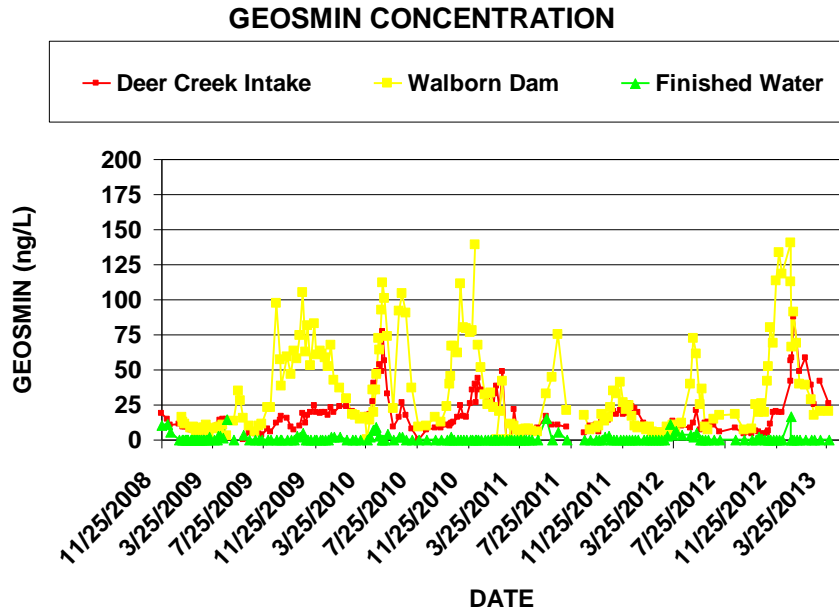
Figure 7: Geosmin concentrations in the two reservoirs and finished water from 2008 to 2013

These figures show the sunny summers with warm weather contributing to potentially high taste and odor problem chemical concentrations in the lake. Then cooler temperatures in the fall transition into winter with higher concentrations of MIB. If rainfall is abnormally high, the water with high MIB concentrations will flow down stream to the intake and into the treatment plant causing problems in the finished water.

Staff found MIB and geosmin at 9 sampling sites. MIB was found in the reservoir and geosmin was found in the tributaries directly upstream of the Price Street and Reeder Street causeways. See Map 2, Table 3, and Figures 7, 8, and 9 for more information.

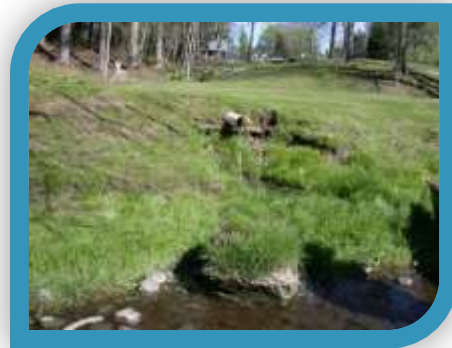
In Stark County, the Stark County Health Department (SCHD) and the Stark County Metropolitan Sewer District (SCMSD) identified homes with above average failure rates for Home Sewage Treatment Systems (HSTSs). These high failure rates are typically in areas with dense housing stock, small lot sizes, and poor soils for a properly functioning HSTS. These areas are a concern due to the potential threat to public health and local water quality. There were four known areas of failing septic systems in the Deer Creek watershed in Stark County. One area in Marlboro Township has around 110 homes. The Army Corps of Engineers, Stark County Sanitary Engineering Department, and Township Trustees completed a wastewater facility in June of 2013. In addition, the Stark County Commissioners have committed to sewerage Limaville with a target installation date of 2017. Limaville and the two other sites that still have home sewage treatment systems issues, the Lynnette neighborhood in Marlboro Township and the States neighborhood in Lexington Township, are shown in Map 26.
