Middle Cuyahoga River Watershed

End of Volume 1, Middle Cuyahoga River Watershed Action Plan

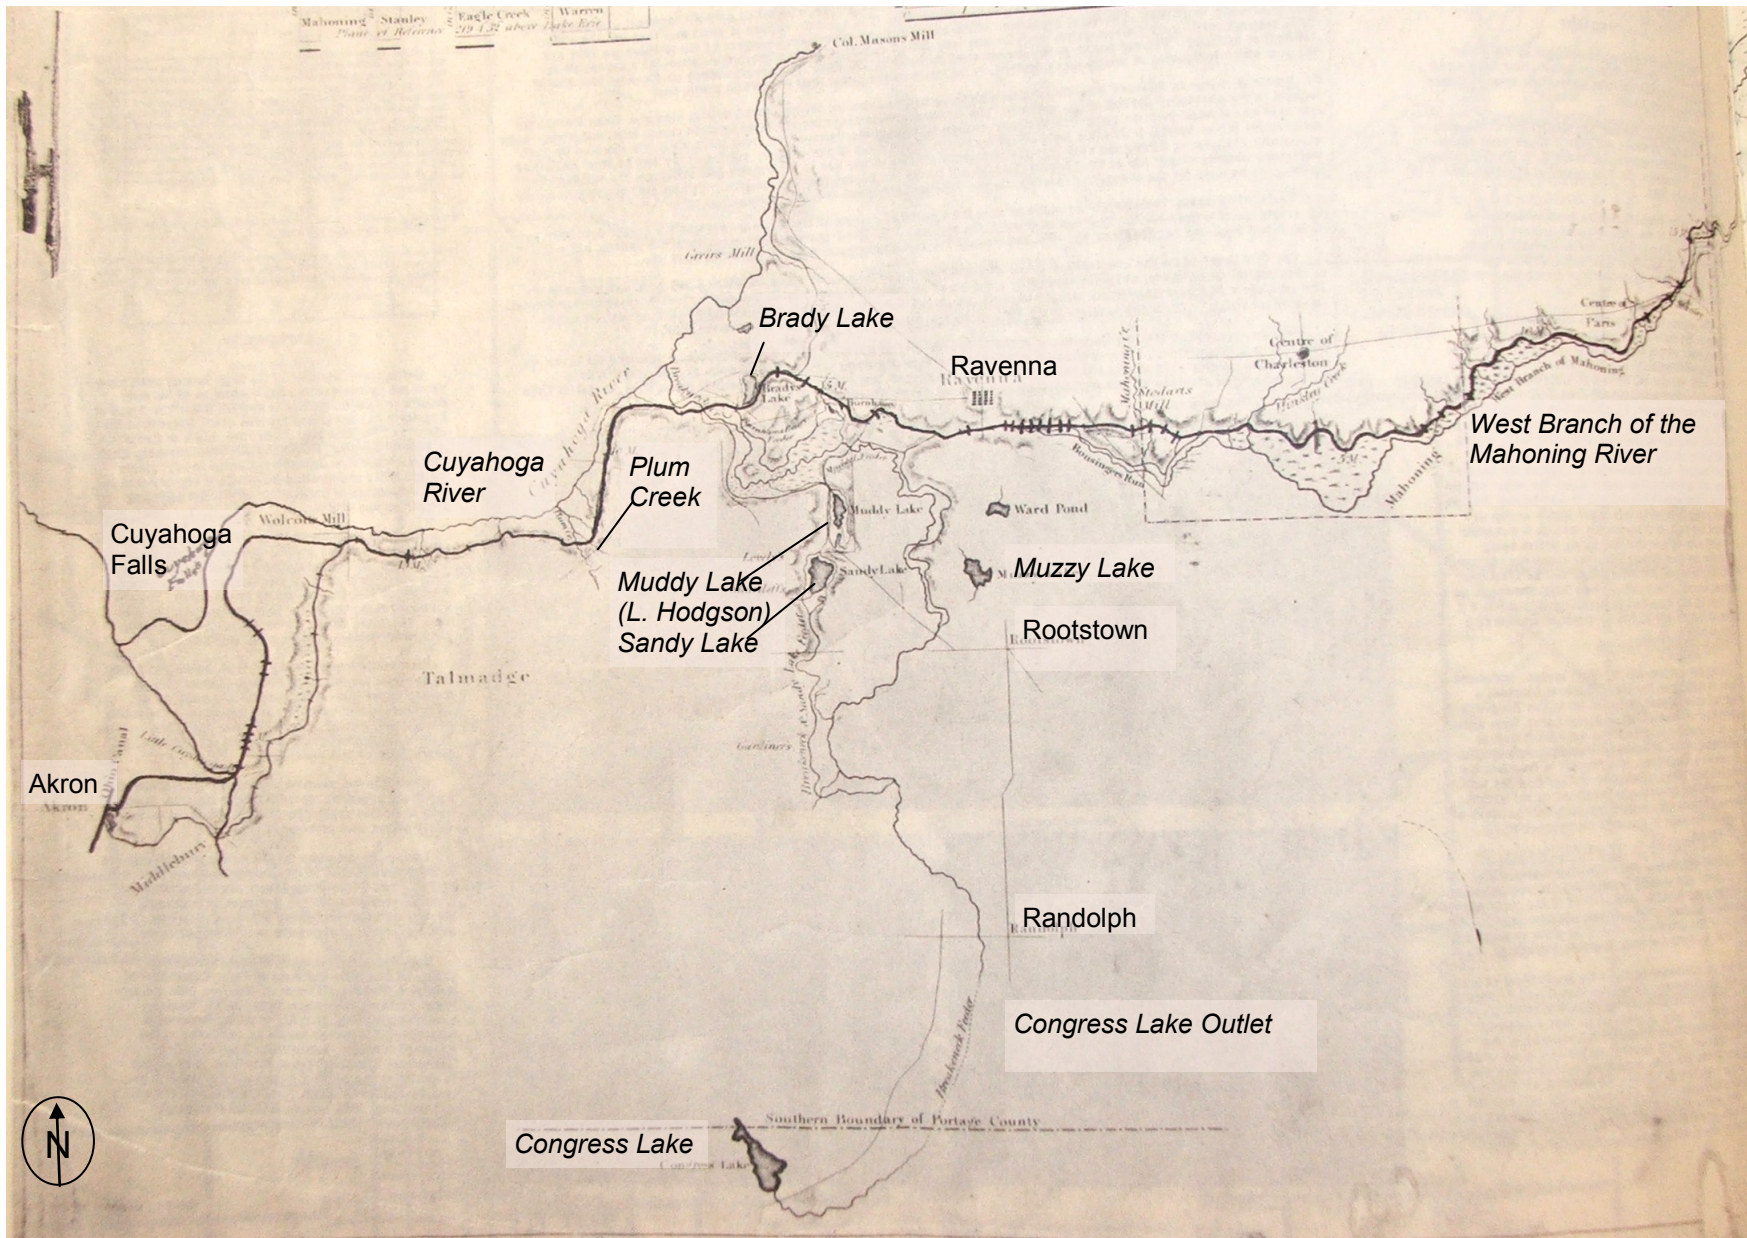
Figure 4b-1 1840s Map of the Pennsylvania and Ohio Canal—Pennsylvania border to Akron

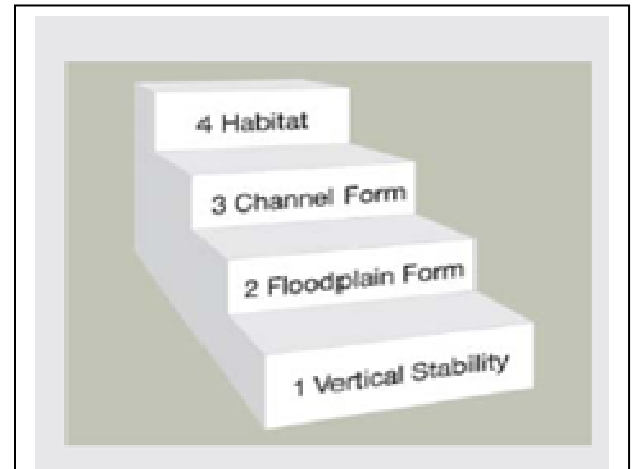
Figure 4d-2 Physical characteristics provide the basis for habitat and biological communities *Source: Ohio Rainwater and Development Manual, App. 7, Planning for Streams, Fig. 1, Ohio DNR, 2006.*

Figures 4d-1 and 4d-2 illustrate that the biological communities are a result of tiered influences related to the physical environment, each level being affected by others. Even though it is not shown in the illustration, it is important to note that chemical parameters are also important at the various levels.

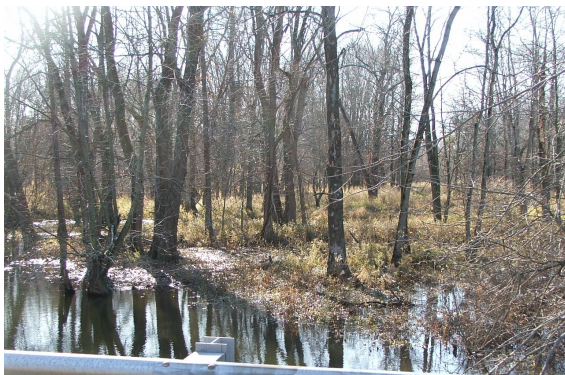
Figure 4d-3. Features of an Intact Riparian Corridor

Riparian zones, wetlands, and floodplains often coincide in the low, wet areas along the streams in the Middle Cuyahoga River watershed.

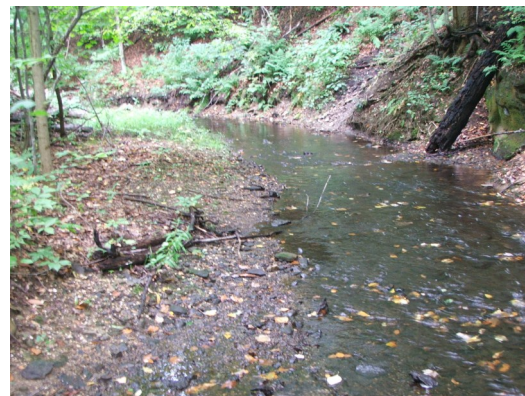
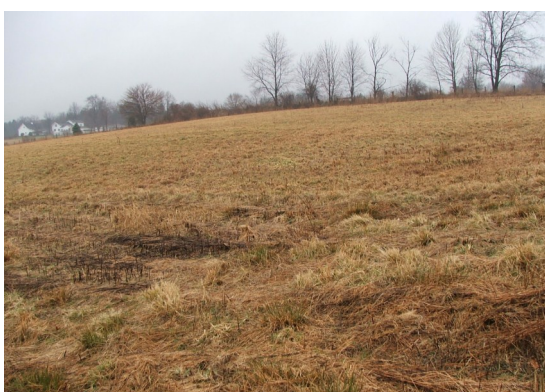
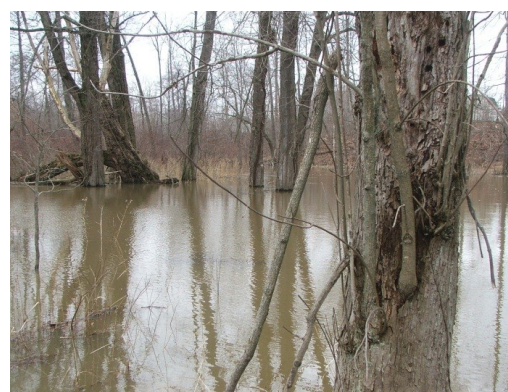
Upland slope – absorbs water – during a day-long storm, only a minimal amount of water trickled off the slope into the stream below. Wooded buffers are even more effective at absorbing water, preventing erosion, and taking up nutrients.

Floodplain at work storing water

Figure 4d-4. Landscape Elements Provide Watershed Benefits, Middle Cuyahoga River Watershed

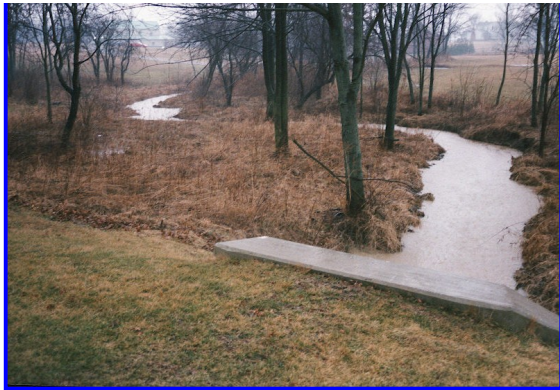
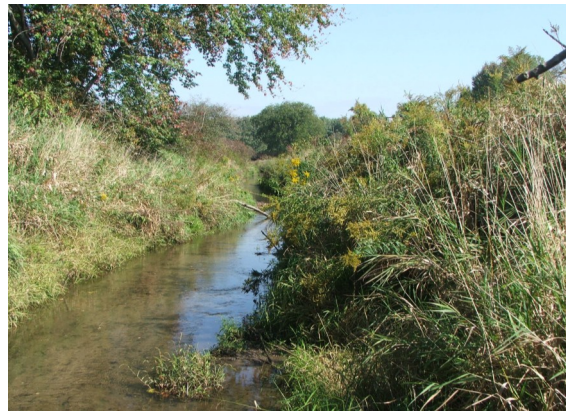
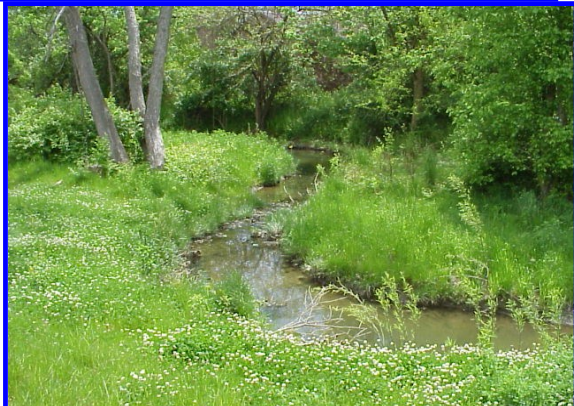
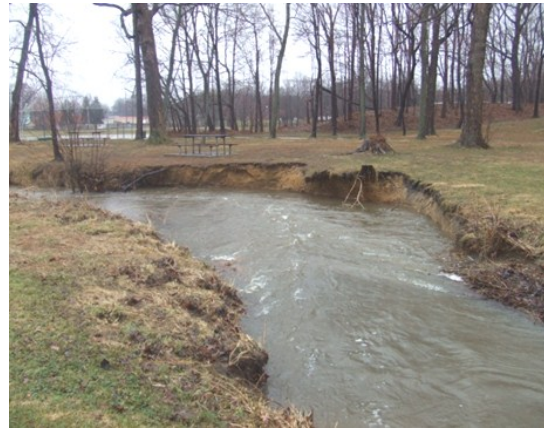
Figure 4d-5 Vertical Stability of Streams

Vertically stable streams (left) have accessible floodplains and riparian zones, and will not erode or silt in over time. (Source: R. Keitz Ohio DNR Oster-Zimber Ditch Presentation n.d.) In contrast, the unstable channels at the right have tall vertical banks. The channel at the top right has uniform, slow flow, with no floodplain access. With no way to clear the sediment out from the channel, it is silting in. The channel at the bottom right is overloaded, has no access to a floodplain, lacks stabilizing vegetation, and is eroding vertically.

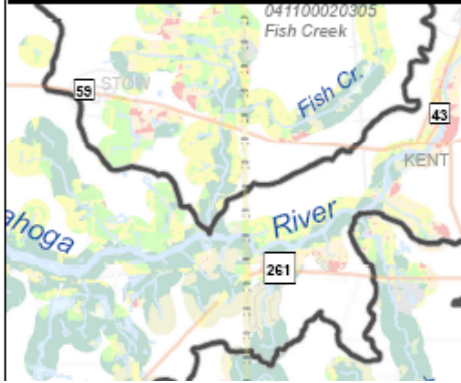
**Figure 4d-8
Land Cover
within Buffers**

Middle Cuyahoga River Watershed - East

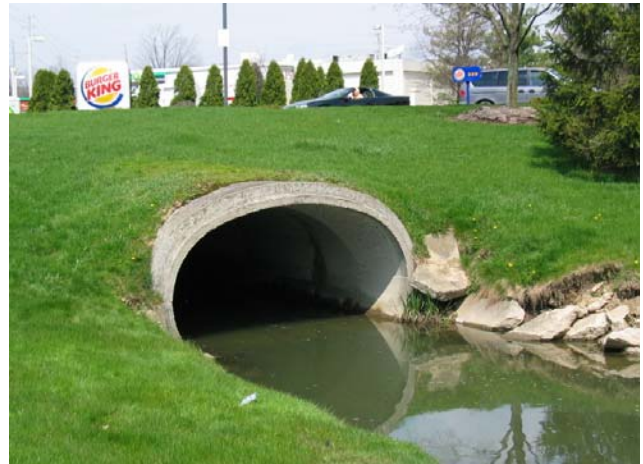
Figure 4d-10. Hydrologic Changes Fish Creek Watershed. The hydrology of Fish Creek tributaries has changed radically in just a few years as the watershed became developed. The upper two maps contrast the stream network from the 1990s (left) with 2006. The circles highlight areas where the hydrology has changed. At location “A” the stream has been covered by a parking lot and encased in a pipe.

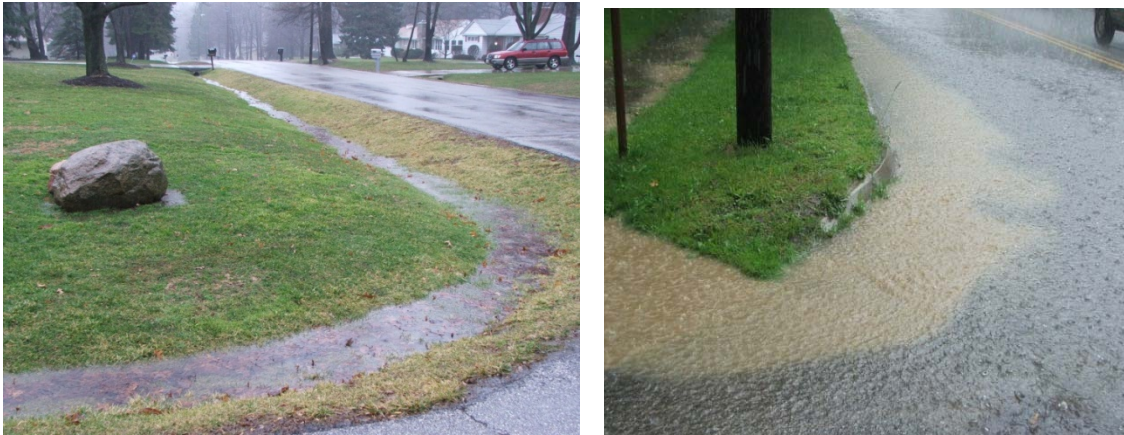
Figure 4d-11
New Headwater Streams

The new urban headwater streams found in the developed areas contribute volume but do not provide any treatment provided by undisturbed riparian landscapes.
