**Middle Cuyahoga River Watershed Action Plan  
Section 4P**

**Watershed Photos by Subwatershed**

**2012 Final**

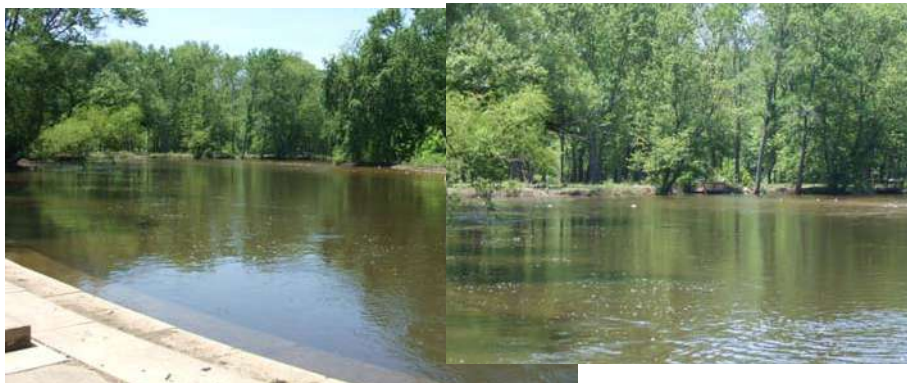
**MS-060** Cuyahoga River at Water Works Park, on a double meander on a low-lying sand/gravel deposit. Park floods during high water. Near public water supply. June, 2011, Mar., 2004.

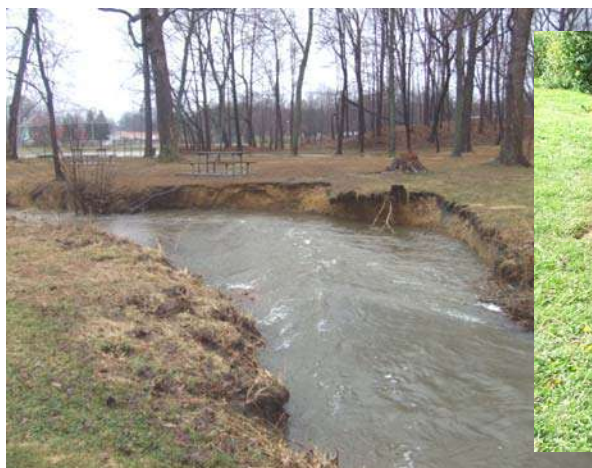
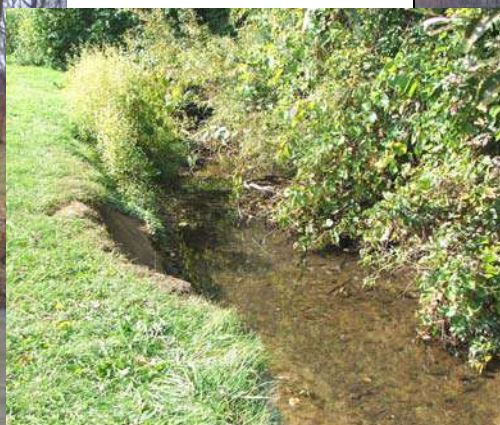
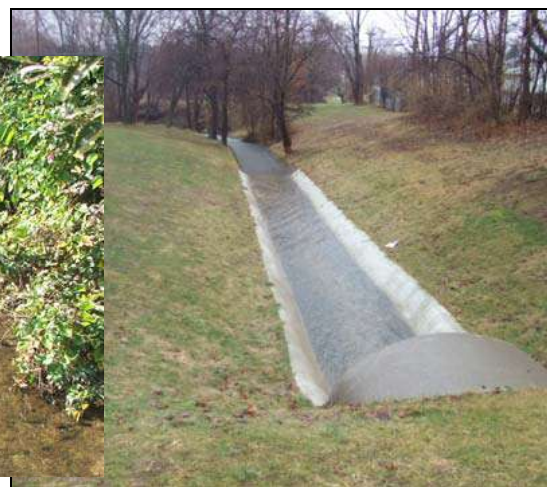
**MS 280, 270** Kelsey Creek in Kennedy Park lacks a functional riparian corridor and is eroding its banks, partially due to excess stormwater from altered stream corridors and impervious surfaces in neighborhoods. The sediment and channel erosion degrade the stream habitat. Many streams in the Main Stem subwatershed are altered. Spring, 2011, Summer, 2010.

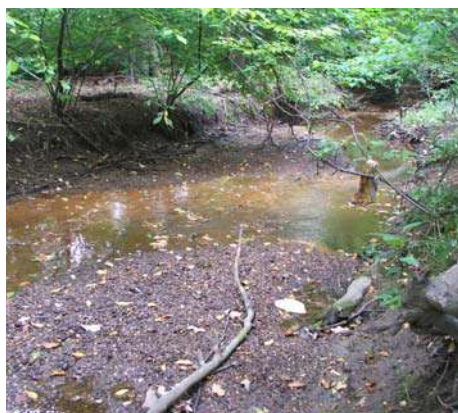
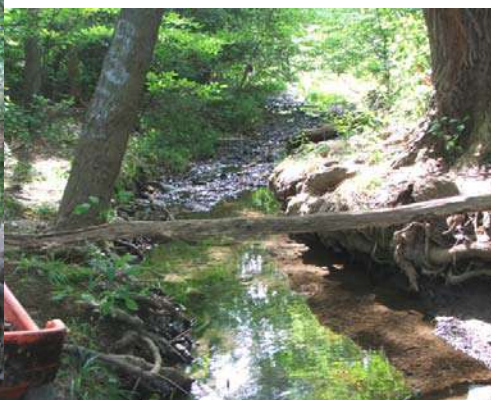
**MS 250, 260** Kelsey Creek is generally low-gradient and is most intact within woods.. (Center) Even a low-gradient portion like this through Galt Park is incising, showing evidence of overloading. Summer, 2010.

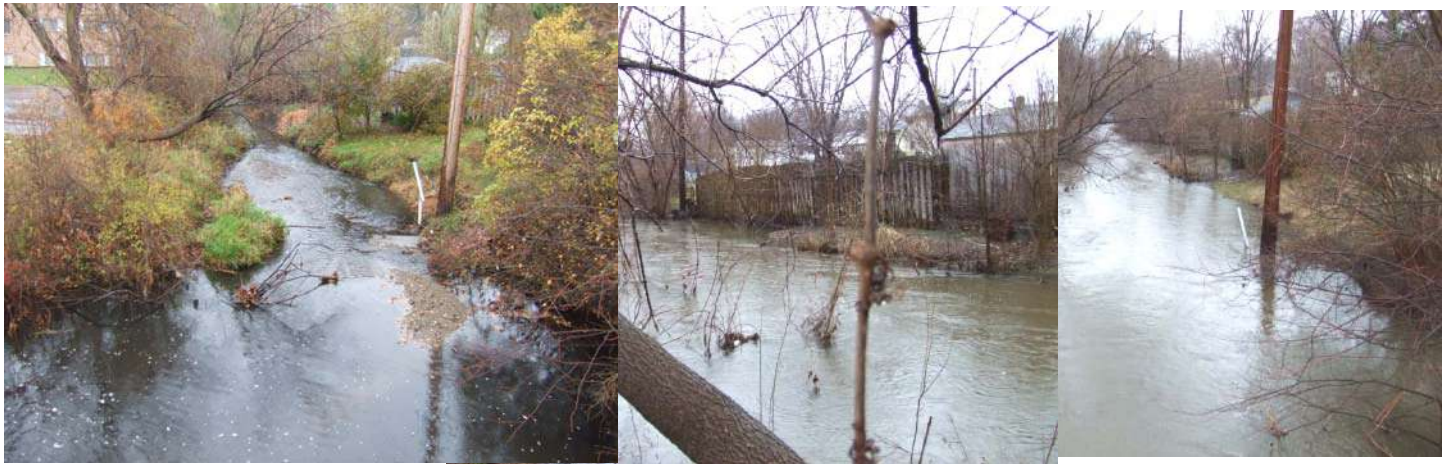
**FC-080** Fish Creek at Spaulding, spring floods on right. Note proximity of flood waters to buildings and partially submerged utility pole, eroding banks, lack of floodplain access. Nov., 2010, March 2011

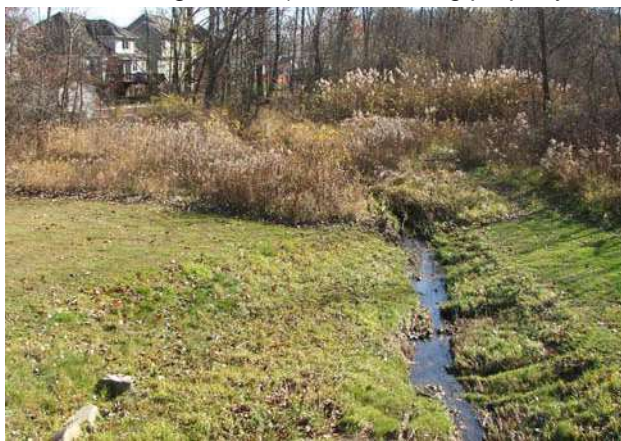
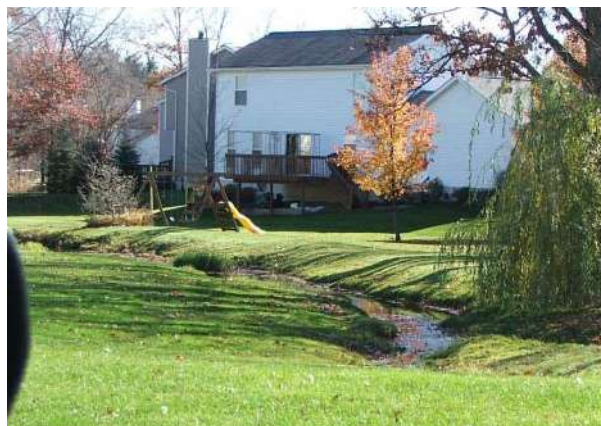
**F-320, F330** Remaining stream in developed area, Edgewater neighborhood. In areas like these, enhancing the narrow riparian area with shrubs, tall grasses, or trees, could reduce the risk of erosion. Nov., 2009.

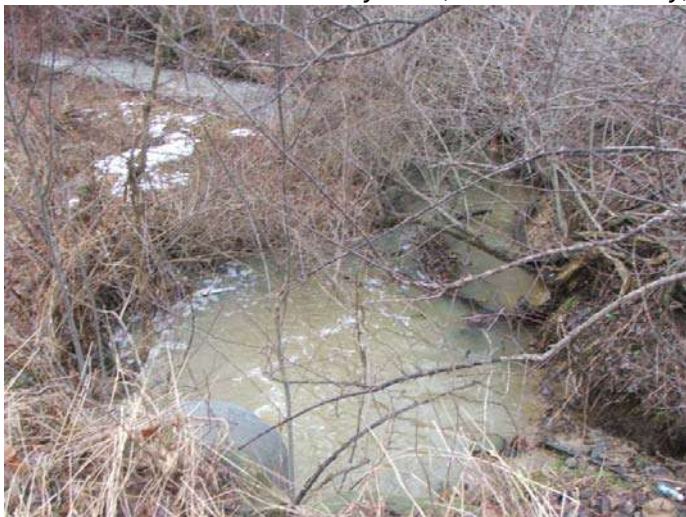
**PI-105** Johnson Ditch at Mogadore Rd. Roadside ditch carrying sediment to Johnson ditch March, 2009.

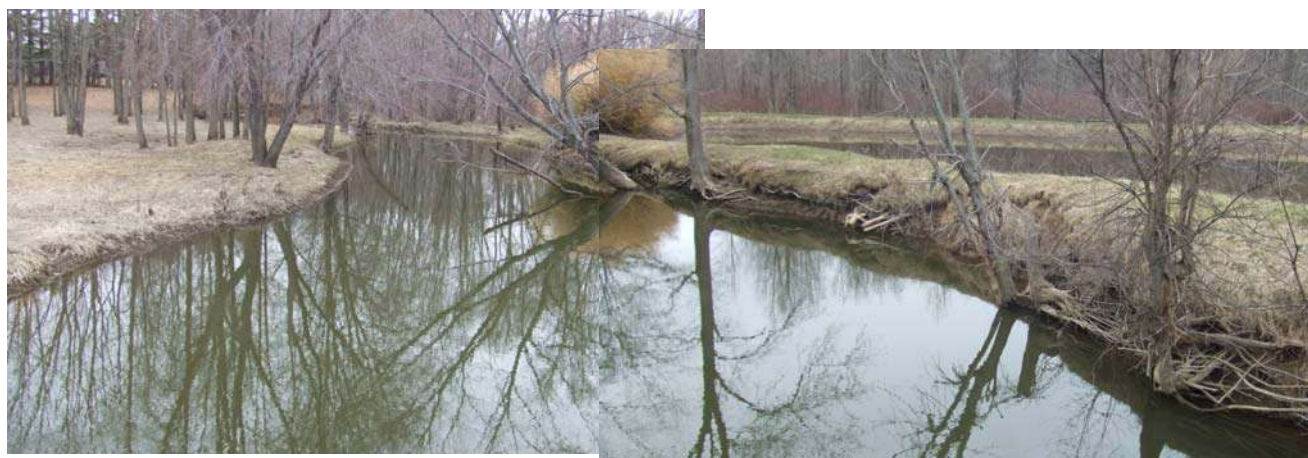
**B-260** At several road crossings, residents near the water have cleared the riparian buffer to the water's edge. In this case, there appears to be a storm pond embankment adjacent to the river, which is eroding. Breakneck Creek at Lynn, downstream of Reed & Hudson Ditches, April, 2011

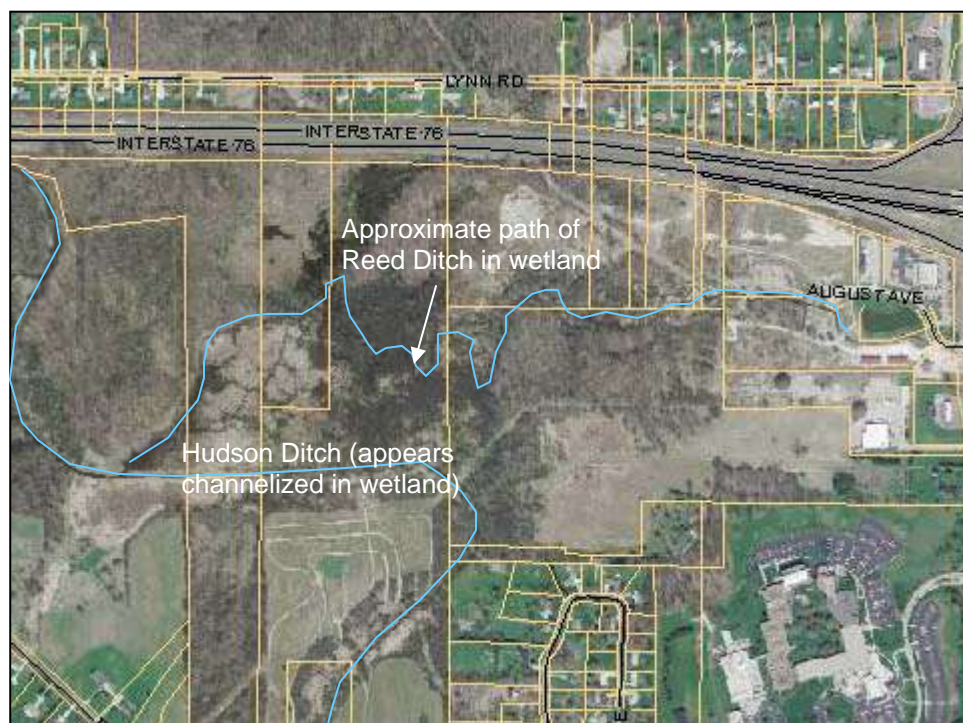
Wetland (dark blotchy area) at confluence of Reed and Hudson Ditches. This wetland may be helping buffer the effects of the ditches on Breakneck Creek immediately downstream.

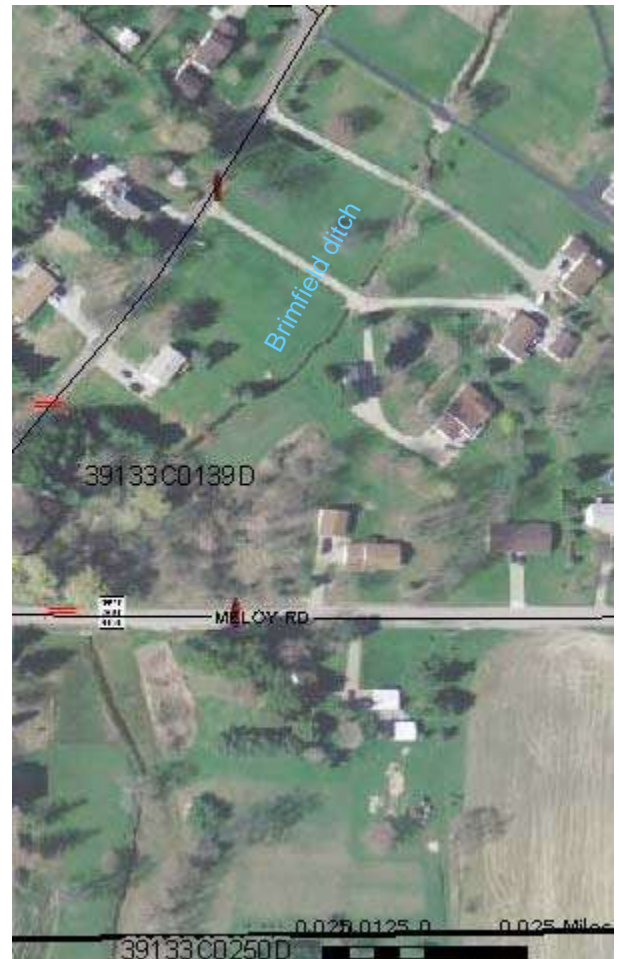
**B-780** Brimfield Ditch at Meloy. Upper left two photos, November and March, 2009. Right, 2006 aerial photo of Brimfield Ditch, which appears to be channelized, at Meloy Rd..

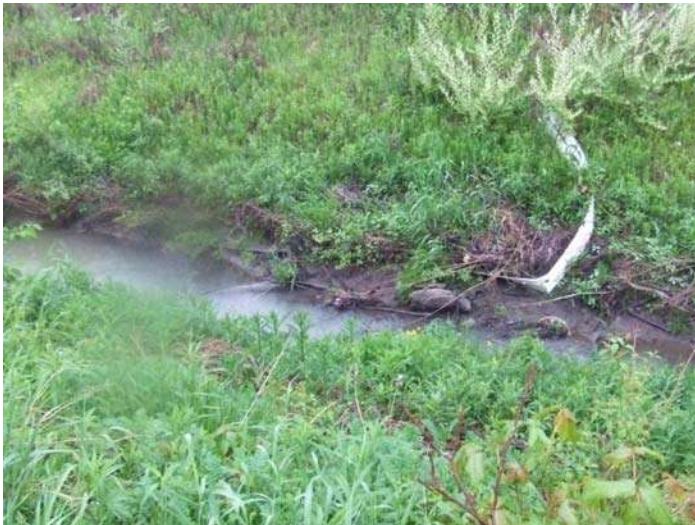
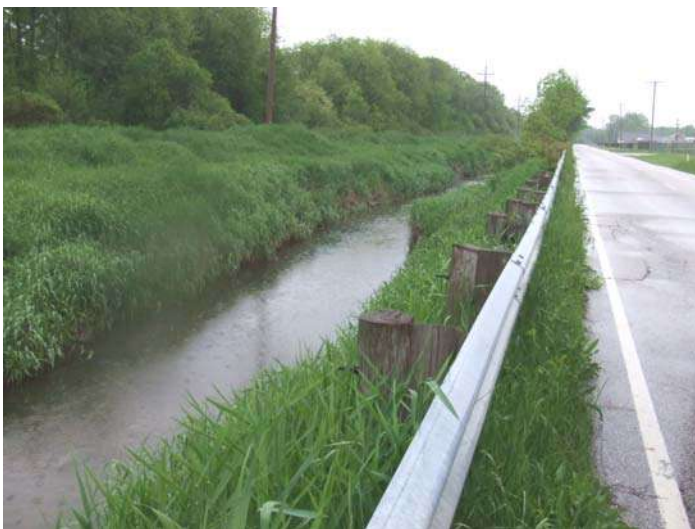
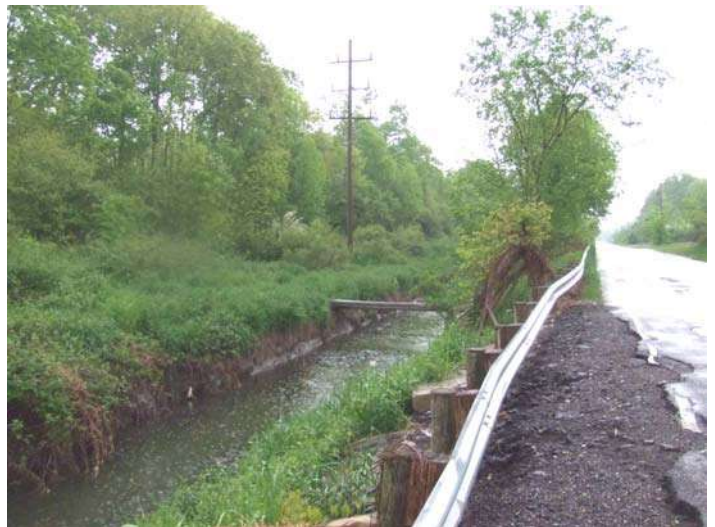
**B-151; 156; 157.** Hommon Ave. Ditch—(left) B-151—upstream of Ravenna Wastewater Treatment Plant; (lower left) B-156—downstream of wastewater treatment plant (WWTP in background right); and (below) B-157—where the bank and road appear to be eroding. Note high tension power lines in corridor, which would constrain channel reconstruction. May, 2011. Pics 25226, 30, 31

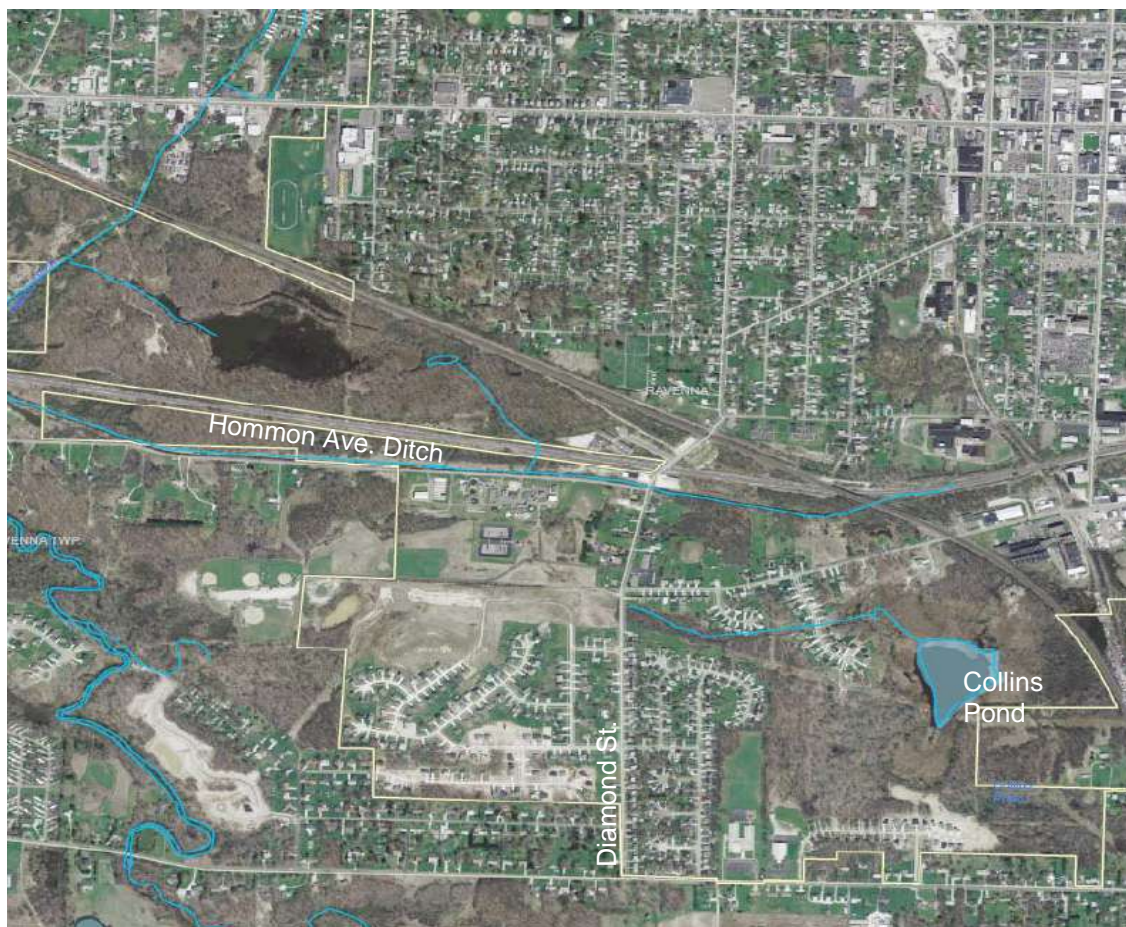
Collins Pond (highlighted in blue in lower right). Neighbors have noted flooding problems. Collins Pond outlet is culverted west of Diamond St. (see previous page). The pond is surrounded by wetlands and “D” (very poorly draining) soils, see photos below. The pond is also largely surrounded by impervious surfaces, which increases the runoff load to the pond and outlet channel. Hommon Ave. Ditch is in a channel between a road, the wastewater treatment plant, and a high tension utility line. It appears that toward the downstream end of the ditch, the embankment is eroding, threatening the road. The pond in the left center of the picture has increased in size and wetness since the early 1900s. Possible measures to consider, in addition to the City’s riparian setback, include setting aside land through easements, reducing or storing runoff from impervious surfaces, daylighting the outlet and restoring some flood storage. Source: Ohio DNR, PCRPC, 2006 Photo.

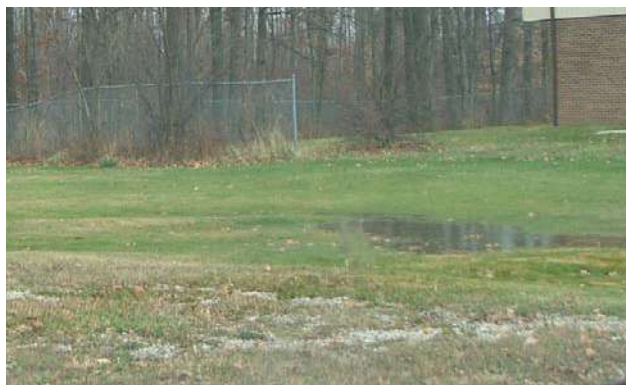
**B-170** Ponding in poorly draining soils near Collins Pond, Fox Run Rd., Nov. 2009.

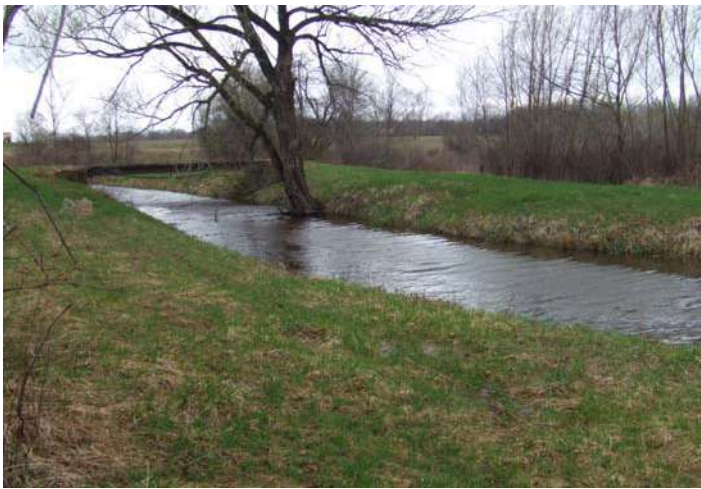
**B-660** Feeder Canal at Old Forge. Algae in April, nearby farms. April, 2011 . (Misnumbered as 550)

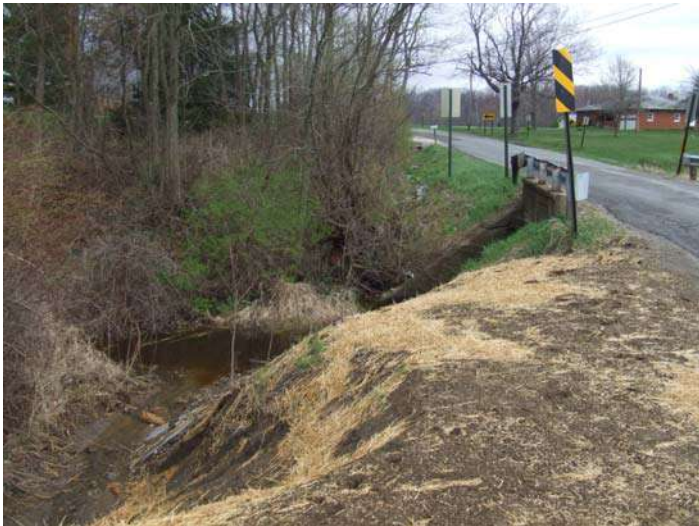
**B-650** Feeder Canal at Saxe Rd. Road ditch drains agricultural and large-lot residential land. April, 2011.

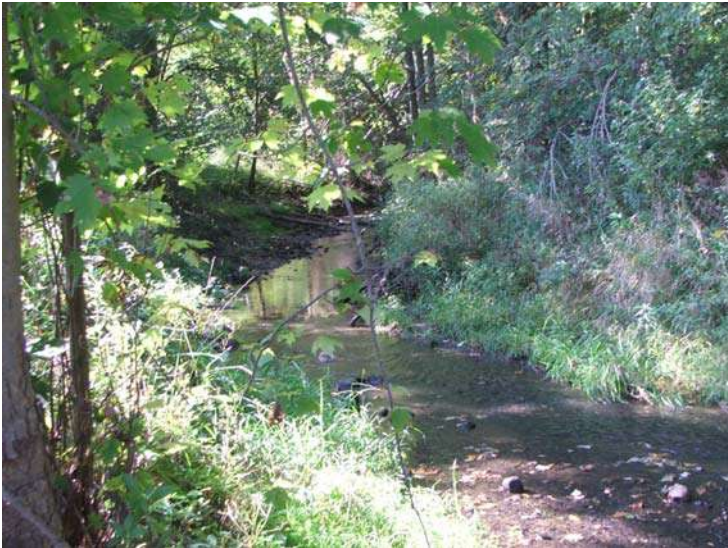
**Po-072** Upstream of potential over-wide ditch location, the channel has substantially recovered and received a good QHEI score. Oct. 2007.

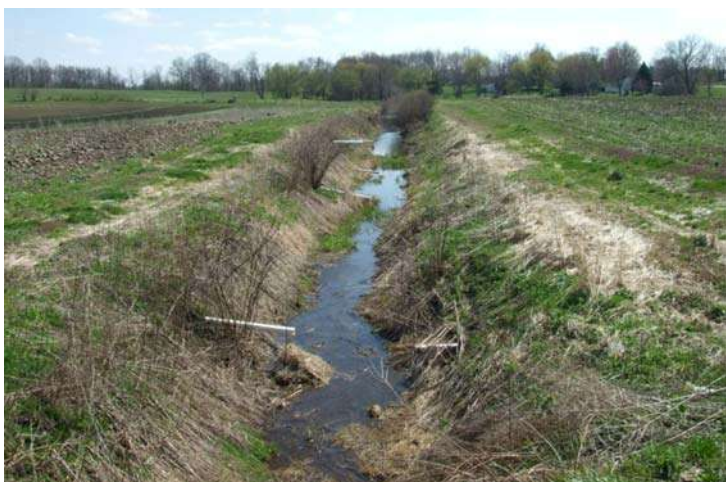
**Po-370** Redinger Ditch at Alexander Rd. Grassed buffer. Tile outlets apparent. Spring 2011.

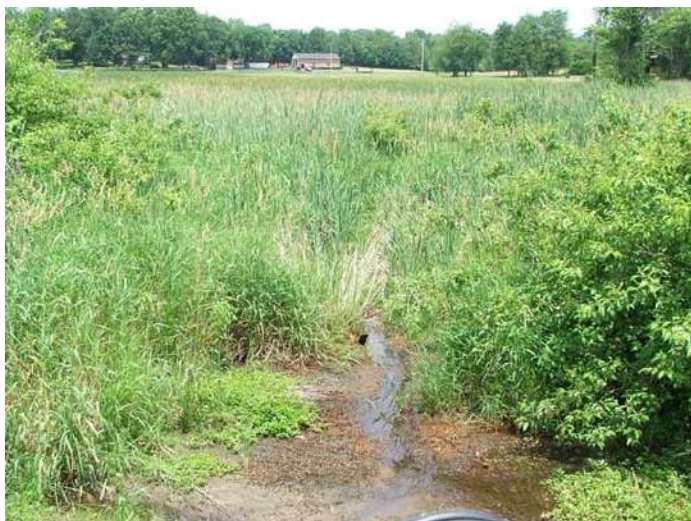
**Po-390** Redinger Ditch at Alexander (w). Typical of tributaries, agricultural use with varying widths of grassed buffer. July, 2010.
