Chapter 6 – Overview Water Quality and Watershed

6. Portage Lakes Water Quality and Watershed

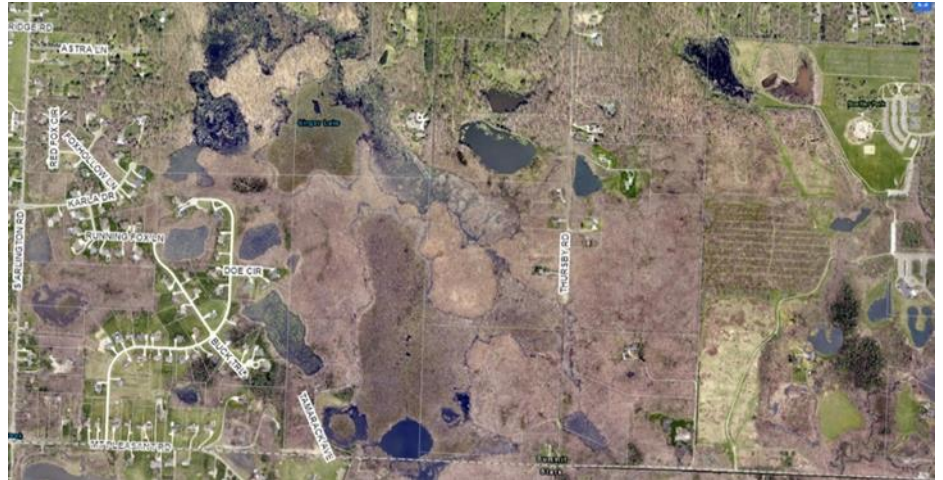
This area around Singer Lake has the kettle lakes, bogs, and other wetlands (darker land) of the ecoregion, as well as the developed uplands.

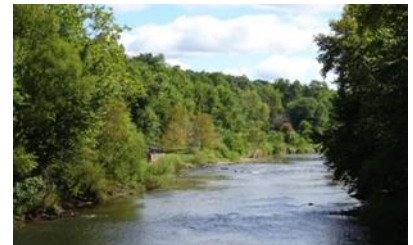
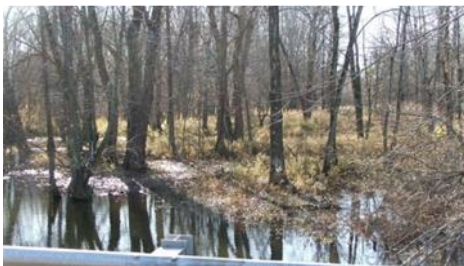
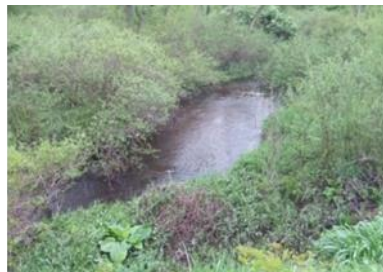
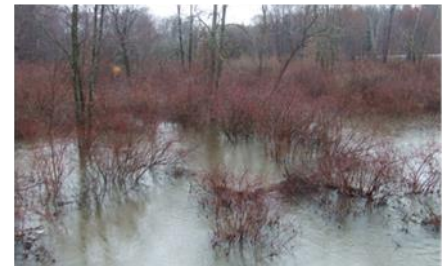
Landscapes providing benefits. Riparian vegetation, with its roots in the water, takes up nutrients and other contaminants and stabilizes streambanks. Floodplains and wetlands store floodwater, keeping it out of lakes and basements, take up nutrients, and allow sediment and associated contaminants to settle out, enriching the habitat.

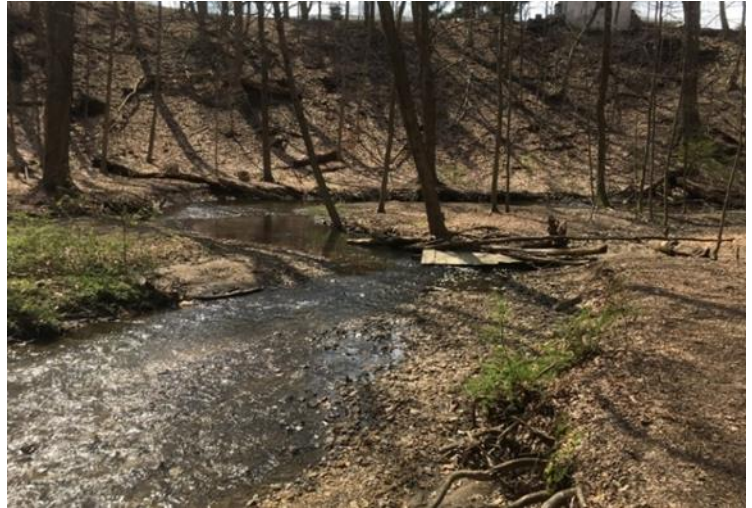
The stream channel form has developed in equilibrium with the slope, amount of water, and sediment coming in. The low gradient stream to the right meanders and shift horizontally but will maintain its vertical position, neither eroding nor silting in.

Meanders help regulate flow, allowing silt to be cleared out of channels in low flow and accommodating higher flows. The riffles (rough water over stones) and pools provide varied, habitats supporting various species. The flow over riffles adds oxygen.

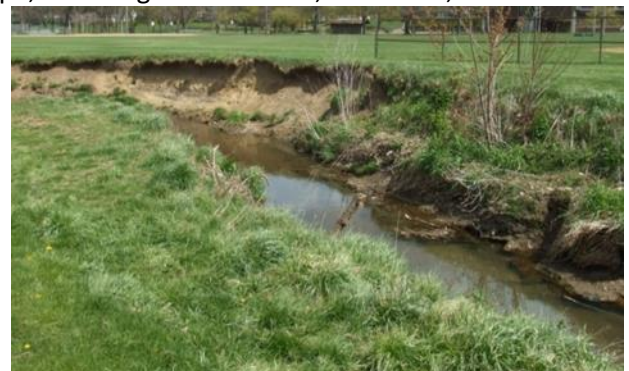
A developed watershed, decades of “mowing to the edge,” and altered stream slope resulted in this eroded, incised stream. The short, thin roots of turf offer little bank stability, flood reduction, or contaminant removal. With no accessible floodplain to store floods, the channel continues to erode, exacerbating a hazard, sediment and pollutant load, and habitat degradation.

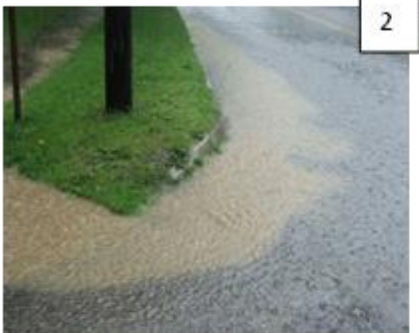
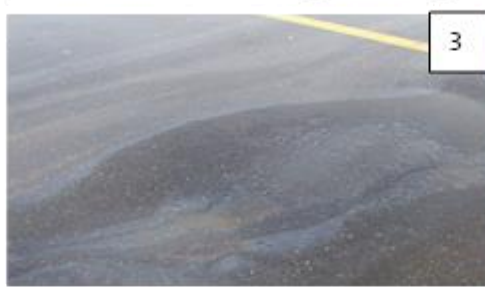
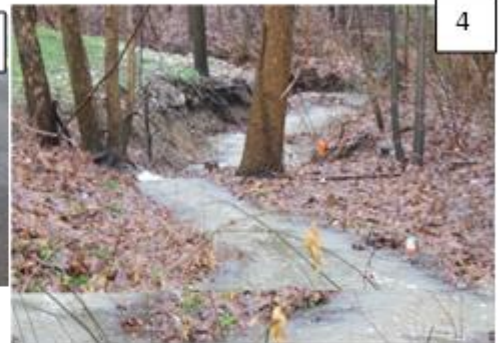
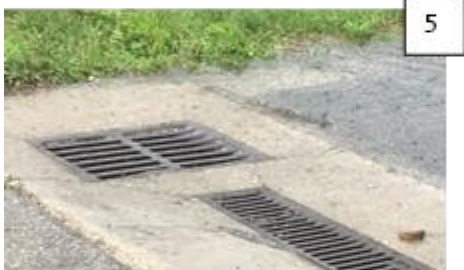
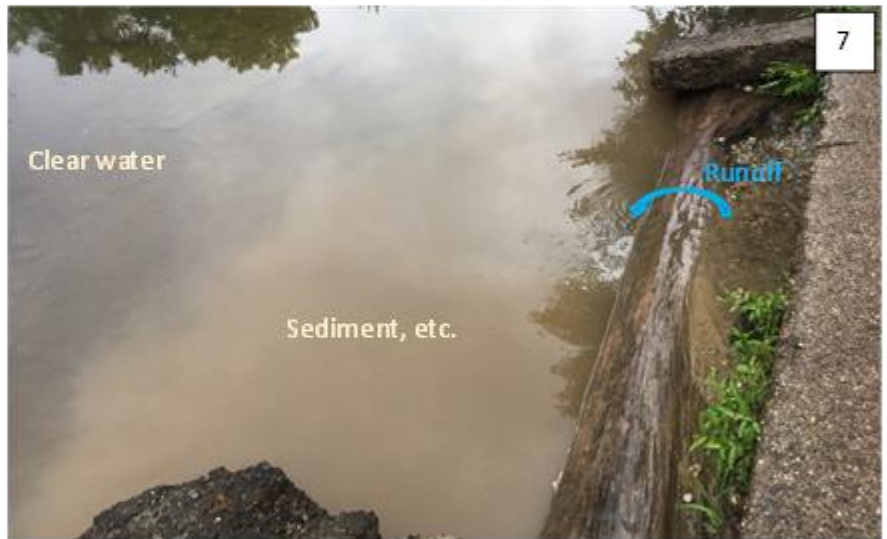
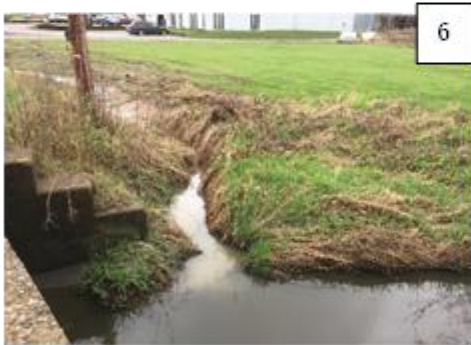
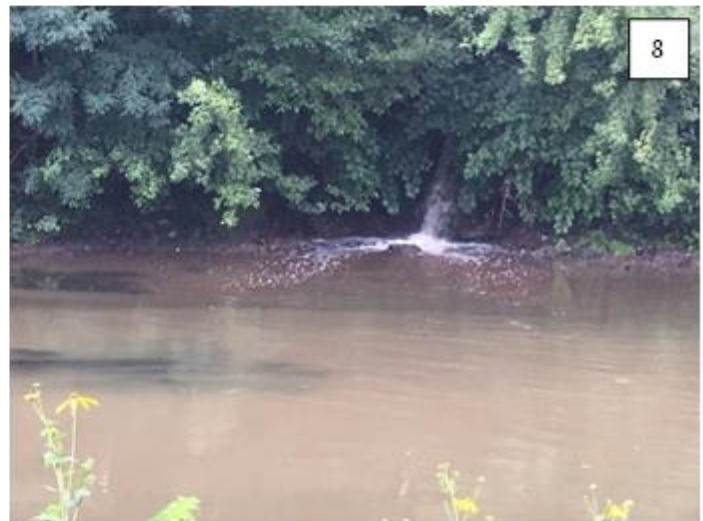
Figure 6.3 Hardened Landscape and Runoff

4 Excess water erodes channels deeper and wider, increasing sediment and everything attached to the sediment, reducing floodplain access, increasing downstream flooding, disrupting habitat, causing hazards. This torrent started off in small ditches along three neighborhood blocks with half-acre lots.

5-8 Runoff enters rivers and streams via storm drains and direct flow. 6 - Runoff entering the Upper Tuscarawas River. 7 - Sediment plume where runoff enters a river (stones are still visible in the clear water). 8 - Coalescing brown plumes show that runoff, laden with sediment and other contaminants, has entered the river from multiple sources, including a storm drain outfall.

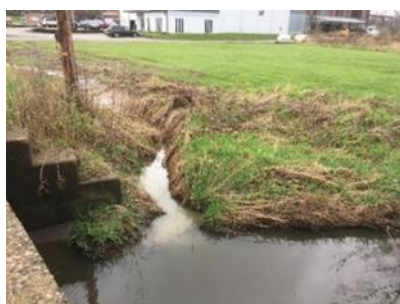
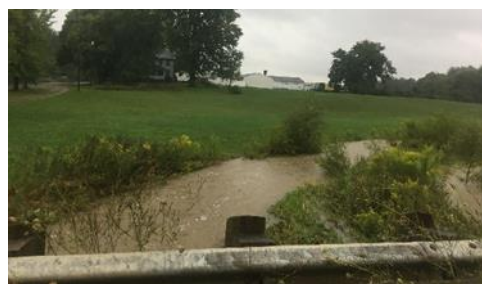
Riparian buffers in the watershed. Left, center – low quality riparian buffers (along the Tuscarawas River and Metzger ditch) are direct conduits for stormwater and contaminants, and lack protective vegetation and habitat. Right, well-vegetated riparian corridor protects streams, habitat, flood storage, and water quality.

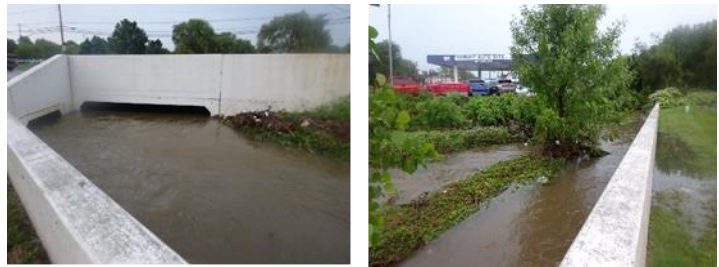
In highly altered Brewster Creek, a little extra room lets it spread out during high flow, reducing erosion, sediment transport, and downstream flooding. S. Main St.

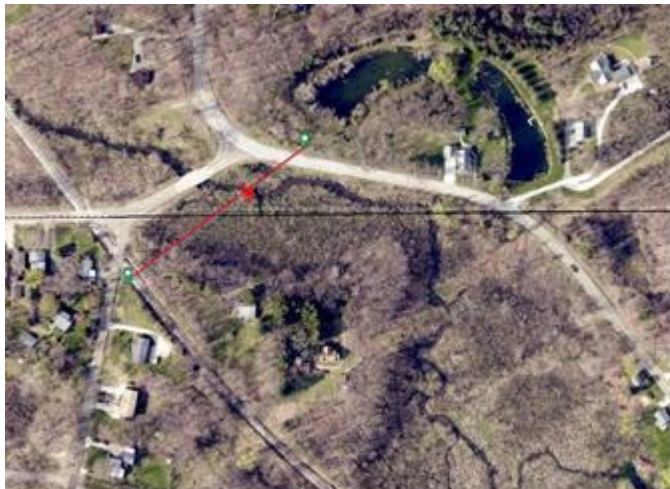
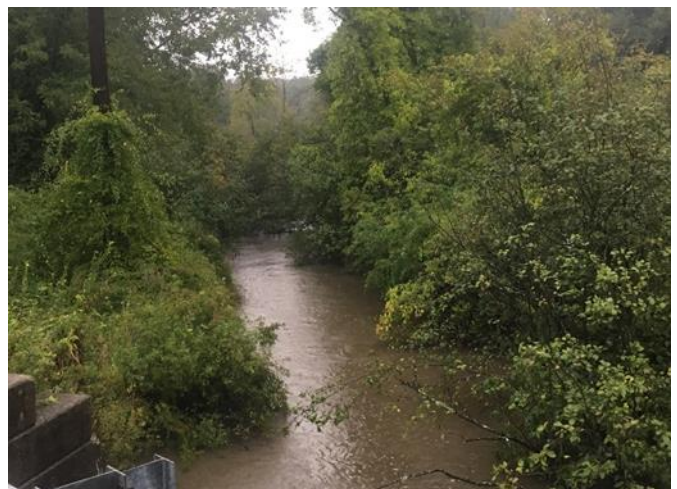
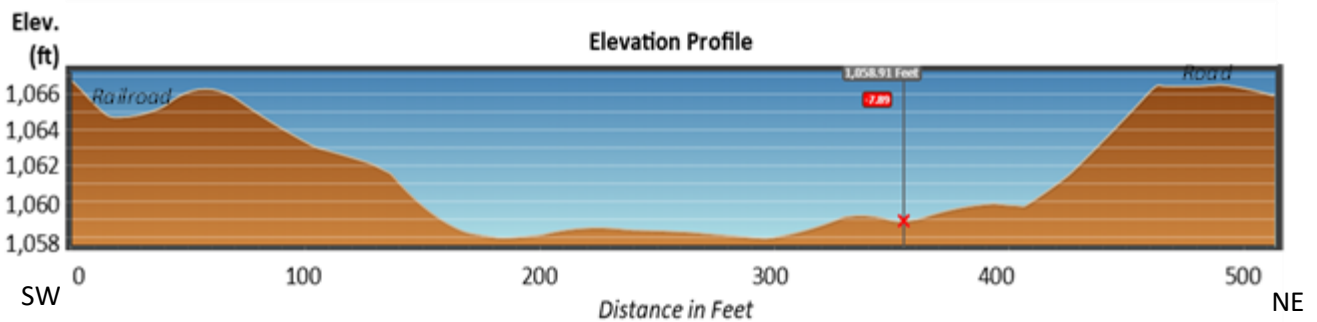
Figure 6.4 Wetlands, Flood Zones, and Floodplains along the Tuscarawas – Meversville Rd. Example

Streams, wetlands, and flood zones tend to coincide. Above left: potential wetlands identified using aerial photography overlain by hydric soils mapping. Wetlands are delineated in the field, using a combination of hydrology, vegetation, and soils. Mapping at this scale can only indicate potential wetlands – soil mapping is generalized, and does not show all the inclusions or gradations. If the landscape has been altered, it may no longer be wet. Above right: FEMA flood hazard zones overlain on the potential wetlands/hydric soil mapping. Below, the cross-section indicates that the tributary is within a broad, low-lying floodplain. The photograph was taken from the road crossing looking southeast. On this rainy day, the Tuscarawas flowed onto its floodplain, leaving water, silt, etc.

The Federal Emergency Management Agency has mapped *flood hazard zones*, areas with a certain risk per year of flooding, to provide information about flood risk to property owners, banks, and insurance agencies. (See examples, Figures 6.4 and 6.5.) Areas with a one percent risk per year are often known as “100 year” flood zones. However, a one percent risk of flood *per year* is 26 percent chance over the life of a 30-year mortgage that a property will be flooded in a severe event. *Flood hazard zones* may differ from natural *floodplains*. Flood hazard zones may extend beyond the functional, natural floodplain.

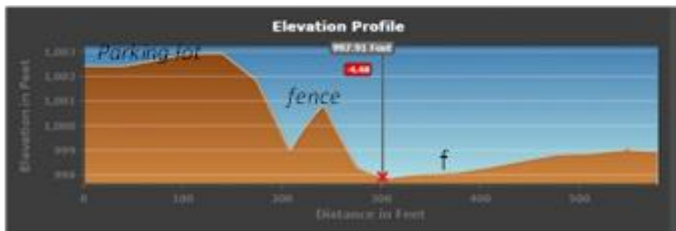
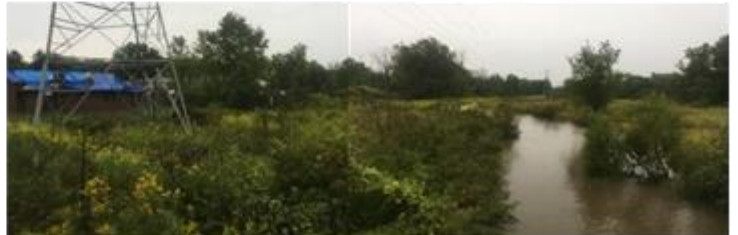
Figure 6.5
Altered Floodplain and Flood Zone

Altered Tuscarawas floodplain Arlington Rd. – The southern portion of the site is low-lying natural floodplain and is mapped as likely wetland. On the northern side, the building (b) is on filled land five feet above the natural floodplain. The 1% per year flood hazard zone extends up beyond the natural floodplain (f), past several buildings. When natural floodplain is filled, the water still goes somewhere, often up, putting buildings and people at risk. Buildings are permitted in the FEMA flood hazard zone if they follow the local requirements for the National Flood Insurance Program. The designated flood hazard zone can change over the years, with improved modeling, as more development upstream increases flooding downstream, and as people fill in the floodplain. This is likely an older use, pre-dating environmental rules.

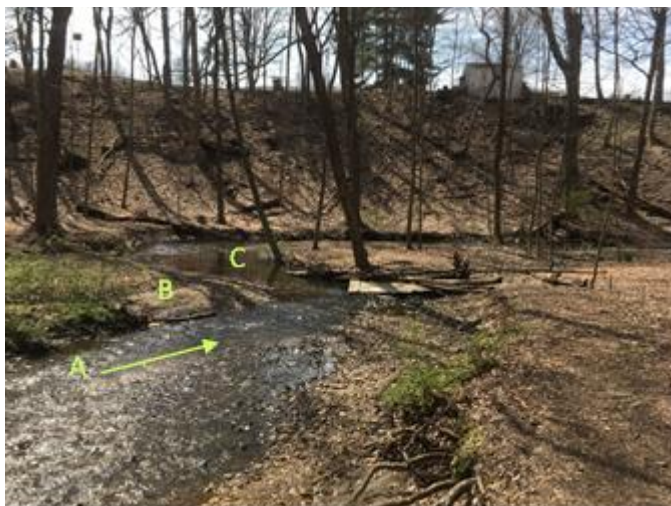
Wonder Lake Creek in Knapp Park shows many features of a healthy stream system. The sinuous form creates narrow areas of fast flow (thalweg, A), which clears out sediment during low flow. The wide, shallow channel accommodates high flow, which can also access the adjacent floodplain. The sinuosity slows down high flow. The substrate is stony, not silted in. It and the tree roots provide excellent habitat. The shallow riffles oxygenate the water and add to habitat. Cut banks due to the thalweg are on the outside of the curves and are paired with point bars (B), sediment deposited inside the curves in high flow. The smooth water in the background (C) may be a pool, increasing habitat diversity. Vegetation (greening up for spring) intercepts runoff, takes up nutrients, and stabilizes the banks.

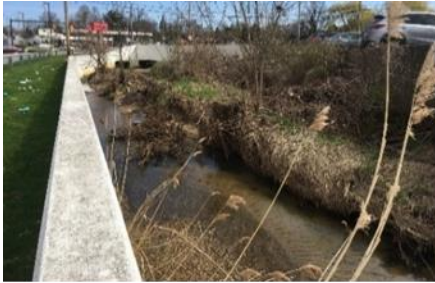
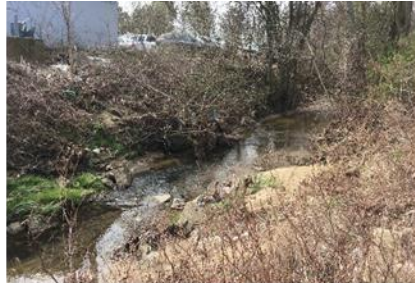
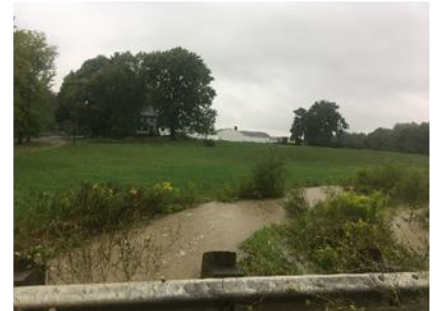
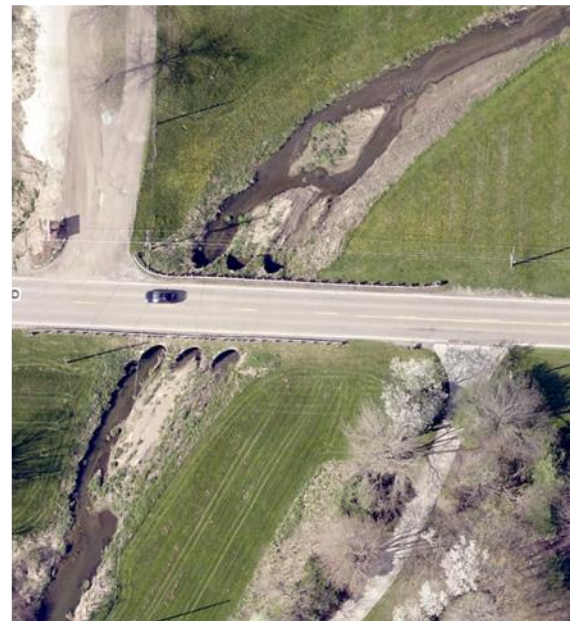
Above left, center - Brewster Creek flows through a highly impervious, watershed, generating heavy “flashy” flows. The banks and stream form have been altered, reinforced, straightened, and there is minimal functional floodplain. The habitat is degraded, banks erode, the creek is full of sediment, and high flows may cause urban flooding.

Above right and right – Metzger Ditch at Raber Rd. Ditches are carved to convey water quickly. Without meanders and accessible floodplain, they have no mechanism to slow down or release storm flow. Metzger/Myersville ditch, has been largely straightened, has minimal buffer, and flows through a densely developed area, which increases runoff. Stormwater races through the ditch in high flow, in an erosive torrent, through three culverts. The sediment deposits and the sediment plume in the channel demonstrate the high sediment load, which fills in stream habitat and receiving waters and carries nutrients, pathogens, and other contaminants.

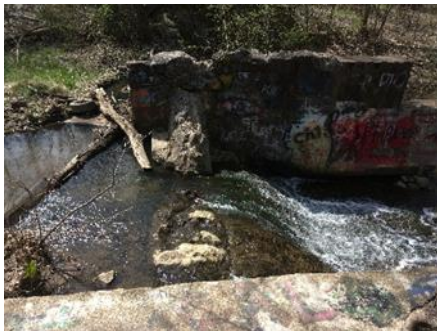
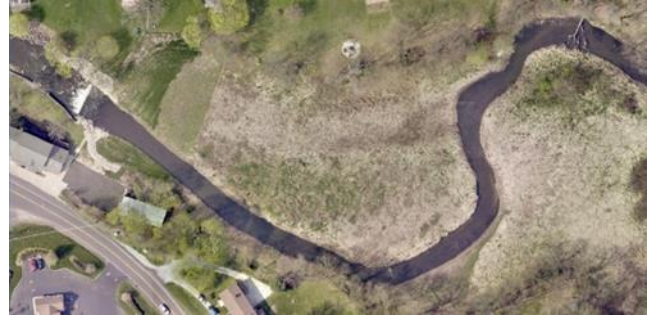
Old dams in the Portage Lakes watershed. As old dams are no longer used and fall into disrepair, it is worth evaluating whether to repair or lower/remove them. The latter improves the stream channel and water quality. Above, the water level behind Tritts Mill dam was lowered (temporarily) to reduce strain on the old dam. Image source Summit County Environmental Viewer. Left, Wonder Lake dam was lowered. The creek in the former dam pool area may be further restored.

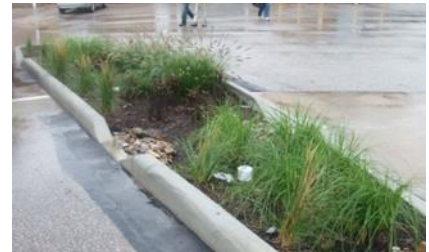
Bioinfiltration devices are similar to rain gardens but more highly engineered. They infiltrate and treat stormwater. Many are put in or next to parking lots to capture and treat stormwater. They are often connected to storm drain systems in case of high flow.

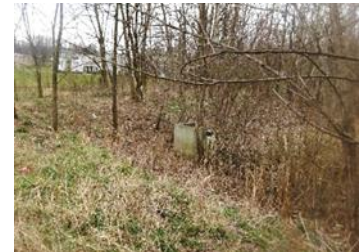
Detention basins/retention basins Stormwater regulations require developments to reduce the peak flow leaving the property, which has resulted in a lot of dry detention basins. These temporarily store water, and release them within a few hours. They provide minimal water quality benefits due to the short detention time, and may contribute to bank erosion, since high (not peak) flow continues for a longer period of time than pre-development conditions. Retention ponds or basins store the water on-site and may include wetland vegetation. These are more efficient at removing nutrients and binding other contaminants. These occasionally need to be cleared out. They are regulated as wetlands.

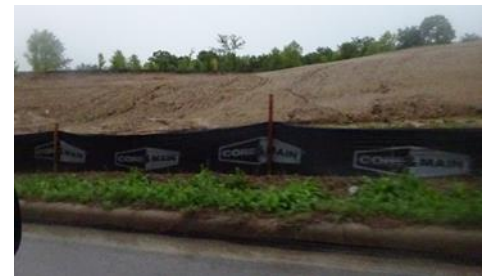
Containing contaminants – Silt fences are used on construction sites to contain disturbed sediment. Coir tubes or mats also can be used. Larger development sites often have sediment basins.
