## Chapter 6 – Overview Water Quality and Watershed

## 6. Portage Lakes Water Quality and Watershed

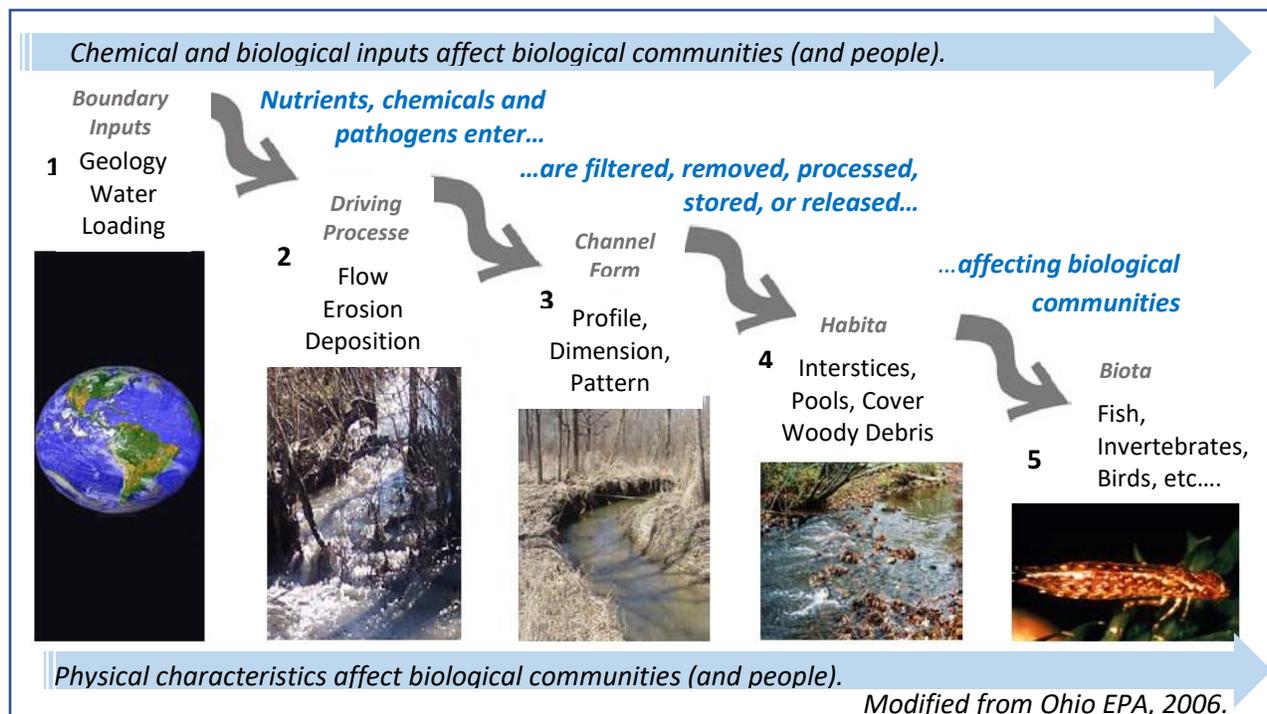
**Figure 6.1 Landscape Effects on Stream and Biota**

1. **Watershed conditions** affect loading of water, sediment, and contaminants into a stream
2. **The slope and load** affect flow, erosion, deposition,
3. **Flow, erosion and deposition** affect channel form, contaminants, and flood management
4. **Channel form** affects the habitat, oxygenation, channel stability (tendency to erode down or silt in), the connections to floodplain, and the sediment within the stream and channel
5. **The characteristics of the system**, from the watershed to the stream segment, affect the type of life that the stream will support.

This chapter presents the known water quality indicators in the context of the contributing watershed. Figure 6.1 illustrates that:<sup>3</sup>

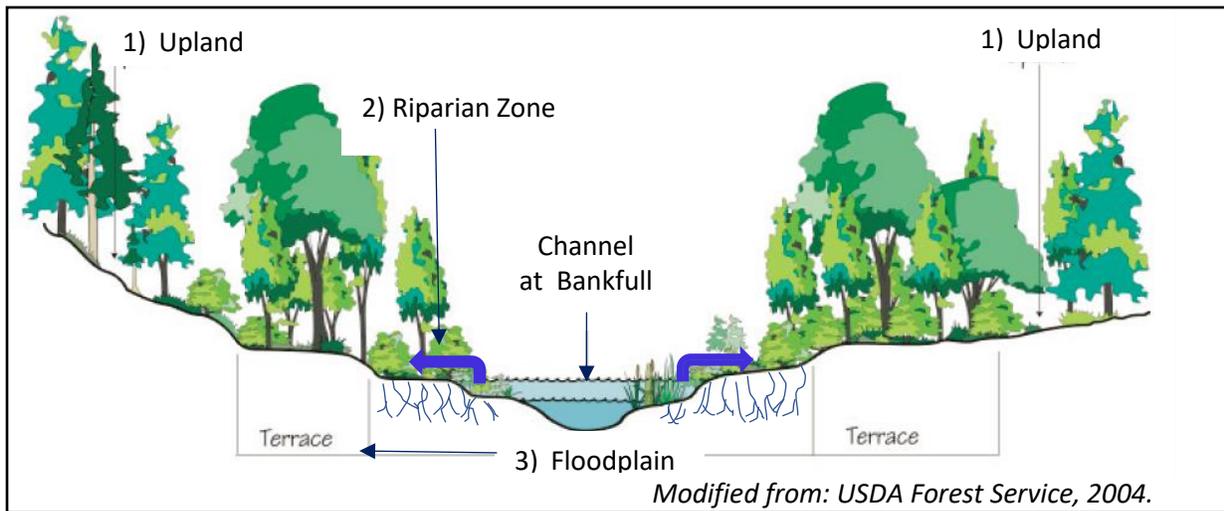
**Figure 6.2 Riparian Ecosystem Cross Section**

1. Upland woods and fields intercept and allow rain to infiltrate into the ground.
2. Wetlands, floodplains, and deep-rooted plants in the riparian (streamside) corridor slow and absorb storm water, take up nutrients, stabilize stream banks, and provide shade, cover, and important habitat. Riparian vegetation is water loving – the roots extend to where the groundwater flows into the stream, taking up nutrients or contaminants.
3. When a stream exceeds bankfull, it spills onto its floodplain, which acts like a safety valve, reducing stream flow and erosion during storms. Floodplains allow silt to settle out, keeping contaminants out of streams and lakes, and sustaining the floodplain habitat.

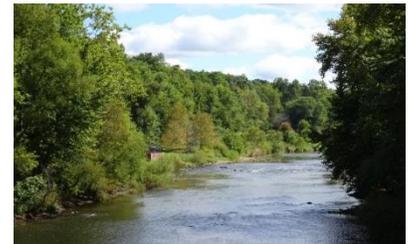
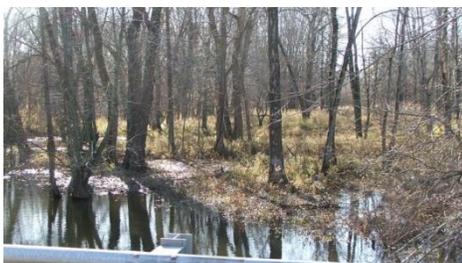
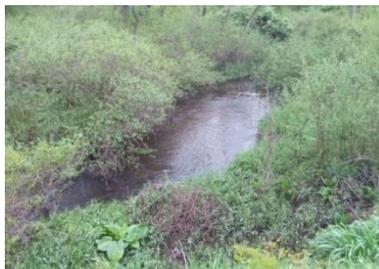
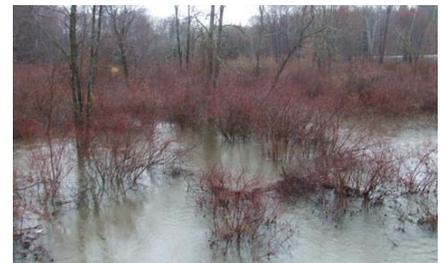
**Landscapes providing benefits.** Riparian vegetation, with its roots in the water, takes up nutrients and other contaminants and stabilizes streambanks. Floodplains and wetlands store floodwater, keeping it out of lakes and basements, take up nutrients, and allow sediment and associated contaminants to settle out, enriching the habitat.

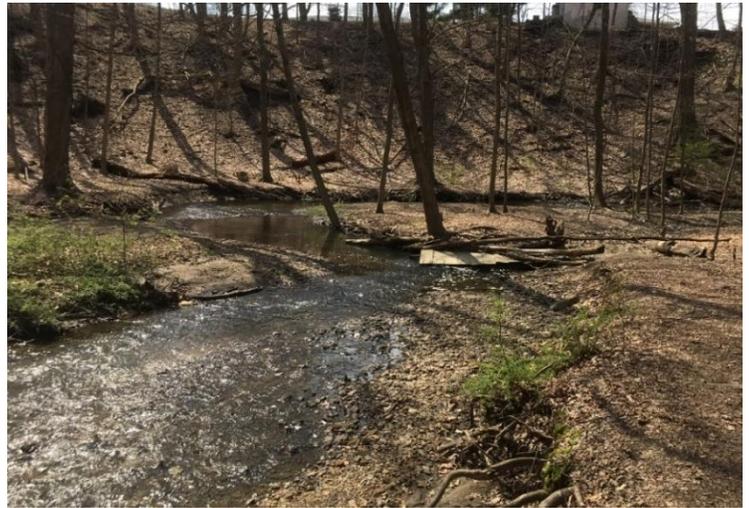
The stream channel form has developed in equilibrium with the slope, amount of water, and sediment coming in. The low gradient stream to the right meanders and shift horizontally but will maintain its vertical position, neither eroding nor silting in.

Meanders help regulate flow, allowing silt to be cleared out of channels in low flow and accommodating higher flows. The riffles (rough water over stones) and pools provide varied, habitats supporting various species. The flow over riffles adds oxygen.

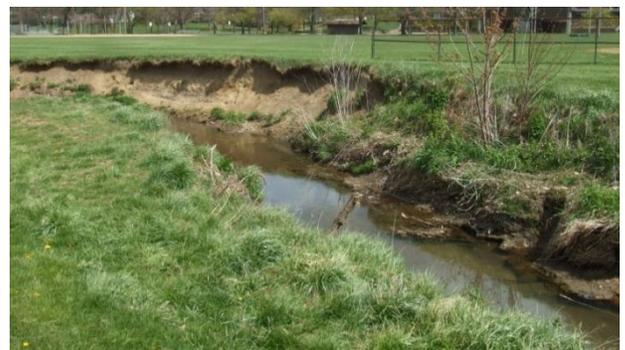
*A developed watershed, decades of “mowing to the edge,” and altered stream slope resulted in this eroded, incised stream. The short, thin roots of turf offer little bank stability, flood reduction, or contaminant removal. With no accessible floodplain to store floods, the channel continues to erode, exacerbating a hazard, sediment and pollutant load, and habitat degradation.*

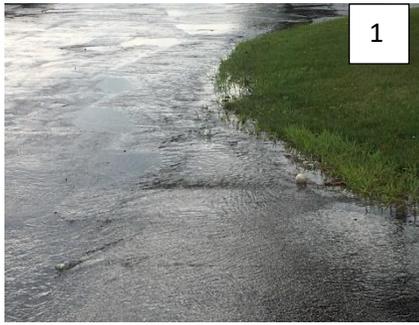
**Figure 6.3 Hardened Landscape and Runoff**

1 Rain runs off hardened surfaces, unvegetated landscape, and turf.  
 2 and 3 Runoff carries with it sediment, oil, toxic metals, chemicals, animal waste, pathogens, nutrients.  
 4 Excess water erodes channels deeper and wider, increasing sediment and everything attached to the sediment, reducing floodplain access, increasing downstream flooding, disrupting habitat, causing hazards. This torrent started off in small ditches along three neighborhood blocks with half-acre lots.

- Altering and hardening natural features increases the water that runs off the land, carrying contaminants from the agricultural and built landscape, including animal waste, chemicals, nutrients, metals, oil, and other toxins. (Figure 6.3)

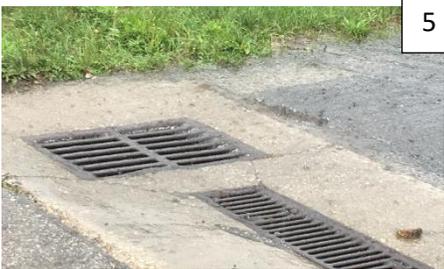
5

5-8 Runoff enters rivers and streams via storm drains and direct flow. 6 - Runoff entering the Upper Tuscarawas River. 7 - Sediment plume where runoff enters a river (stones are still visible in the clear water). 8 - Coalescing brown plumes show that runoff, laden with sediment and other contaminants, has entered the river from multiple sources, including a storm drain outfall.

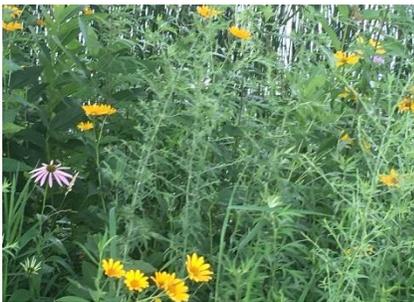
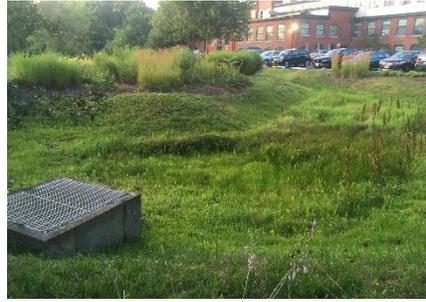
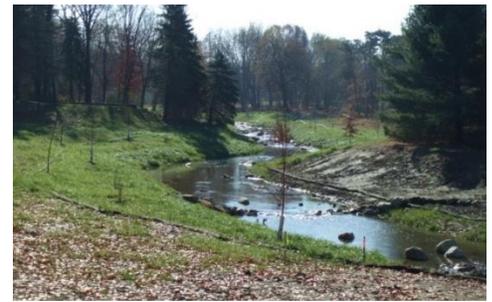
**Restoring natural landscape functions.** Best management practices range in scale and complexity, from replacing turf with native plants, shrubs, or trees, to addressing stormwater at the scale of a development or stream reach. Left - Deep-rooted native plants help rainwater infiltrate into the ground reducing runoff and taking up nutrients. Center – Stormwater detention basins temporarily store runoff. Vegetation, especially tall vegetation with deep roots, helps filter out, adsorb, and take up nutrients and other contaminants. Right – Stream channel restoration restores floodplains and meanders, improving flood storage, habitat, and resiliency of streams. Native plants planted along the riparian area will protect the stream. Restoration projects are typically protected by easements. With a range of costs, such projects can be funded privately, included in development requirements, or grant-funded.

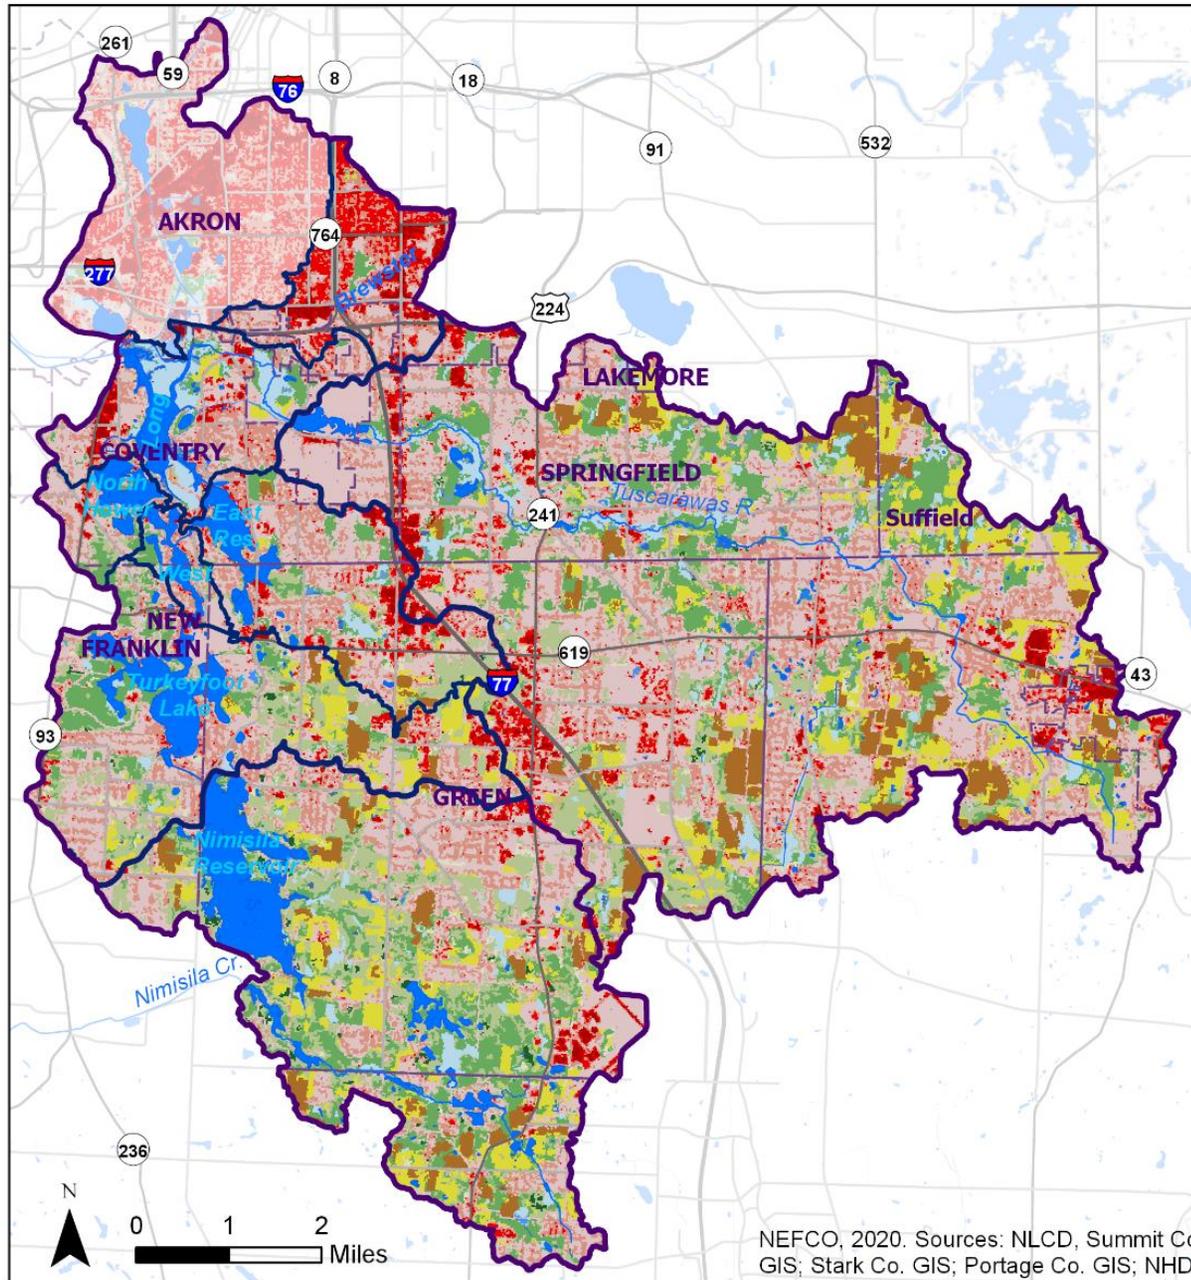
Map 6.2 Land Cover by Subwatershed

Land cover is mapped from aerial imagery and helps predict water quality impacts of the landscape. The Portage Lakes watershed is primarily altered by development and agriculture. Runoff from these landscapes can degrade water quality. Best management practices can reduce impacts.

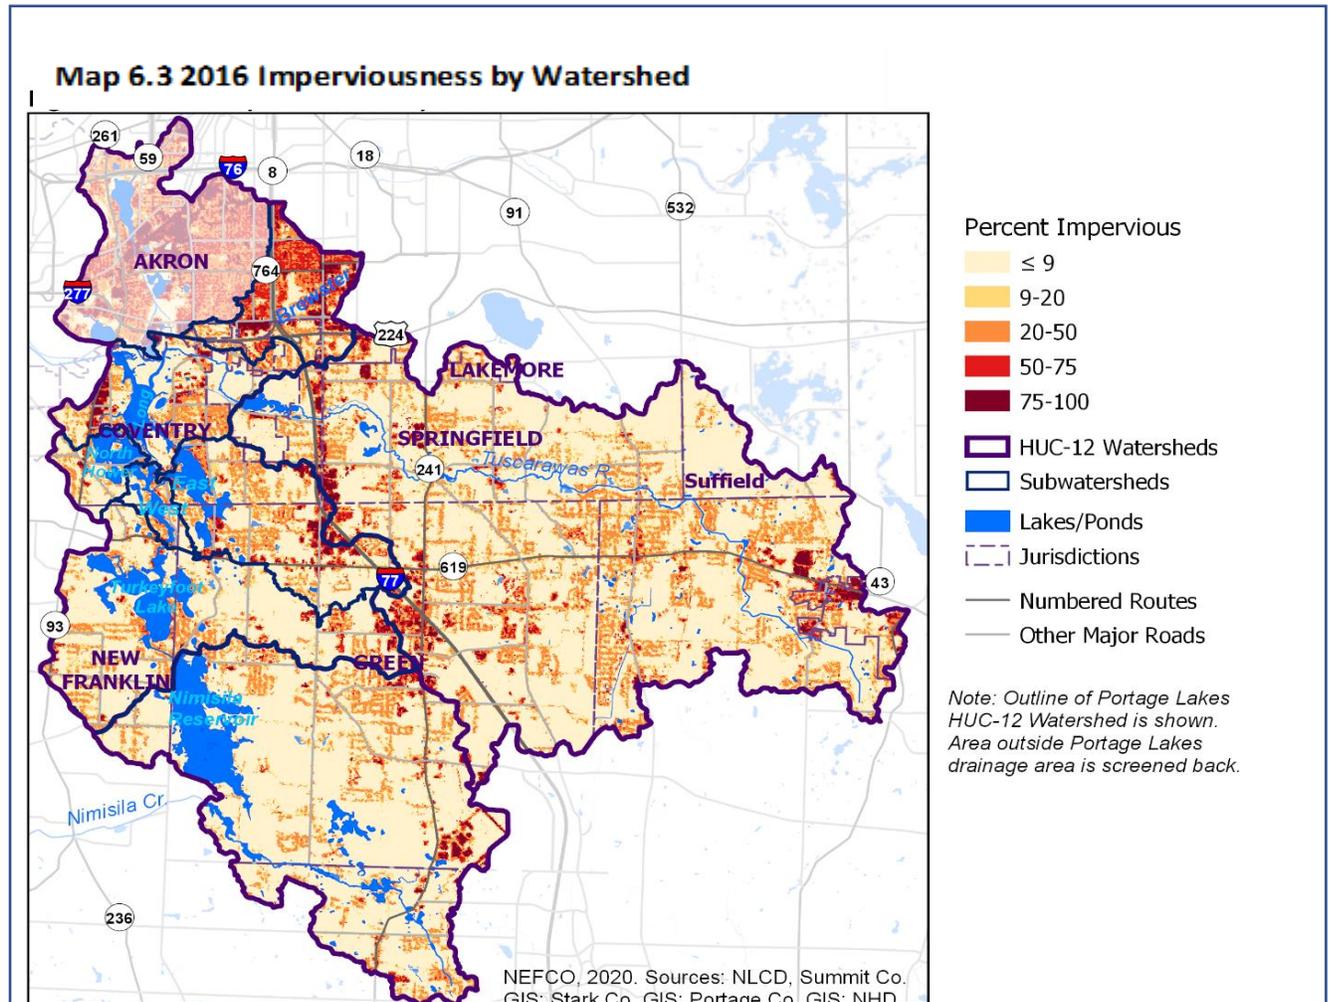
As shown on Map 6.3 and Table 6.3, imperviousness may lead to degraded streams in most watersheds:

- Most of the watersheds range from 13 to 20 percent impervious, making degradation likely.
- Turkeyfoot Lake watershed is over 10 percent impervious, and streams could start to degrade.
- Nimisila is under eight percent impervious. Depending on riparian vegetation and the effects of agriculture, many of the streams may still be relatively intact.
- Brewster Creek is highly impervious, reflecting its high degree of development.

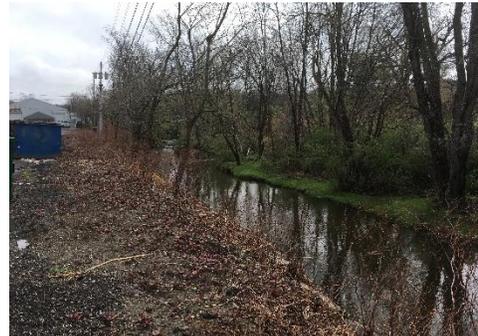
*The riparian buffer of the Tuscarawas River near Arlington Road would be evaluated using the width for larger streams (vegetation beyond 10 m). The near side is a highly disturbed riparian buffer - low score. The far side is well-vegetated - high score.*

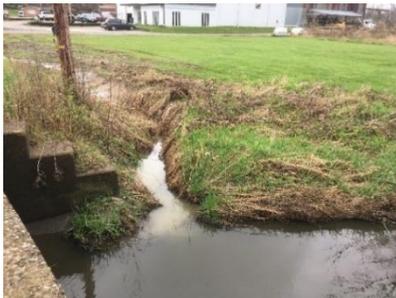
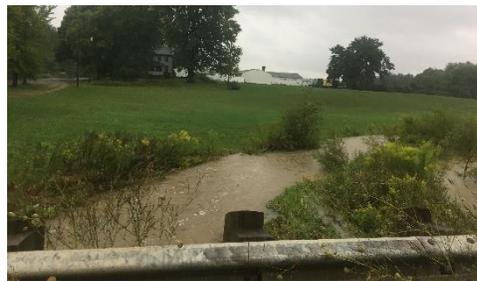
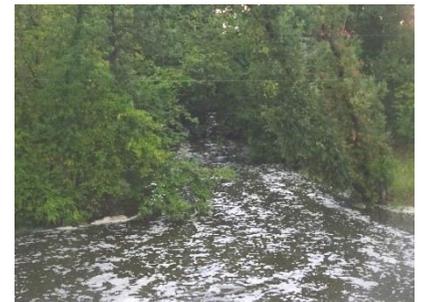
**Riparian buffers in the watershed.** Left, center – low quality riparian buffers (along the Tuscarawas River and Metzger ditch) are direct conduits for stormwater and contaminants, and lack protective vegetation and habitat. Right, well-vegetated riparian corridor protects streams, habitat, flood storage, and water quality.

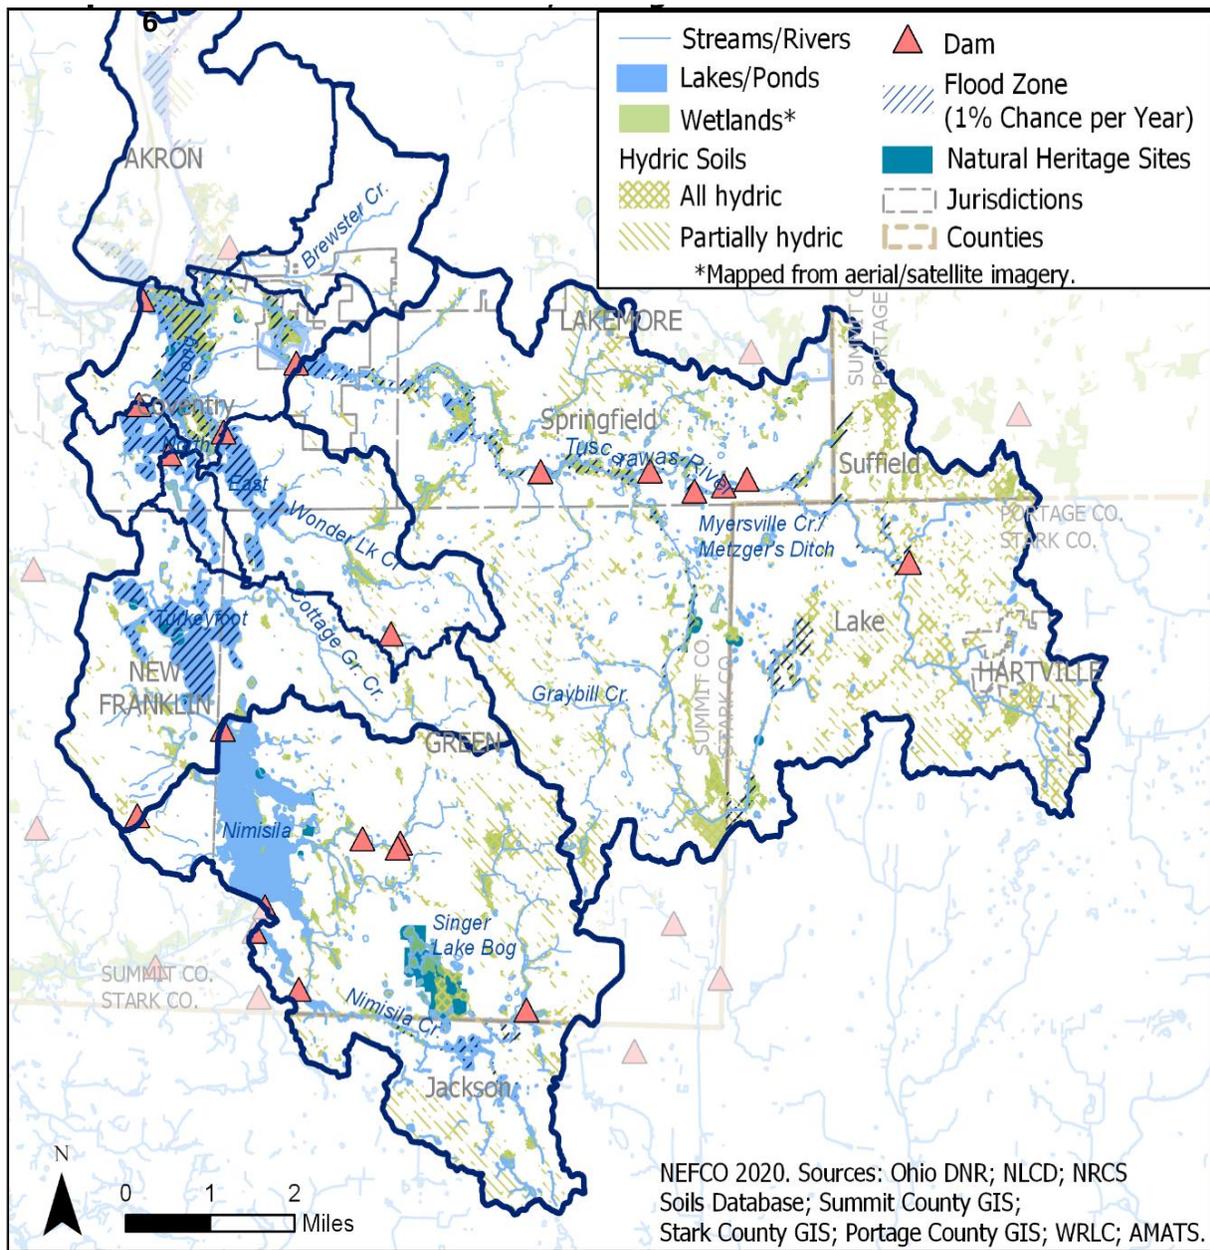
Map 6.7 Wetlands, Flood Zones, and Natural Heritage Areas, Portage Lakes Watershed

Wetlands, especially along streams and rivers, are one of the key landscape features protecting the health and functioning of streams, reducing impacts to the lakes. Map 6.7 shows potential wetland areas and flood zones, based on available mapping.

Map 6.7 shows flood hazard zones along many of the lakes, Tuscarawas River, and some large wetlands.<sup>13</sup> Floods in developed areas are hazardous to people and degrade streams and water quality, especially where toxic materials could enter the water. Flood hazard areas are mapped using models and topographic mapping. Delineation of requires field work to determine how far the stream can spill out onto the nearby land. Floodplains and flood hazard zones are best left undisturbed if possible.

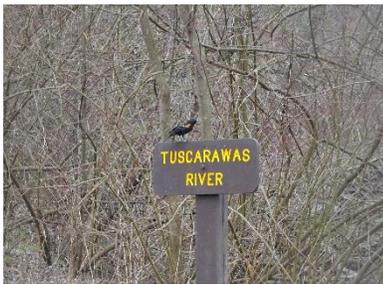
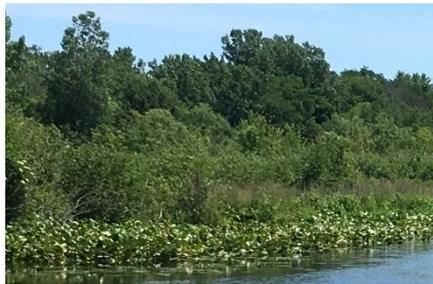
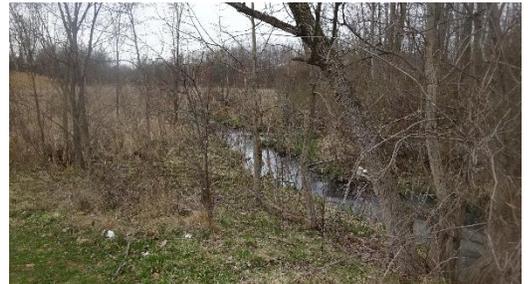
Left - The land surrounding the Tuscarawas River in Firestone Metro Park is mapped as likely wetland. Center – wetlands by Long Lake. Right – this wetland in a developed setting, affected by invasive *Phragmites* reeds, may have a less diverse/high quality habitat, but it still provides tremendous flood management and water quality benefits.

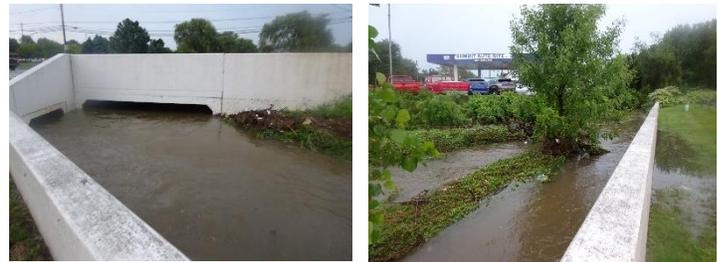
*In highly altered Brewster Creek, a little extra room lets it spread out during high flow, reducing erosion, sediment transport, and downstream flooding. S. Main St.*

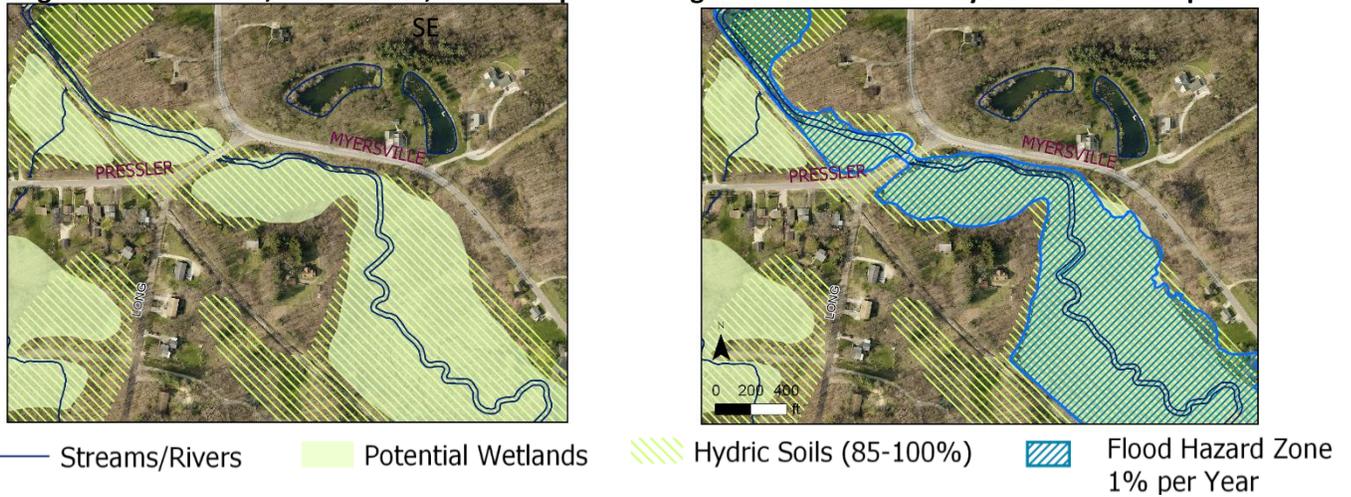
Figure 6.4 Wetlands, Flood Zones, and Floodplains along the Tuscarawas – Meyersville Rd. Example

Streams, wetlands, and flood zones tend to coincide. Above left: potential wetlands identified using aerial photography overlain by hydric soils mapping. Wetlands are delineated in the field, using a combination of hydrology, vegetation, and soils. Mapping at this scale can only indicate potential wetlands – soil mapping is generalized, and does not show all the inclusions or gradations. If the landscape has been altered, it may no longer be wet. Above right: FEMA flood hazard zones overlain on the potential wetlands/hydric soil mapping. Below, the cross-section indicates that the tributary is within a broad, low-lying floodplain. The photograph was taken from the road crossing looking southeast. On this rainy day, the Tuscarawas flowed onto its floodplain, leaving water, silt, etc.

The Federal Emergency Management Agency has mapped *flood hazard zones*, areas with a certain risk per year of flooding, to provide information about flood risk to property owners, banks, and insurance agencies. (See examples, Figures 6.4 and 6.5.) Areas with a one percent risk per year are often known as “100 year” flood zones. However, a one percent risk of flood *per year* is *26 percent chance* over the life of a 30-year mortgage that a property will be flooded in a severe event. *Flood hazard zones* may differ from natural *floodplains*. Flood hazard zones may extend beyond the functional, natural floodplain.

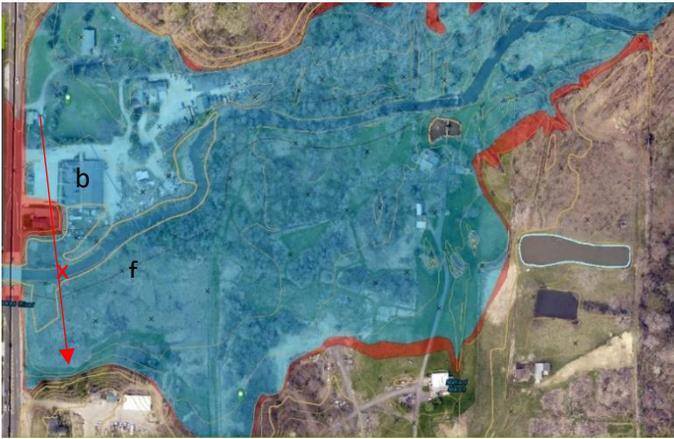
**Figure 6.5**  
**Altered Floodplain and Flood Zone**

*Altered Tuscarawas floodplain Arlington Rd. – The southern portion of the site is low-lying natural floodplain and is mapped as likely wetland. On the northern side, the building (b) is on filled land five feet above the natural floodplain. The 1% per year flood hazard zone extends up beyond the natural floodplain (f), past several buildings. When natural floodplain is filled, the water still goes somewhere, often up, putting buildings and people at risk. Buildings are permitted in the FEMA flood hazard zone if they follow the local requirements for the National Flood Insurance Program. The designated flood hazard zone can change over the years, with improved modeling, as more development upstream increases flooding downstream, and as people fill in the floodplain. This is likely an older use, pre-dating environmental rules.*

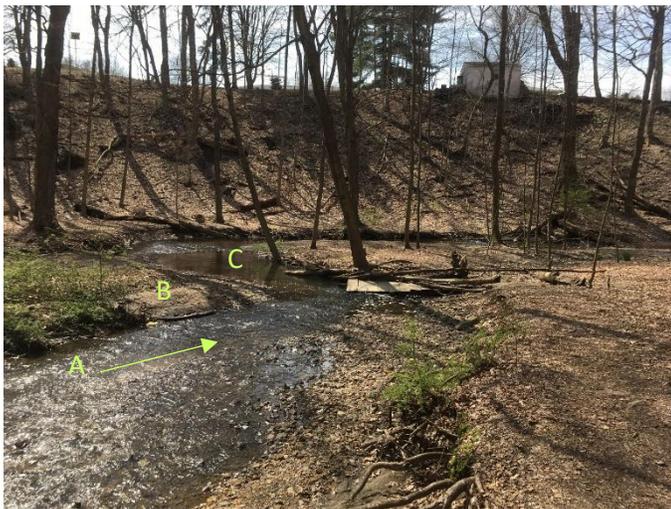
*Wonder Lake Creek in Knapp Park shows many features of a healthy stream system. The sinuous form creates narrow areas of fast flow (thalweg, A), which clears out sediment during low flow. The wide, shallow channel accommodates high flow, which can also access the adjacent floodplain. The sinuosity slows down high flow. The substrate is stony, not silted in. It and the tree roots provide excellent habitat. The shallow riffles oxygenate the water and add to habitat. Cut banks due to the thalweg are on the outside of the curves and are paired with point bars (B), sediment deposited inside the curves in high flow. The smooth water in the background (C) may be a pool, increasing habitat diversity. Vegetation (greening up for spring) intercepts runoff, takes up nutrients, and stabilizes the banks.*

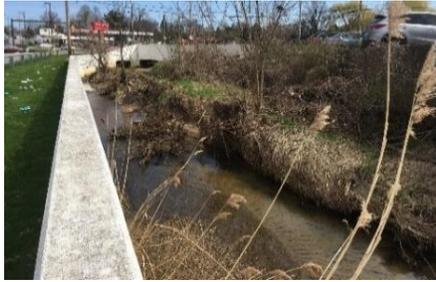
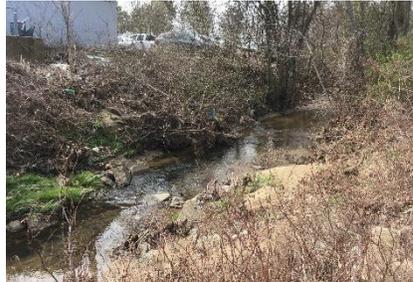
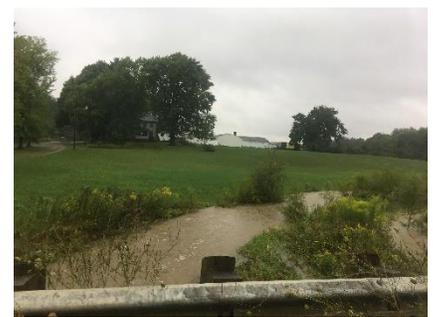
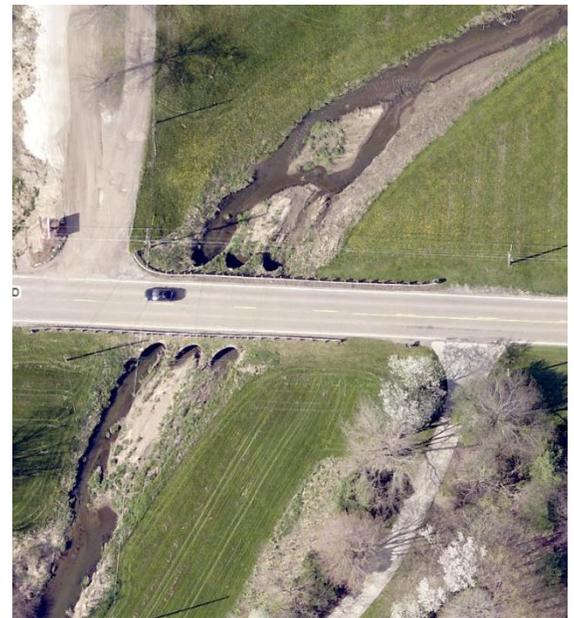
*Above left, center - Brewster Creek flows through a highly impervious, watershed, generating heavy “flashy” flows. The banks and stream form have been altered, reinforced, straightened, and there is minimal functional floodplain. The habitat is degraded, banks erode, the creek is full of sediment, and high flows may cause urban flooding.*

*Above right and right – Metzger Ditch at Raber Rd. Ditches are carved to convey water quickly. Without meanders and accessible floodplain, they have no mechanism to slow down or release storm flow. Metzger/Myersville ditch, has been largely straightened, has minimal buffer, and flows through a densely developed area, which increases runoff. Stormwater races through the ditch in high flow, in an erosive torrent, through three culverts. The sediment deposits and the sediment plume in the channel demonstrate the high sediment load, which fills in stream habitat and receiving waters and carries nutrients, pathogens, and other contaminants.*

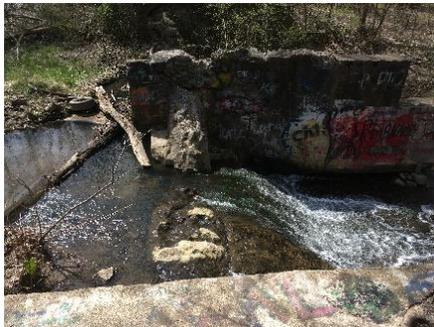
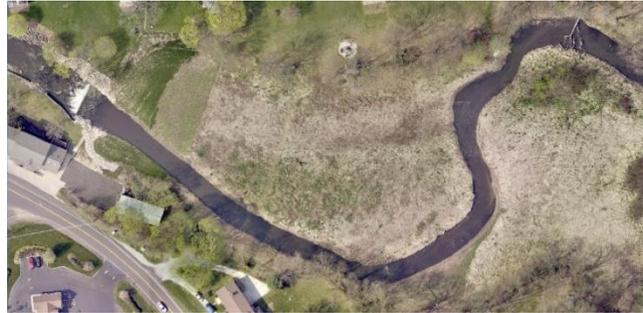
**Old dams in the Portage Lakes watershed.** As old dams are no longer used and fall into disrepair, it is worth evaluating whether to repair or lower/remove them. The latter improves the stream channel and water quality. Above, the water level behind Tritts Mill dam was lowered (temporarily) to reduce strain on the old dam. Image source Summit County Environmental Viewer. Left, Wonder Lake dam was lowered. The creek in the former dam pool area may be further restored.

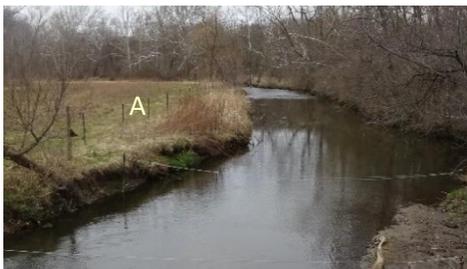
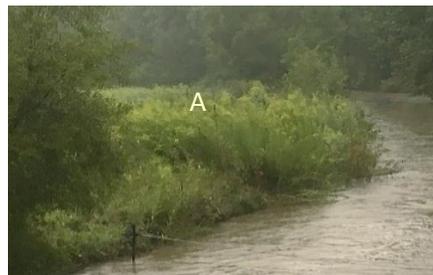
*Fencing agricultural fields (A) is an effective way to keep livestock off most of the bank and protects the streambank from erosion.*

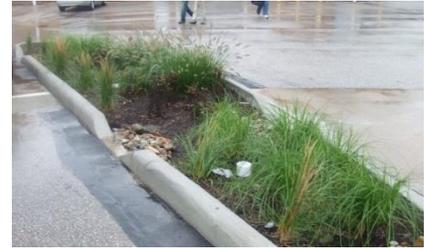
**Bioinfiltration** devices are similar to rain gardens but more highly engineered. They infiltrate and treat stormwater. Many are put in or next to parking lots to capture and treat stormwater. They are often connected to storm drain systems in case of high flow.

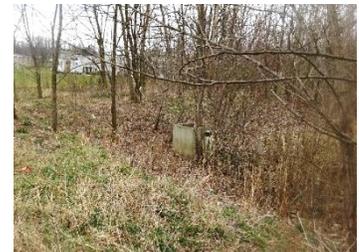
**Detention basins/retention basins** Stormwater regulations require developments to reduce the peak flow leaving the property, which has resulted in a lot of dry detention basins. These temporarily store water, and release them within a few hours. They provide minimal water quality benefits due to the short detention time, and may contribute to bank erosion, since high (not peak) flow continues for a longer period of time than pre-development conditions. Retention ponds or basins store the water on-site and may include wetland vegetation. These are more efficient at removing nutrients and binding other contaminants. These occasionally need to be cleared out. They are regulated as wetlands.

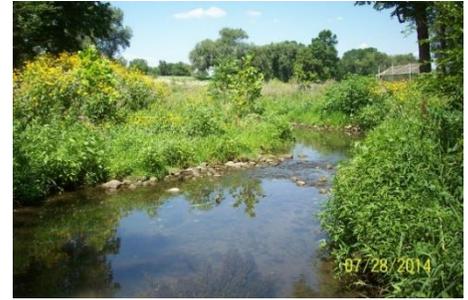
*Formerly incised stream, with restored channel and floodplain. Photo source: R. McCleary, 2014.*

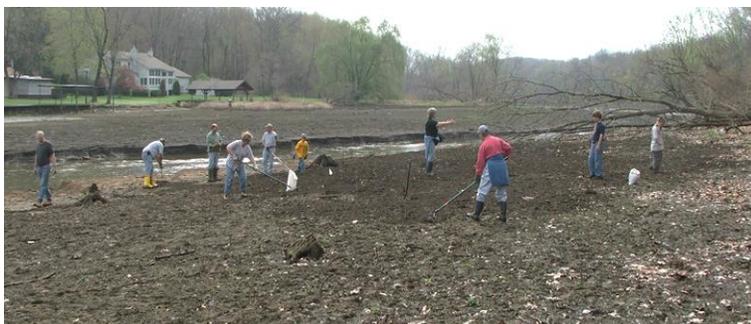
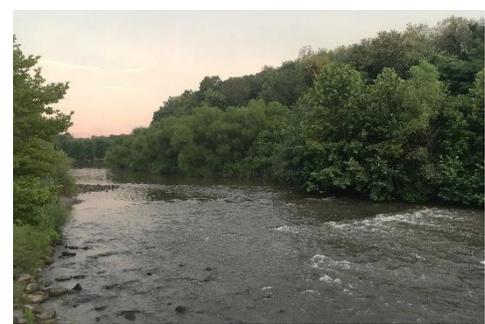
*Left - Volunteers planting a former dam pool. Right – View of the bank they planted several years later.*
