Chapter 6 – Overview

Water Quality and Watershed

6. Portage Lakes Water Quality and Watershed

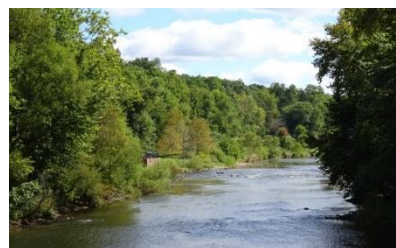
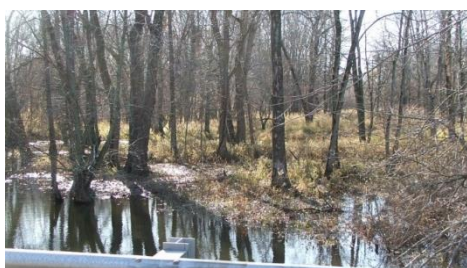
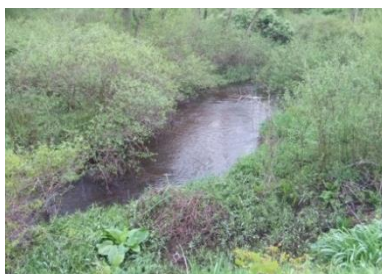
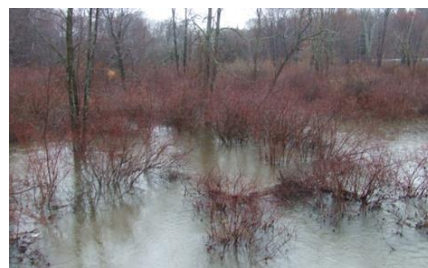
Landscapes providing benefits. Riparian vegetation, with its roots in the water, takes up nutrients and other contaminants and stabilizes streambanks. Floodplains and wetlands store floodwater, keeping it out of lakes and basements, take up nutrients, and allow sediment and associated contaminants to settle out, enriching the habitat.

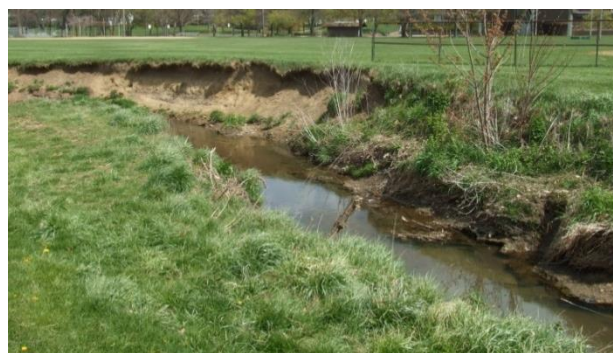
A developed watershed, decades of “mowing to the edge,” and altered stream slope resulted in this eroded, incised stream. The short, thin roots of turf offer little bank stability, flood reduction, or contaminant removal. With no accessible floodplain to store floods, the channel continues to erode, exacerbating a hazard, sediment and pollutant load, and habitat degradation.

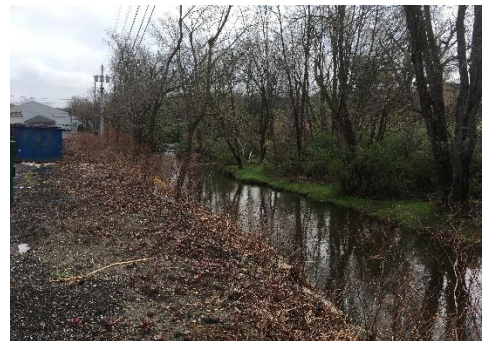
The riparian buffer of the Tuscarawas River near Arlington Road would be evaluated using the width for larger streams (vegetation beyond 10 m). The near side is a highly disturbed riparian buffer - low score. The far side is well-vegetated - high score.

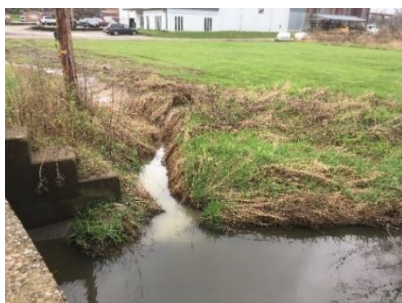
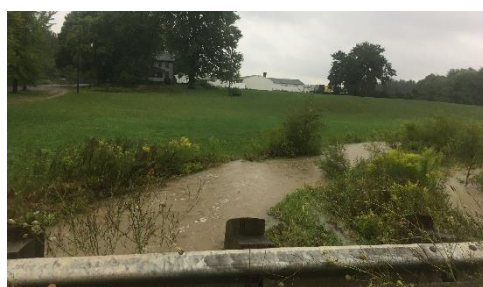
Riparian buffers in the watershed. Left, center – low quality riparian buffers (along the Tuscarawas River and Metzger ditch) are direct conduits for stormwater and contaminants, and lack protective vegetation and habitat. Right, well-vegetated riparian corridor protects streams, habitat, flood storage, and water quality.

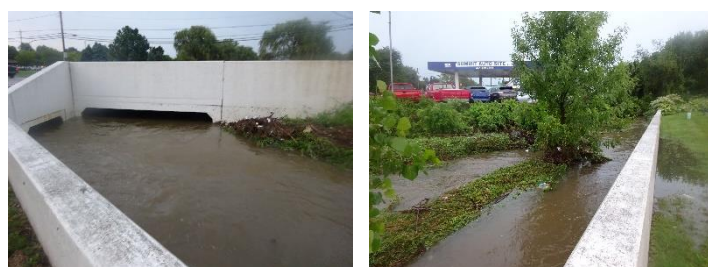
In highly altered Brewster Creek, a little extra room lets it spread out during high flow, reducing erosion, sediment transport, and downstream flooding. S. Main St.

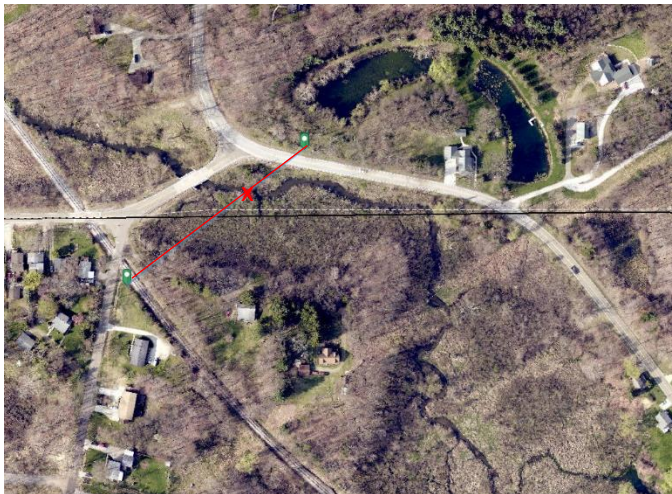
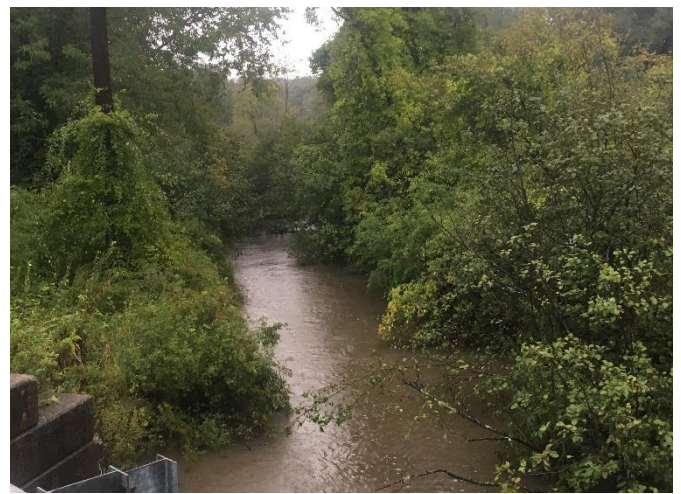
Figure 6.4 Wetlands, Flood Zones, and Floodplains along the Tuscarawas – Meyersville Rd. Example

Streams, wetlands, and flood zones tend to coincide. Above left: potential wetlands identified using aerial photography overlain by hydric soils mapping. Wetlands are delineated in the field, using a combination of hydrology, vegetation, and soils. Mapping at this scale can only indicate potential wetlands – soil mapping is generalized, and does not show all the inclusions or gradations. If the landscape has been altered, it may no longer be wet. Above right: FEMA flood hazard zones overlain on the potential wetlands/hydric soil mapping. Below, the cross-section indicates that the tributary is within a broad, low-lying floodplain. The photograph was taken from the road crossing looking southeast. On this rainy day, the Tuscarawas flowed onto its floodplain, leaving water, silt, etc.

The Federal Emergency Management Agency has mapped *flood hazard zones*, areas with a certain risk per year of flooding, to provide information about flood risk to property owners, banks, and insurance agencies. (See examples, Figures 6.4 and 6.5.) Areas with a one percent risk per year are often known as “100 year” flood zones. However, a one percent risk of flood *per year* is *26 percent chance* over the life of a 30-year mortgage that a property will be flooded in a severe event. *Flood hazard zones* may differ from natural *floodplains*. Flood hazard zones may extend beyond the functional, natural floodplain.

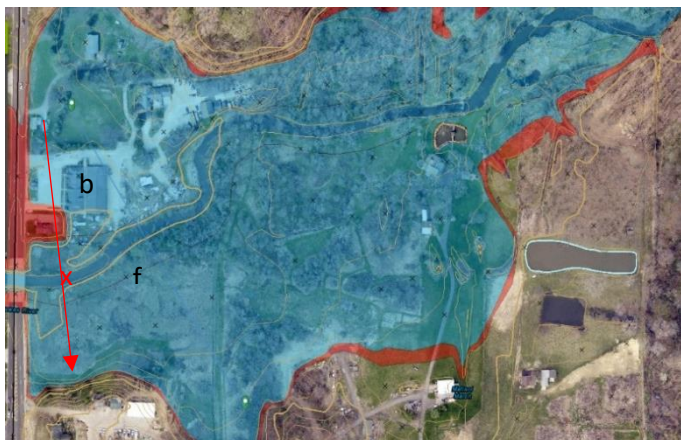
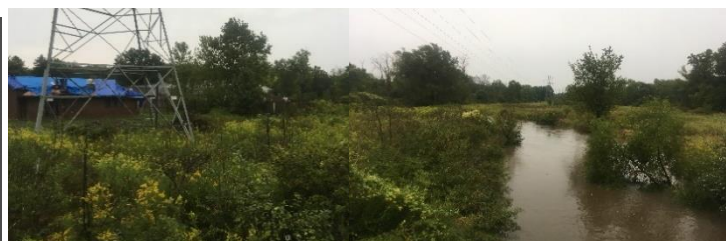
Figure 6.5
Altered Floodplain and Flood Zone

Altered Tuscarawas floodplain Arlington Rd. – The southern portion of the site is low-lying natural floodplain and is mapped as likely wetland. On the northern side, the building (b) is on filled land five feet above the natural floodplain. The 1% per year flood hazard zone extends up beyond the natural floodplain (f), past several buildings. When natural floodplain is filled, the water still goes somewhere, often up, putting buildings and people at risk. Buildings are permitted in the FEMA flood hazard zone if they follow the local requirements for the National Flood Insurance Program. The designated flood hazard zone can change over the years, with improved modeling, as more development upstream increases flooding downstream, and as people fill in the floodplain. This is likely an older use, pre-dating environmental rules.

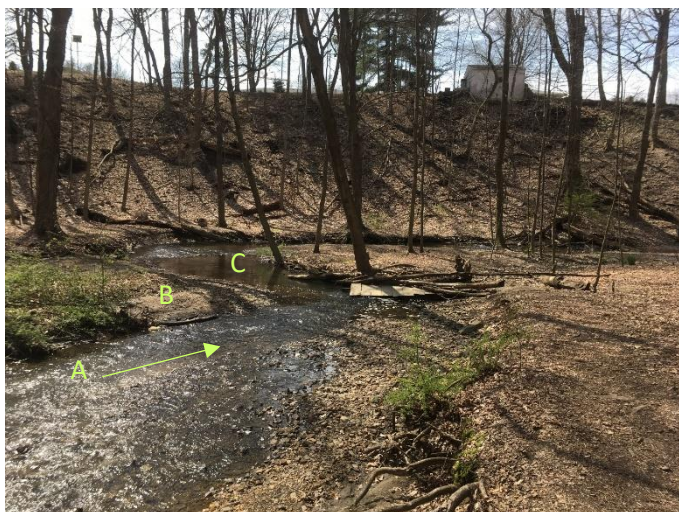
Wonder Lake Creek in Knapp Park shows many features of a healthy stream system. The sinuous form creates narrow areas of fast flow (thalweg, A), which clears out sediment during low flow. The wide, shallow channel accommodates high flow, which can also access the adjacent floodplain. The sinuosity slows down high flow. The substrate is stony, not silted in. It and the tree roots provide excellent habitat. The shallow riffles oxygenate the water and add to habitat. Cut banks due to the thalweg are on the outside of the curves and are paired with point bars (B), sediment deposited inside the curves in high flow. The smooth water in the background (C) may be a pool, increasing habitat diversity. Vegetation (greening up for spring) intercepts runoff, takes up nutrients, and stabilizes the banks.

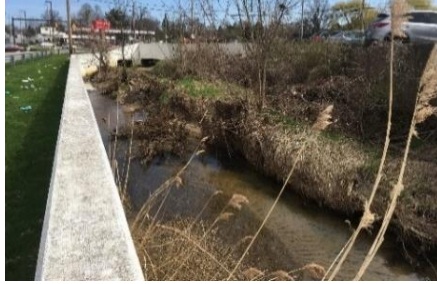
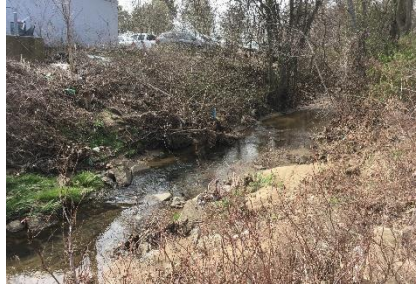
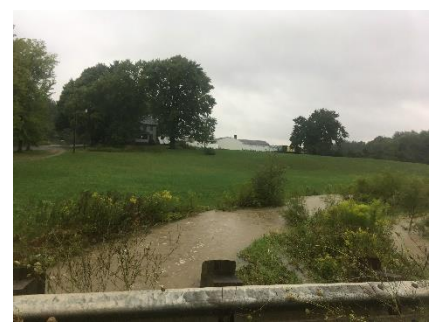
Above left, center - Brewster Creek flows through a highly impervious, watershed, generating heavy “flashy” flows. The banks and stream form have been altered, reinforced, straightened, and there is minimal functional floodplain. The habitat is degraded, banks erode, the creek is full of sediment, and high flows may cause urban flooding.

Above right and right – Metzger Ditch at Raber Rd. Ditches are carved to convey water quickly. Without meanders and accessible floodplain, they have no mechanism to slow down or release storm flow. Metzger/Myersville ditch, has been largely straightened, has minimal buffer, and flows through a densely developed area, which increases runoff. Stormwater races through the ditch in high flow, in an erosive torrent, through three culverts. The sediment deposits and the sediment plume in the channel demonstrate the high sediment load, which fills in stream habitat and receiving waters and carries nutrients, pathogens, and other contaminants.

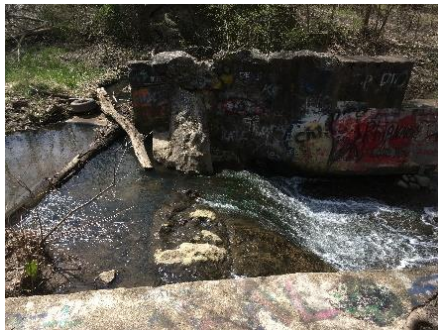
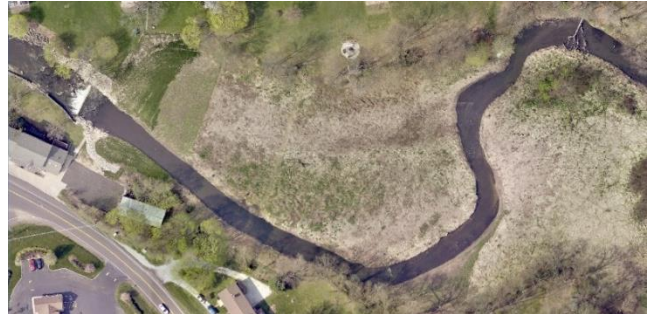
Old dams in the Portage Lakes watershed. As old dams are no longer used and fall into disrepair, it is worth evaluating whether to repair or lower/remove them. The latter improves the stream channel and water quality. Above, the water level behind Tritts Mill dam was lowered (temporarily) to reduce strain on the old dam. Image source Summit County Environmental Viewer. Left, Wonder Lake dam was lowered. The creek in the former dam pool area may be further restored.

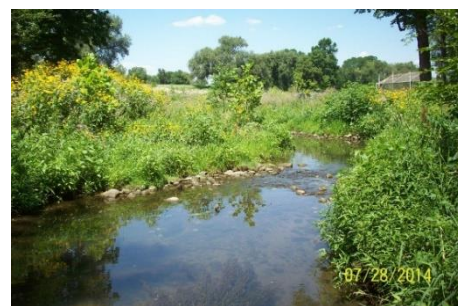
Formerly incised stream, with restored channel and floodplain. Photo source: R. McCleary, 2014.
