TRAFFIC SIGNAL MASTER PLAN

CITY OF OAKWOOD, OHIO

JUNE 14, 2023

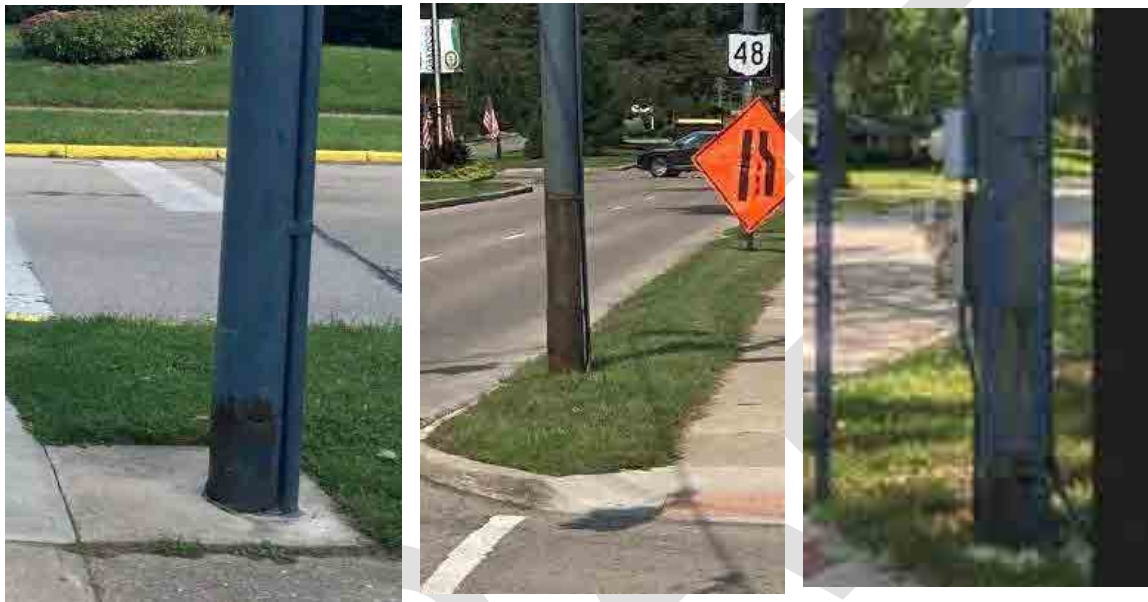
PHOTO 1: POLE CONDITION (L-R: ABERDEEN/SHAFOR, FHA/ABERDEEN, FHA/OAKWOOD)

An equipment audit of each was performed to document equipment condition. Field visits at each site included documenting types of traffic signal support and equipment used. See **Appendix B** for the ODOT Traffic Signal Timing Inspection forms. Visible corrosion was noted on many of the signal supports. See photos below of strain pole condition.

The existing traffic control equipment in the field is typically more than 20 years old. The strain poles typically more than 50 years old. The following table (**Table 2**) from NCHRP Report 713: Estimating Life Expectancies of Highway Assets (2008) provided guidance regarding useful life of various signal components:

6. Signal head and controller equipment upgrades to replace existing equipment that is beyond its useful life. Maintenance costs will continue to increase as the reliability of the existing equipment degrades.

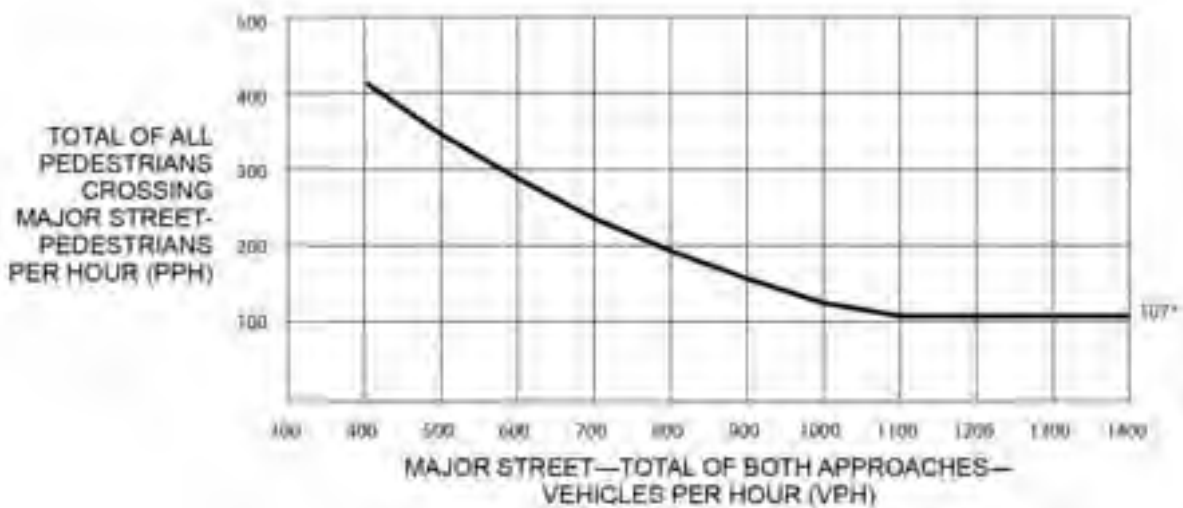
FIGURE 4: OMUTCD FIGURE 4C-5 WARRANT 4, FOUR-HR PEDESTRIAN VOLUME

The four highest pairs of total hourly pedestrian volume crossing a major street and its corresponding total hourly volume from both major street approaches were used in analyzing warrant #4. The signal warrant spreadsheet then plots and compares these volumes with the signal warrant #4 thresholds presented in Figure 4C-5 and Figure 4C-7 of the OMUTCD (see **Figure 4** and **Figure 5** respectively) and determines whether the signal is warranted.

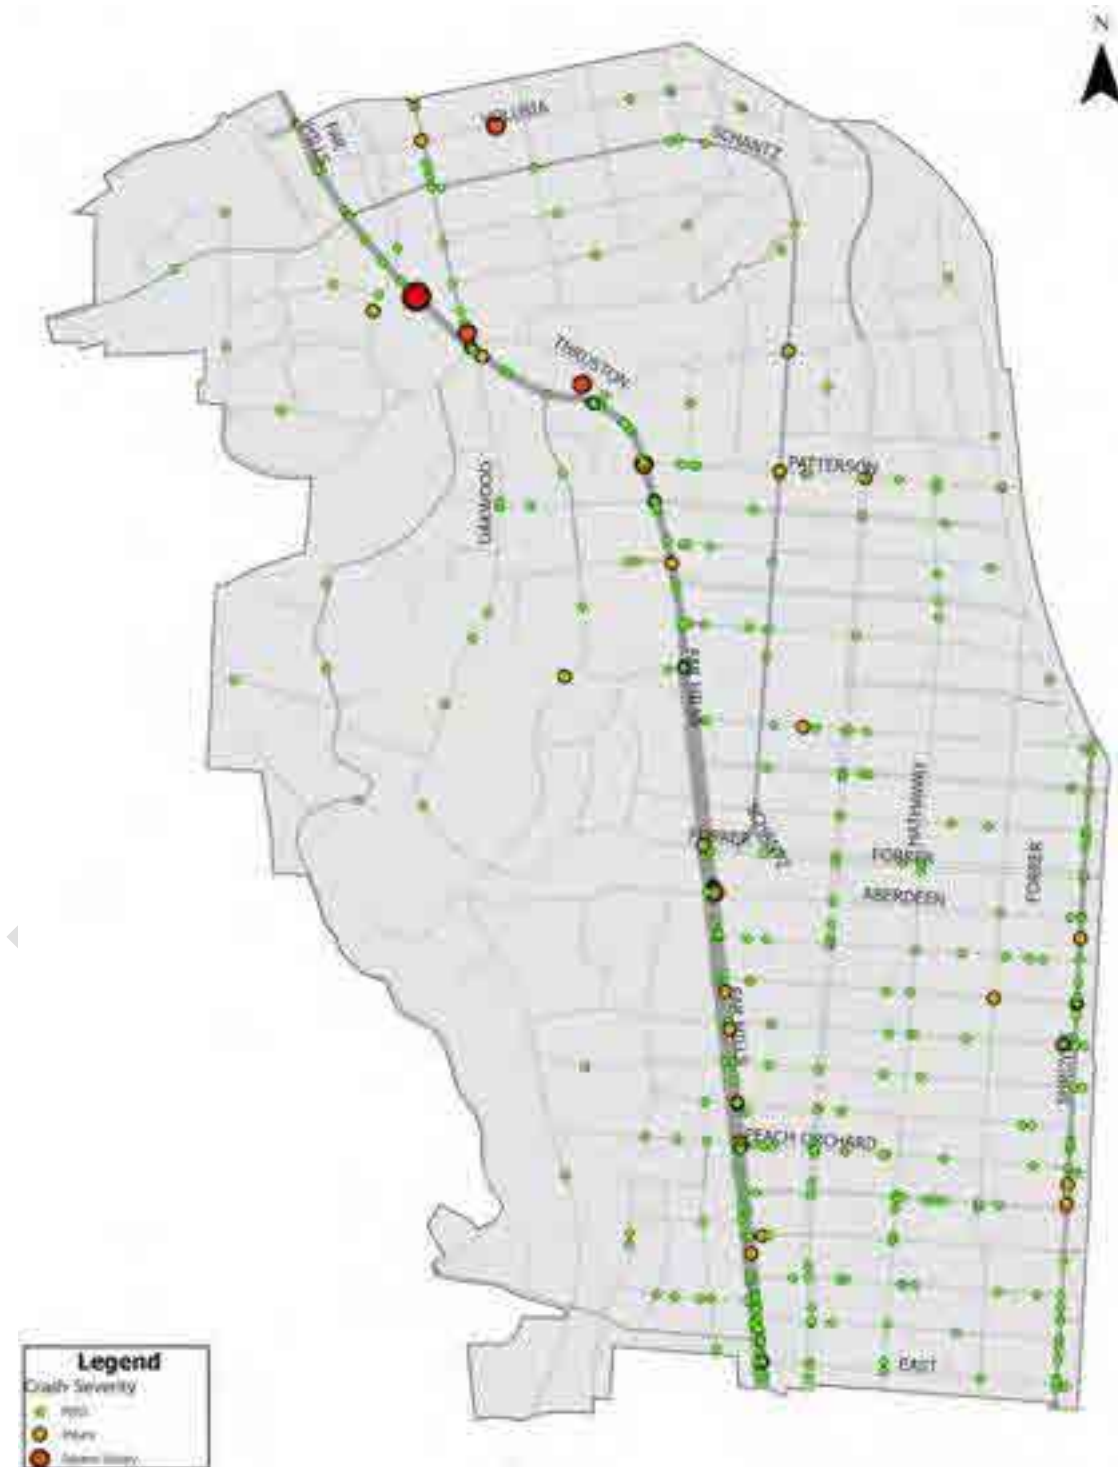
FIGURE 8: CRASH DATA 2018- 2021

Crash analysis was conducted to identify the priority locations within the county roadway system using crash data from January 1, 2017 - December 31, 2021. During the study period 494 crashes occurred within the City of Oakwood. These crashes resulted in a total of one fatality and 6 serious injury crashes. **Figure 8** shows all crashes and the severity by location for the overall study area.

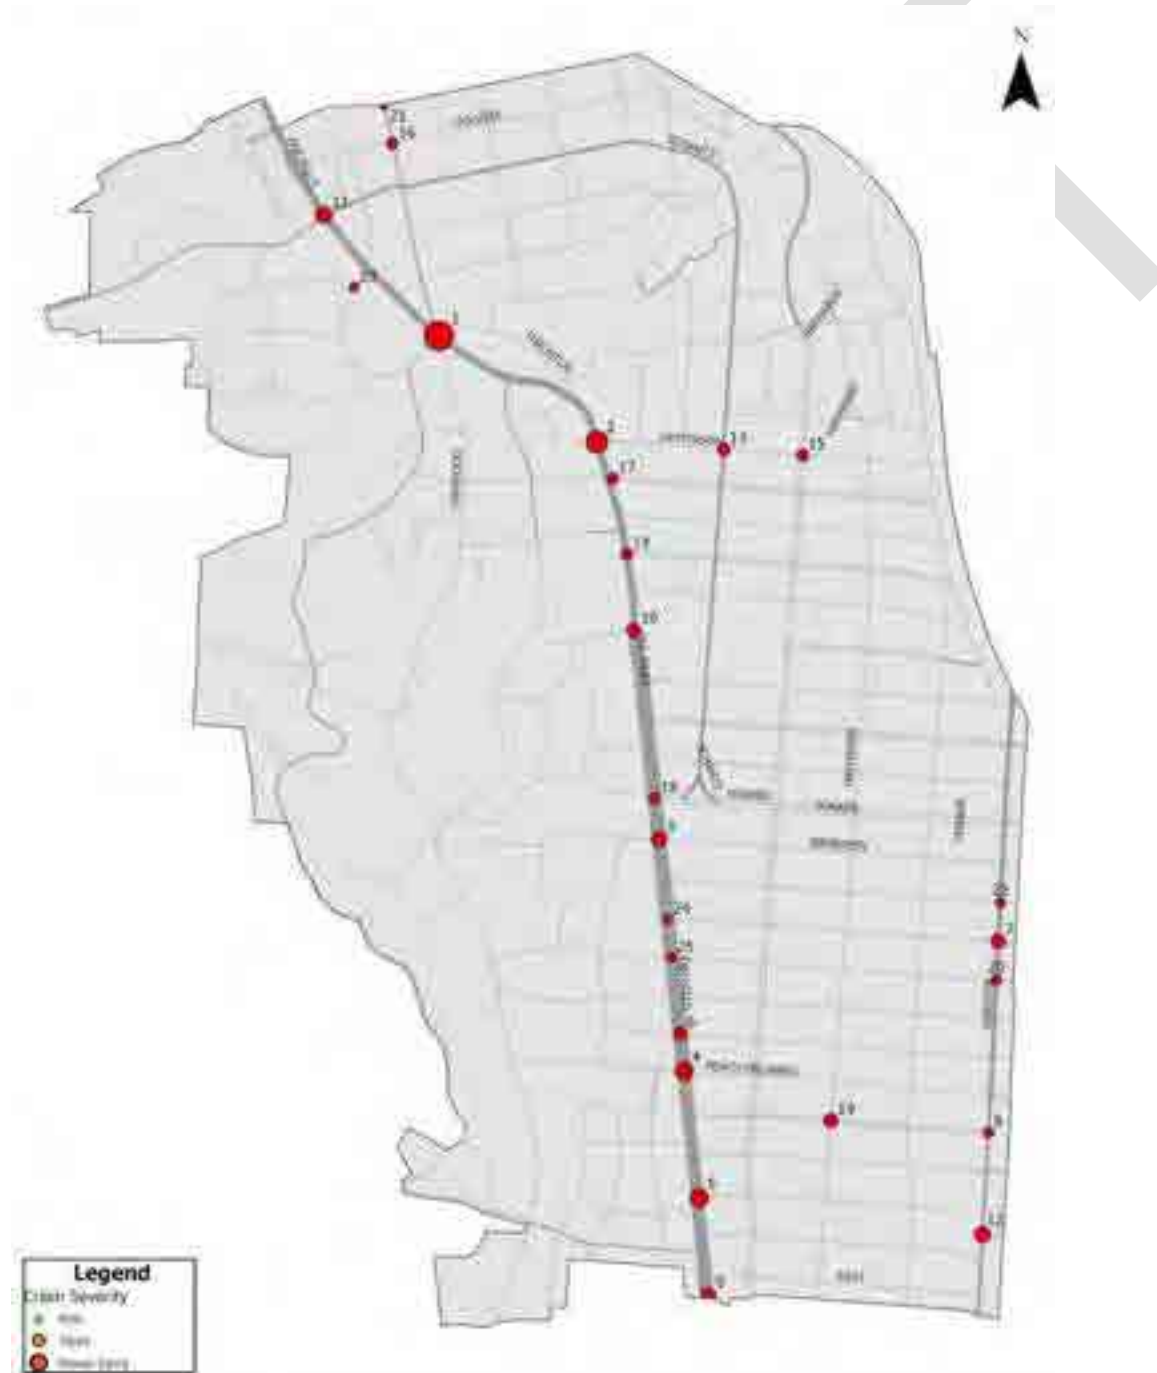
FIGURE 10: OAKWOOD PRIORITY LOCATIONS

The revised priority list is the basis for future systemic, abbreviated or formal safety funding. The top location (Far Hills Avenue at Oakwood Avenue/ Thruston Blvd) was selected to conduct a more detailed evaluation to determine if feasible countermeasures could be developed to obtain ODOT safety funding. **Figure 10** shows the Top 25 priority locations.

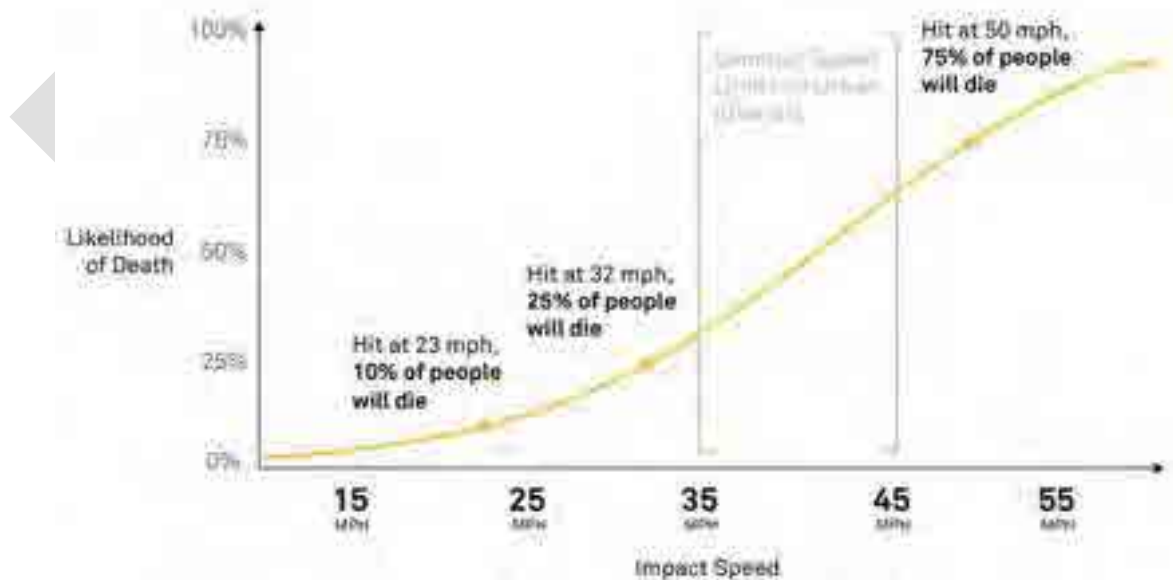
FIGURE 13: SPEED VS FATALITY COMPARISON

The National Association of City Transportation Officials (NACTO) graphic in a 2020 City Limits document shows the probability of a fatality for different operating speeds. Based on the 85th percentile speeds on SR48 north of the subject intersection, the likelihood of a fatality may be as high as 50% based on an operating speed of 42 MPH.

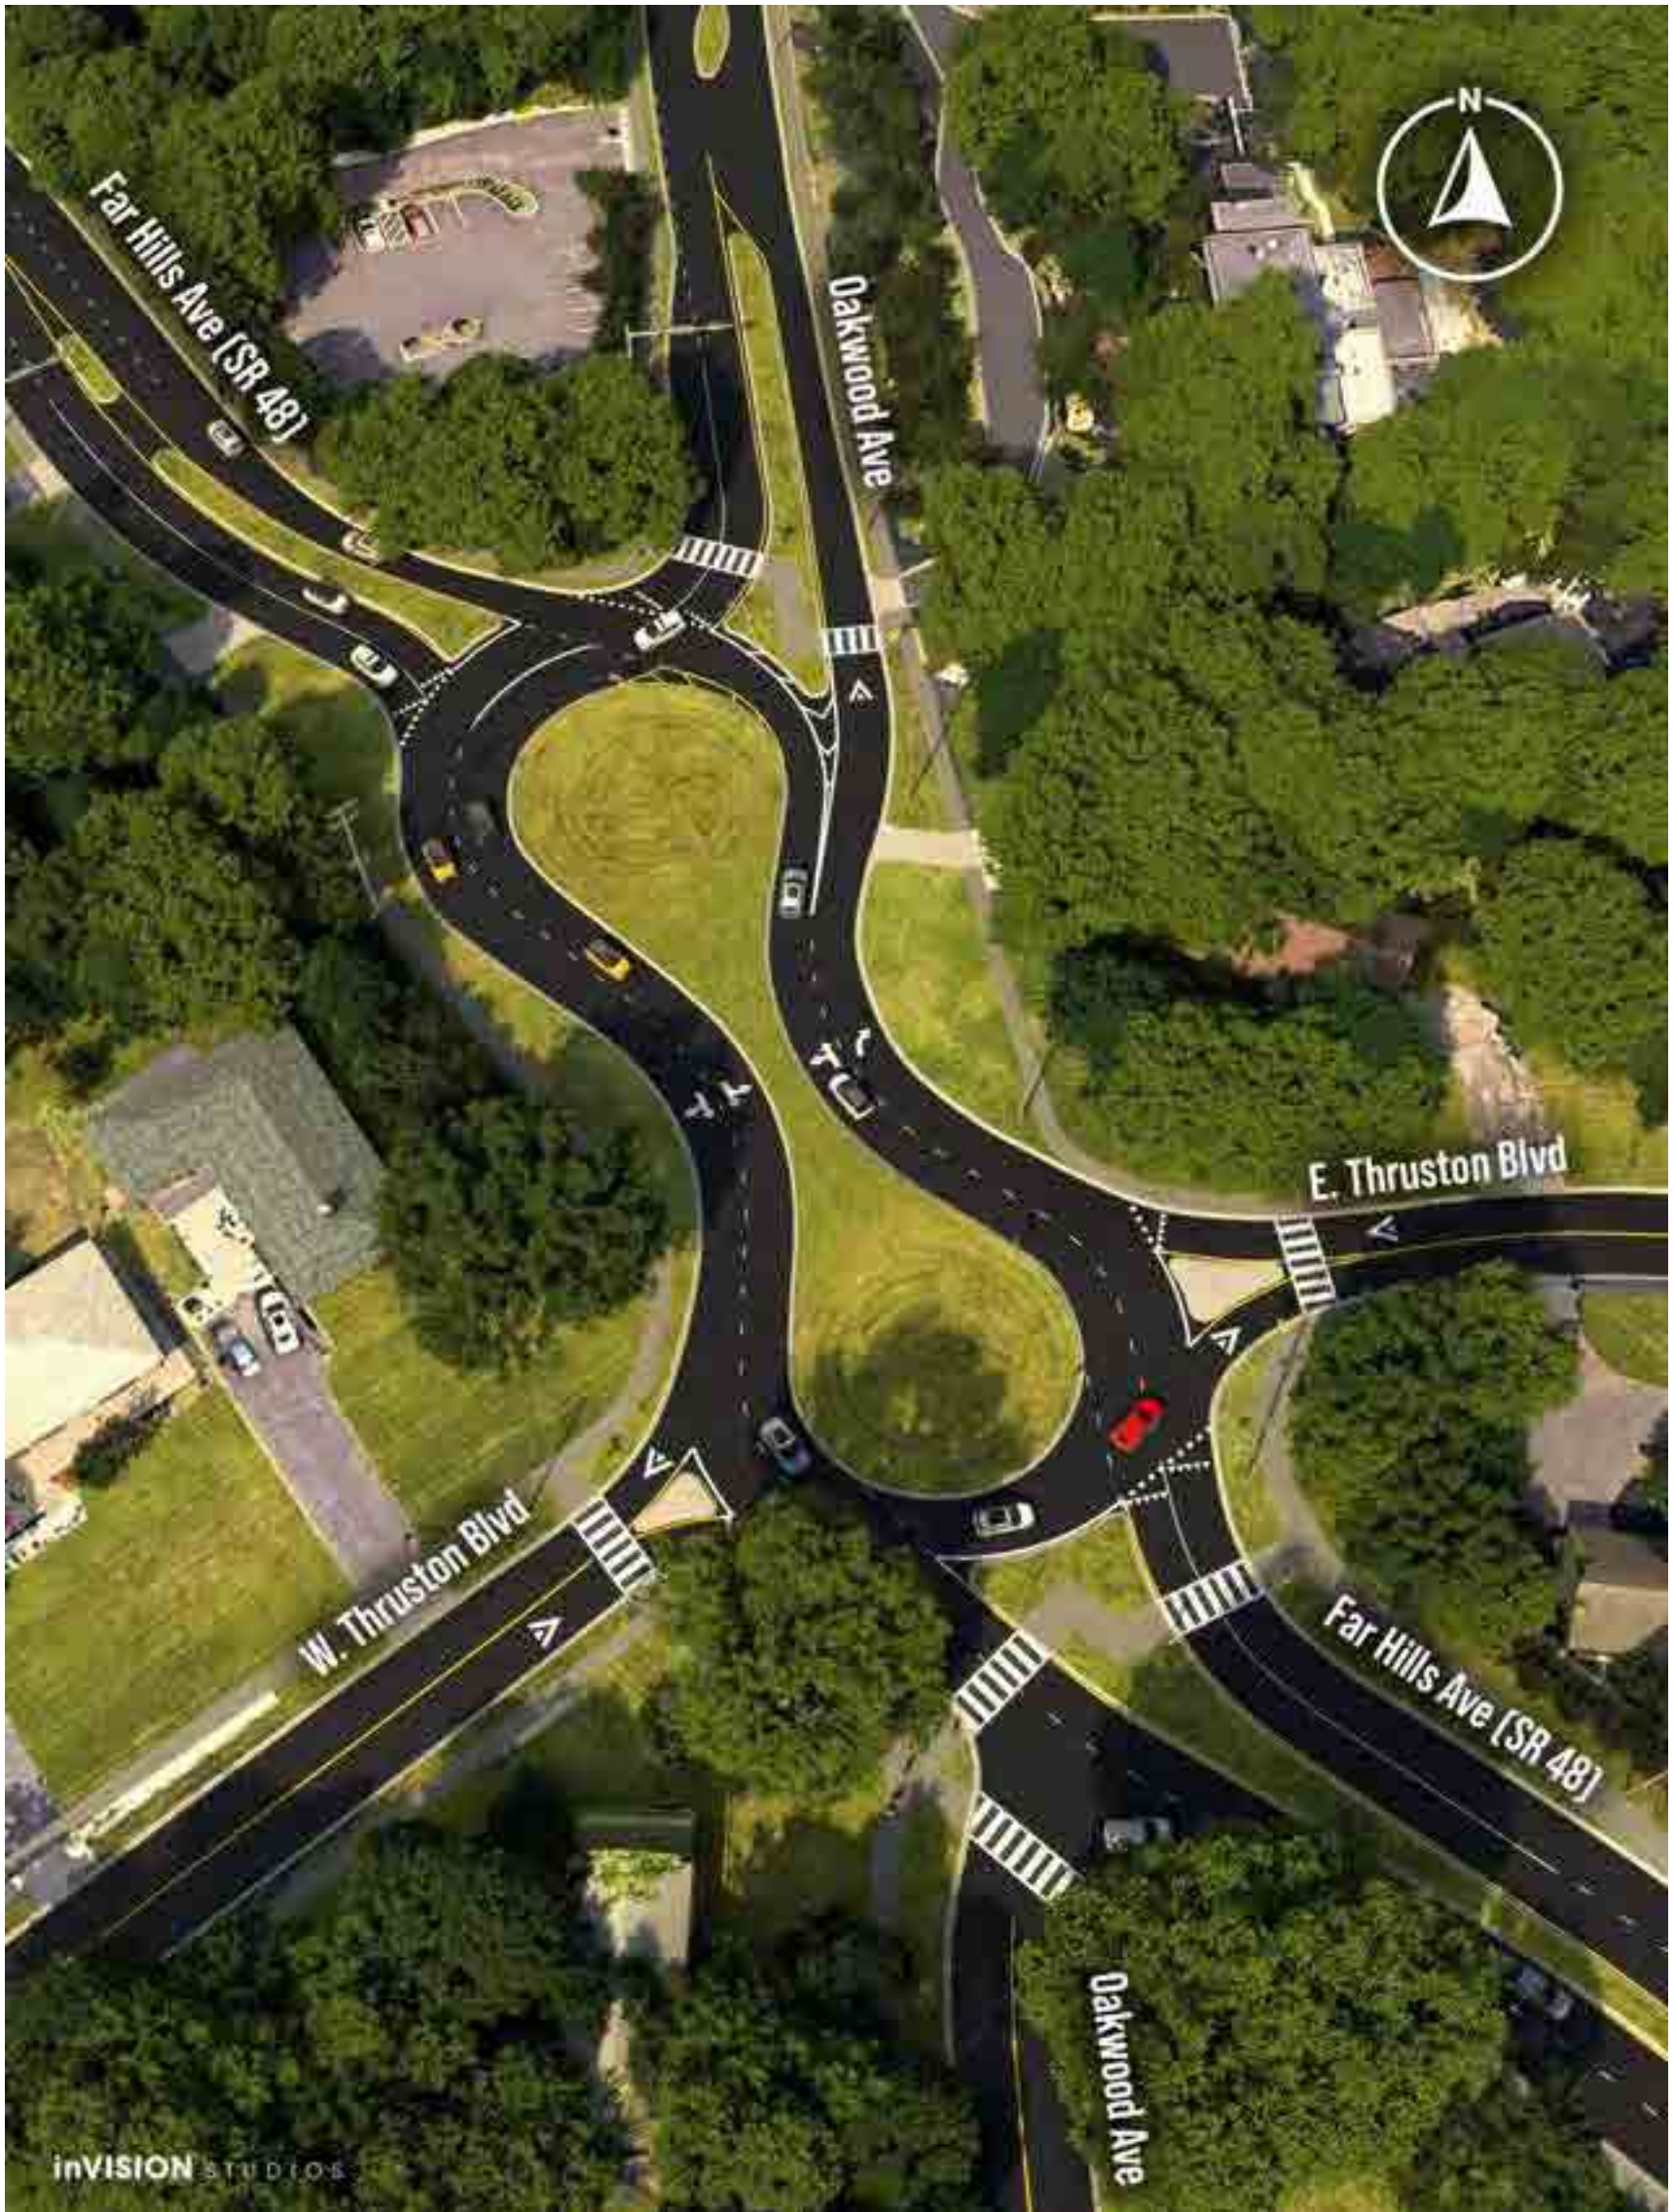
FIGURE 14: ROUNDABOUT CONCEPT PLAN

Appendix G contains additional information related to the roundabout alternative. Note the Schantz Park Historic District is located north of the Five Points intersection. Two properties (501 Oakwood Avenue; 414 Oakwood Avenue) are listed on the Ohio Historic Inventory which is a state level designation (i.e., not listed on the National Register of Historic Places). Minor property acquisition may be required to accommodate a roundabout at the Five Points intersection.
