DRAFT BIOLOGICAL RESOURCES ASSESSMENT

FALCON POINT ASSOCIATES, LLC
CREEKWOOD HOUSING DEVELOPMENT PROJECT

MAY 2024

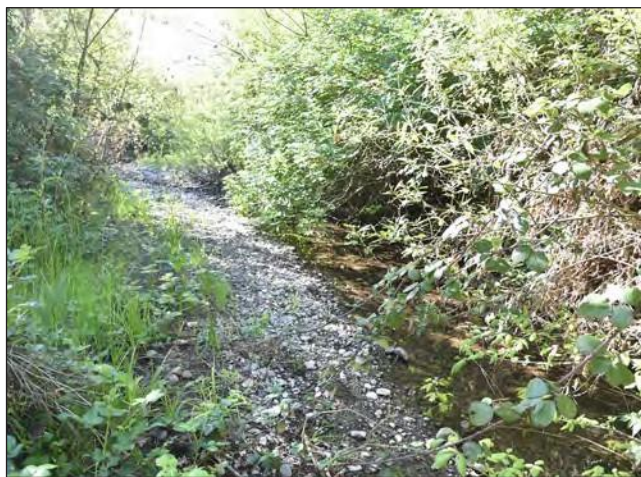
PHOTO 3: Adobe Creek.

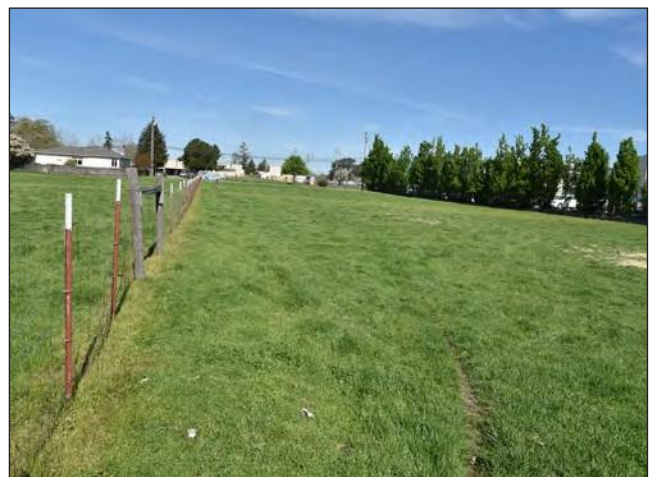
PHOTO 4: East to west view of grazing pasture of non-native grassland fields.

Approximately 4.15 acres of annual grassland habitat occurs within the Project Site. The annual grasslands fall under the classification of *Avena spp. – Bromus spp.* Herbaceous Semi-Natural Alliance (CNPS 2023b). This area, shown in **Figure 4**, had been disked and planted with mixed non-native grasses and forbs as forage crops for sheep grazing. Species observed in these fields include oats (*Avena spp.*), soft brome (*Bromus hordeaceus*), riggut brome (*Bromus diandrus*), field bindweed (*Convolvulus arvensis*), wall barley (*Hordeum murinum*), bristly ox-tongue (*Helminthotheca echioides*) common stork's-bill (*Erodium cicutarium*), and Italian ryegrass (*Festuca perennis*). Representative photos of this habitat can be seen in Photos 4, 5, and 6 of **Figure 5 of Appendix A**.

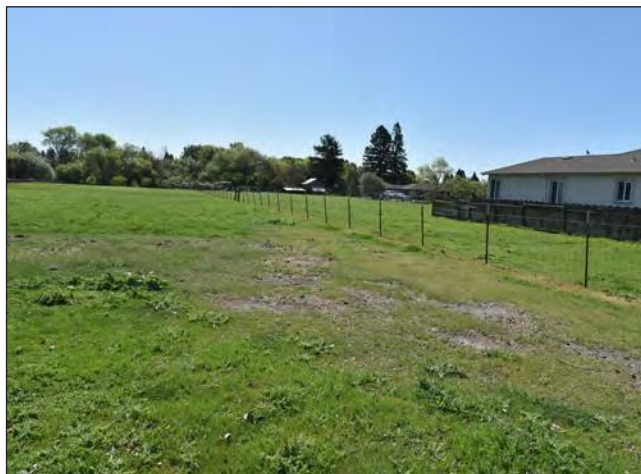
PHOTO 5: West to east view of property from Casa Grande Road.

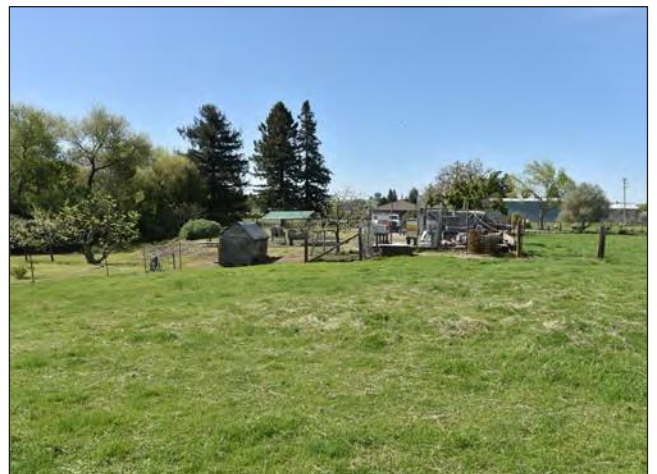
PHOTO 6: Animal pens including fields, riparian corridor in the background.

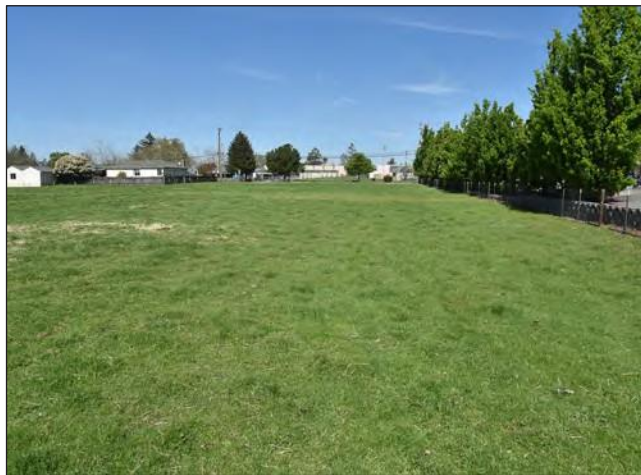
PHOTO 3: A representative view of the annual grassland habitat occurring within the Study Area, facing northwest towards Casa Grande Road.

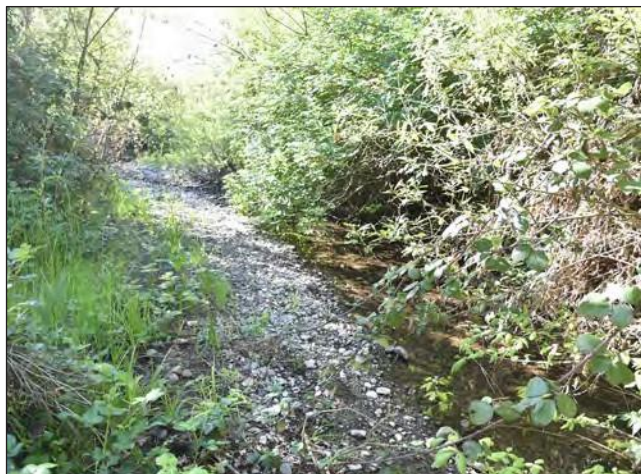
PHOTO 5: Showing the dense riparian habitat along Adobe Creek.

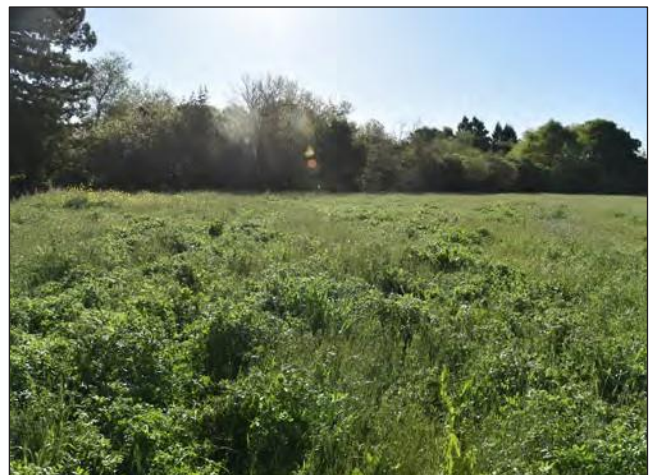
PHOTO 4: Riparian habitat along the eastern boundary of the Study Area.
